# Rail Accident Report

## Road vehicle incursion onto the railway at Aspatria, Cumbria 26 October 2013

Report 14/2014  
June 2014

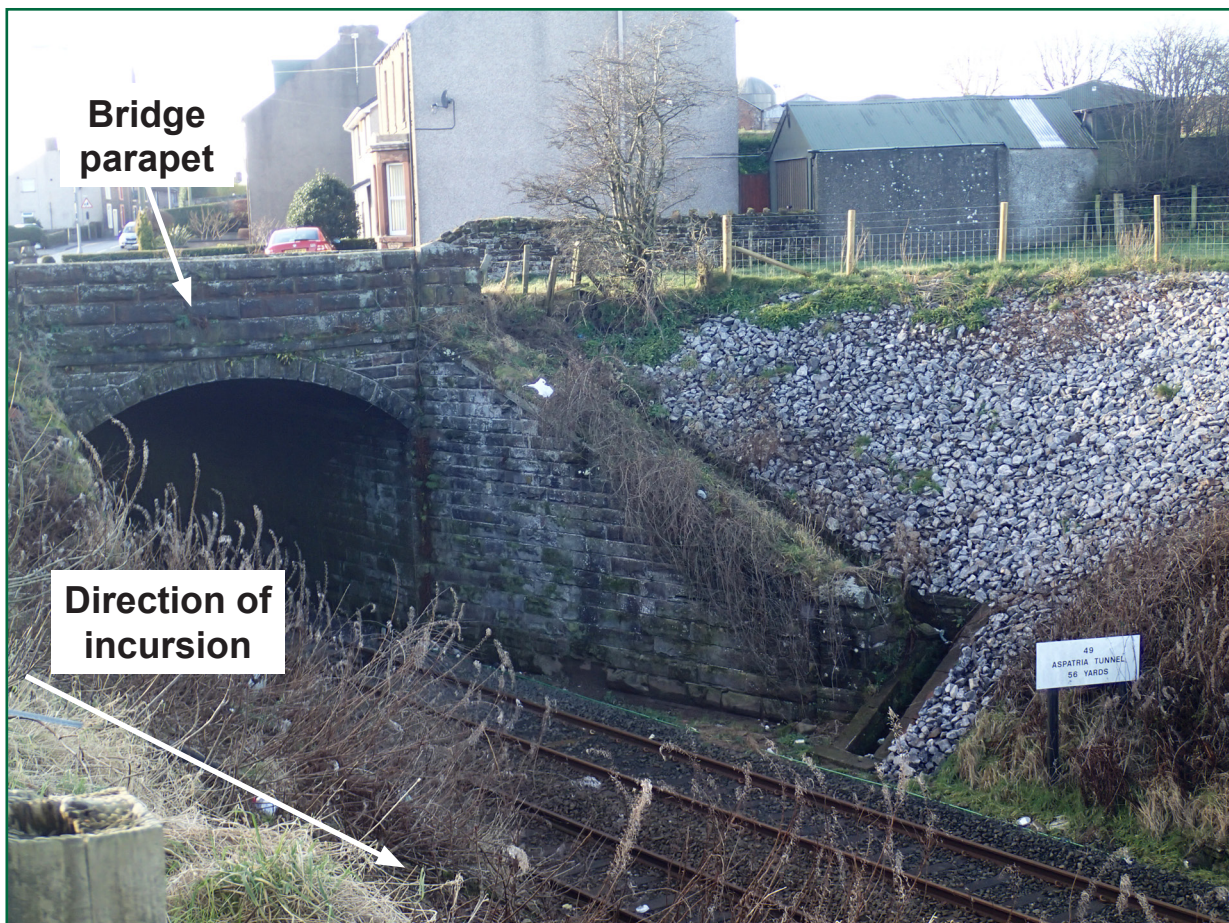
Figure 2: Bridge 49 at Aspatria

- 12 The incident occurred at Aspatria immediately to the east of bridge 49 (otherwise known as Aspatria tunnel) (figure 2) at 8 miles 40 chains<sup>1</sup> on the double track railway from Workington to Carlisle. This line is in Network Rail's London North Western *Route* and is mainly used by passenger trains operating a service at roughly hourly intervals in each direction. A few freight trains also operate on the route. The maximum permitted speed of passenger trains is 60 mph (90 km/h). Freight trains can also travel at a maximum speed of 60 mph (90 km/h) approaching Aspatria, but there is a *permanent speed restriction* requiring them to slow to 20 mph (32 km/h) between 8 miles 40 chains and 7 miles 68 chains in each direction because of the condition of the track.

- 15 Bridge 49 carries the A596 road over the railway at a significant skew resulting in the width of the bridge between the *parapets* being 51.2 metres (56 yards). The A596 road runs from Thursby, just outside Carlisle, to Maryport and Workington and approaches the bridge from the north-east running broadly parallel to the railway until it crosses over it. It was classified as a *trunk road* until it was formally *detrunked* on 1 April 2003. Just before the road crosses the railway, there is a junction with the B5299 Brayton Road, approaching from the east (figure 3).

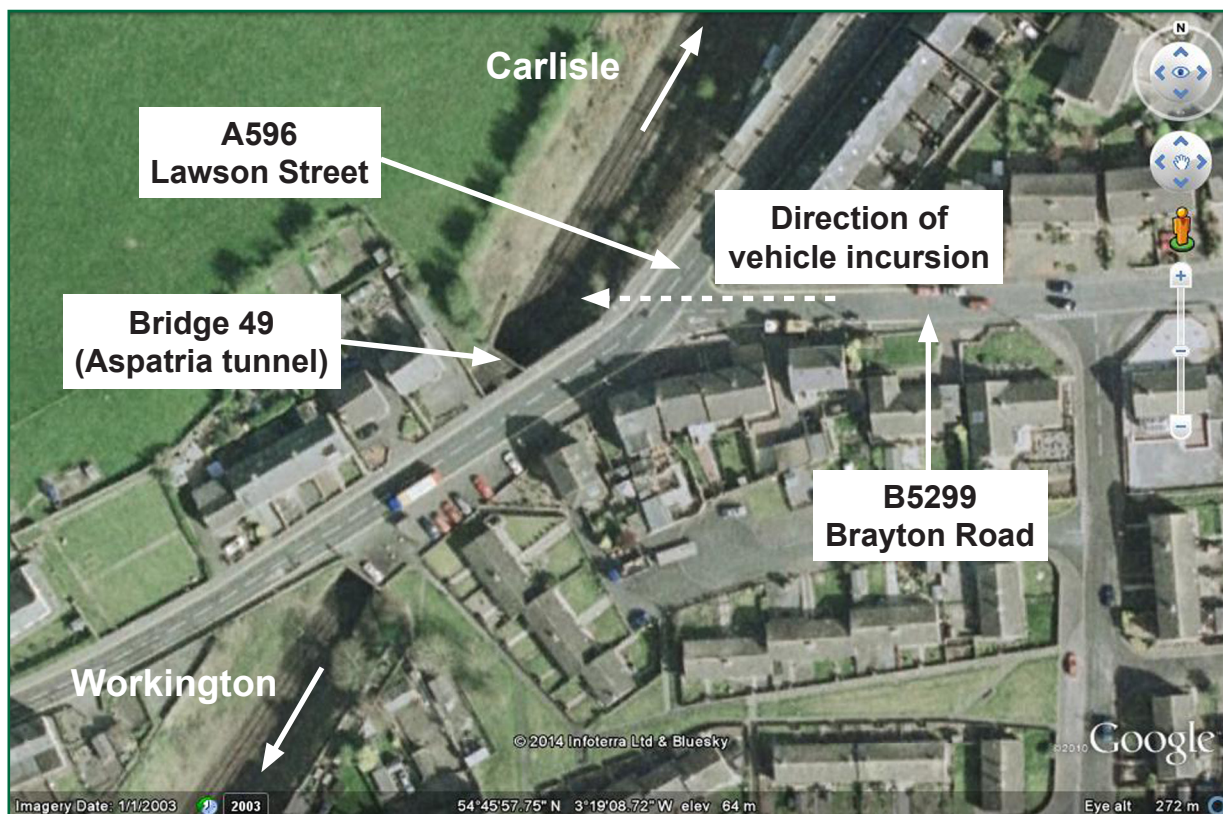
Figure 3: Site location, Aspatia

- 16 Brayton Road approaches the junction with the A596 on a downward gradient of about 3% (1 in 33) and directly opposite the junction the railway boundary is protected by a wooden fence. Beyond the fence, the railway lies in a cutting immediately before bridge 49. Between the end of the wooden fence and the bridge parapet there is a section of parapet laid on top of the cutting's *retaining wall* (figures 4a, 4b, 5a and 5b).

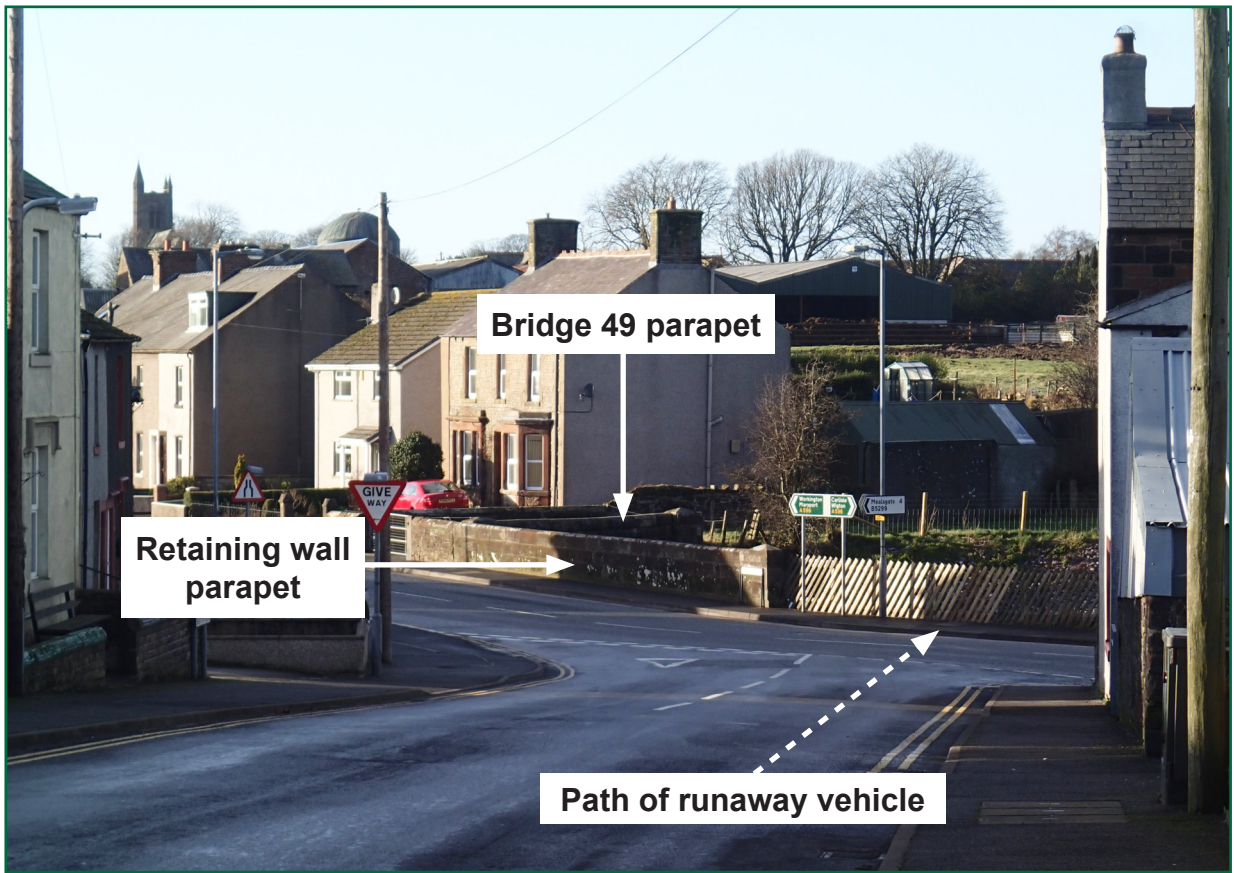
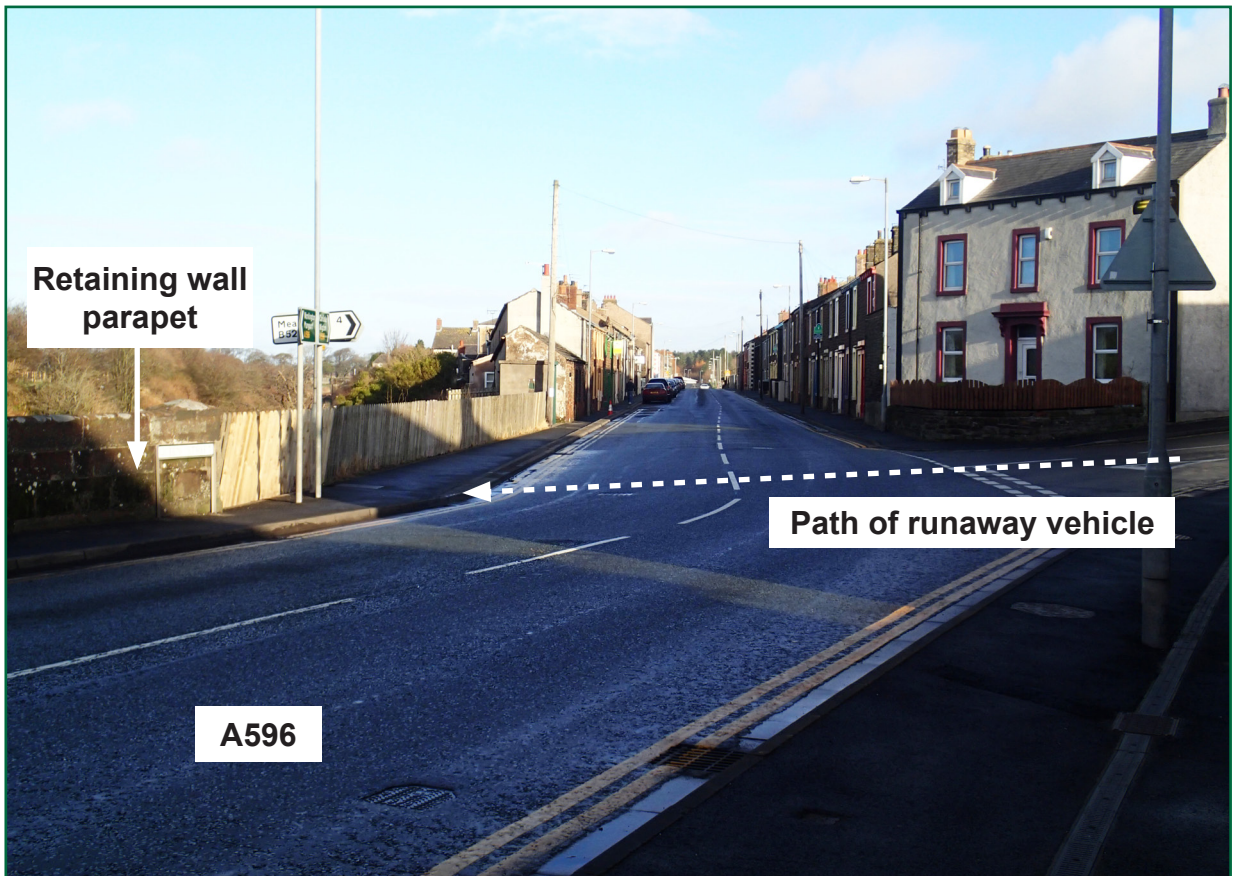
Figure 4a: The wooden fenced boundary opposite the A596/B5299 junction

Figure 4b: The wooden fenced boundary opposite the A596/B5299 junction

- 43 The RAIB has concluded that the approach adopted was inappropriate, because the wooden section of fence, forming the boundary between the A596 road and the railway, is not part of the bridge 49 parapets. The wooden fence adjoins the section of the parapet built on the cutting's retaining wall before the bridge is reached (paragraph 16 and figure 4a).

- 63 At the time of publication, Network Rail was working on the design of a safety barrier to be implemented to reduce the risk of vehicle incursion opposite the B5299/A596 junction. The funding for this would be shared between Network Rail and the highway authority.

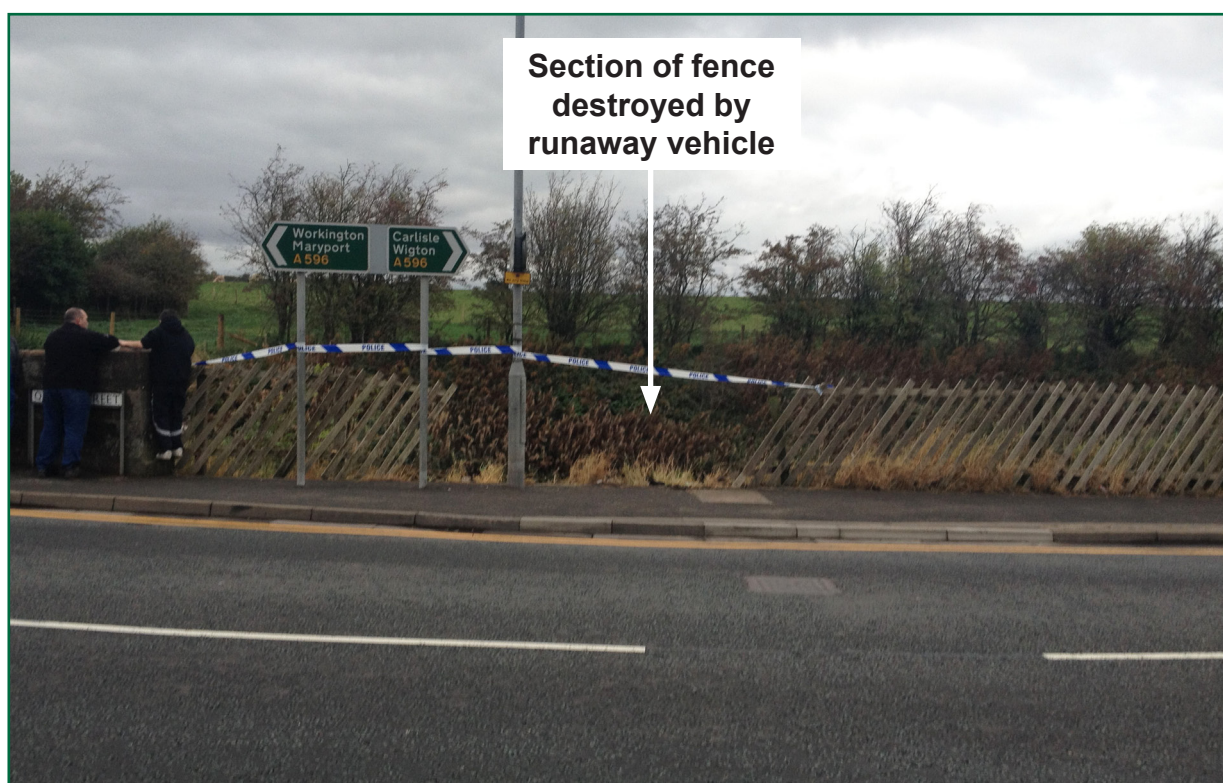
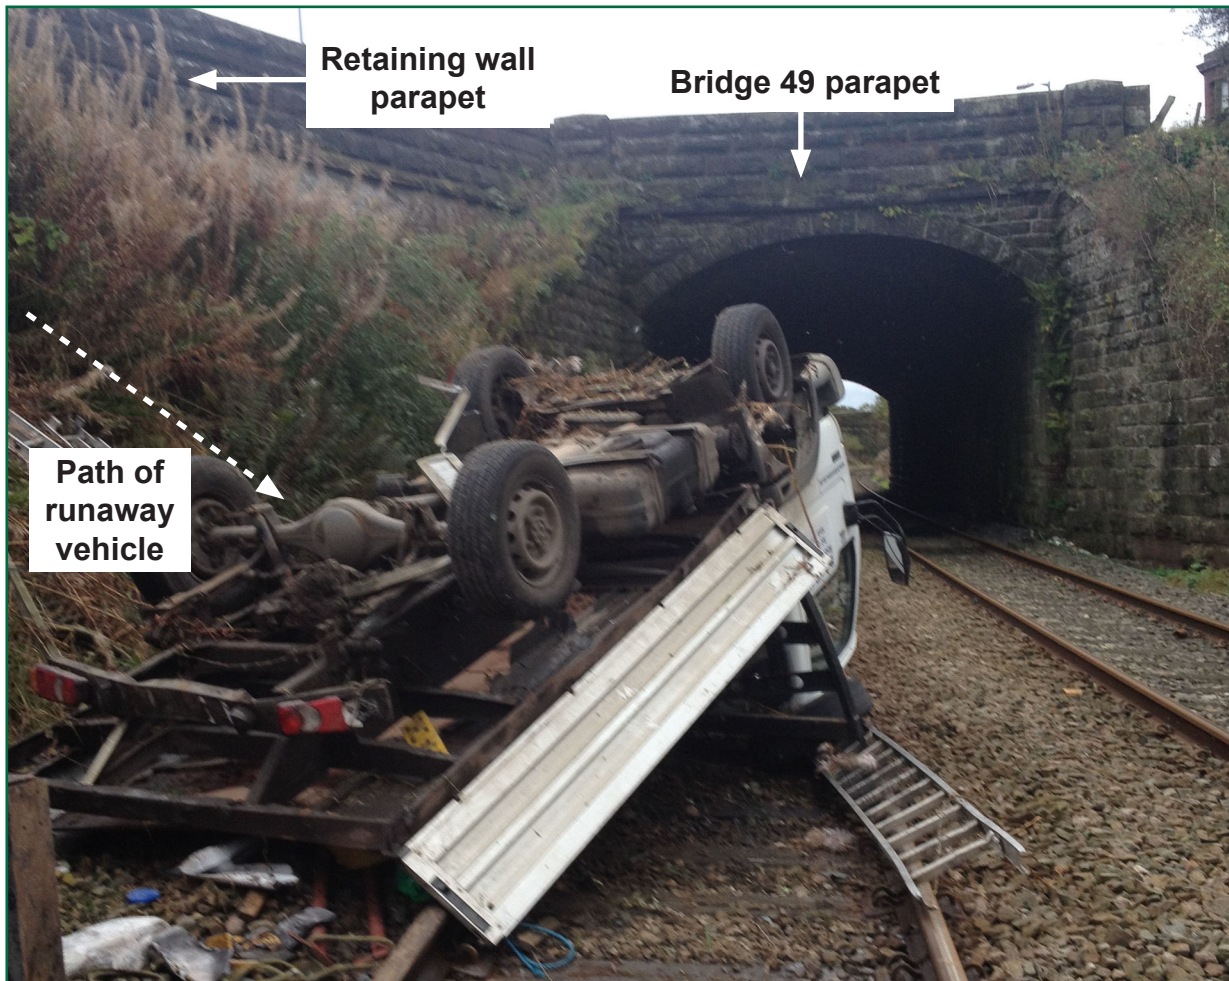
- 22 The vehicle driver parked the Nissan Cabstar on the offside of Brayton Road, facing uphill, about 100 metres from its junction with the A596, shortly before 10:00 hrs on 26 October.
- 23 About two minutes later, according to its driver, the vehicle ran away onto the railway (figures 5a and 5b). The police reported that it appeared part of the handbrake had failed, although it was not possible to determine which part because of the damage caused to the vehicle.

Figure 5a: The consequences of the runaway from the B5299/Brayton Road (courtesy of Network Rail)

Figure 5b: The consequences of the runaway from the B5299/Brayton Road (courtesy of Network Rail)

- 48 **The unattended road vehicle ran away down the B5299 Brayton Road towards the railway and neither the roadside kerb nor the wooden fence forming the railway boundary opposite the road junction with the A596 Lawson Street prevented the road vehicle entering the railway infrastructure.**

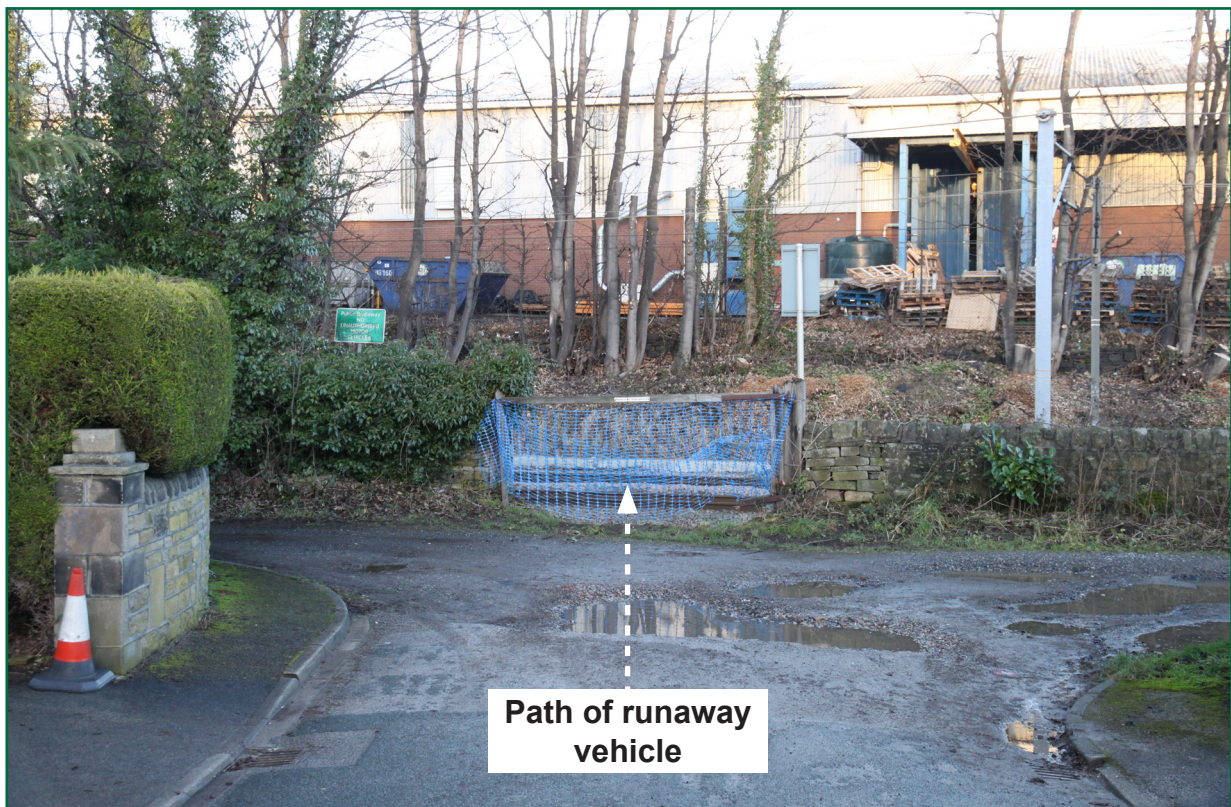
- 56 A vehicle incursion incident occurred at Bingley, West Yorkshire, on 11 November 2013, which was similar in nature to the incident at Aspatria. Just before 20:43 hrs, an unattended Vauxhall Corsa car parked on Healey Avenue ran away down the hill and, at a T-junction with an unmade road, carried straight on through a wooden gate in the railway boundary wall and ended up on the railway track (figure 6). The vehicle was subsequently struck by train 2H70, the 20:26 hrs from Leeds to Skipton (figure 7). There were no injuries and the train was not derailed.

Figure 6: The location of the vehicle incursion incident from Healey Avenue, Bingley, on 11 November 2013

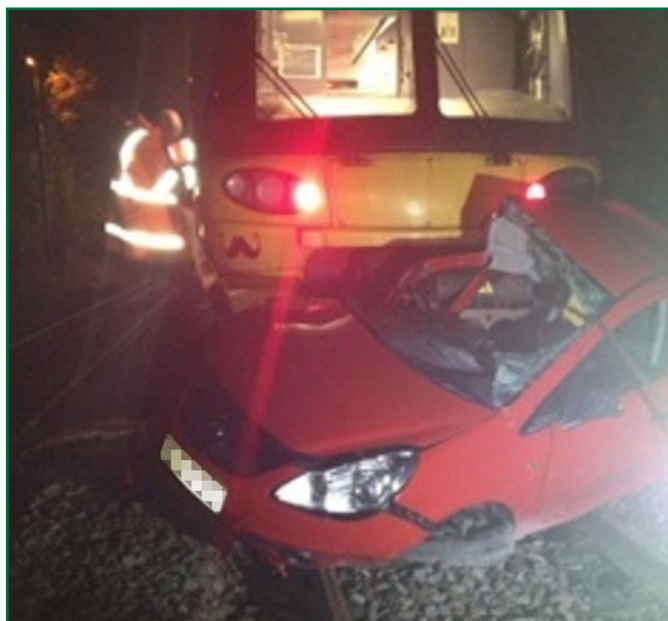
Figure 7: The accident at Bingley following the runaway from Healey Avenue onto the railway (courtesy of Northern Rail)
