Rail Accident Investigation Branch

# Rail Accident Report

## Uncontrolled evacuation of a London Underground train at Holland Park station 25 August 2013

Report 16/2014  
July 2014

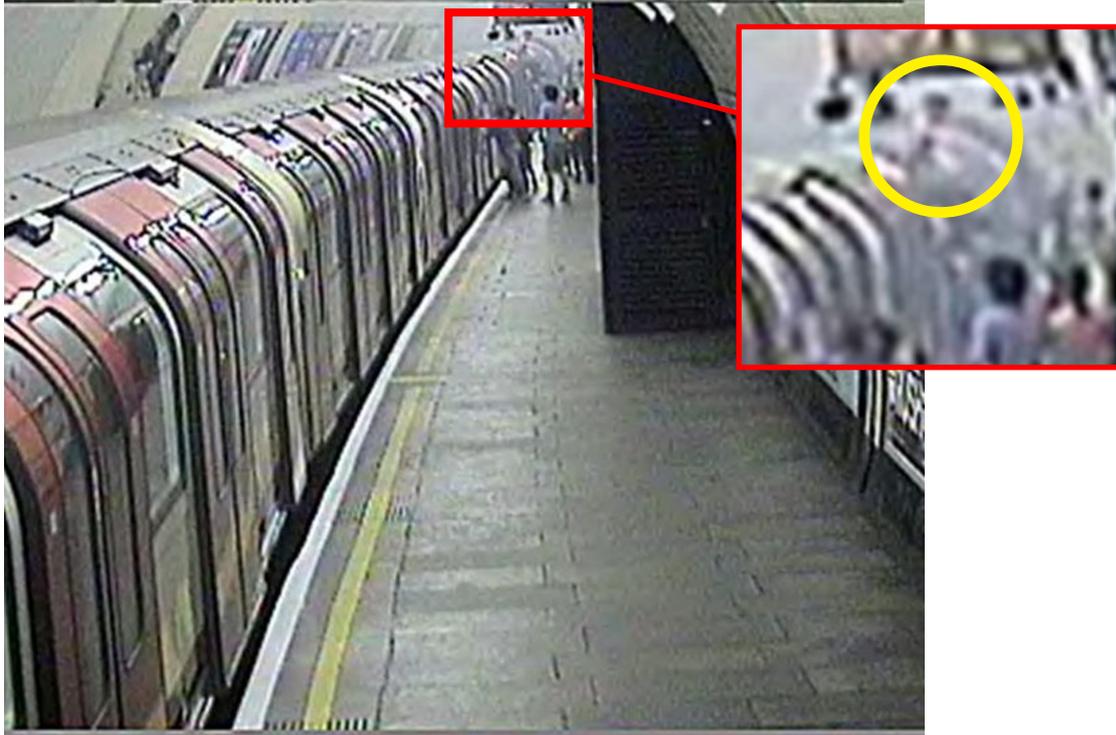
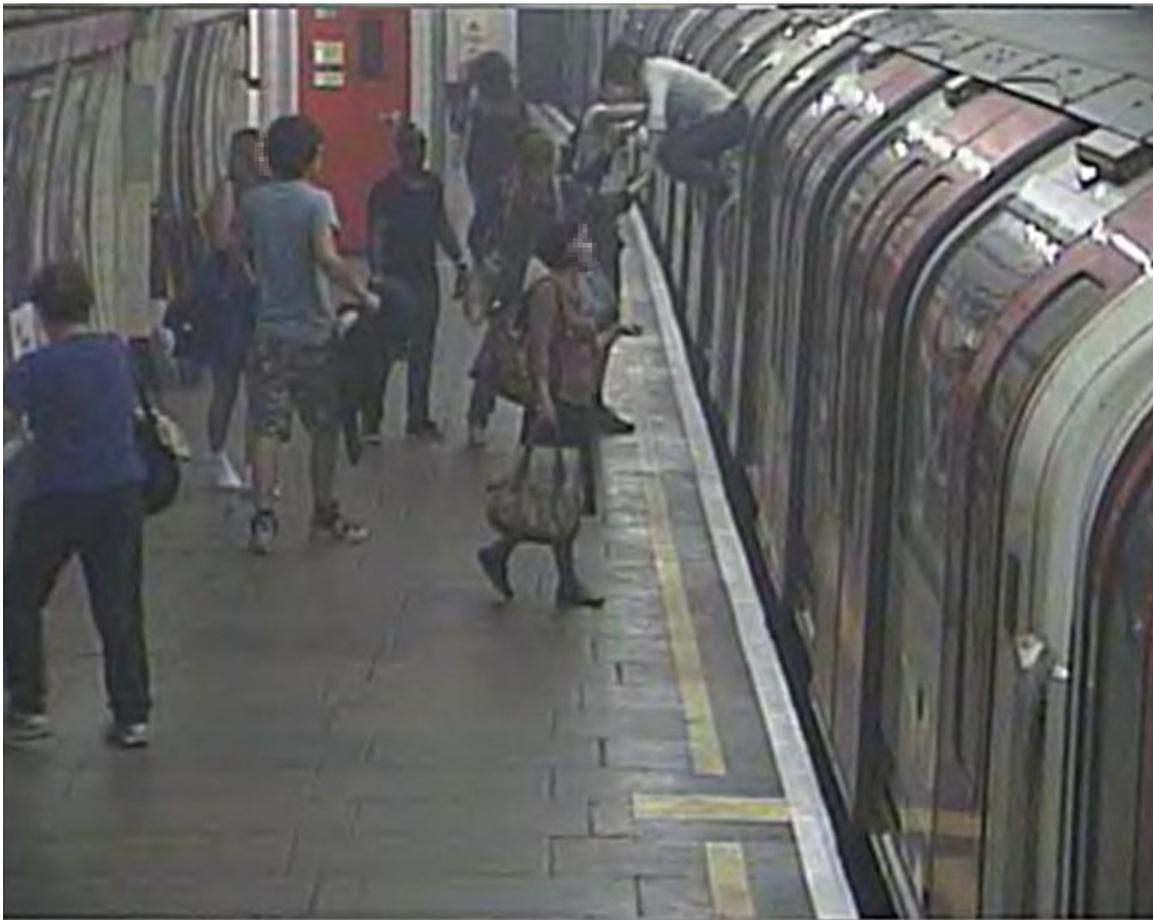
- 6 The train came to a stand with part of the leading car in the running tunnel and with the remainder of the train in the platform. The doors remained locked. Very quickly, fear spread through the train and people, both on the train and on the platform, tried unsuccessfully to force open the doors.
- 7 After less than two minutes passengers began to get out of the train using the interconnecting doors between cars. Over a two minute period approximately 13 people, including some children, climbed over barriers in the gaps between cars to reach the platform (figures 2 and 3).

Figure 2: CCTV images of persons self-evacuating the train

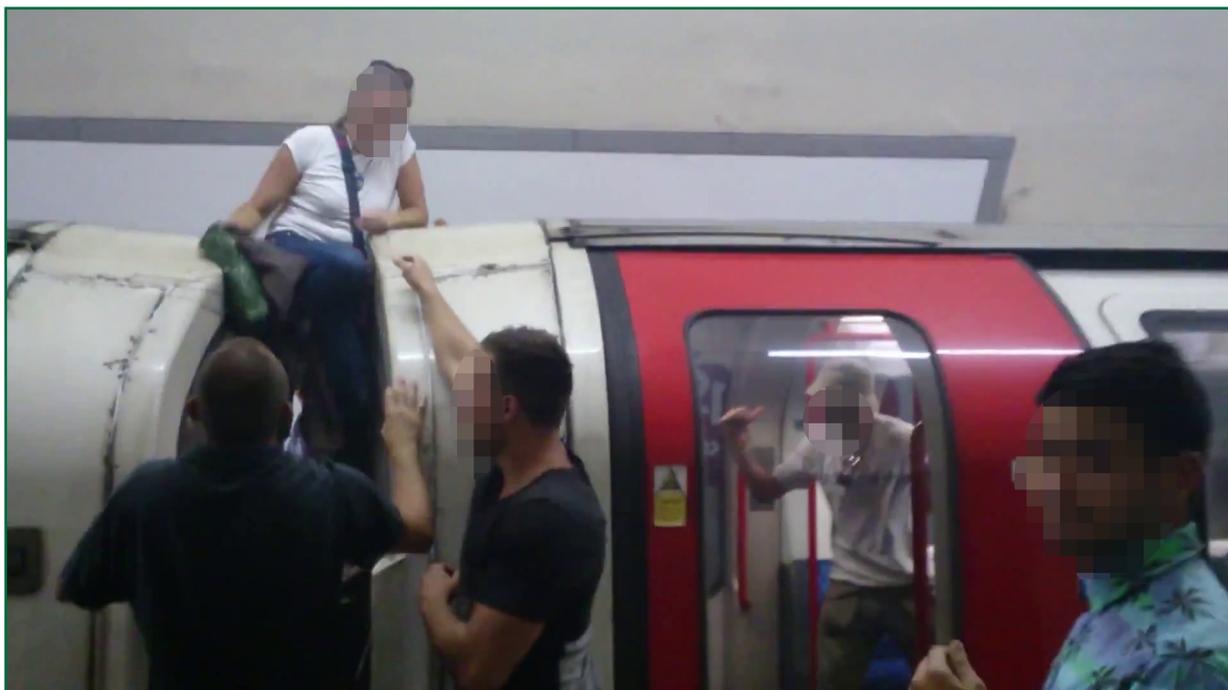
Figure 3: Passenger climbing out between cars 3 and 4 (image courtesy of newsflare.com)

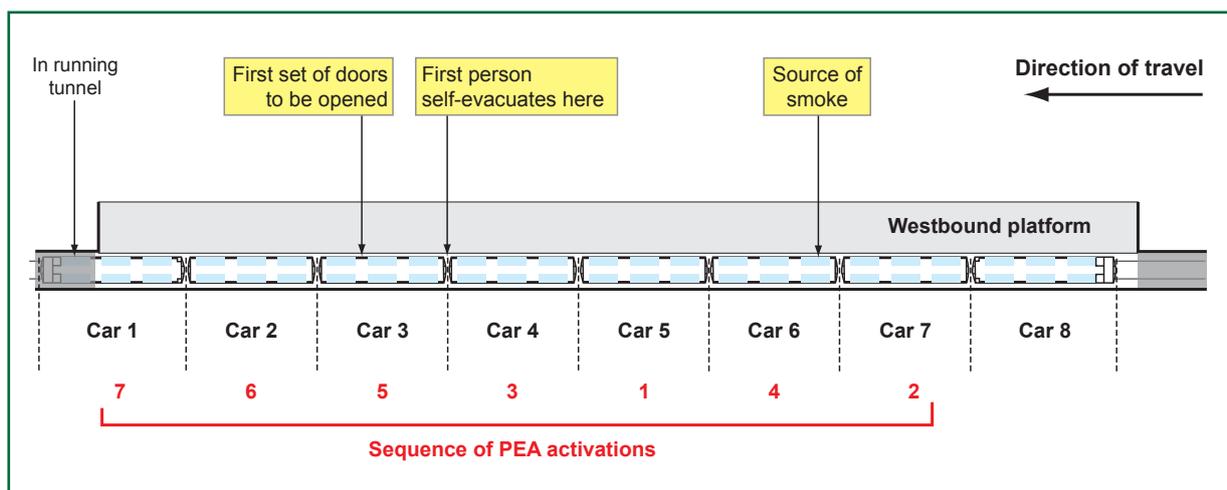
Figure 5: Diagram of train showing incident position in the platform and the sequence of passenger emergency alarm activations

- 44 Around 18:35 hrs, train 003 moved off from the platform at Holland Park station but within seconds was brought to a stand by the activation of a passenger emergency alarm (figure 6) in car 5. The train had travelled about five metres, putting the leading car partly in the running tunnel. Twenty-two seconds later a passenger emergency alarm activation was made in car 7, followed at short intervals by activations from cars 3, 6, and 4. Over a period of almost three minutes there were seven passenger emergency alarm activations in total (figures 5 and 8). The train doors remained locked.

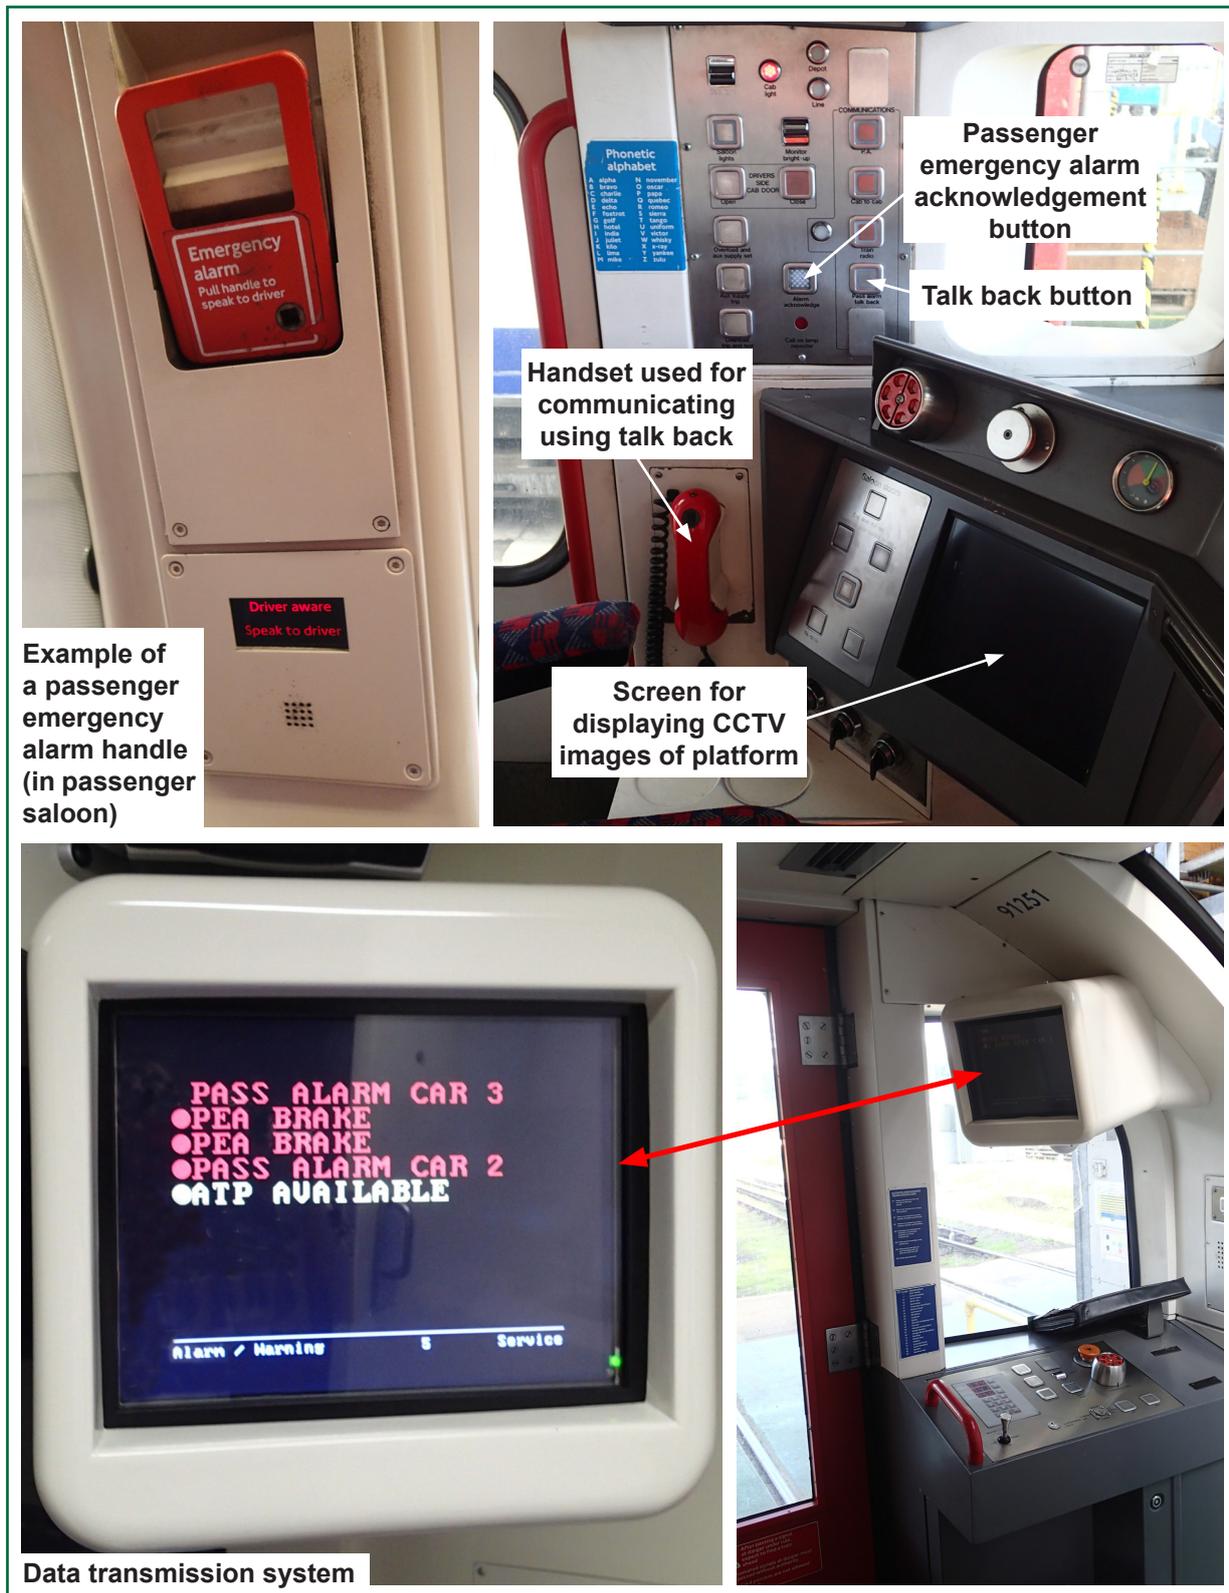
20 Trains are equipped with a passenger emergency alarm system (figure 7). The operation of a passenger emergency alarm handle when at least part of the train is within a platform will apply the train's emergency brake, otherwise the train will automatically continue to the next station. This is because the principle underpinning the passenger emergency alarm system is that an emergency on a train is best dealt with in a station. The passenger emergency alarm system has a talkback facility for two-way communications between the train operator and passengers in the car in which the handle has been activated.

Figure 7: Passenger emergency alarm (PEA) equipment

- 1 *The purpose of this recommendation is to promote a design review of the passenger emergency alarm system on 1992 tube stock and the adoption of ergonomics best practice in an improved design.*

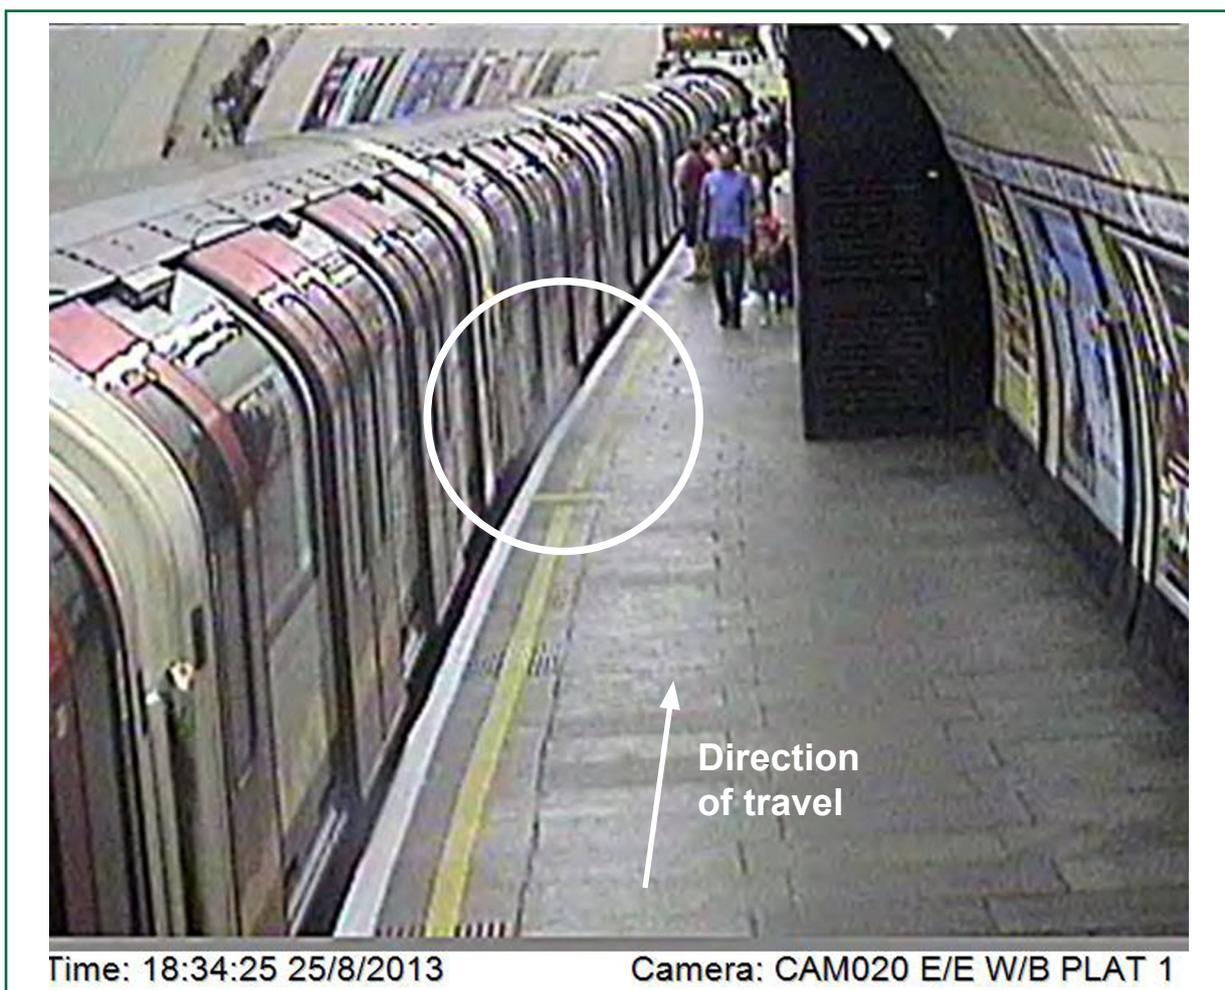
- 42 By the time train 003 arrived at Holland Park station there was smoke coming from the trailing end of car 6 (figure 9). While it was standing in the platform a line information specialist (paragraph 23) telephoned the DSM at Holland Park station to request that a member of station staff be sent urgently to investigate the burning smell that had been reported from Notting Hill Gate station. The content of the call was recorded but the DSM has no recollection of receiving a call at this time and there is no evidence that this request was acted upon.

Figure 9: Smoke emitting from trailing end of car 6 as train 003 was coming to a stand at Holland Park station

- 70 Although there may have been some smell from the brakes, the primary cause of the smoke and burning smell was almost certainly a faulty traction motor. When the train was examined at the depot it was found that one of the traction motors at the trailing end of car 6 had suffered 'flashover' damage. This type of damage occurs when a motor suffers from an insulation breakdown and there is a subsequent electrical short circuit, known as a flashover<sup>6</sup>. It is often accompanied by arcing and smoke from the breakdown and burning of insulation. The train is fitted with safety systems to ensure that the safety of passengers is not at risk from a motor flashover.

131 LUL has reported that, in the short term, the algorithm used to calculate the risk of motor flashover will be changed to increase the weighting given to a motor once it has been in service for 1.6 years after overhaul. This will allow motors to be more accurately targeted for preventative maintenance. Efforts are also ongoing to prevent motors becoming susceptible to flashover; there is an ongoing trial of a modification to the motor which is due to be completed in 2015 and a proposal to develop another modification to reduce wear on motor components associated with flashover (paragraph 72). In the longer term, LUL is seeking to introduce changes to the train and motor control systems to reduce stresses on the motor which appear to be a factor in the process leading to a motor flashing over.

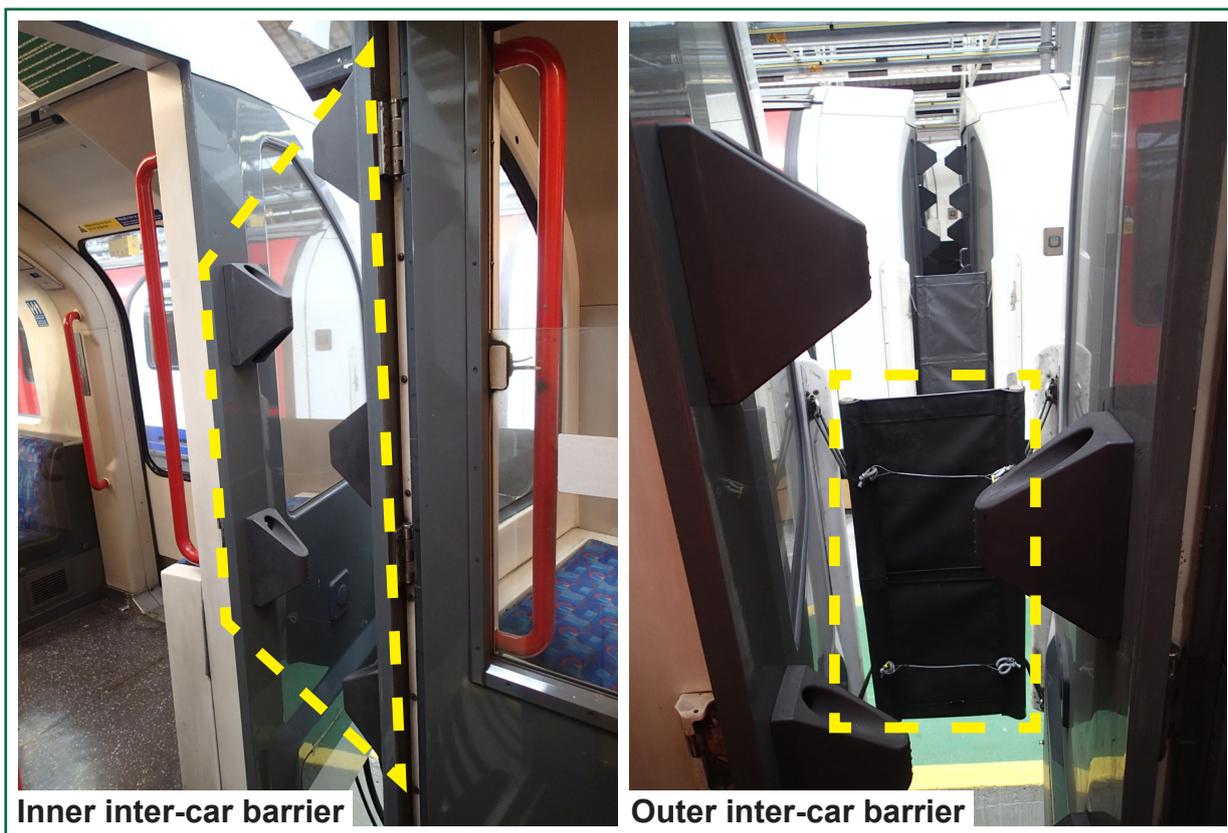
Figure 10: Inner and outer inter-car barriers fitted to Central Line trains

- 98 Inner inter-car barriers were retrofitted to Central Line stock during the early part of 2013. They were fitted to deter a passenger from attempting to get out of a train via the car end-doors after failing to leave the train at the final station stop and being over-carried into sidings where the train operator changes ends. Once the barriers had been fitted, LUL removed the previous requirement for station staff at the final station stop to check that all passengers had got off the train before it moved off to the sidings.

- passengers could not see any staff on the platform responding to the situation (**paragraph 90, Recommendation 5 – see paragraph 132**).
- 127 Passengers were able to climb over the inner inter-car barriers to self-evacuate the train (**paragraph 96, no recommendation – see paragraph 133**).
