Rail Accident Investigation Branch

Rail Accident Report

**Near-miss at Butterswood level crossing,
North Lincolnshire
25 June 2013**

Report 12/2014
June 2014

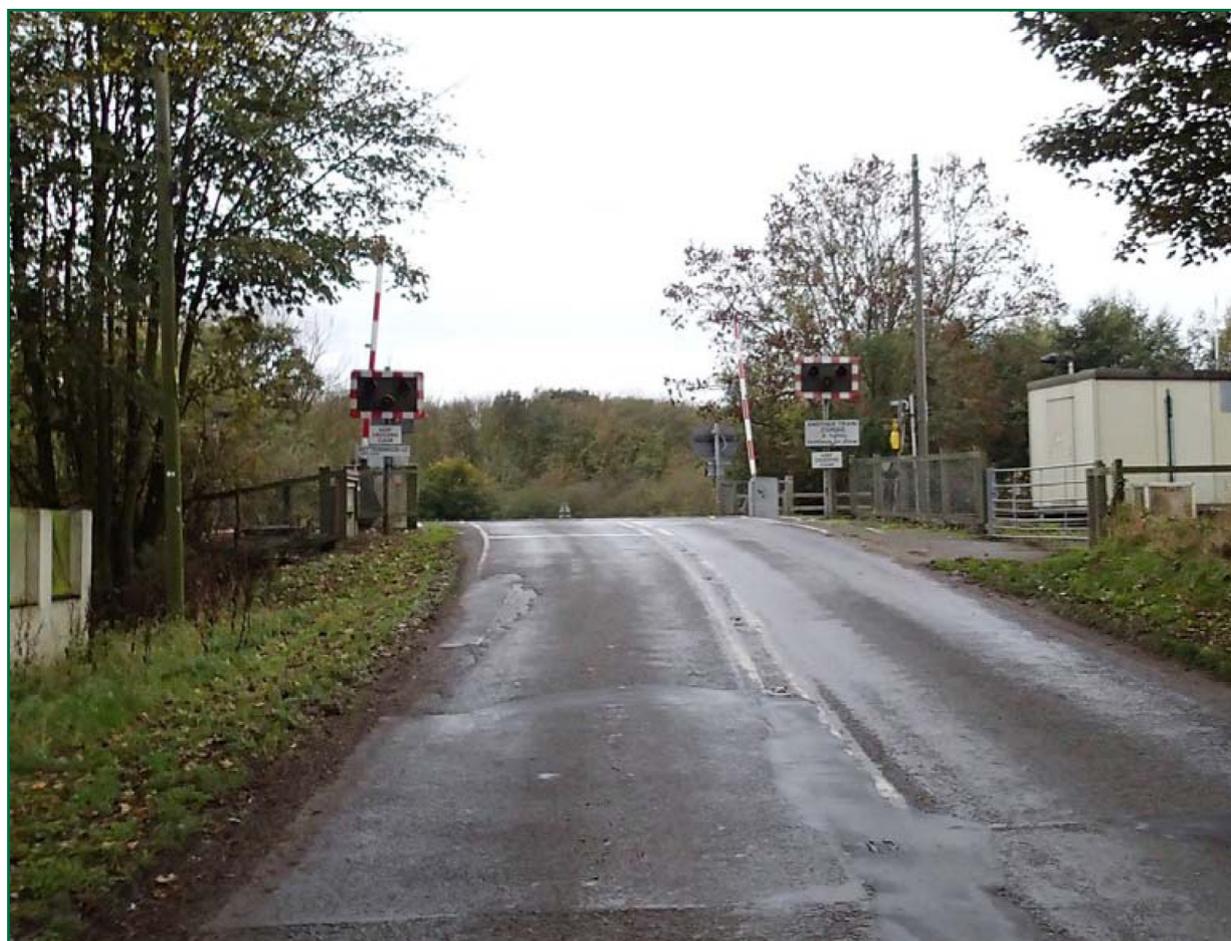
Figure 3: Butterswood ABCL level crossing - road approach

- 14 Butterswood level crossing is of a type known as an automatic barrier crossing, locally monitored (ABCL). ABCLs are normally operated automatically by an approaching train, rather than by the actions of a signaller or crossing keeper. They have lifting barriers pivoted at the near-side of the road that, when lowered, extend to the road centre-line (ie they are 'half barriers'). Each road approach is provided with road traffic signals on the nearside and offside of the road to warn road users and pedestrians that a train is approaching. Figure 3 shows the road approach to the level crossing.

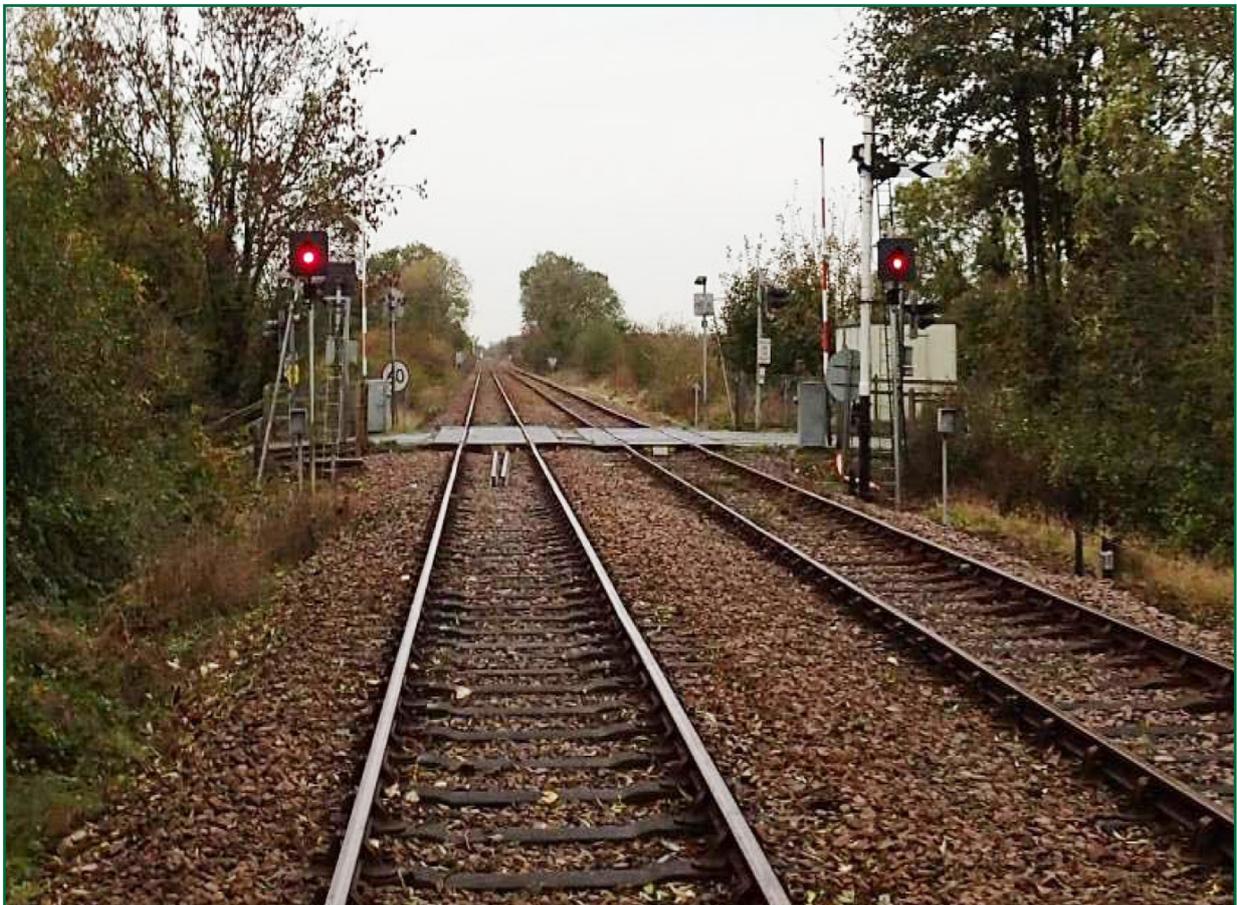
Figure 4: Butterswood ABCL level crossing - rail approach

- 15 In their 'normal' state, the barriers are raised and the road traffic signals are extinguished. The crossing is open to road traffic. On the railway approach, an indicator known as the driver's crossing indicator (DCI) is located close to the crossing. When this shows a flashing red light, it indicates to the driver of an approaching train that the crossing is open to road traffic. The crossing closure sequence is initiated by the train, which depresses a treadle and operates a track circuit located around 720 metres from the crossing for trains approaching from Cleethorpes; this is around 35 seconds before the train reaches the crossing when travelling at the maximum permitted line speed of 45 mph (72 km/h). When the train initiates the crossing sequence the road traffic signals are activated and the half barriers then lower across the carriageway. Once the barriers have begun to lower, the flashing red light at the DCI is replaced by a flashing white light. This flashing white light informs the train driver that the crossing is functioning correctly (hence the term 'locally monitored'). Figure 4 shows the rail approach to the level crossing.

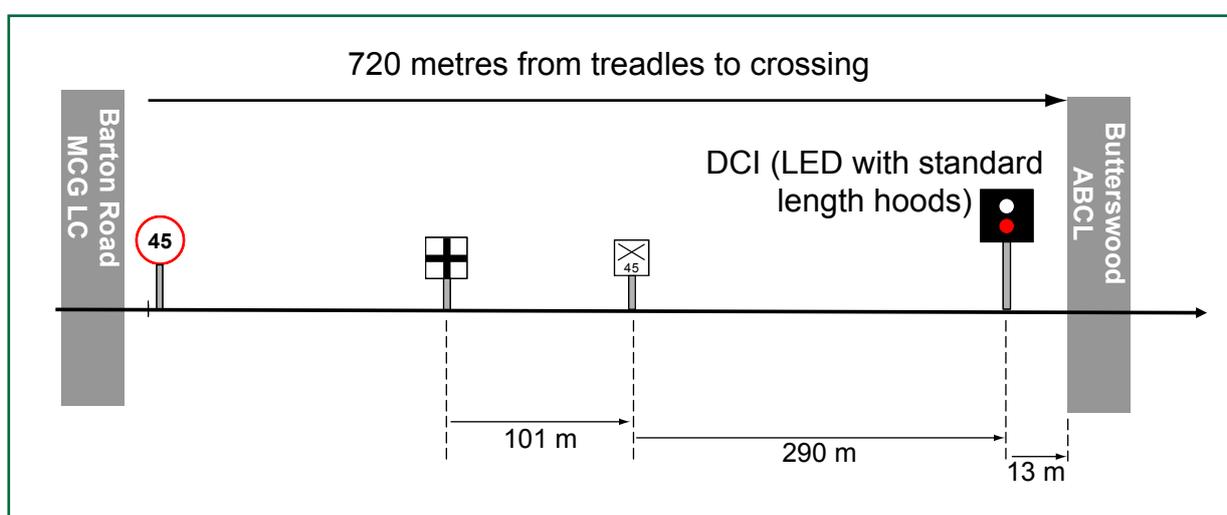
Figure 5: The arrangements for trains approaching Butterswood ABCL (not to scale)

- 18 The SSRB for trains travelling in the down direction was located 303 metres from Butterswood level crossing, and indicated a maximum speed of 45 mph (72 km/h). This is the same as the maximum permitted line speed (paragraph 15). The arrangements for trains approaching Butterswood ABCL crossing are shown at figure 5.

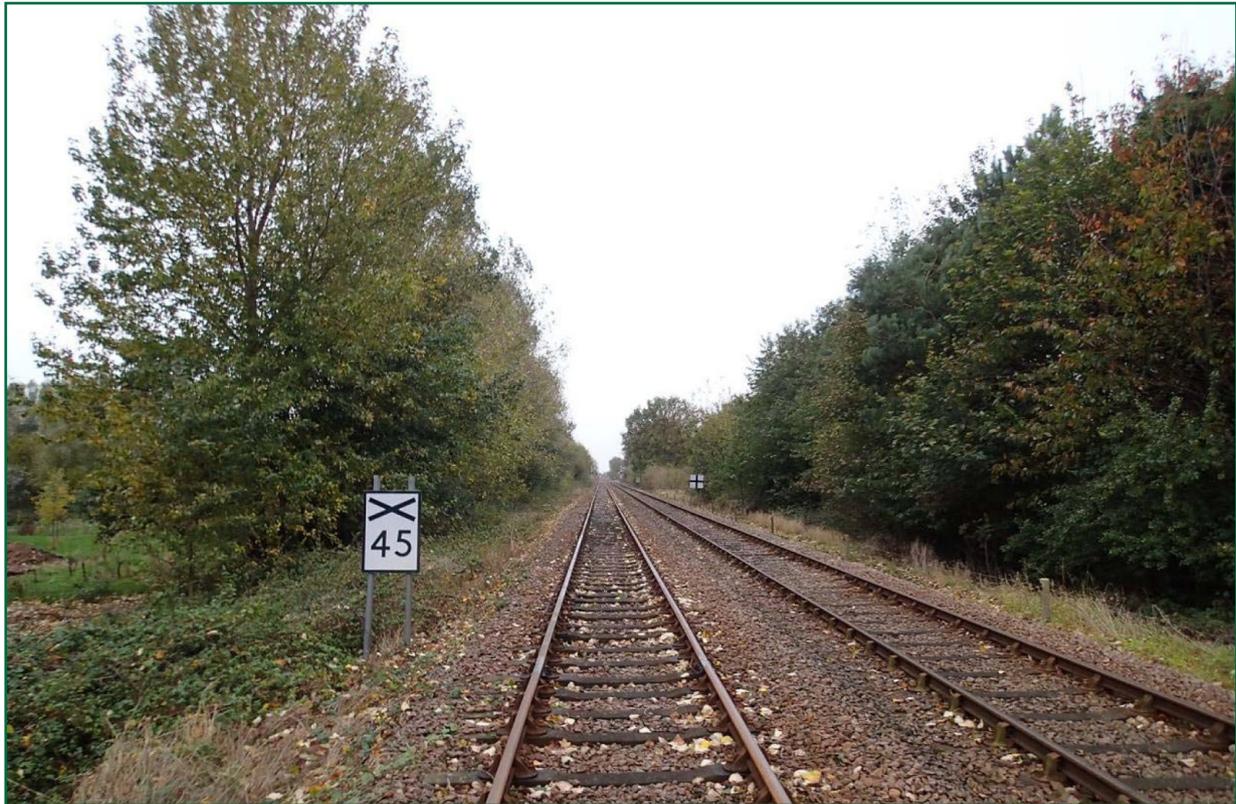
Figure 6: The special speed restriction board, around 303 metres from the level crossing

- 47 **The train driver did not focus his attention on the DCI at the time that his train passed the SSRB, which was the point at which he needed to confirm that the crossing had operated correctly for the passage of his train.**
- 48 The RAIB undertook cab rides over the route to video and time the operation of the DCI at Butterswood level crossing. The DCI normally changes from a flashing red light to a flashing white light around the time the front of the train is close to the AWB (around 404 metres from the level crossing – see paragraph 17). Around 7 seconds later the train passes the SSRB, which is the point where train drivers need to confirm that the DCI is showing a flashing white light and that the crossing is clear (because the train can still be stopped before it reaches the crossing if the light has not changed).

- 49 Data from the incident train's OTDR indicated that the driver only applied the emergency brake when the train was around 110 metres beyond the SSRB (approximately six seconds after passing it). If at any point before reaching the SSRB the driver had noticed that the DCI was showing a red light, he could still have stopped the train safely before the crossing.
