Rail Accident Investigation Branch

Rail Accident Report

**Person trapped in a train door and dragged at
Jarrow station, Tyne and Wear Metro
12 April 2012**

Report 26/2012
December 2012

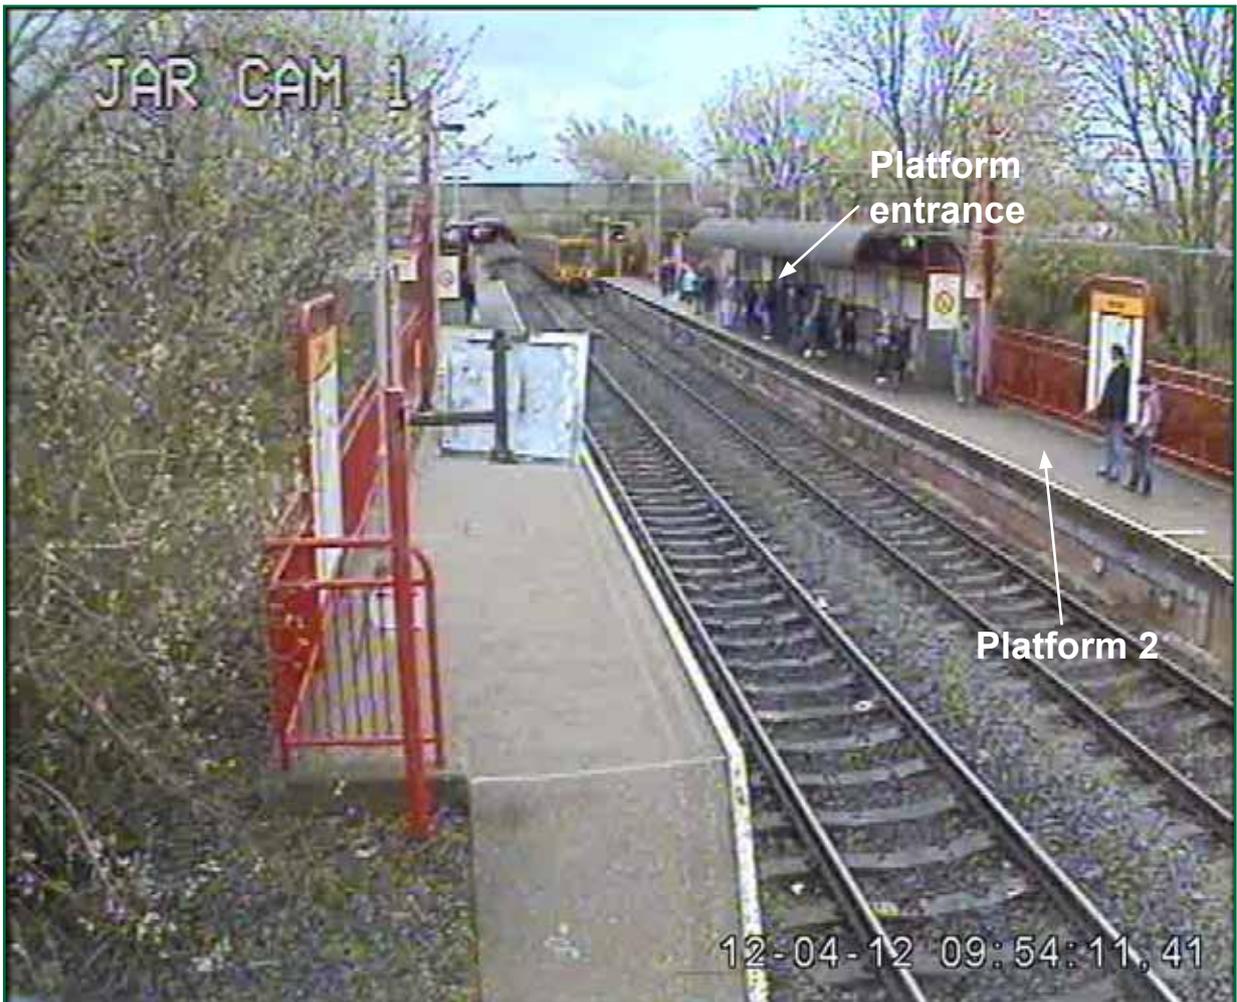
Figure 3: CCTV image of train T135 approaching Jarrow platform 2 on 12 April 2012

- 7 The location of Jarrow station on the network is shown in figure 1 and a closed circuit television (CCTV) image of the incident train approaching platform 2 is shown in figure 3. Platform 2 serves trains heading towards Newcastle Central station, and is on the left-hand side in the direction of travel (figure 4). Passengers reach platform 2 after passing through a small concourse. At the normal stopping position of trains, door 7 is closest to the concourse.

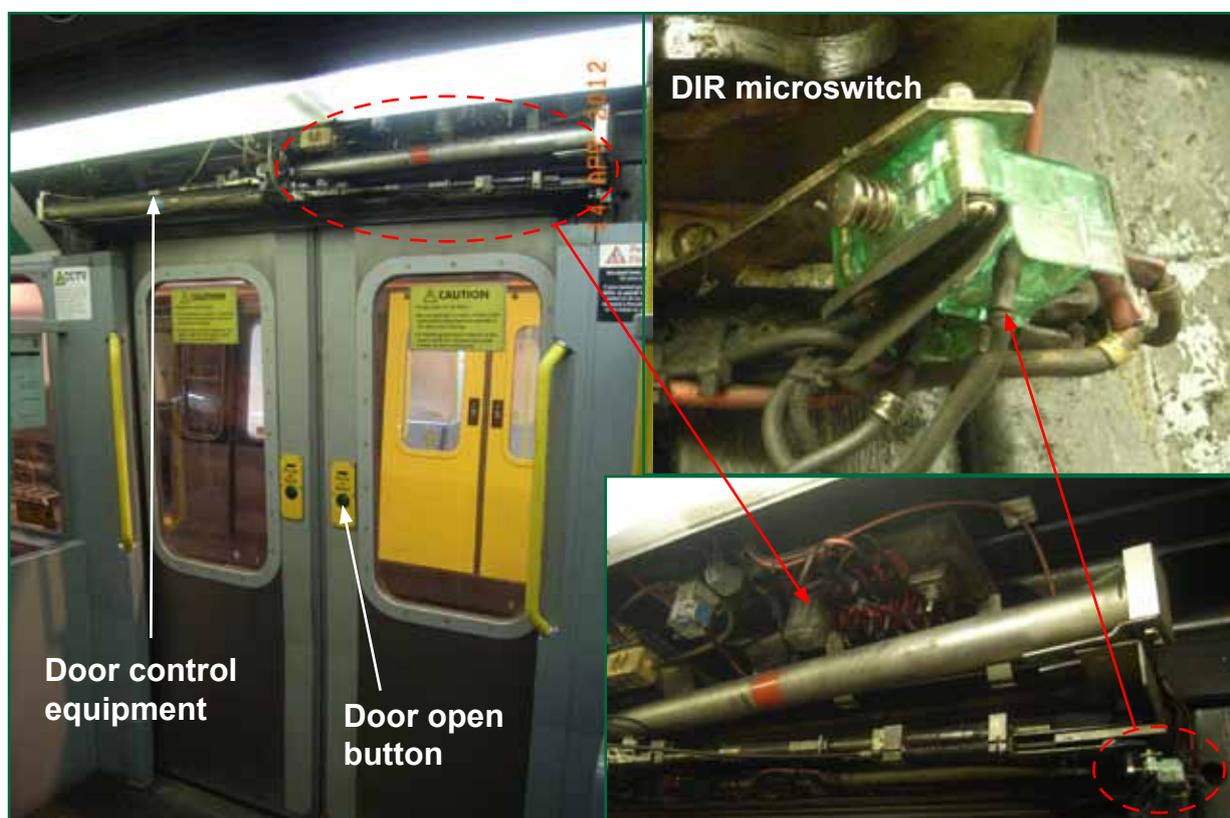
Figure 5: Door control equipment and position of DIR microswitch above door 7

- The faults that occurred during the incident could only be replicated by holding the traction interlock switch for the right-hand door leaf, called the 'DIR' switch (figure 5), in the depressed position as the door was opened and then closed with an obstruction held in the door. This simulated what would have happened at Jarrow if the DIR switch had stuck in the depressed position. Holding down any of the other microswitches on door 7 and operating the door in the same way did not reproduce the observed faults.

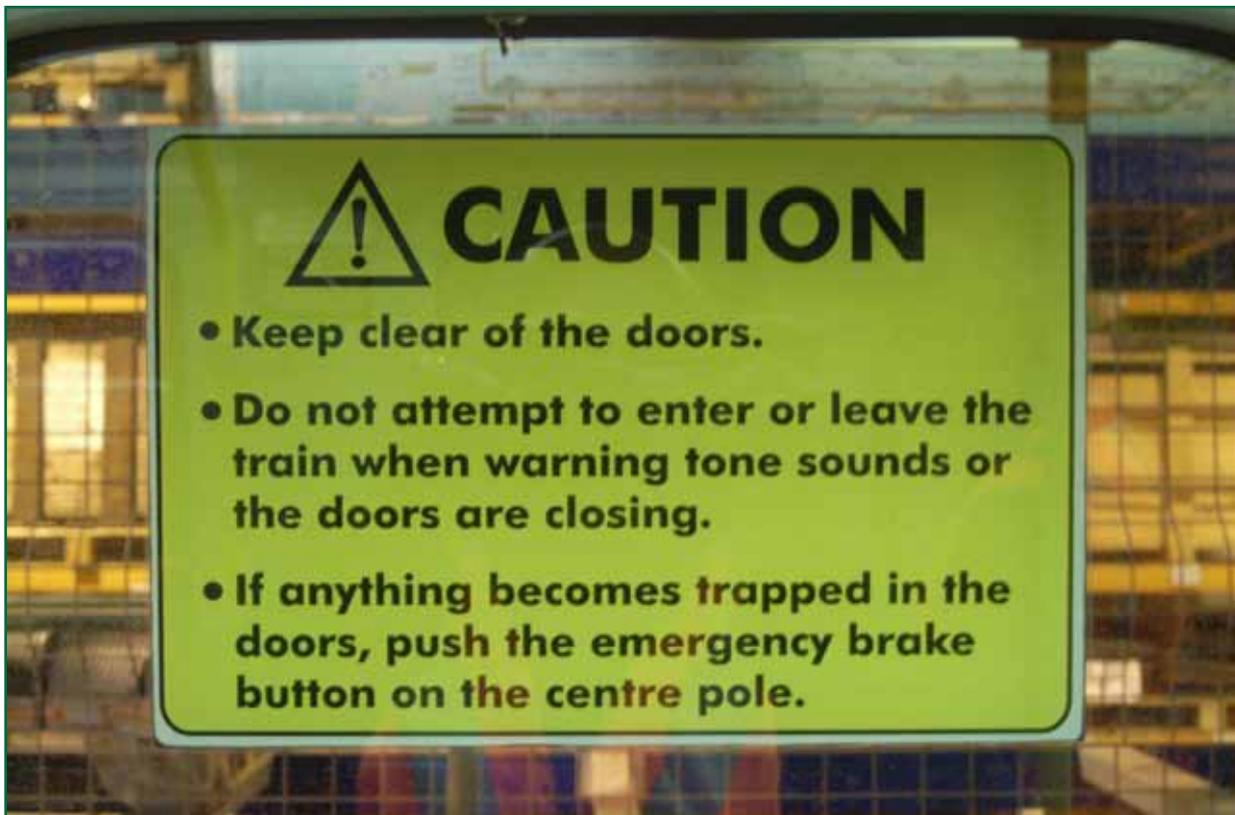
Figure 7: Warning notice posted on both sides of each door leaf

27 On TWM trains there are yellow caution notices on both the inside and outside of the doors (figure 7) warning passengers not to leave or enter the train when the warning tone is sounding or when the doors are closing.

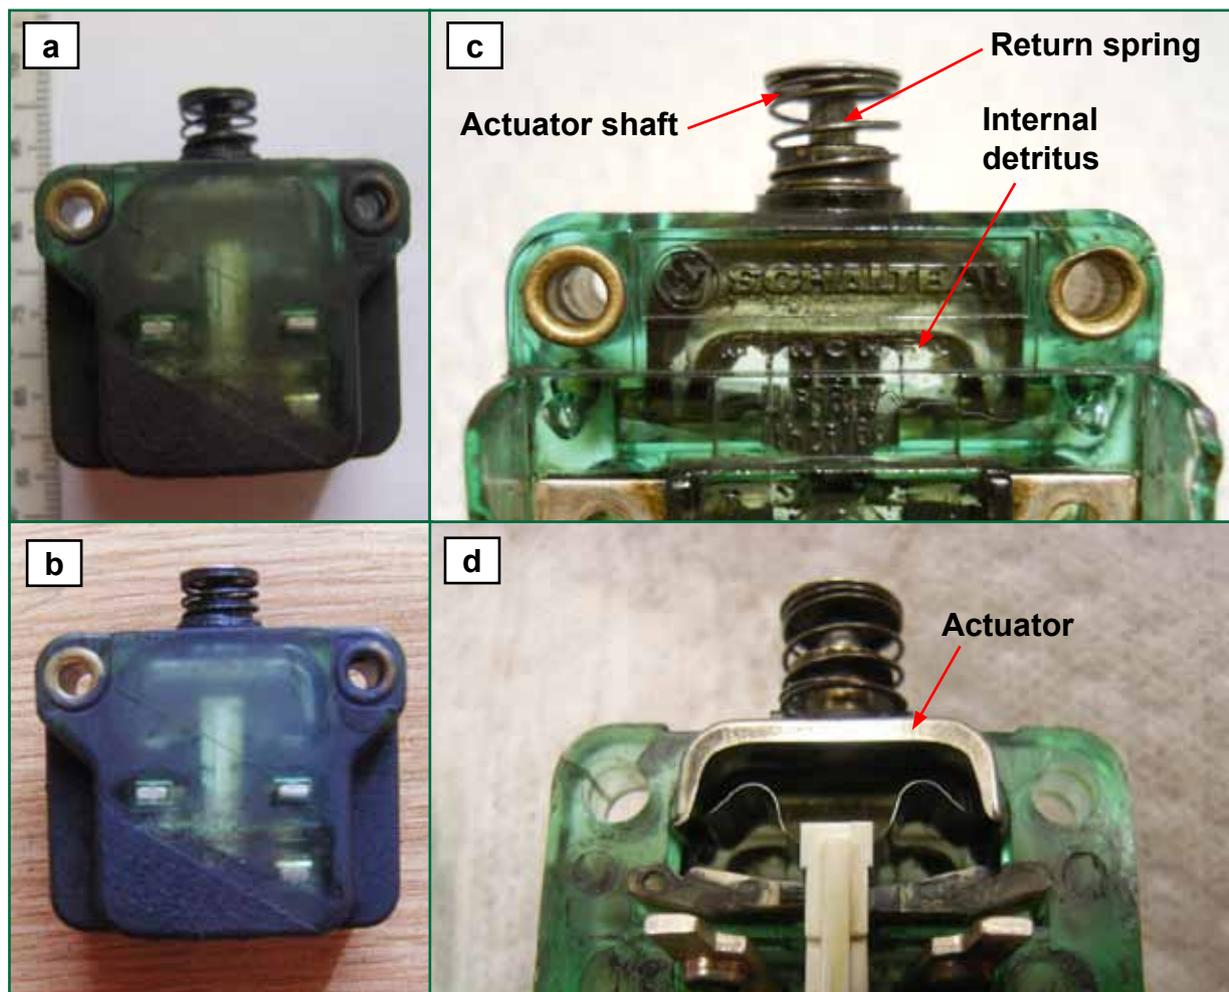
Figure 8: DIR microswitch showing (a) normal actuator position, (b) actuator stuck down, (c) accumulated internal detritus and (d) switch with cover removed

- 35 Since it was only a malfunction of the DIR switch from door 7 that could replicate the condition which occurred during the incident, it was decided to examine this switch more closely. After multiple manual operations of the switch, it was found that it remained stuck down in the depressed position on one occasion (figure 8). This should never happen with a correctly functioning switch. However, after pressing the plunger again, it released and despite further operations of the switch, this fault could not be repeated. The investigation concluded that this switch was capable of intermittent failure and that this fault would explain exactly what was seen to happen in the CCTV footage and post incident testing.

- 36 Normally, when the doors open, the actuator shafts of the traction interlock switches on each door leaf are released and extend from the switch bodies under the action of the return spring (figure 8c). This breaks the traction interlock circuit and energises the obstruction detection circuit of each door leaf, ready for the next door closure. If, when the doors open, a traction interlock switch sticks in the depressed position for some reason, the obstruction detection circuit on that door leaf is not energised and is therefore disabled. In this incident, the obstruction detection circuit on the right hand door leaf was disabled but the corresponding circuit of the left hand door leaf remained active. However, when the passenger placed her arm into the closing doors, the left-hand leaf was leading slightly and so did not detect any obstruction by the time it had fully closed. The lagging right-hand leaf then trapped the passenger's arm against the already closed left-hand leaf but it could not detect the arm because its obstruction detection was already disabled.

- 37 Additionally, because the traction interlock circuit was not broken by the right-hand door leaf microswitch (DIR switch) when the door opened at Jarrow station, it remained in this condition even when the door had only partially closed against the passenger's arm. When all the other doors on the train had closed, the complete traction interlock circuit around the train was made (even though door 7 was partially open) and the driver was able to release the train brake and take traction power.

- 38 When the DIR switch was stripped down and examined with the assistance of Schaltbau, a significant amount of *debris* was found to have accumulated inside the switch (figure 8) together with an oily residue. It is almost certain that the debris did not get into the switch during manufacture. Further, had it done so, it would almost certainly have been picked up in Schaltbau's quality control process or during installation by the train manufacturer, Metro-Cammell. Additionally, there was no evidence of other switches having similar internal contamination. The oily residue was probably from the light proprietary penetrating oil used by DBTW to clean the switches, once removed from the train, during periodic maintenance. Schaltbau do not use any lubrication when the switches are manufactured.

- 40 The contamination in the switch was abnormal and is the most likely cause of the switch sticking down. There are two possible paths for the contamination to enter the switch:

- the clearance between the actuator shaft and switch body into which the shaft can pull in contaminants from outside as it slides; and
 - the joint between the actuator shaft and actuator, which was noted to be slightly loose and around which a ring of debris had accumulated.

DB Regio Tyne and Wear should identify ways to improve the reliability of the door obstruction detection and traction interlock systems, including consideration of improvements in:

- design of the control circuitry;
- ingress protection of the microswitches;
- switch cleaning method;
- replacement procedures;

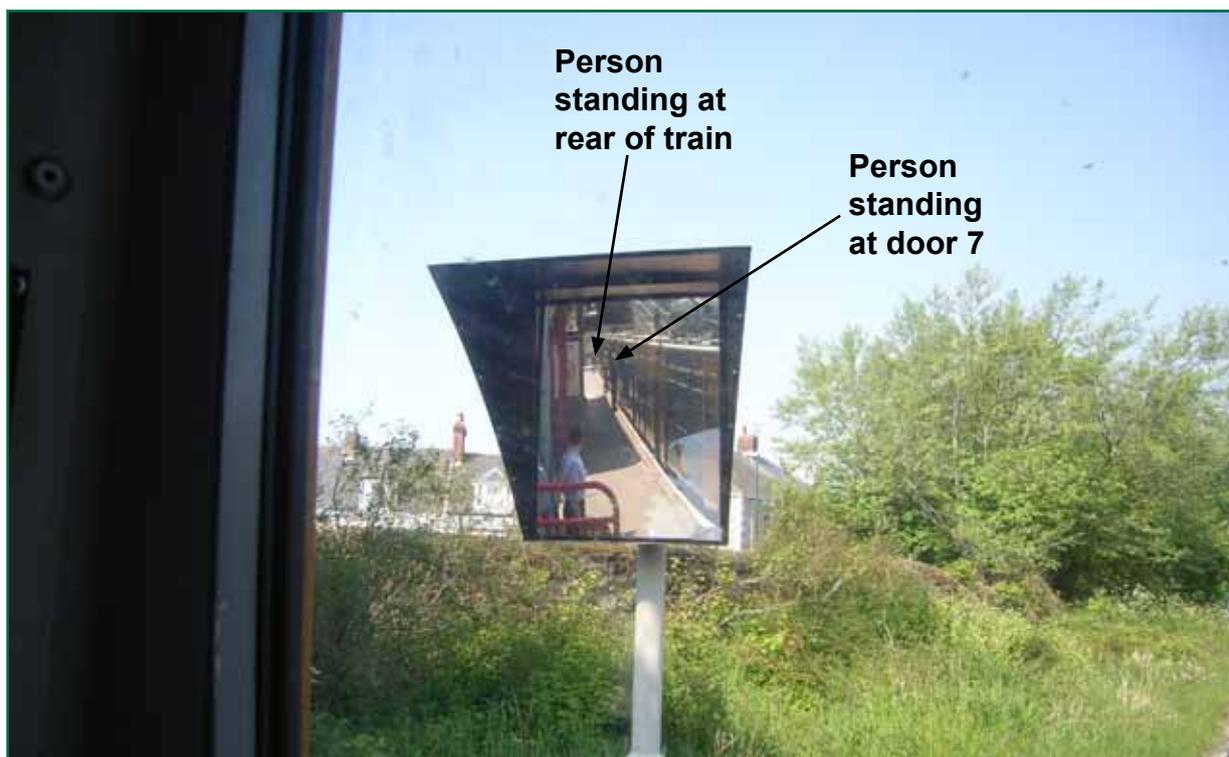
Figure 9: Typical view of the platform/train interface from the driver's cab through the mirror on platform 2 at Jarrow station (Note that the station canopy shadow at the time of the incident would not have been so pronounced)

- 53 A reconstruction was carried out, using a test train, to check the visibility of the platform/train interface from the driver's cab at the stopping position of train T135. This stopping position could be determined from CCTV images of the incident train. The reconstruction confirmed that the view from the platform mirror included the whole of the platform/train interface (figures 9 and 10). However, the platform mirror is angled relative to the platform and so the side of the train forms the background to any person standing next to it. It is therefore not a true view along the side of the train.

- 54 There was a period of around 6 seconds between the passenger first arriving on the platform and the train departing, and around 4.5 seconds between the passenger becoming trapped and the train departing. During this latter period she should have been visible in the platform mirror but the driver cannot explain why he did not see her.

- a. review the visibility of trapped passengers from driving cabs at stations on its network, including consideration of how lighting, shadows at different times of the day, colour of passenger's clothing and train paint schemes may adversely affect that visibility; and
 - b. implement identified improvements, to include consideration of realignment of platform mirrors and provision of additional CCTV monitors (paragraph 74).
- 4 *The intent of this recommendation is that the test method used for checking the door obstacle extraction forces is aligned with those specified in the relevant industry standards.*
