Rail Accident Investigation Branch

Rail Accident Report

Derailment of a tram at East Croydon 17 February 2012

Report 04/2013
March 2013

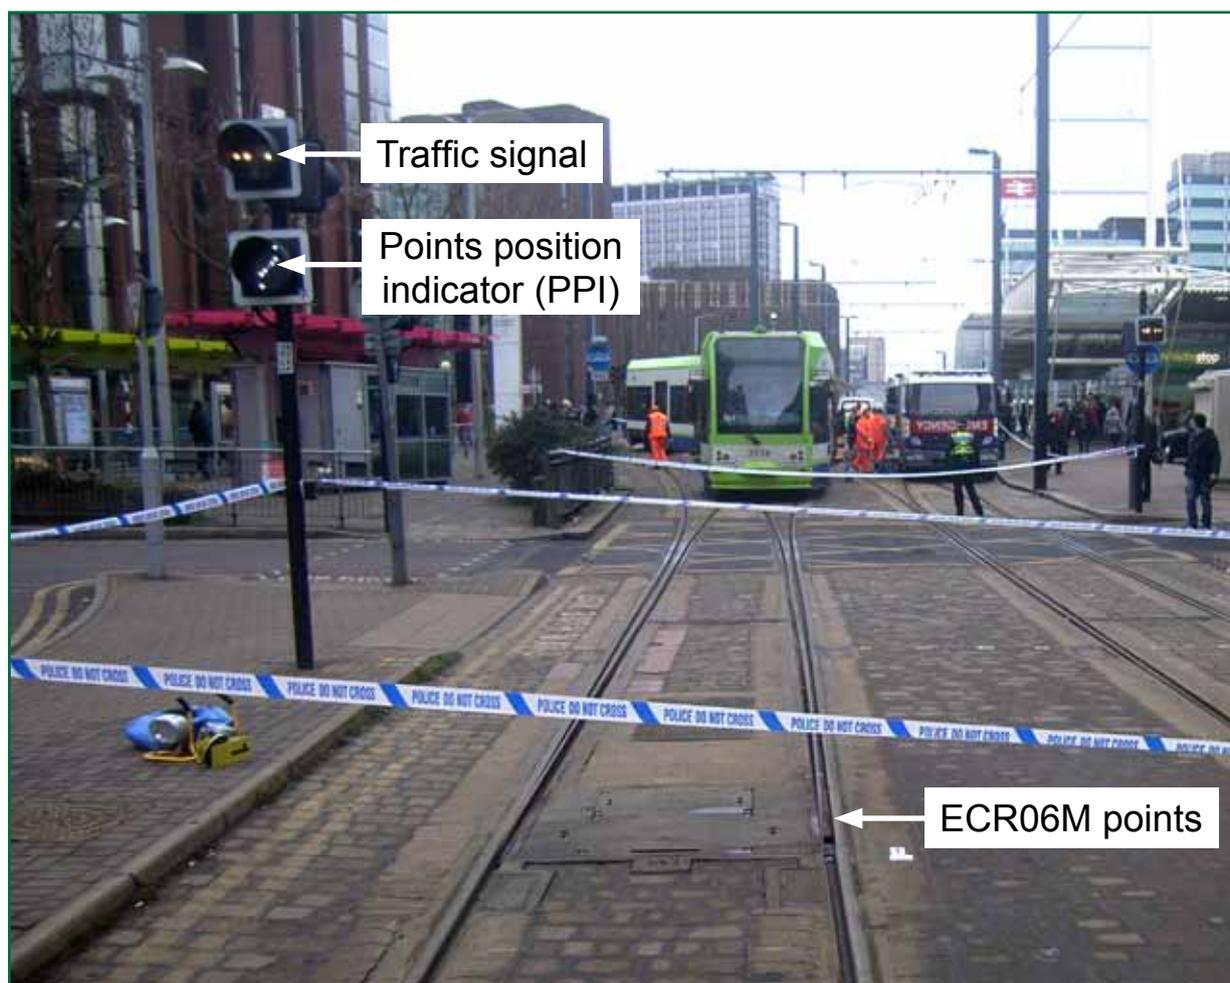
Figure 3: Billinton Hill (Post Office Road) crossing showing points ECR06M, the traffic signal (showing a horizontal row of lights indicating 'stop') and PPI (indicating a route to the right)

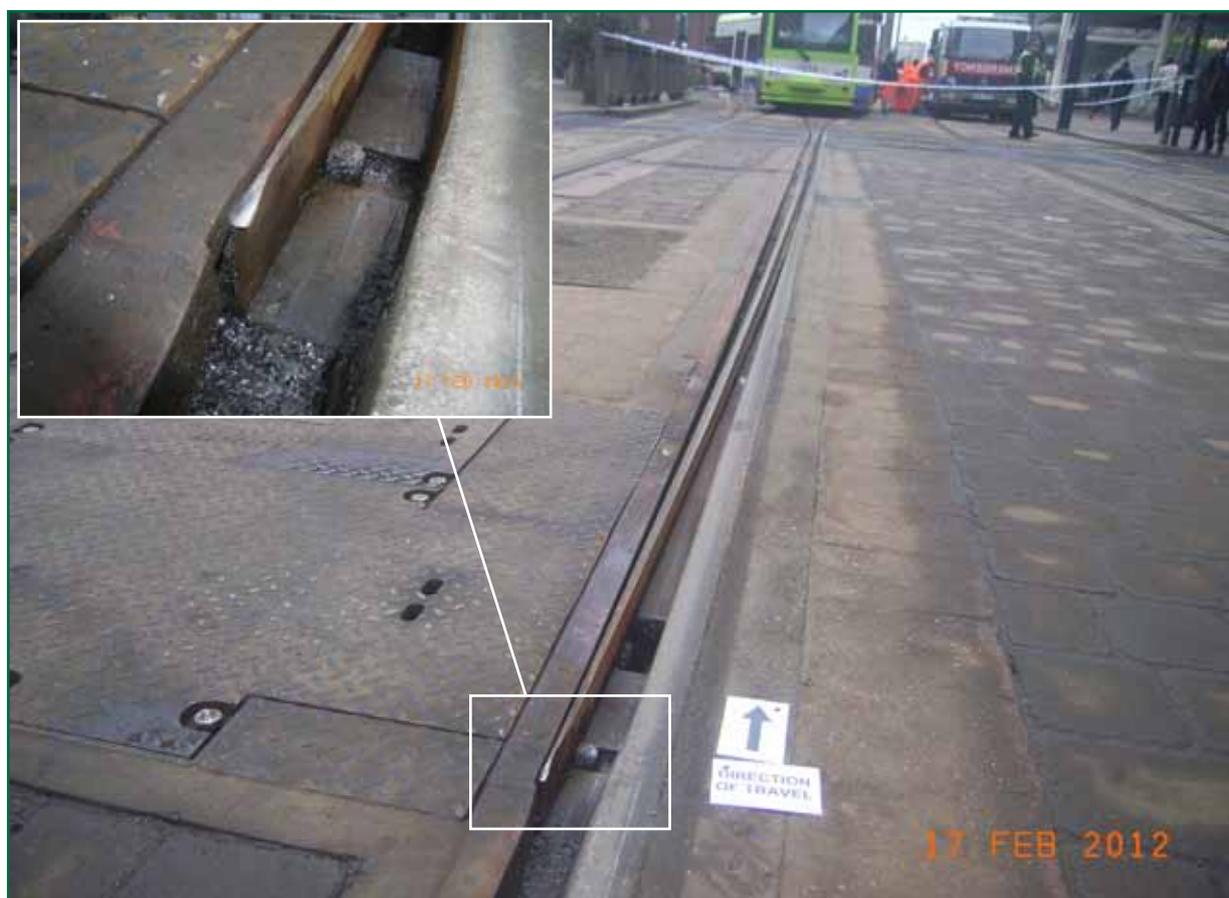
Figure 2: Map of East Croydon tram stop

Figure 5: Damage to right-hand switch rail tip (points ECR06M)

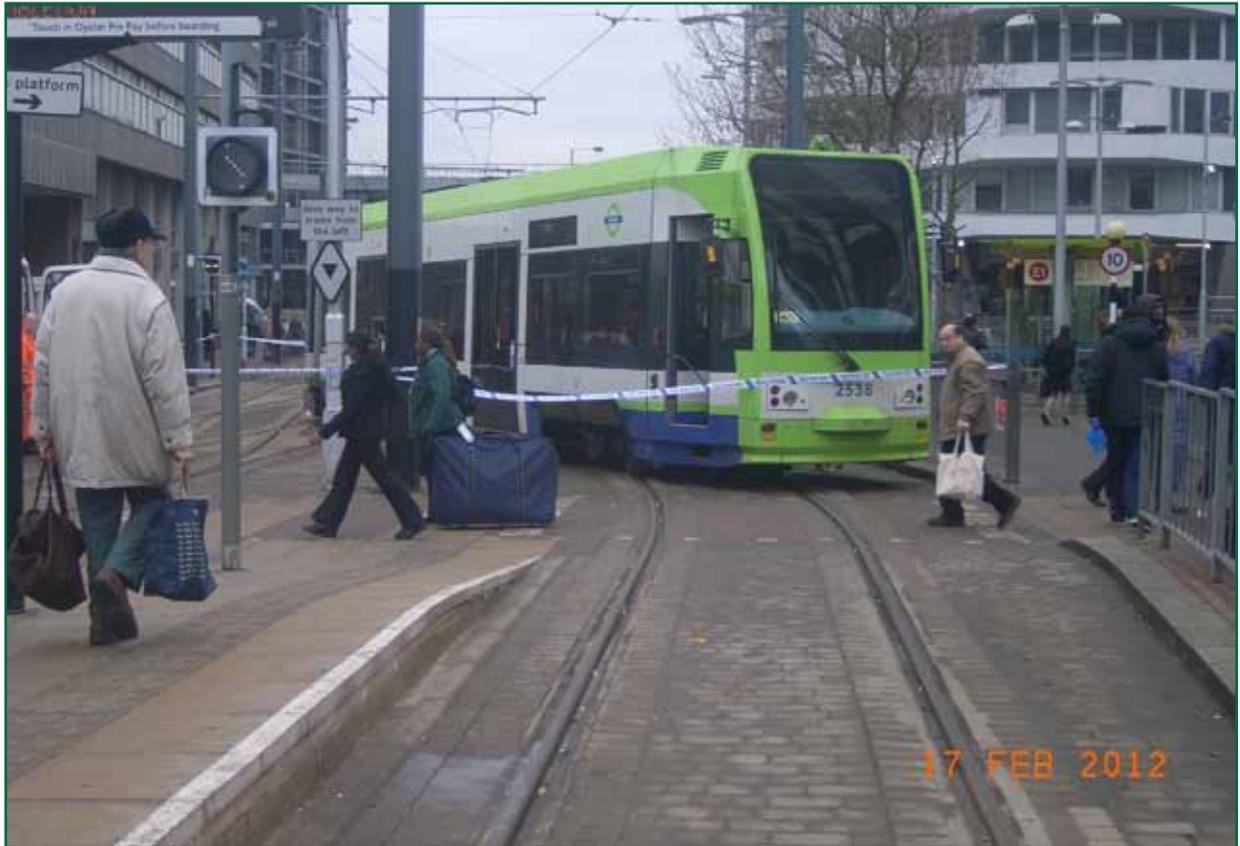
- 16 Tram 2538 was travelling at 12 km/h (7.5 mph) when the centre bogie derailed to the left. This occurred 34 metres beyond the switch rail tip when the vehicle's articulation was unable to accommodate the diverging routes taken by the leading and centre bogies. The tram driver sensed an unusual movement and applied the vehicle's emergency brake. The tram came to a stop after travelling for a further 4 metres in a derailed condition (figures 6 and 7).
- 17 There were no injuries among approximately 100 passengers on the tram, some of whom were standing. Passengers left the tram under the guidance of the driver via the leading passenger door which had stopped close to East Croydon tram stop.

Figure 6: Front view of tram 2538 following derailment

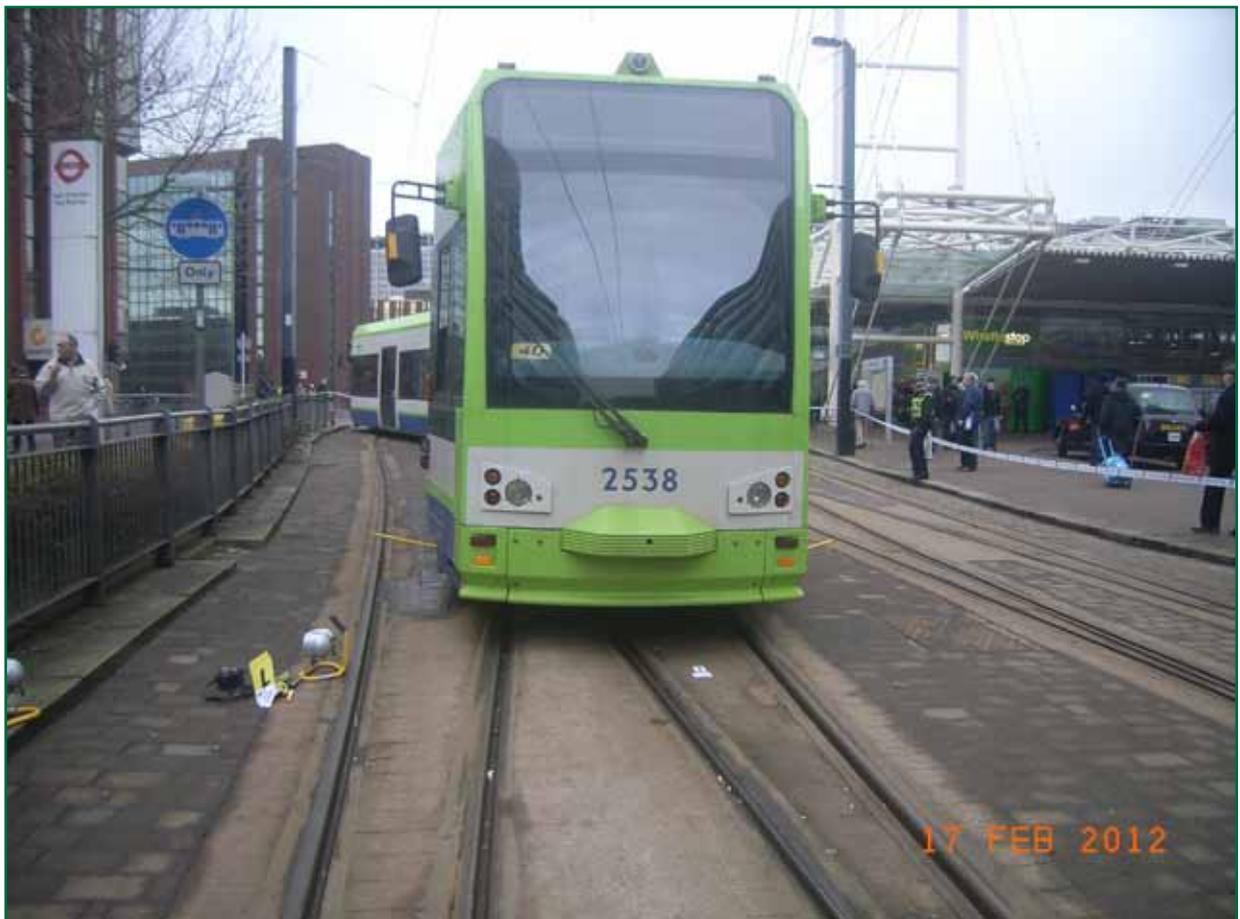
Figure 7: Rear view of tram 2538 following derailment

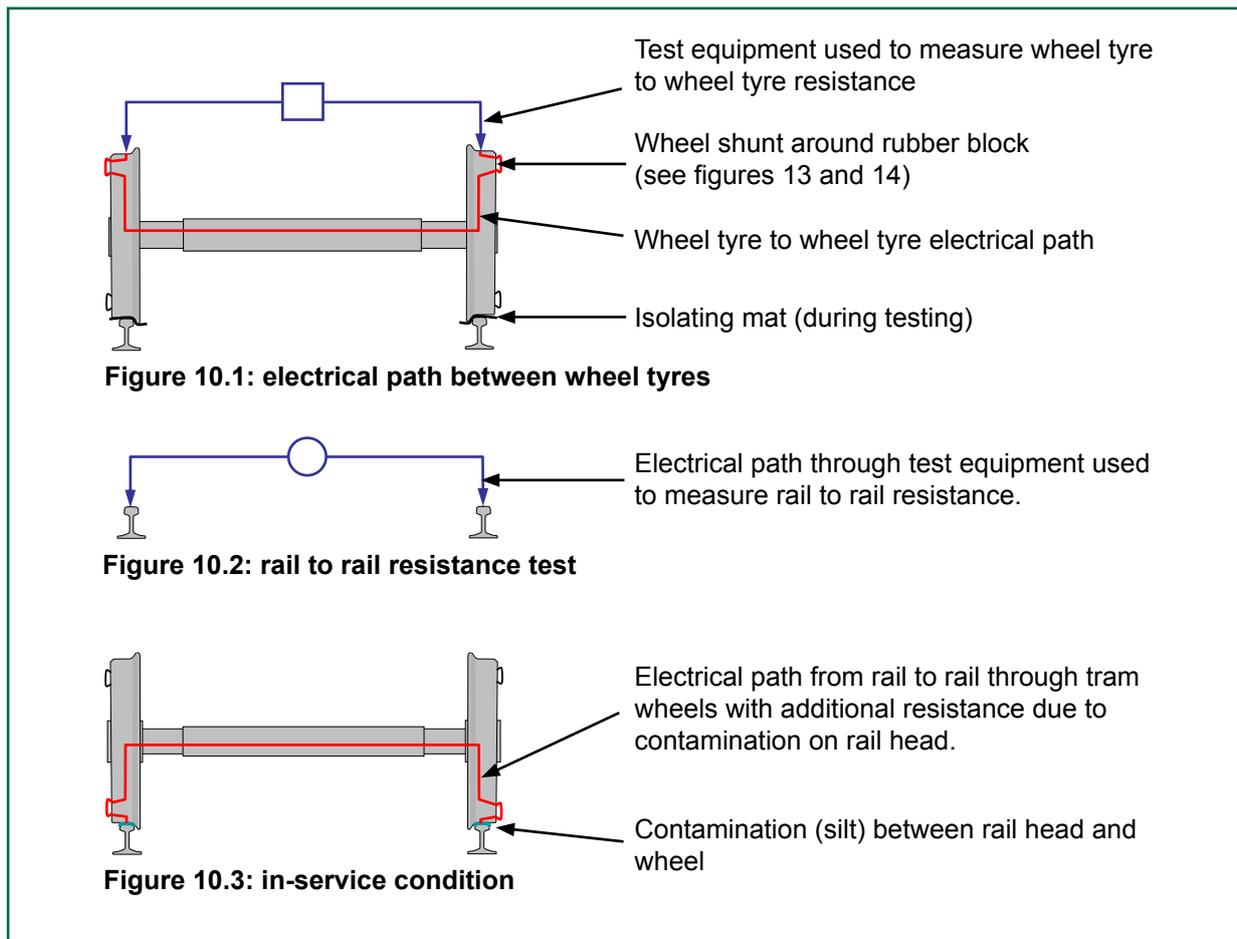
Figure 10: Diagram of electrical paths affecting operation of track circuit

- It is possible that the track circuit responded to the test tram and not the incident tram because the wheel tyre to wheel tyre resistances of the test tram leading bogie (0.0004 ohms for each axle, table 1) were lower than the corresponding resistances on the accident tram (0.021 ohms⁴ and 0.023 ohms) (figure 10).

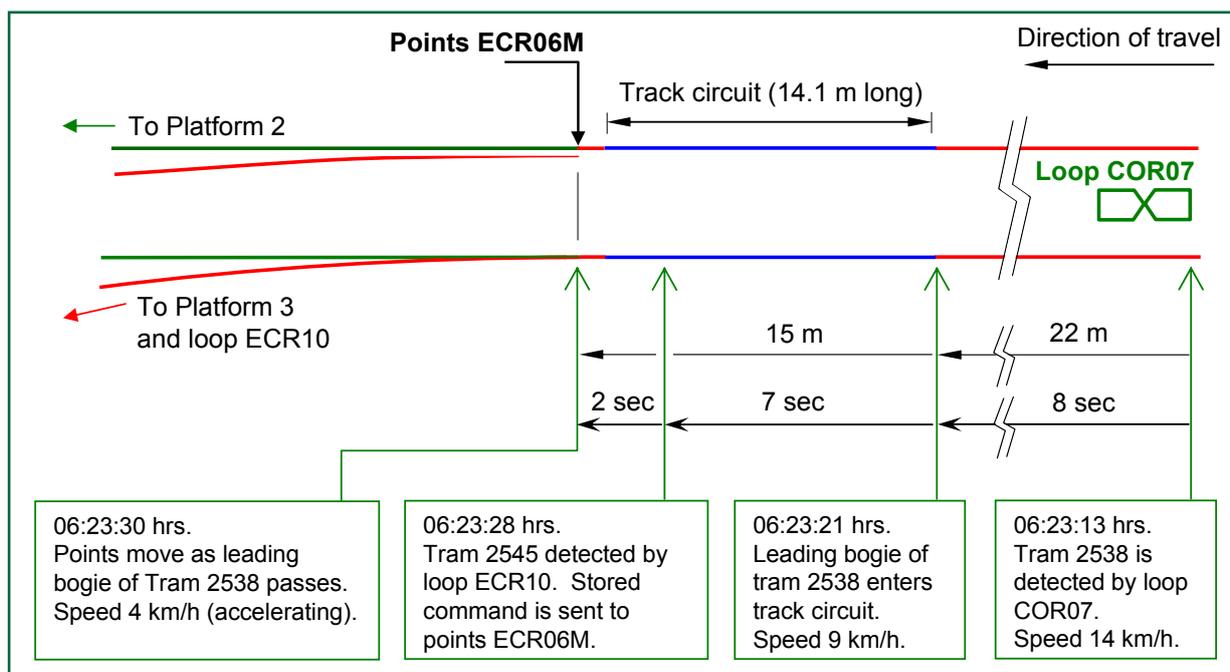
- 42 At the moment that the points were requested to move, tram 2538 was only about 3 metres, and 2 seconds, from the point tips. The points were still moving as the leading bogie passed over the switch rail tip (figure 11).

Figure 11: Diagram showing calculated position of tram 2538

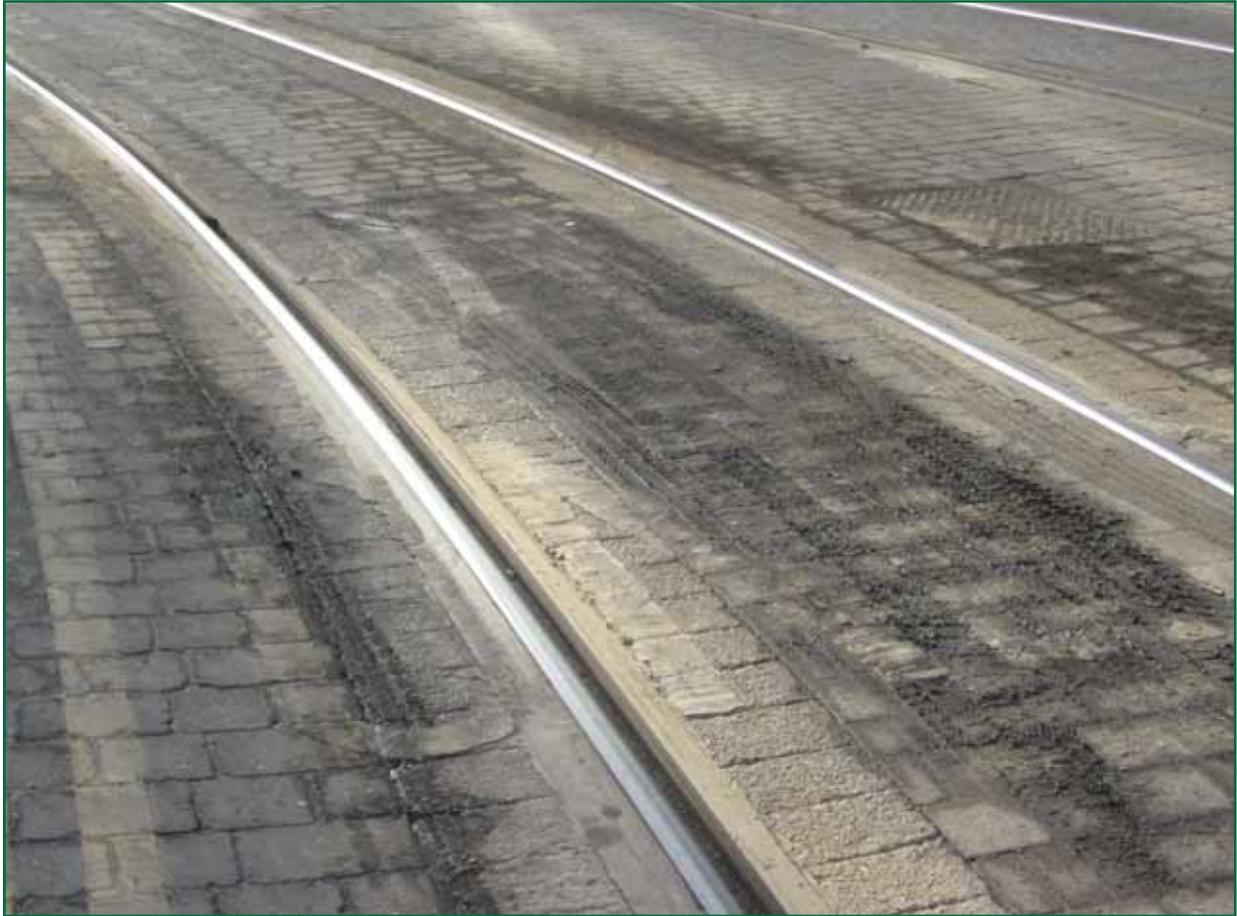
- 54 Although a post-accident inspection by the RAIB did not identify any unusual contamination on the track circuit rail head, some silt contamination was seen. It is possible that this was sufficient to prevent the track circuit, as set up at the time of the accident, from responding to the presence of tram 2538.
- 55 It is possible that some of the silt seen on the rail head had come from an accumulation of silt seen on the roadway near Cherry Orchard Road crossing during the RAIB's inspection (figure 12). It is probable that this silt had accumulated since the area was swept mechanically one week before the derailment as part of the routine fortnightly mechanical sweeping of embedded track in Croydon town centre. Drainage works were undertaken in 2009 which had reduced, but did not eliminate, the accumulation of silt near Cherry Orchard Road.

Figure 12: Silt on paved surface west of Cherry Orchard Road crossing on 17 February 2012

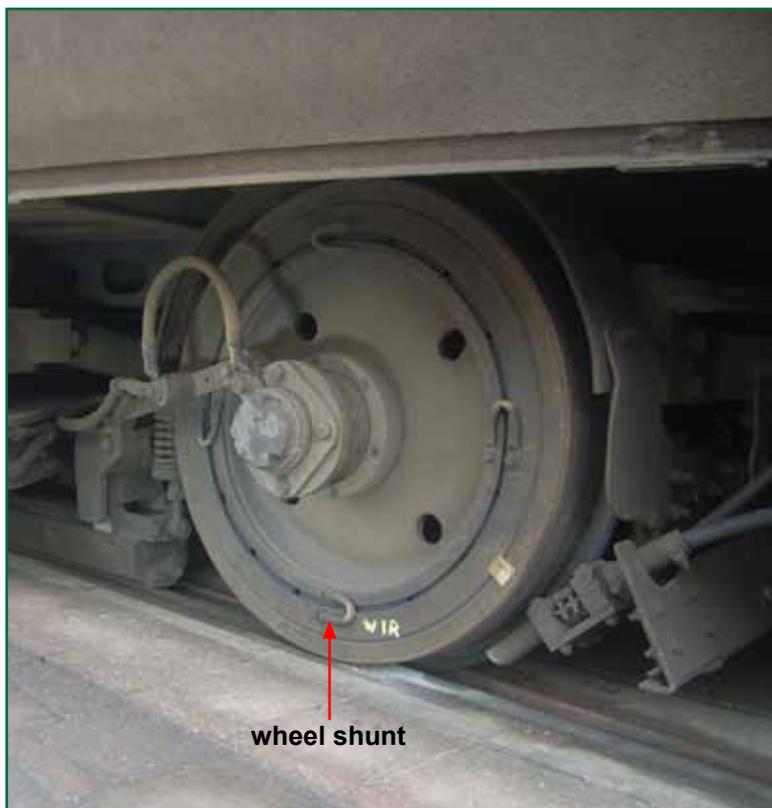
- 57 All axles on the CR4000 tram have *resilient wheels* with braided copper bonds (*wheel shunts*) on each wheel providing electrical continuity between the wheel hub and tyre (figures 13 and 14). Bombardier's maintenance specification for the CR4000 fleet states that wheel tyre to wheel tyre resistance should not exceed 0.01 ohms on a new bogie, or rise above 0.1 ohms in service. The wheel shunts are designed to provide an electrical path for traction current to return to the rails, and Bombardier stated that the requirement for the trams to operate track circuits was not specified when the trams were designed. At the time of the derailment, Bombardier's maintenance staff remained unaware that the wheel shunts performed both roles.

Figure 13: Leading bogie of tram 2538 showing wheel shunt
