Rail Accident Investigation Branch

# Rail Accident Report

**Fatal accident at Mexico footpath crossing (near  
Penzance)  
3 October 2011**

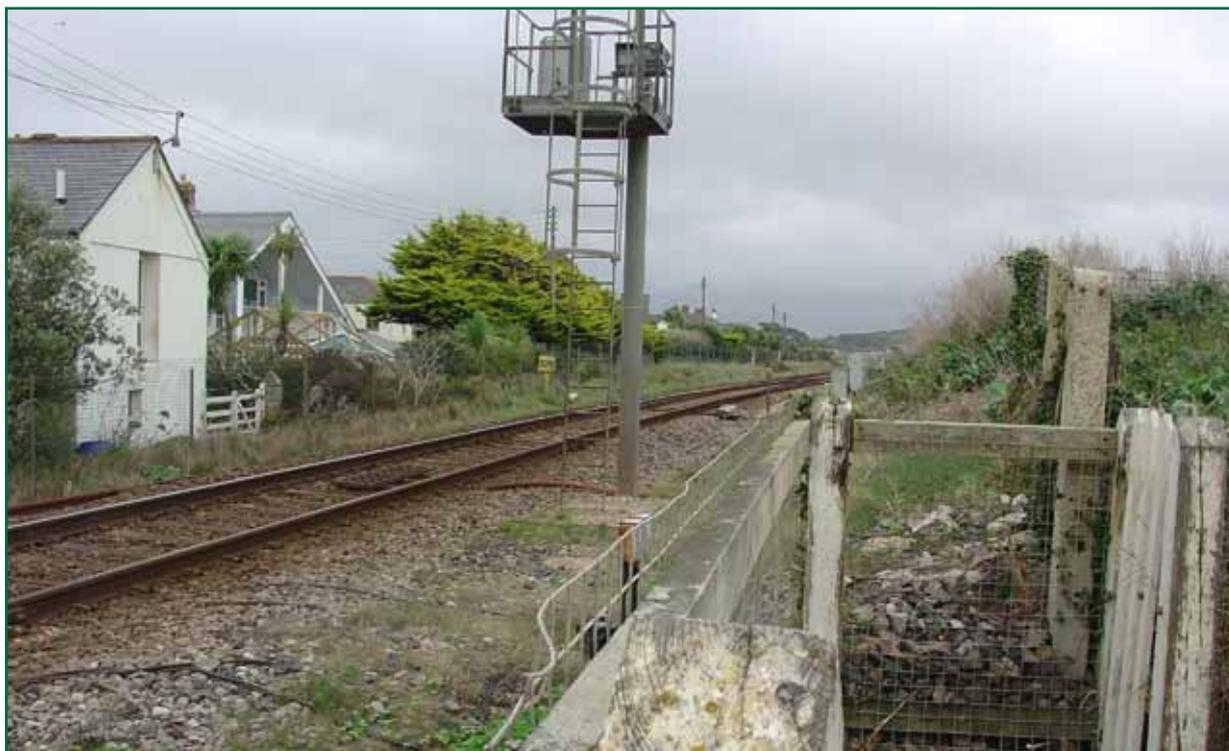
Figure 6: View east from the gate on the south side of the crossing (4.25 metres from the nearer rail)

- 34 From all three locations, the crossing user's view to the east is partially obstructed by an equipment case and the signal post, but an approaching train can still be seen because of its height and width in relation to the structures. This is discussed later in the report (paragraph 65 and figure 10).

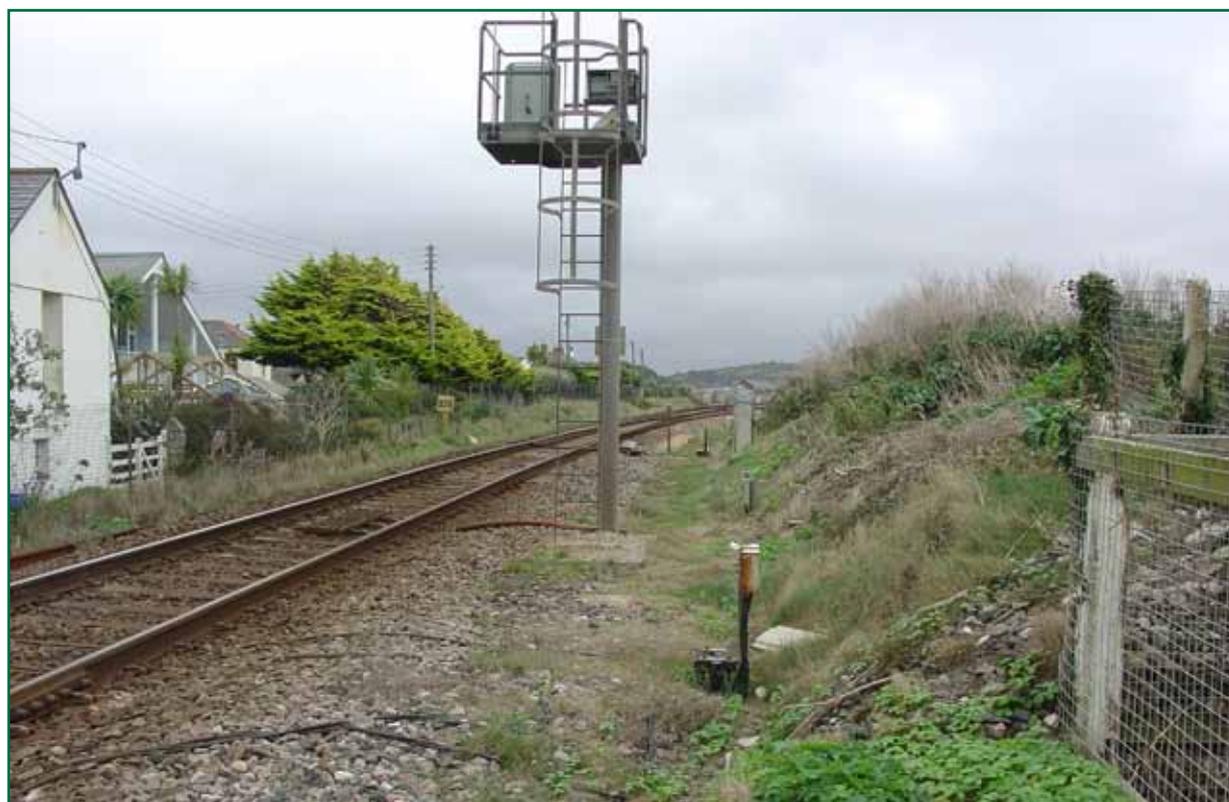
Figure 7: View east from a position alongside the sign on the south side of the crossing (3.40 metres from the nearer rail)

- 32 The sign which instructs users how to cross safely was located between the gate and the track at a distance of 3.40 metres from the nearer rail. At this location, the view to the east for a user is marginally better than that from the gate; see figure 7.

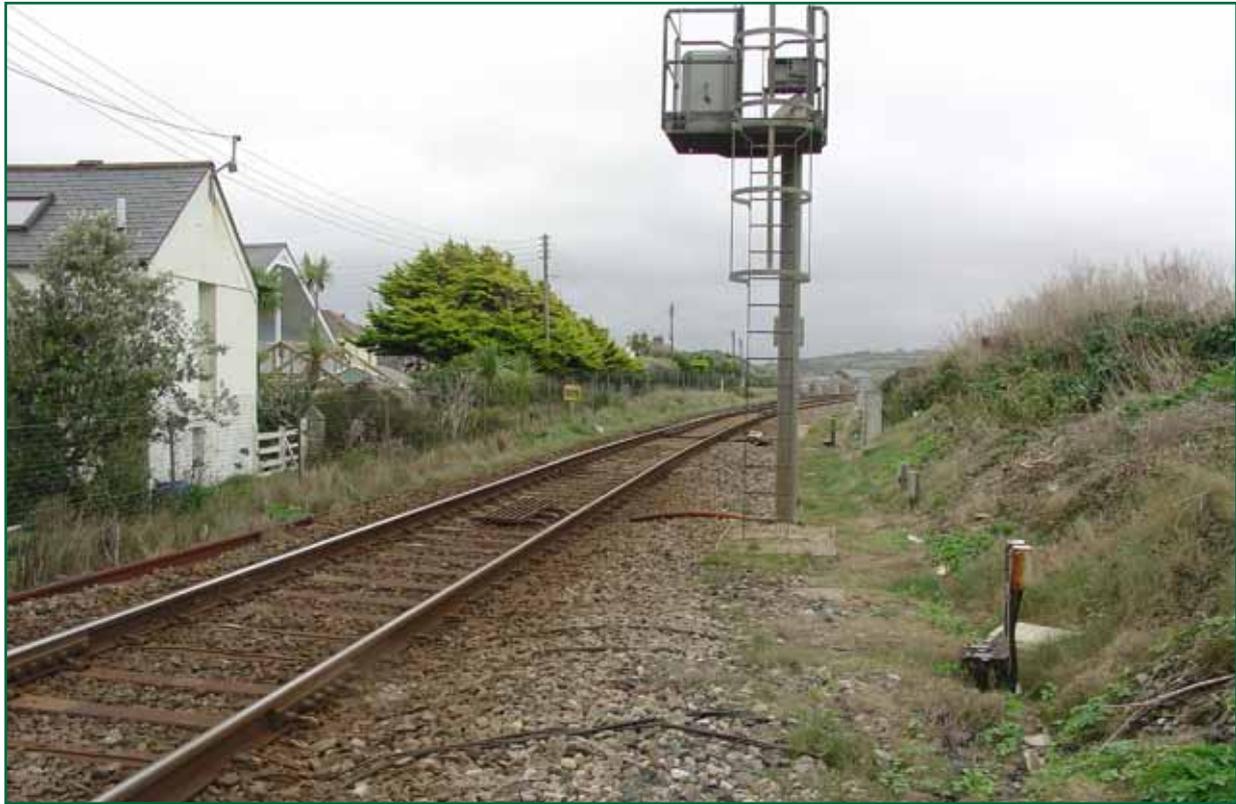
Figure 8: View east from a position on the south side of the crossing (2 metres from the nearer rail)

- 33 When assessing *sighting distances* at level crossings, it is Network Rail's practice in its Western route (which includes Mexico footpath crossing) to take measurements from a position two metres from the nearer rail; see figure 8. This corresponds with the minimum distance defined in the guidance from the Office of Rail Regulation (table 1). At two metres from the nearer rail, a user can see further to the east than is possible from 3.40 metres.

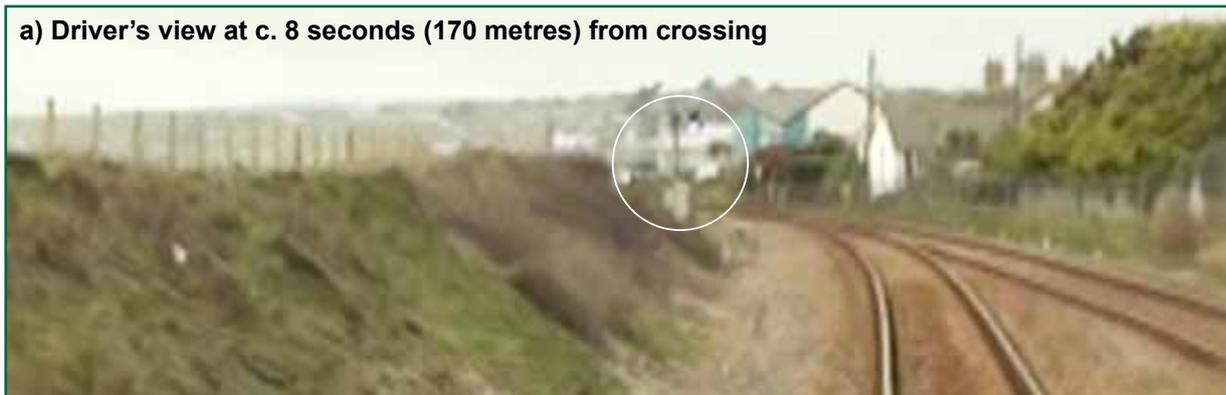
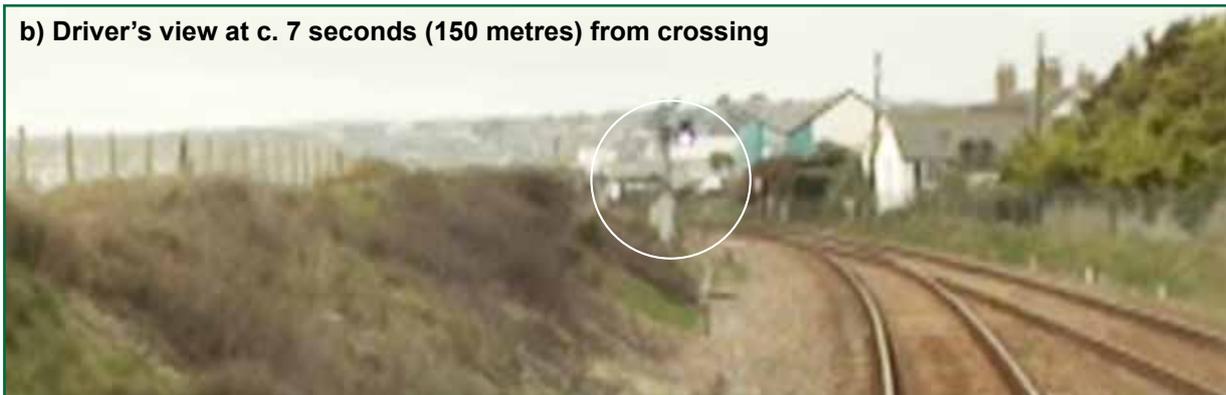
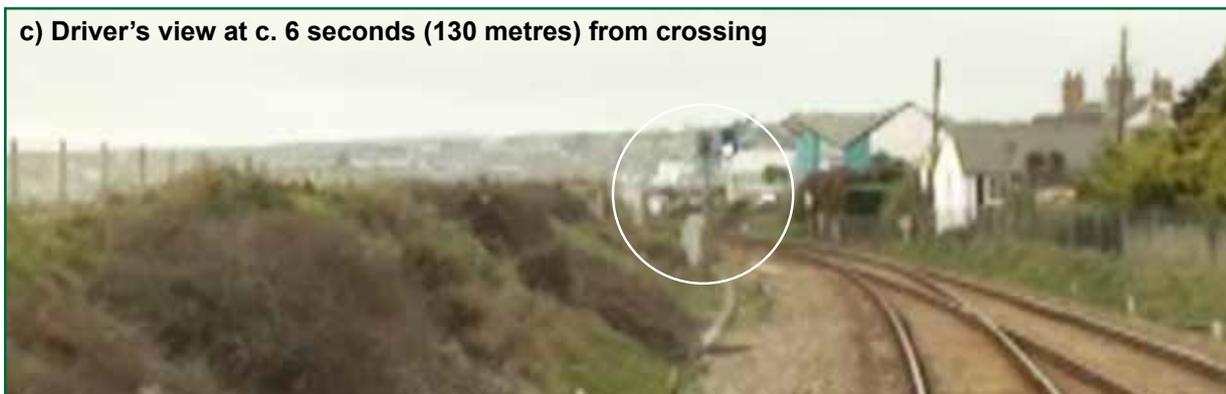
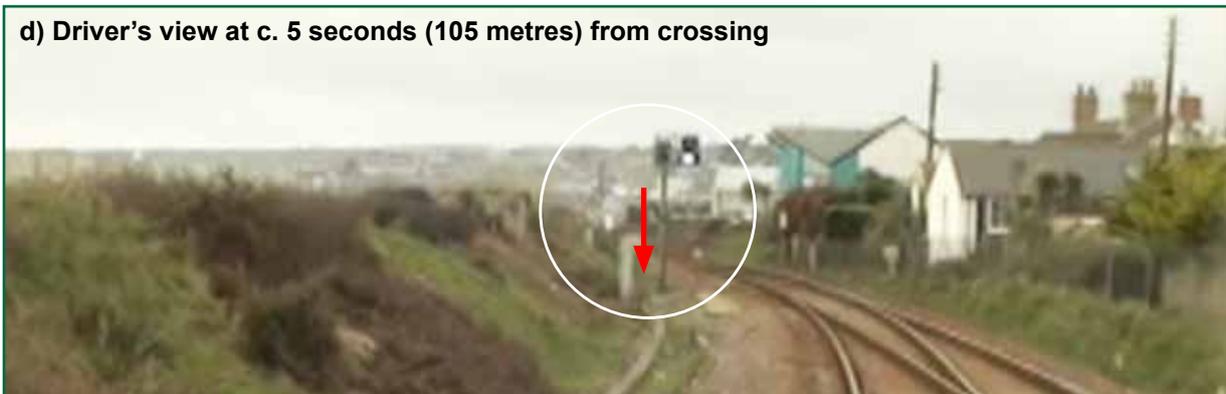
Figures 9a to 9d: The train driver's view approaching Mexico footpath crossing (source RAIB video). It can be seen that the driver's view of the area (circled) immediately to the left of the crossing (the location where Mrs Nicholls was most likely to have been standing and arrowed in figure 9d) was initially obscured by the signal and the equipment cases, and it is not until the train is approximately five seconds from the crossing that the relevant area becomes visible to the driver. Note that the green signal that can be seen clearly in the photograph is mounted to the right of the post that comprises part of the obstruction to the driver's view.

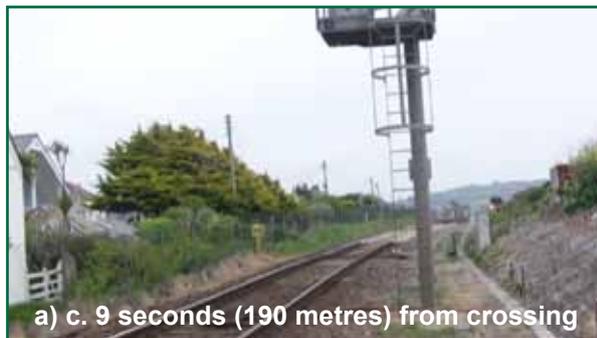
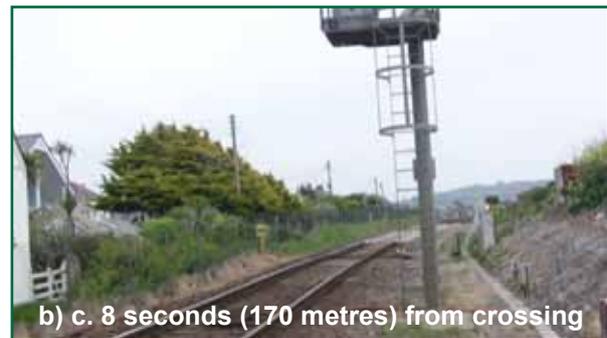
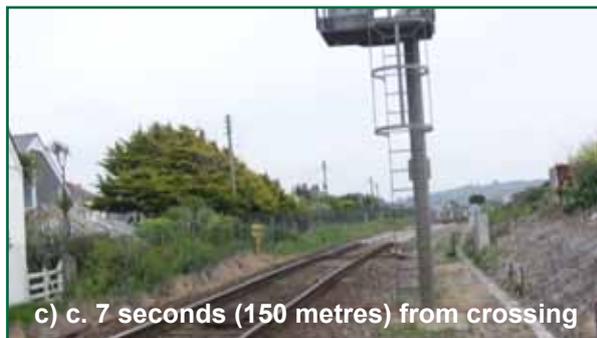
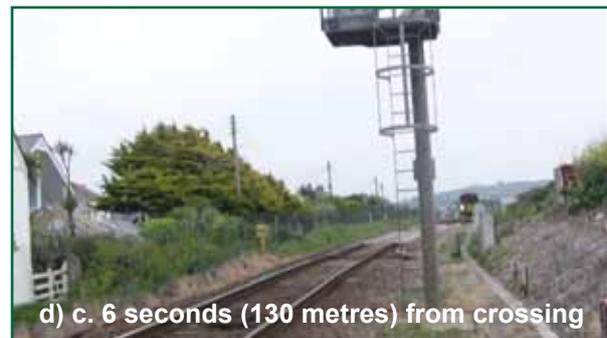
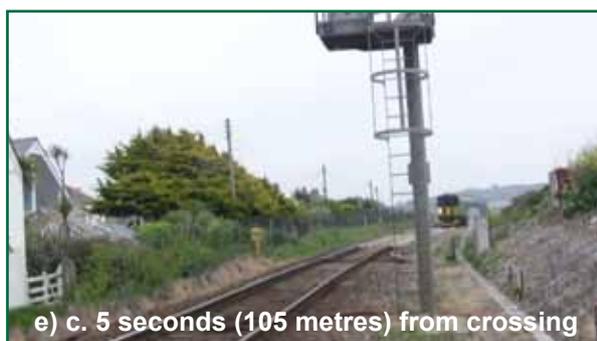
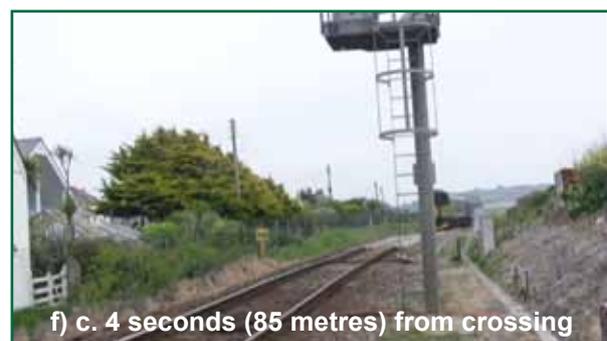
- 65 Figures 10a to 10f show that although the train is visible when it is around nine seconds running time from the crossing, the lower half of the train is obscured by two equipment cases for a period of around one second as it moves towards the crossing. The marker light which helps a pedestrian to distinguish the train as it approaches is obscured at this point, although the upper half of the front of the train and the side of the train are still visible. These findings are valid for someone looking from a position of 1.45 metres above ground. The RAIB noted that when the same train is viewed from 1.6 metres above ground (current Network Rail practice), the period of time over which the marker light disappears is shorter. This is because the roof of the equipment case is pitched and the higher the viewpoint, the narrower the obstruction to the user's view of the marker light (for a tall person, there would probably be no obstruction at all). The signal post also obscures the marker light, but at this point the train is closer and the period over which the marker light disappears is shorter.

Figures 10a to 10f: Views from the south side of Mexico footpath crossing towards a train approaching from the east taken at 1.45 metres above ground level and at 2 metres from the nearer rail. The images show that although part of the train is always in view, the distinctive marker light at the front of the train is temporarily hidden by the equipment cases at 7 seconds from the crossing and by the signal post at 4 seconds from the crossing.

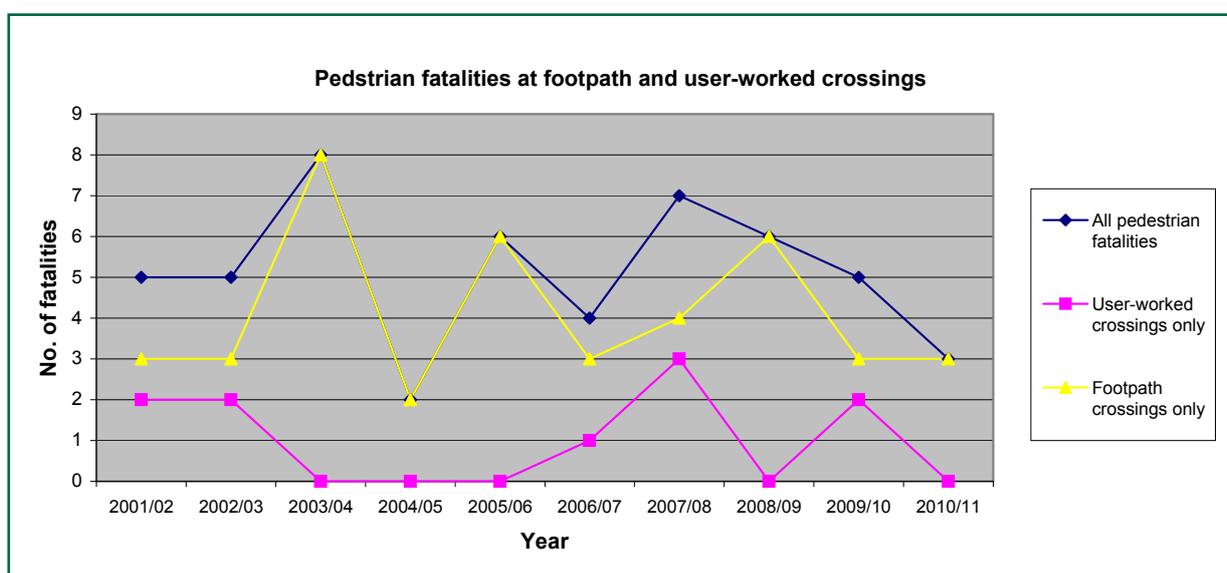
Figure 11: Fatal accidents to pedestrians on footpath and user-worked crossings, 2001-2011

- 91 The data in figure 11 relates to pedestrian fatalities on both 'active' and 'passive' crossings. On active crossings, a positive indication is given to users of the approach of a train (eg miniature stop light or barriers which close automatically as a train approaches), whereas on passive crossings (such as Mexico footpath crossing), there is no such indication. With regard to near-miss incidents, figure 12 shows that while there has been an increase in the number of near-miss incidents on passive crossings since 2007, the number was increasing throughout the period from 2001 to 2011 and the rate of increase did not change significantly after 2007.

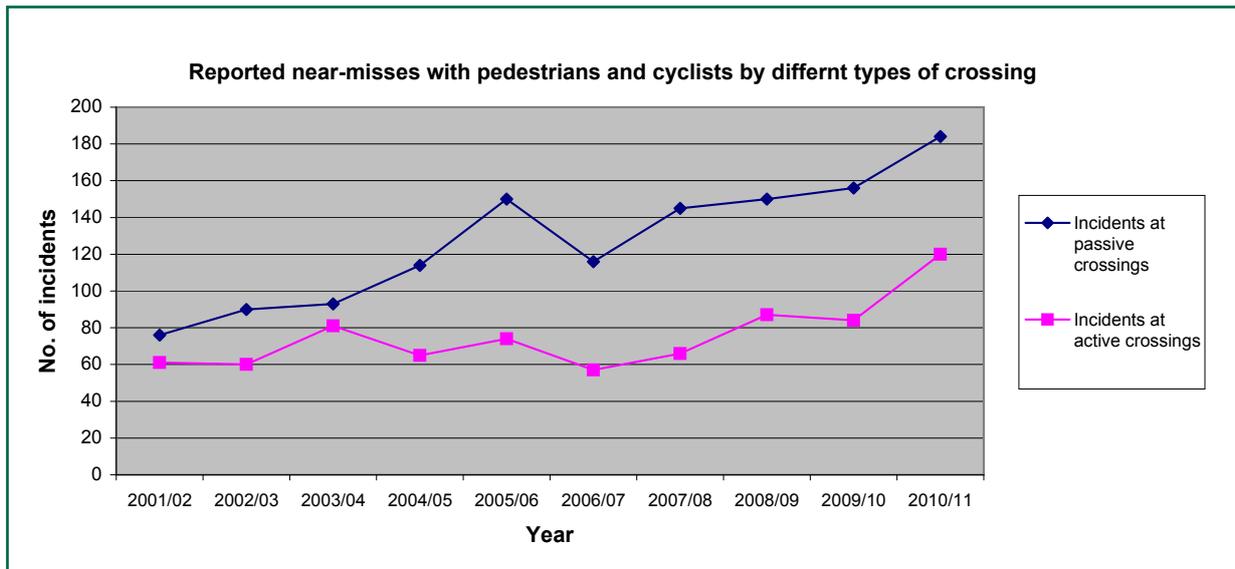
Figure 12: Near-miss incidents on active and passive crossings, 2001-2011

- 92 Not all passive crossings are equipped with whistle boards. The data reflected in figure 12 does not allow any determination of whether trends at whistle board crossings in the period from 2001 to 2011 are different from those at crossings without whistle boards. In order to determine if the change to sounding only the low tone at whistle boards is a significant factor in the increase in near-miss incidents since 2007, it would be necessary to separate the passive crossing data into crossings with and without whistle boards.
