Rail Accident Investigation Branch

Rail Accident Report

**Fatal accident at Gipsy Lane footpath crossing,
Needham Market, Suffolk
24 August 2011**

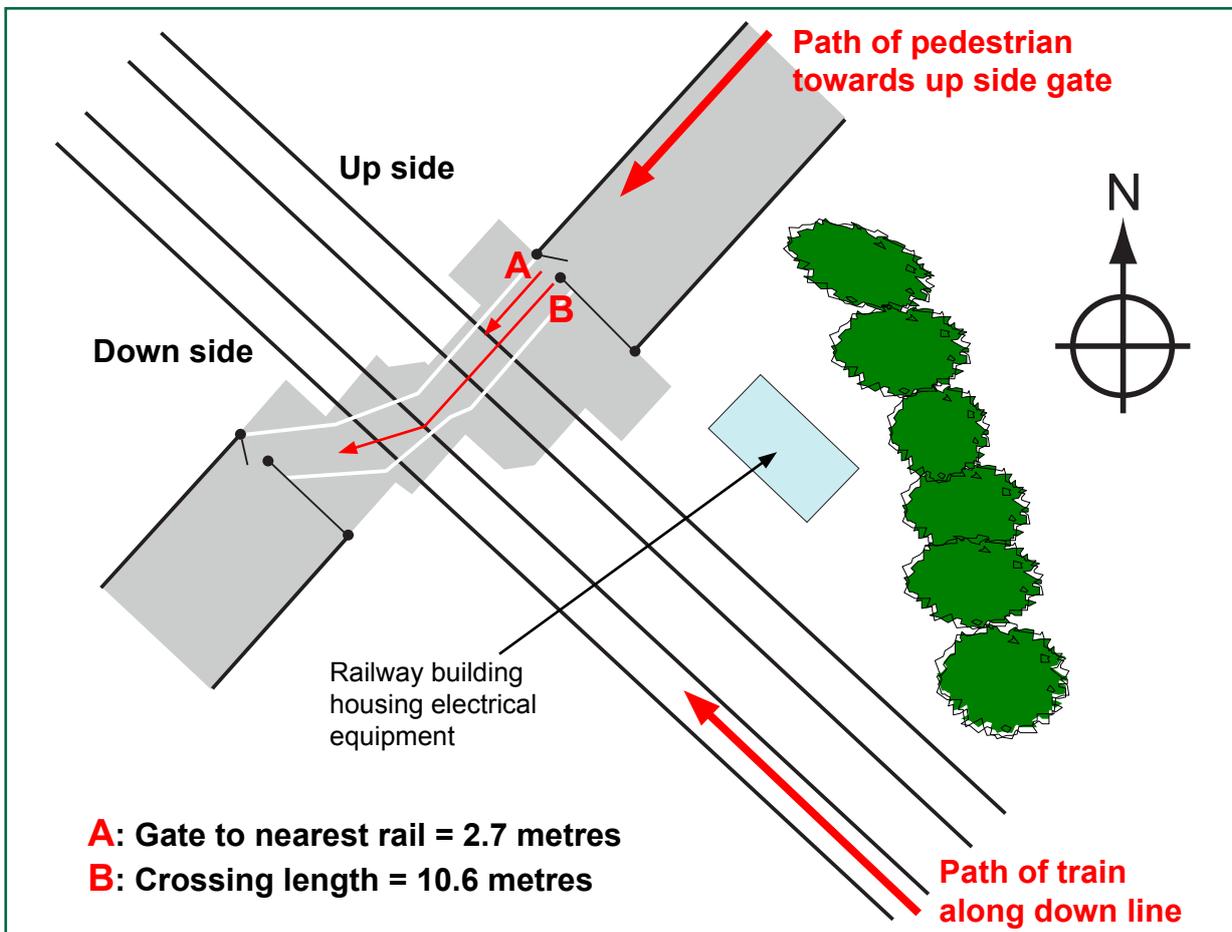
Figure 3: Layout of Gipsy Lane footpath crossing

- 10 Pedestrians have a restricted view of trains approaching along the down line (ie from the London direction) due to line curvature and seasonal vegetation growth. For this reason, a *whistle board* is provided to warn pedestrians of an approaching down train. This is located 396 metres from the crossing.

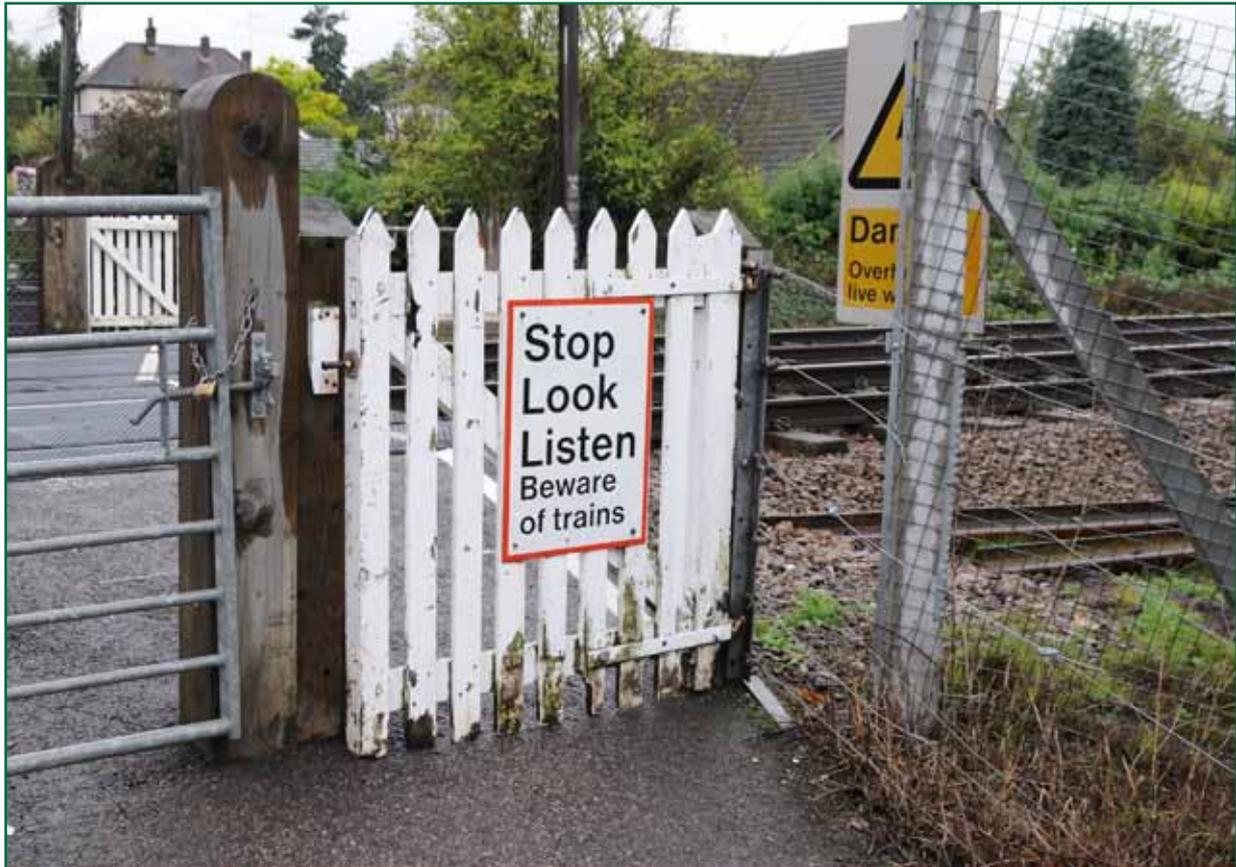
Figure 5: Sign at the crossing gate (view taken from the up side of the crossing - the side from which the pedestrian approached)

- 16 The crossing was fitted with wooden gates on both approaches which opened outwards (ie away from the railway). Signs instructing pedestrians to stop, look, listen and beware of approaching trains were attached to each gate (figure 5).
- 17 The crossing surface comprised rubber panels and asphalt strips. The condition of the crossing surface was not a factor in the accident.

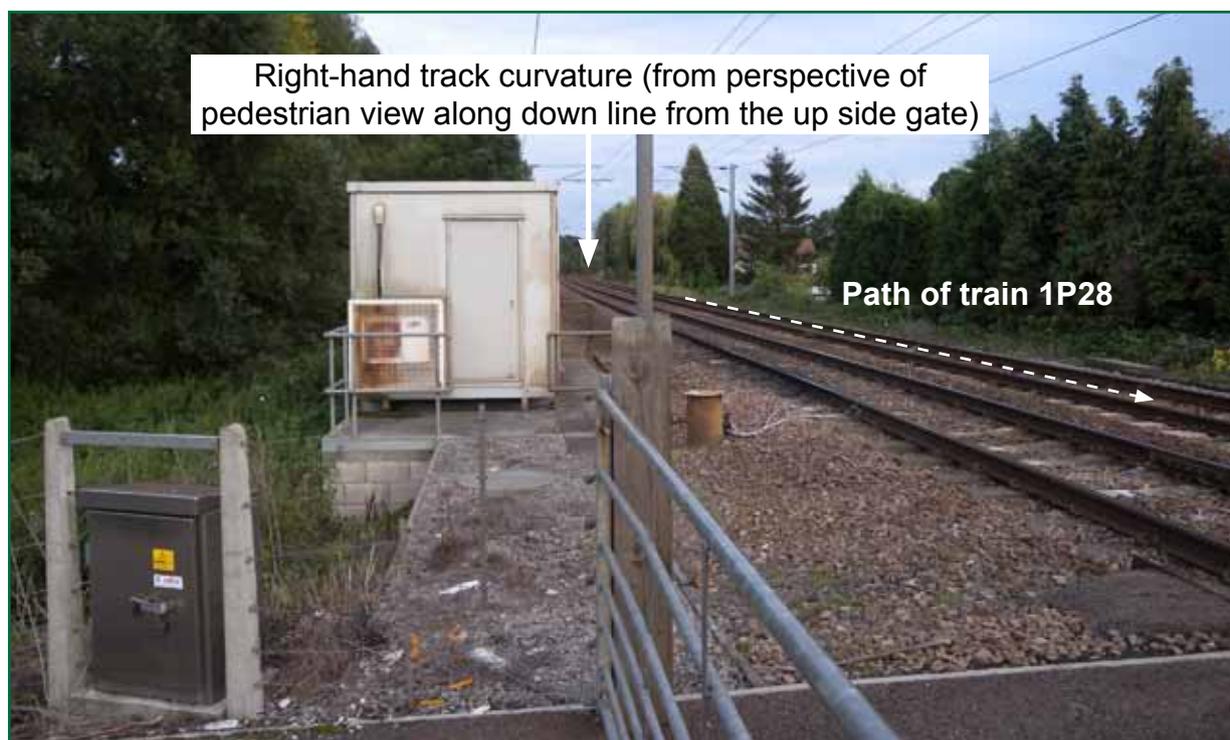
- 42 The view from the up side gate towards trains approaching on the down line is restricted by line curvature and vegetation. On the day of the accident the *sighting distance*⁹ was recorded as 348 metres using the up side gate as the decision point - see figure 6. In June 2011, Network Rail had assessed that the required sighting distance needed to be a minimum of 448 metres if users were to rely on sighting alone when judging whether it was safe to cross (at this time vulnerable crossing users (see footnote 7) had not been identified and no additional traverse time had been allowed for).

Figure 6: Sighting of down line trains from the up side gate

- Required sighting distance on the down line, based on the traverse time and line speed: 448 metres. The available sighting distance at Gipsy Lane footpath crossing was therefore deficient by 58 metres.

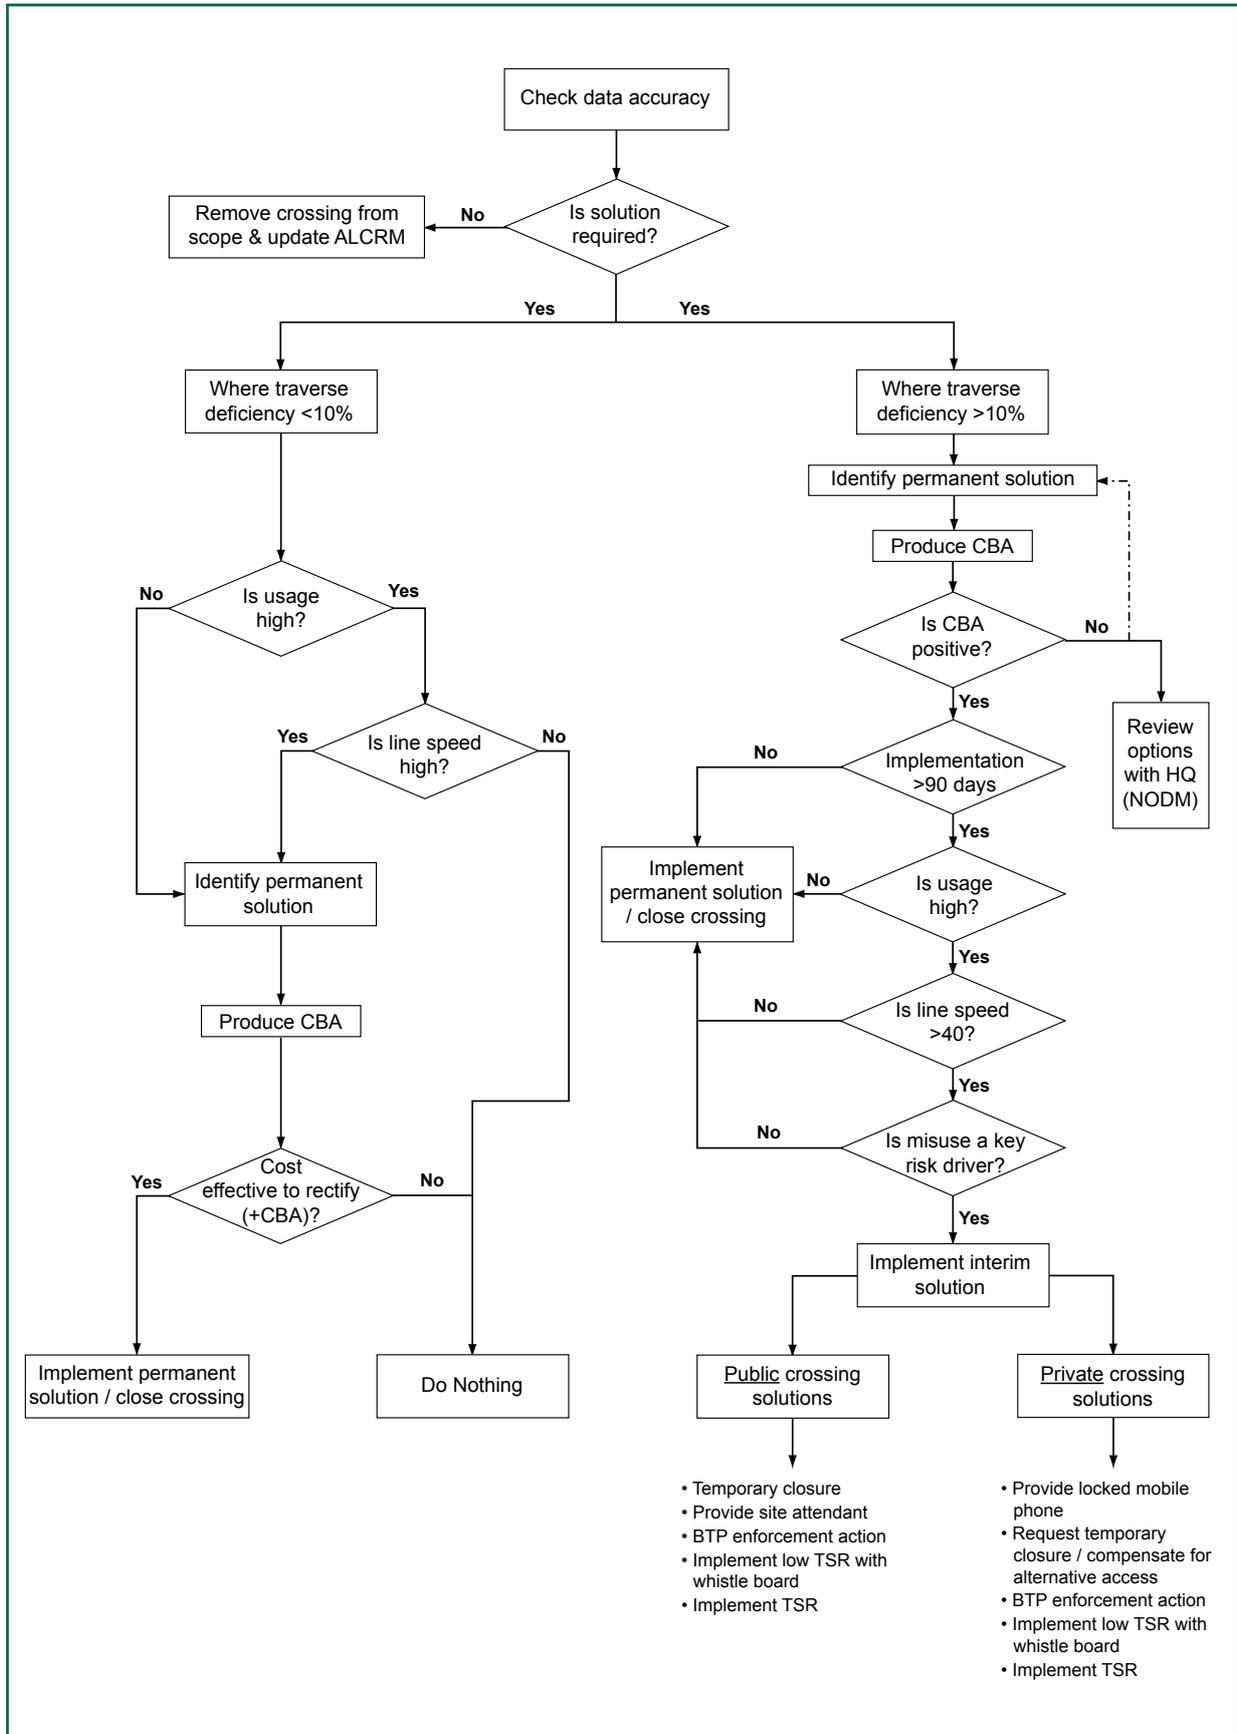
- Traverse distance: 10.6 metres using the decision point as the up side gate, located 2.7 metres from the nearest rail. The use of this location is consistent with ORR guidance (paragraph 38); the sign indicating how to use the crossing safely was visible at a point where the crossing user could also view trains approaching from either direction.

Figure 7: Level crossing decision flowchart devised by the national level crossings team

118 Guidance, in the form of a decision flowchart provided by Network Rail's national level crossings team, sometimes discouraged those involved in level crossing risk management from making short-term changes to reduce risk at crossings such as Gipsy Lane (**paragraph 97, Recommendation 3**).

- 3 *The intent of this recommendation is for Network Rail to develop guidance for use by the level crossing teams on the circumstances under which short-term mitigation measures are to be implemented at level crossings that have insufficient sighting or warning of approaching trains (paragraphs 117d, 117f, 118 and 119d).*
