Rail Accident Investigation Branch

Rail Accident Report

Track worker struck by a train at Stoats Nest Junction 12 June 2011

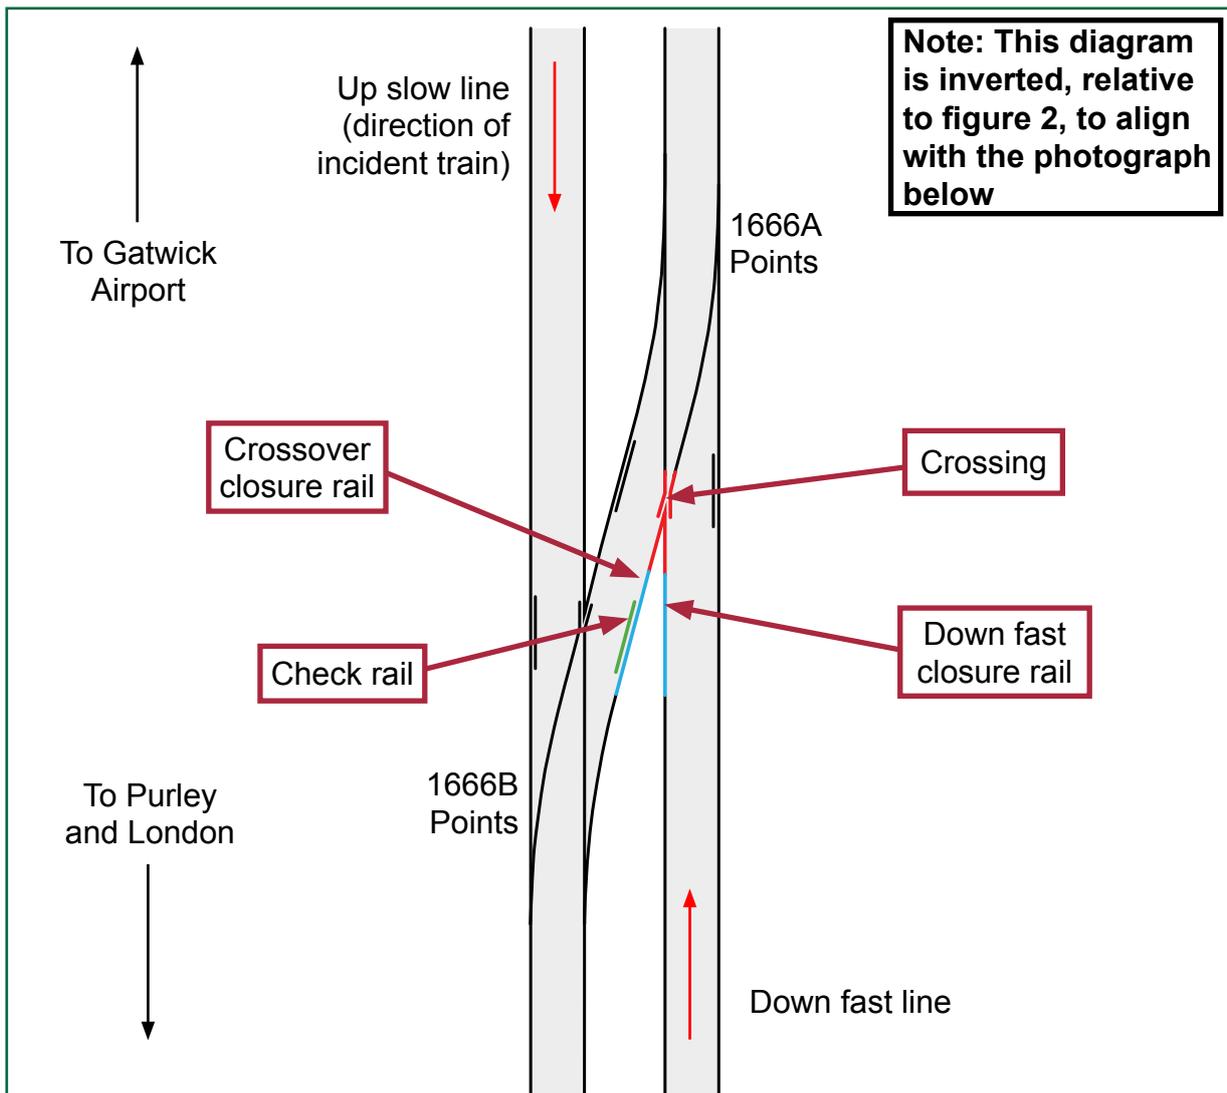
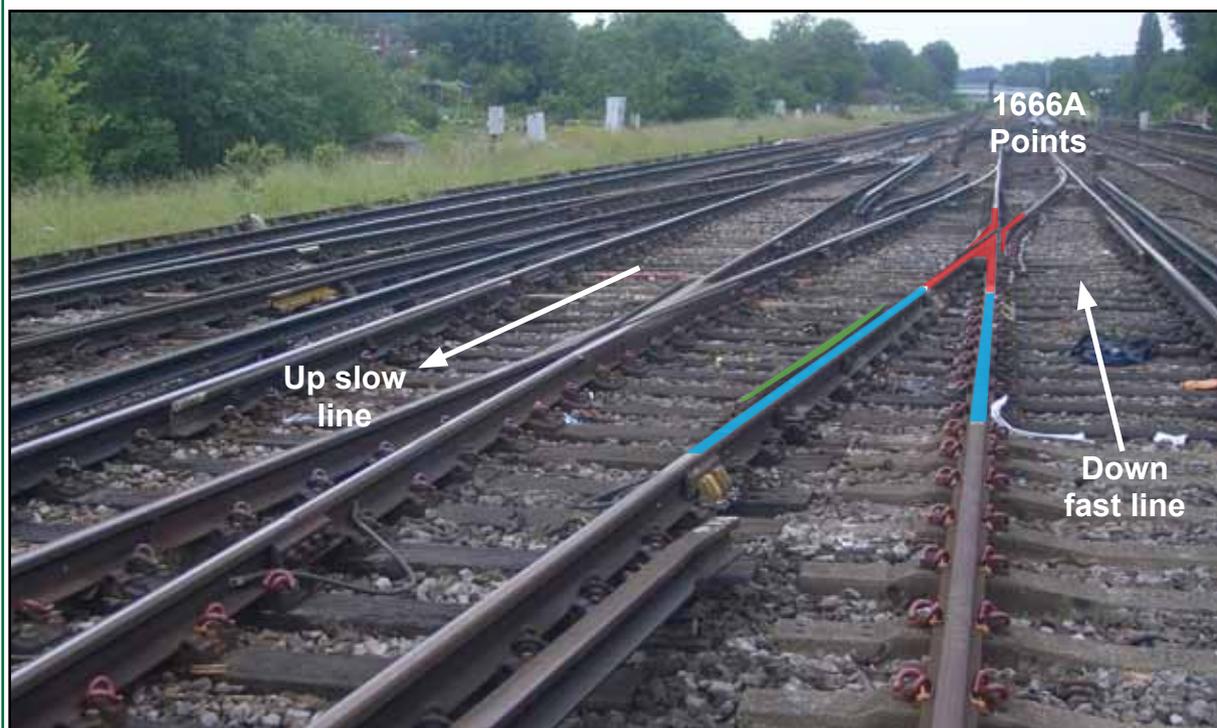
Figure 3: Crossover detail at Stoats Nest Junction

- 39 Initially, the gang removed the rail fixings and cut out the cracked crossing section, in preparation for lifting out and replacement.
- 40 Two RRVs were used to bring the replacement crossing piece to site, from near Purley, along with two lengths of *closure rail* that had been cut to length to accommodate the new crossing assembly (figure 3).

- 85 By this time the welds on the down fast line closure rail (figure 3) were under way, and the track workers were preparing to clamp the crossover closure rail into position so that the up slow line could be handed back on schedule. Although this meant that the crossover would only be able to be used at low speed, the fact that it normally had a 25 mph (40 km/h) speed restriction meant that this would cause no disruption.

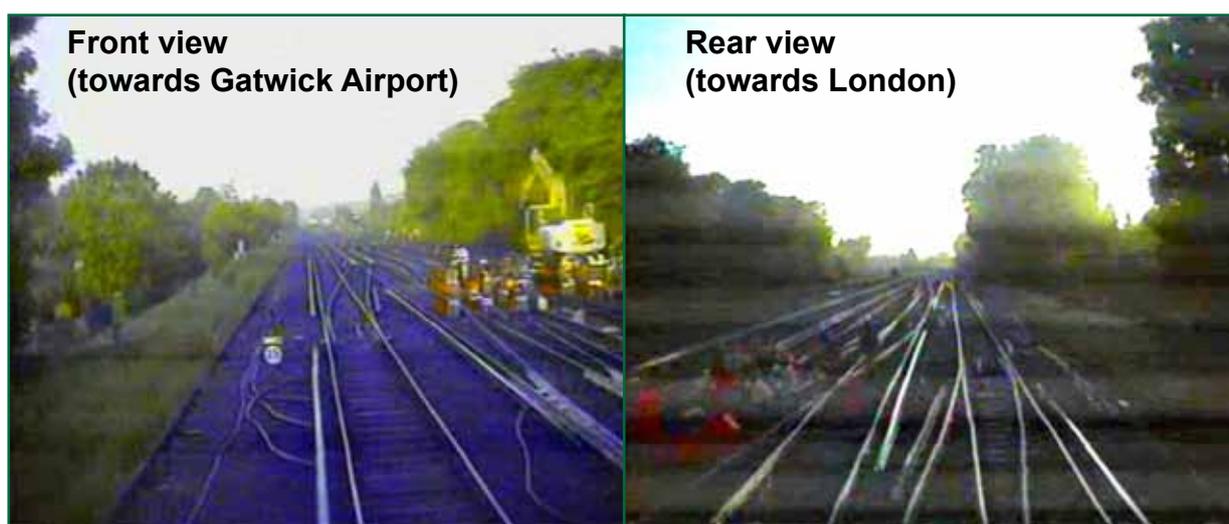
Figure 4: CCTV images of the work site at 05:24 hrs

- 49 At 05:17 hrs the PICOP contacted the Three Bridges signaller to hand back the up slow line for traffic.
- 50 A recording of the forward (and rear) facing CCTV of a passing train, on the down slow line, shows that work was still ongoing on the crossover closure rail, at 05:24 hrs. Personnel were still present in the space between the up slow line, which was now returned to traffic, and the down fast line, which was still blocked. One person was in the *four-foot* of the up slow line, which was open to traffic (figure 4).

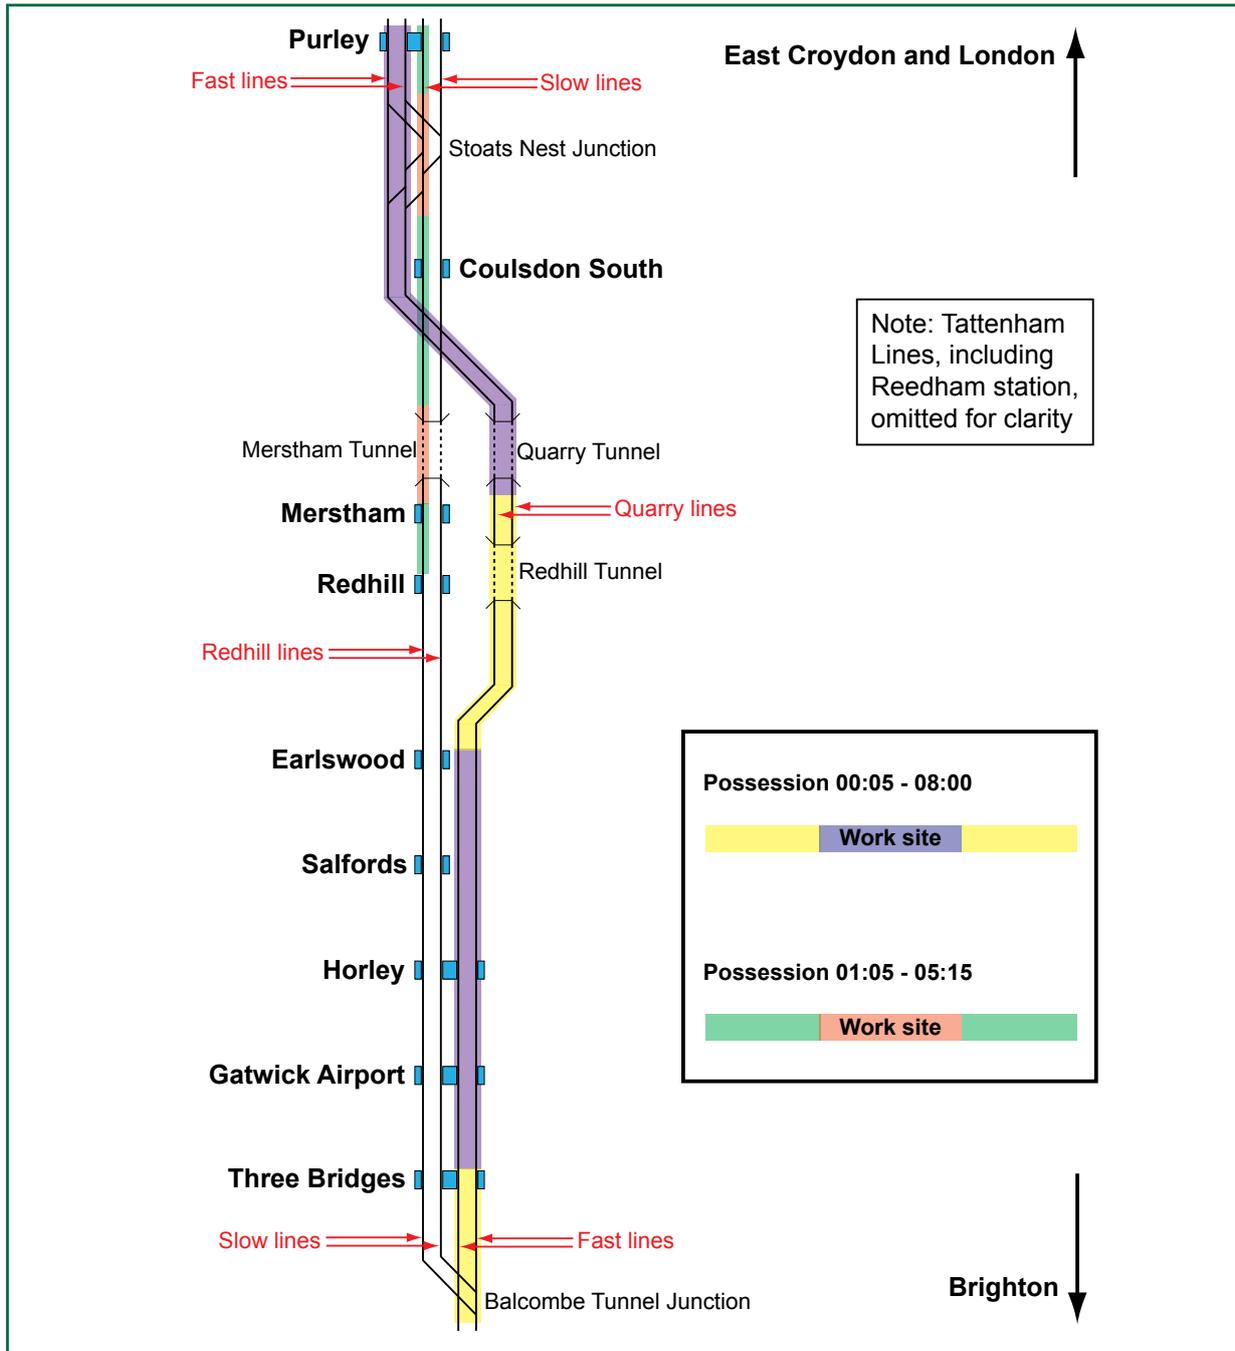
Figure 6: Simplified layout of the possessions

69 The work at Stoats Nest Junction on the night of 11-12 June 2011 was being carried out under a three part² possession of the lines between Purley and Balcombe Tunnel Junction (figure 6).

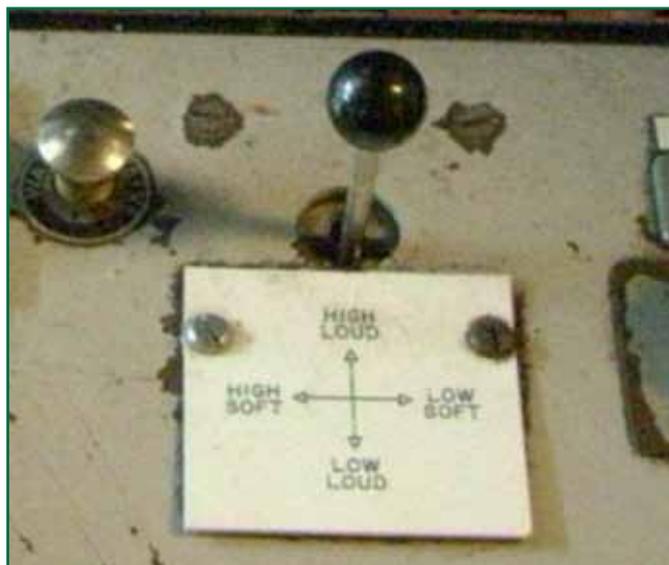
Figure 7: Train horn lever

- 138 The class 442 units are fitted with a four-way horn lever (figure 7). This allows the driver to sound two different horn tones in the loud volume setting, by moving the lever forwards and backwards. A further two tones in the soft volume setting can be sounded by moving the horn lever left and right.

- 139 The train driver believes that he sounded the horn using the soft volume level, when he sighted the track gang close to the line. The driver stated that he used the soft volume level because he was close to the track workers at the time, and believed that they were clear of the train. However, because the OTDR on the train does not record horn use (paragraph 135), there is no evidence to confirm whether the horn was sounded, the timing of any horn use or its volume.

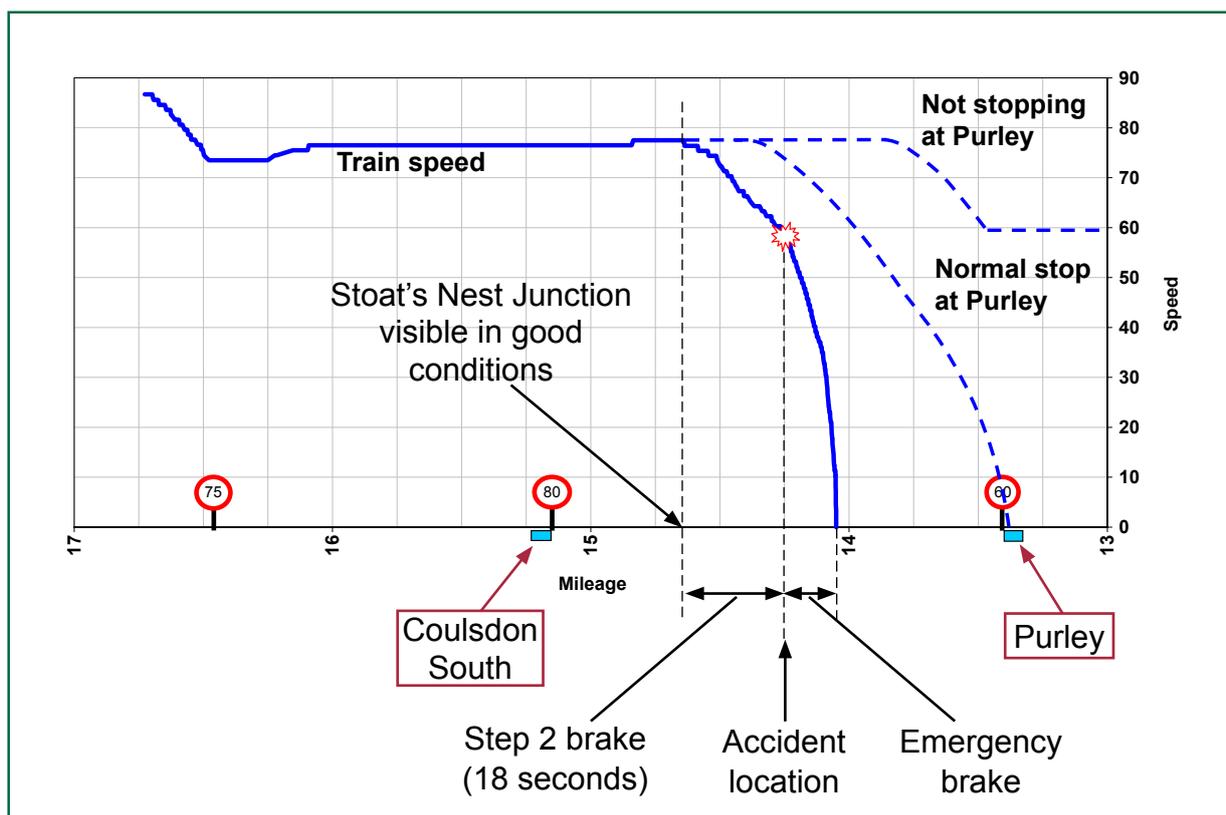
Figure 8: Train speed and line speeds

- 148 Approximately 550 metres (18 seconds) before the impact, the driver applied the brakes, bringing the speed down ahead of the 60 mph (96 km/h) restriction at Purley. This brake application was about 50 metres after the first opportunity at which the driver would have had a clear view towards Stoats Nest Junction (in ideal conditions). Evidence from a driver trainer indicates that the brake application was approximately 350 metres earlier than the normal braking point required to stop the train at Purley, and 1250 metres earlier than would have been required to slow the train to pass through Purley without stopping. Figure 8 shows the train's speed profile on the approach to Stoats Nest Junction as well as the speed profiles for normal services stopping at, or passing through, Purley.
