Rail Accident Investigation Branch

# Rail Accident Report

## **Safety incident between Dock Junction and Kentish Town 26 May 2011**

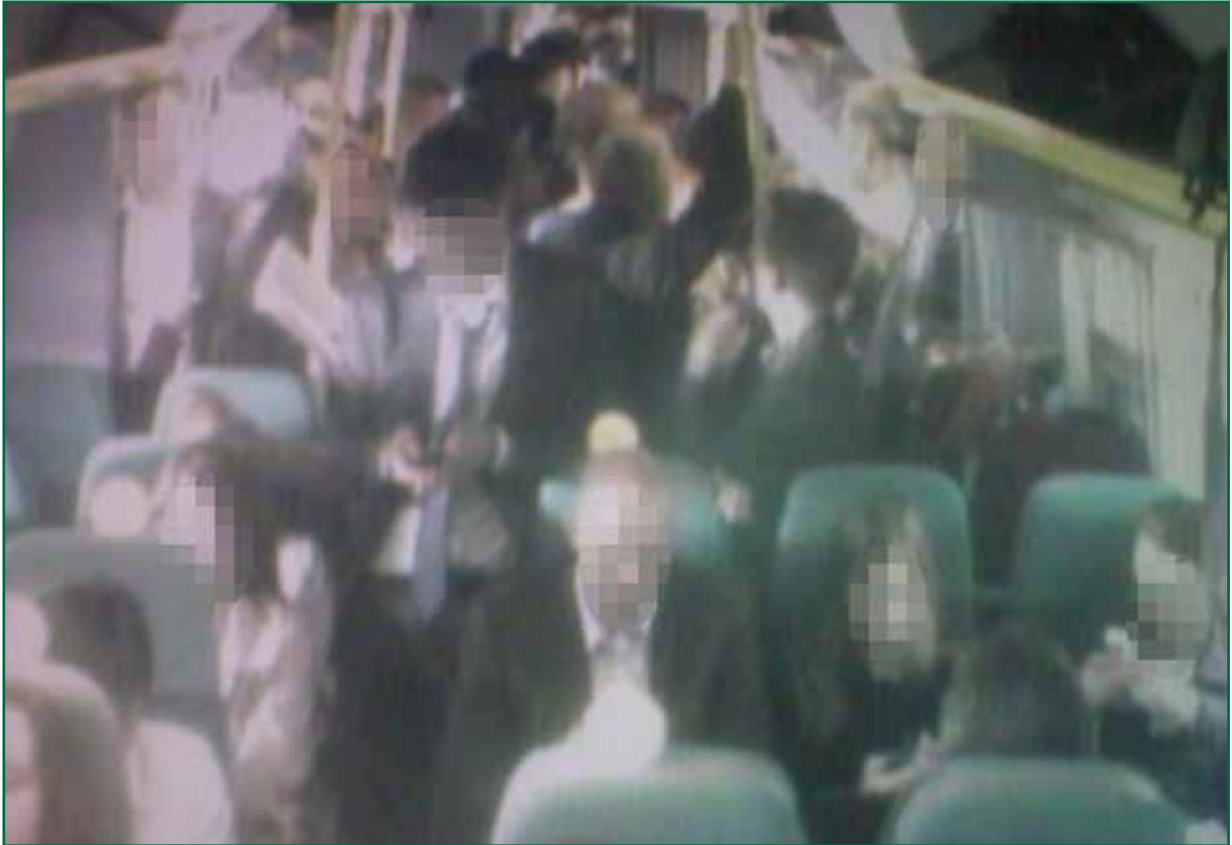
Figure 6: Image showing passengers within 1W95. The train has 482 seats available with an average evening peak train accommodating approximately 700 passengers.

77 Train 1W95 was heavily loaded, having already stood at St. Pancras station for 20 minutes while the driver attempted to remedy the problem. For part of that time, the train was without power, so the batteries were already starting to be depleted. The train systems restarted for 13 minutes when the train gained power from the front pantograph, prior to its departure from St. Pancras. Once the train had stopped again between St. Pancras and Kentish Town with no power, it automatically started to shed electrical load again. The air conditioning and the electrical operation of the flushing system in the toilets stopped functioning almost immediately. At around 19:10 hrs, the internal CCTV system and the public address system ceased to function, which meant that the driver could no longer speak to all passengers from the cab. The passenger communication system continued to function intermittently, which enabled the driver to speak to the passenger who had made the call and identify the area from which the call had been made on his in-cab display.

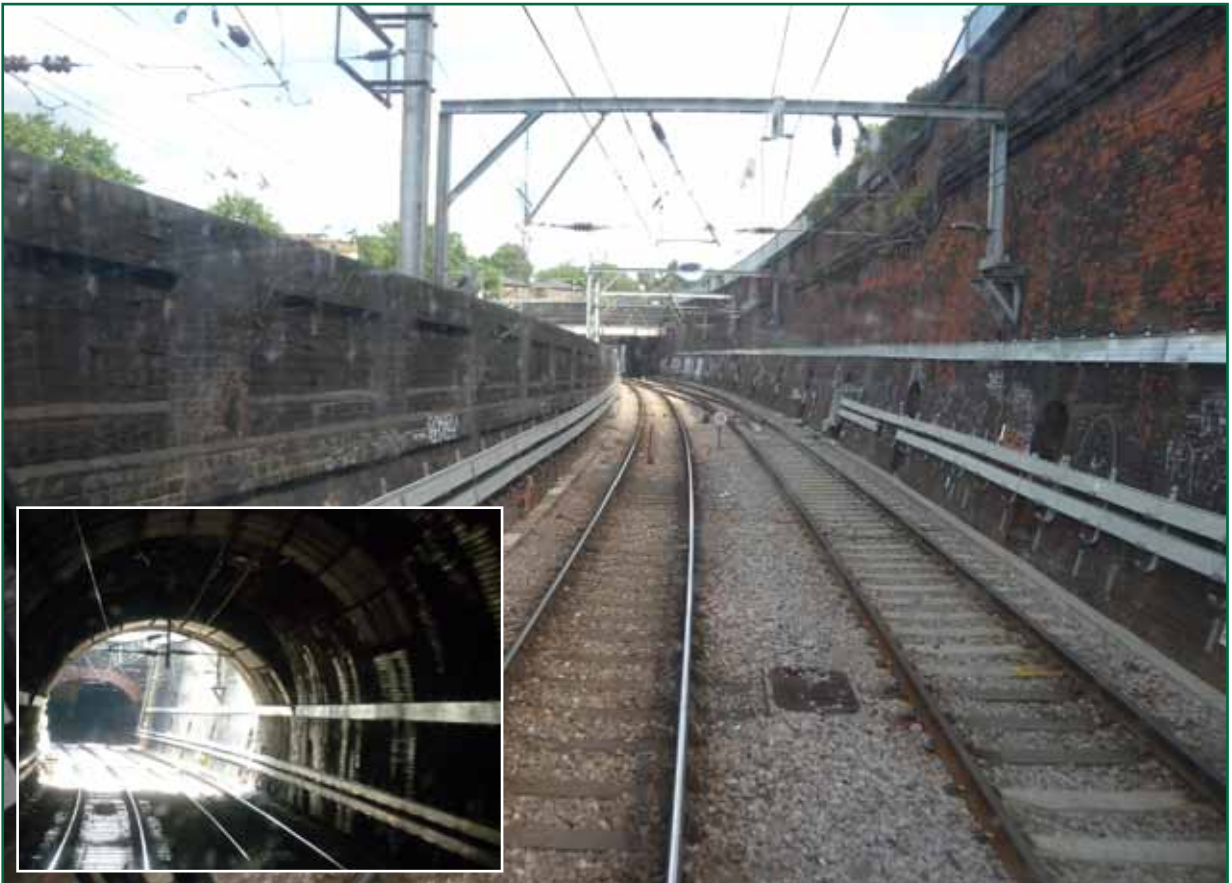
Figure 7: Down Moorgate line near Dock Junction North

- 32 Shortly before 18:26 hrs, the OHLE tripped again and the train stopped near to Dock Junction (figure 7). The electrical control room operator decided not to reset the OHLE again in order to prevent damage occurring. Although the driver had not reported that the train had failed, the signaller advised him that a FCC depot technician would be in contact as both the signaller and FCC controller believed that the problem was a technical fault on the train. The driver made a further announcement to the passengers to update them on the situation.

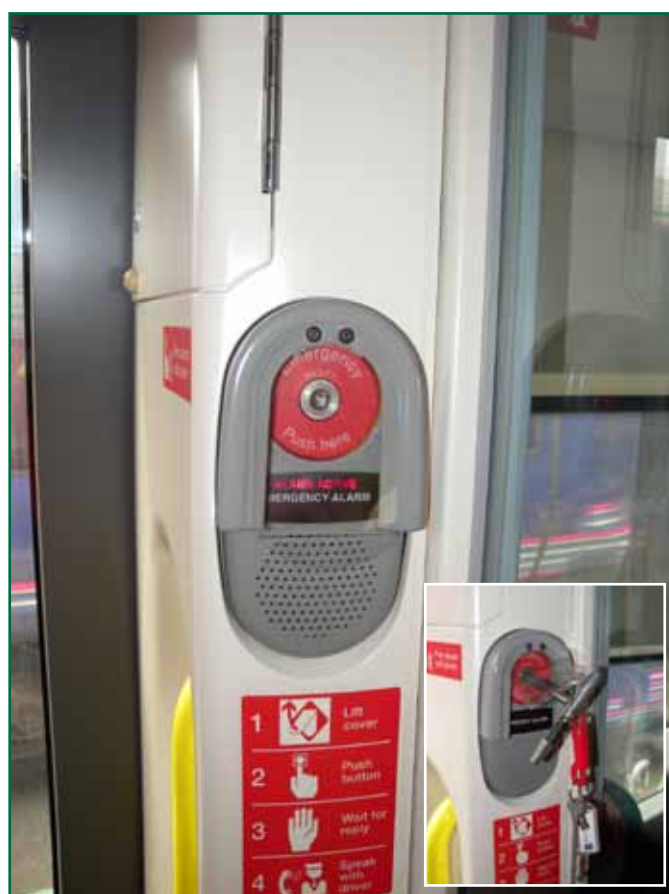
- 35 By 18:57 hrs, the driver of train 1W95 started to receive warnings via the train management system that passenger doors had been opened and passenger communication alarms had been activated. He walked back through the train with difficulty (due to the number of standing passengers), resetting the passenger alarms manually with a key, and closing two doors which he found to be open (figures 8 and 9). Some passengers became verbally abusive and others complained of the high temperatures within the train and the lack of announcements and progress. The driver explained that a rescue train was expected in five minutes, but was only able to communicate with individual groups of passengers as the public address system was no longer operational.

Figure 8: Passenger communication alarm with alarm active (inset - alarm being manually reset using a key)

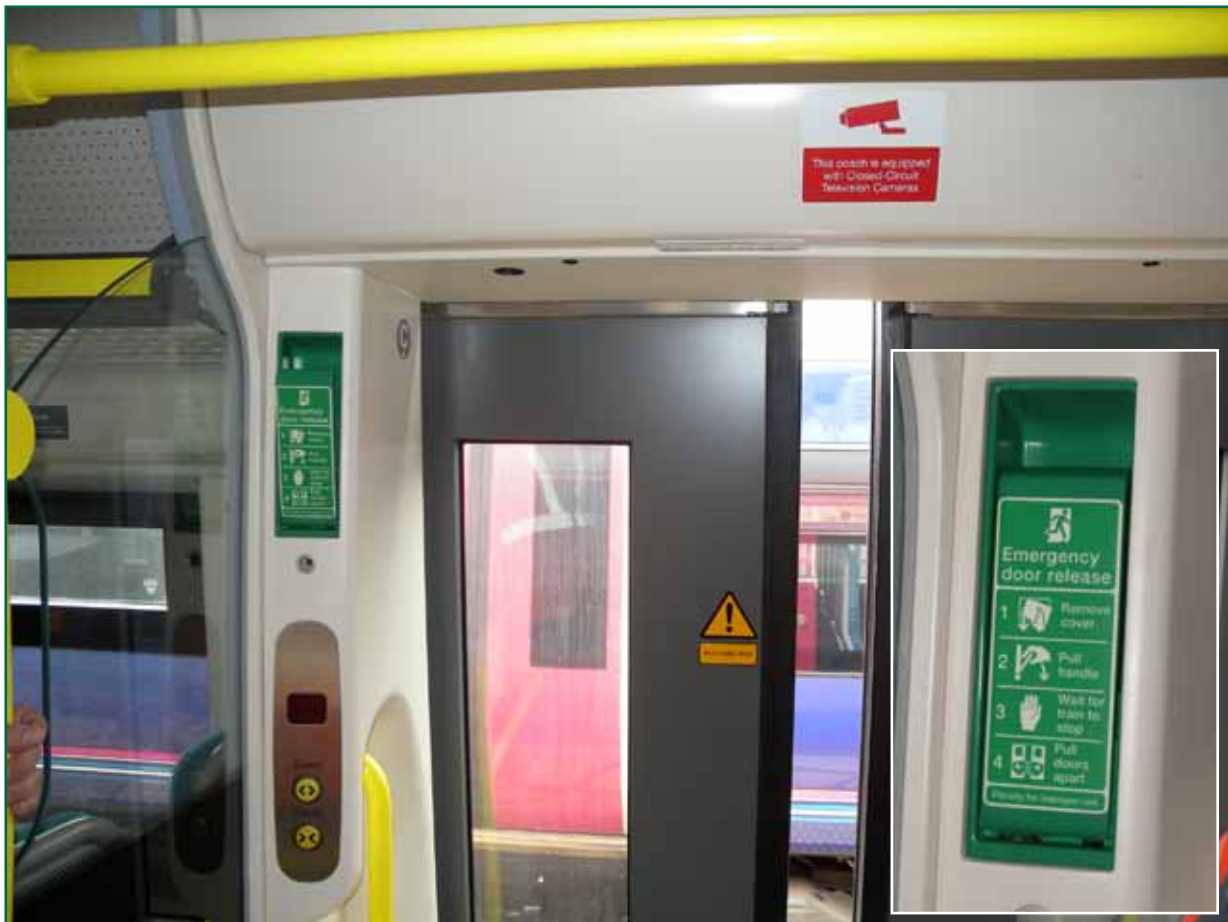
Figure 9: Door egress handle allowing partial opening of the train door after egress handle is pulled down (inset - egress alarm in its normal state)

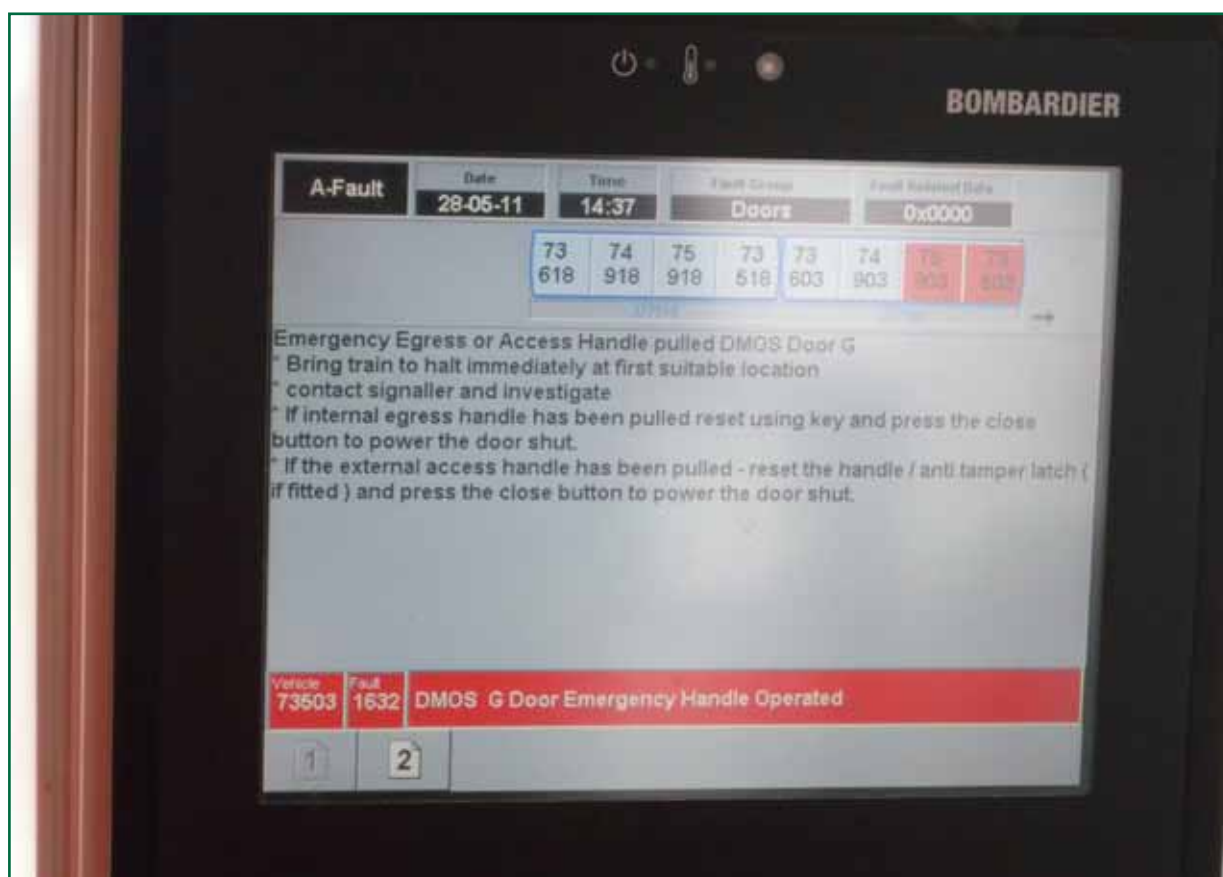
- 41 The driver of train 1W95 made his way to the front of the combined trains, which now consisted of 12 coaches. He started the combined train's computer controlled train management system at 20:29 hrs, but the public address system on the failed 8-cars still did not work. Operation of the emergency door release handles and passenger communication alarms continued, and this meant that the driver was still unable to move the train because there was a safety interlock which prevented him from taking traction power with the alarms operated. The fitter volunteered to walk through the train to reset all of the passenger communication alarms and to close any open doors. As he walked through the train he asked passengers (some of whom had been standing for over two hours) not to activate emergency door release handles and passenger communication alarms again as this would prevent the train from moving. However, some passengers ignored this request. The driver's computer display screen continued to show door faults on the failed portion of the train, which meant that he was unable to determine whether the doors were open or closed (figure 10). It was still not possible to obtain the door interlock necessary for movement of the train.

Figure 10: Door activation and instructions given to the train driver on the in-cab display

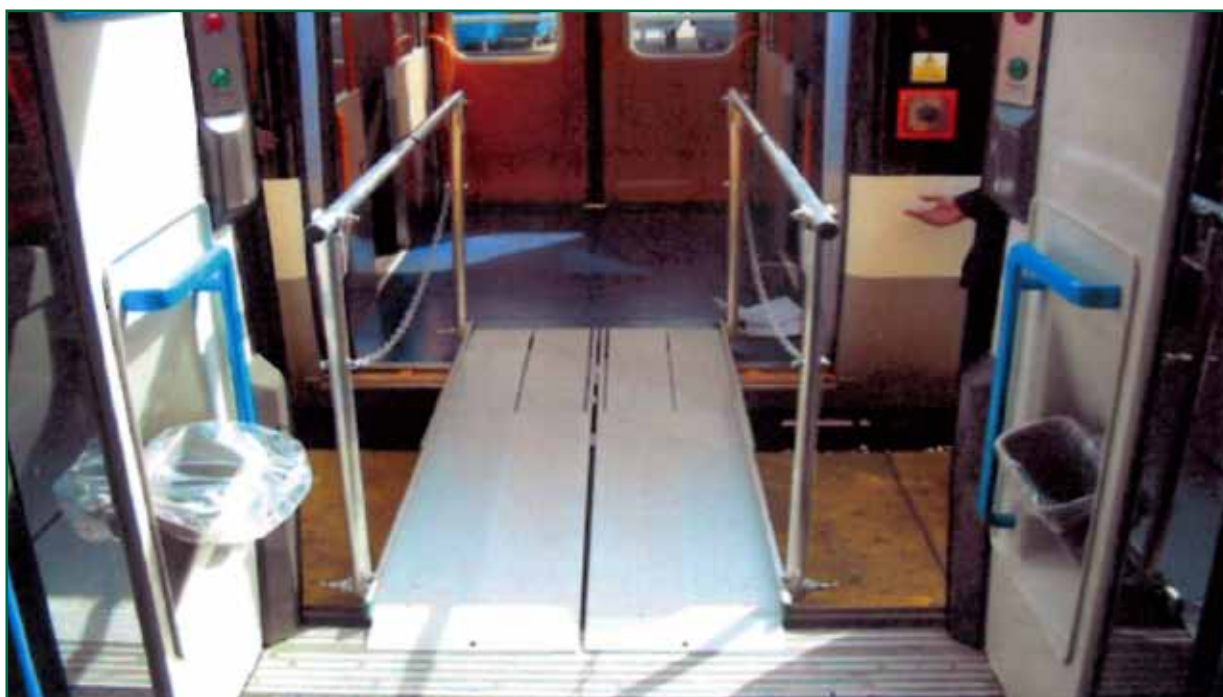
- 65 *Transboardment bridges* (figure 12) could have been used to transfer passengers from the failed train to another train drawn up alongside<sup>6</sup>. FCC's procedure for dealing with stranded trains (paragraph 62) included this option. Although the document had been authorised as a company procedure in January 2011, it had only been loaded onto FCC's intranet system on 17 May 2011, a week before the incident. The intranet system was the source of information for control room staff on FCC's company procedures.
- 66 An audit undertaken after the incident confirmed that some key staff (including those in the control room) were not aware of the contents of the procedure because the briefing program had lapsed. Control room staff were therefore unaware of the existence of transboardment bridges and the option was not considered

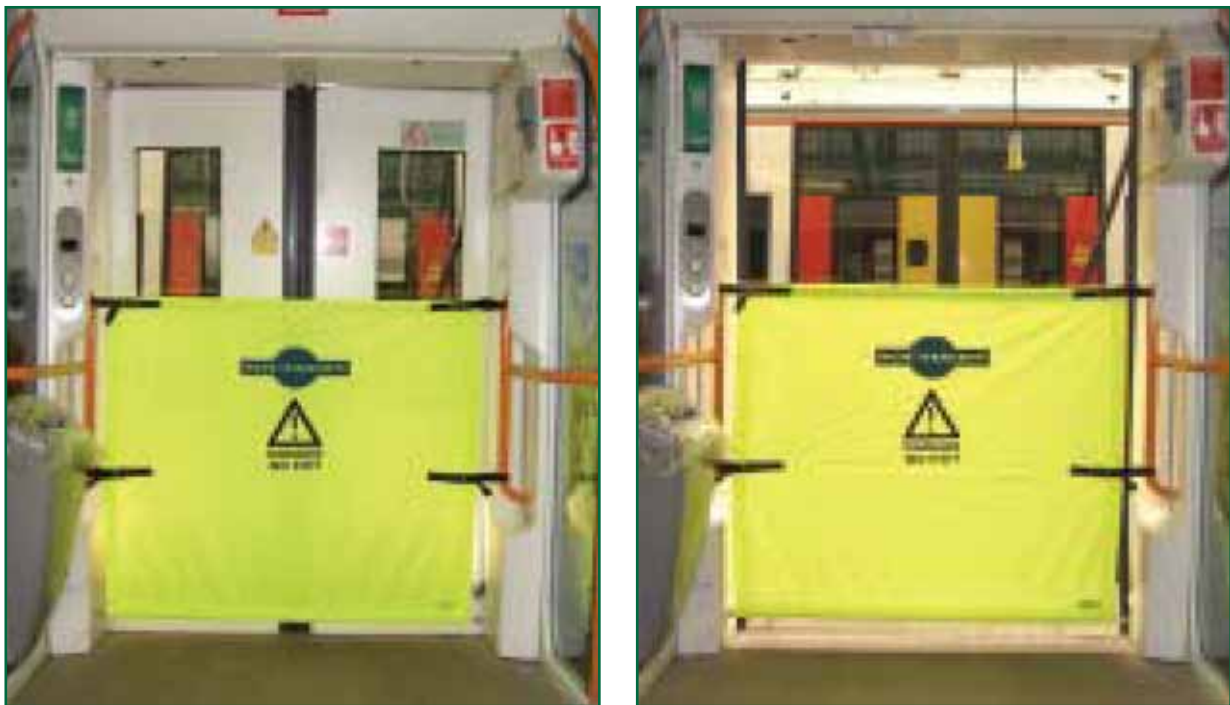
- 87 Following this incident, a formal investigation was completed by Railtrack and a number of recommendations were made including the provision of door screens (figure 13) to enable some doors to be opened without compromising passenger safety.

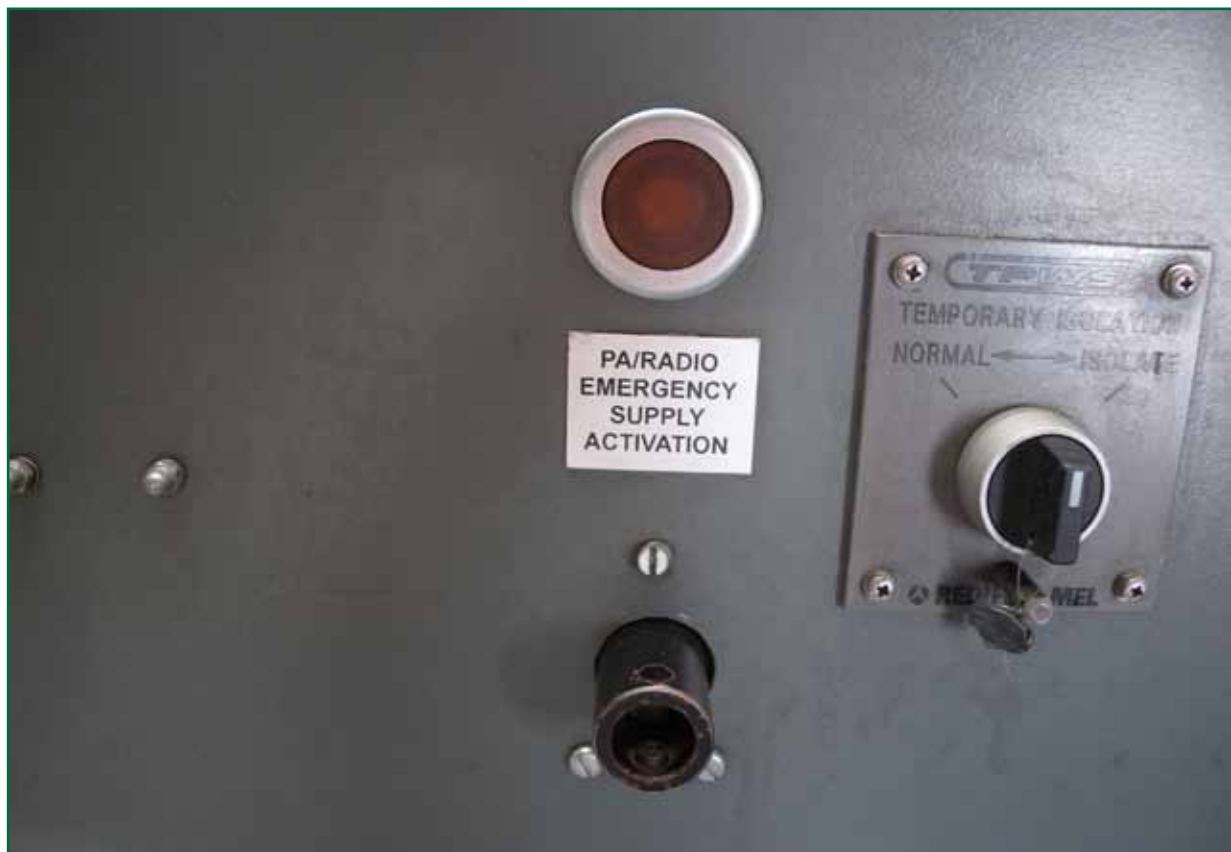
- 94 The class 319 units that had operated most services on Thameslink routes before the introduction of the class 377/5 units were equipped with an auxiliary battery button which allowed drivers to continue to use the public address system when power had been lost. The class 377/5 units were not equipped with such a button, but it was established after the incident on 26 May 2011 that drivers can obtain power for the public address system for up to five discrete periods of around seven minutes each by re-setting the auxiliaries. However, FCC was unaware of this (the seven minute cycle is mentioned in FCC training material but does not specifically mention that it will enable the public address system to be used) and its use had not therefore been briefed to drivers.

Figure 14: Auxiliary battery button on the class 319 train

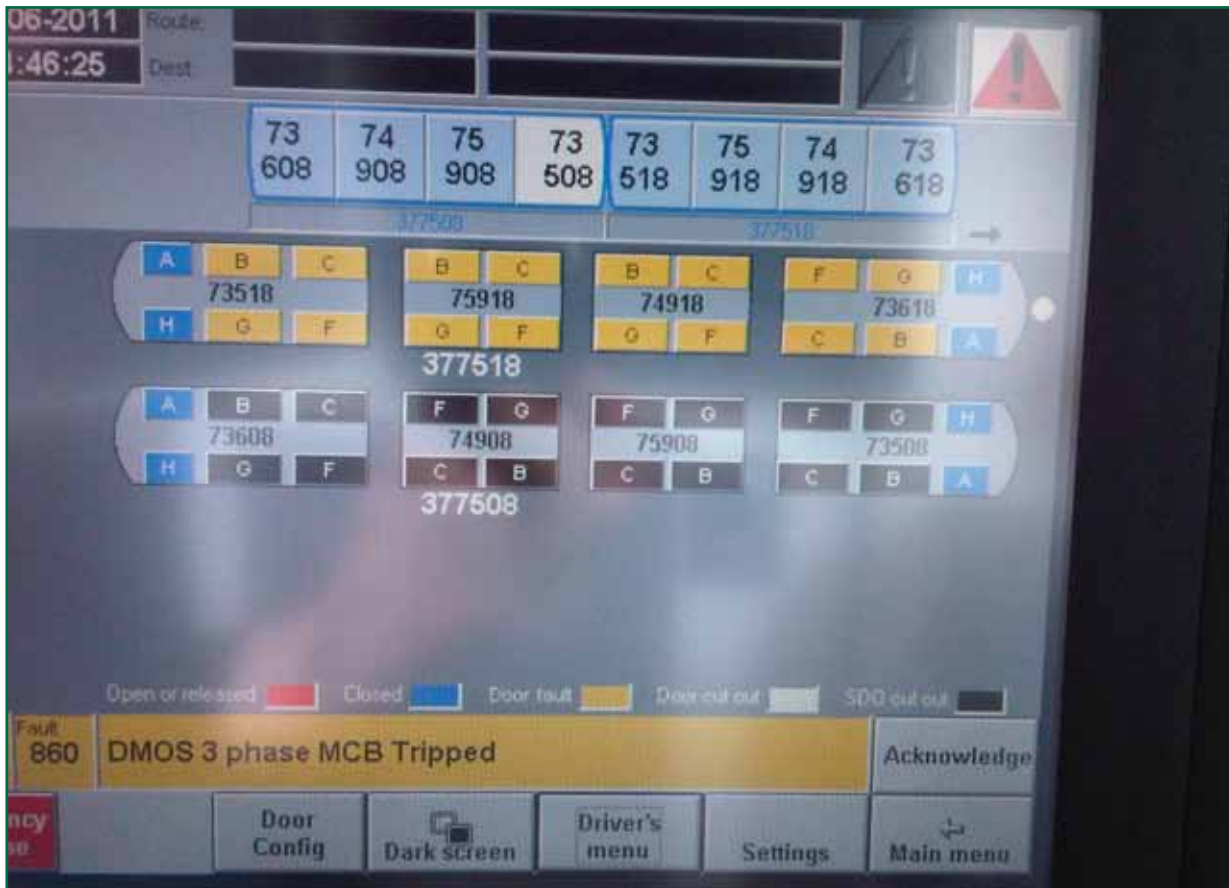
Figure 16: Image showing (yellow) door fault indication on the driver's in-cab display

104 The driver's display screen showed the status of all doors on the rear eight coaches as 'door fault' (yellow). This meant that the status of the doors was unknown; it did not necessarily mean that they were open.
