Rail Accident Investigation Branch

Rail Accident Report

Detachment of a cardan shaft at Durham station 10 April 2011

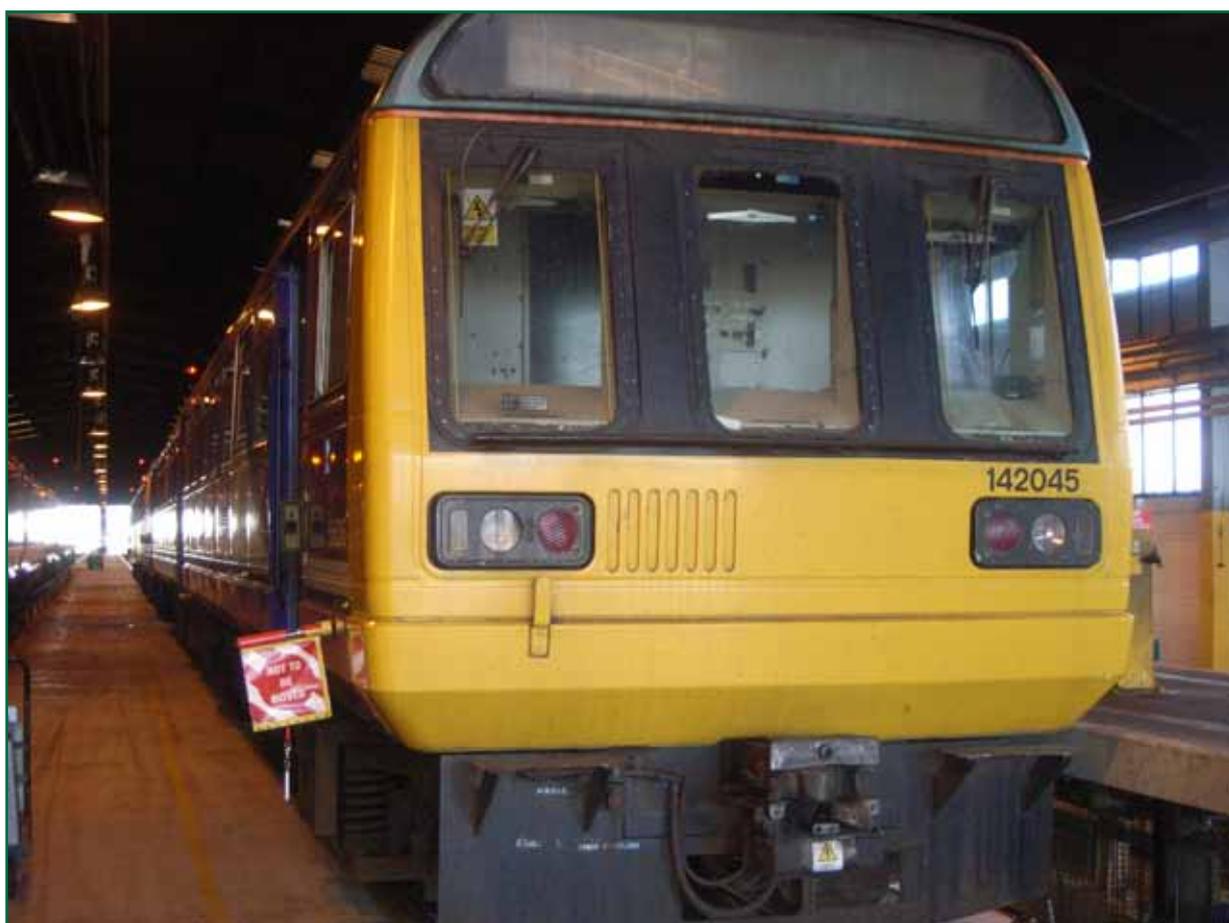
Figure 1: Unit 142045 at Heaton depot on 11 April 2011

- 9 The train involved was formed of two 2-car class 142 units (figure 1). The shaft detached at the trailing end of the third vehicle and was not held up by its *retention devices* (in this case two *safety loops* – figure 3). The detached cardan shaft came to rest between the rails of an adjacent line after damaging the underside of the third and fourth vehicles, piercing the fuel tank on the fourth vehicle and releasing around 500 litres of diesel fuel onto the railway.
- 10 Unaware of what had occurred, but alerted by an un-commanded brake application and the engine warning light illuminating on his cab console, the driver stopped his train on the approach to signal T291, 2 miles (3.2 km) outside Durham station (figure 2).

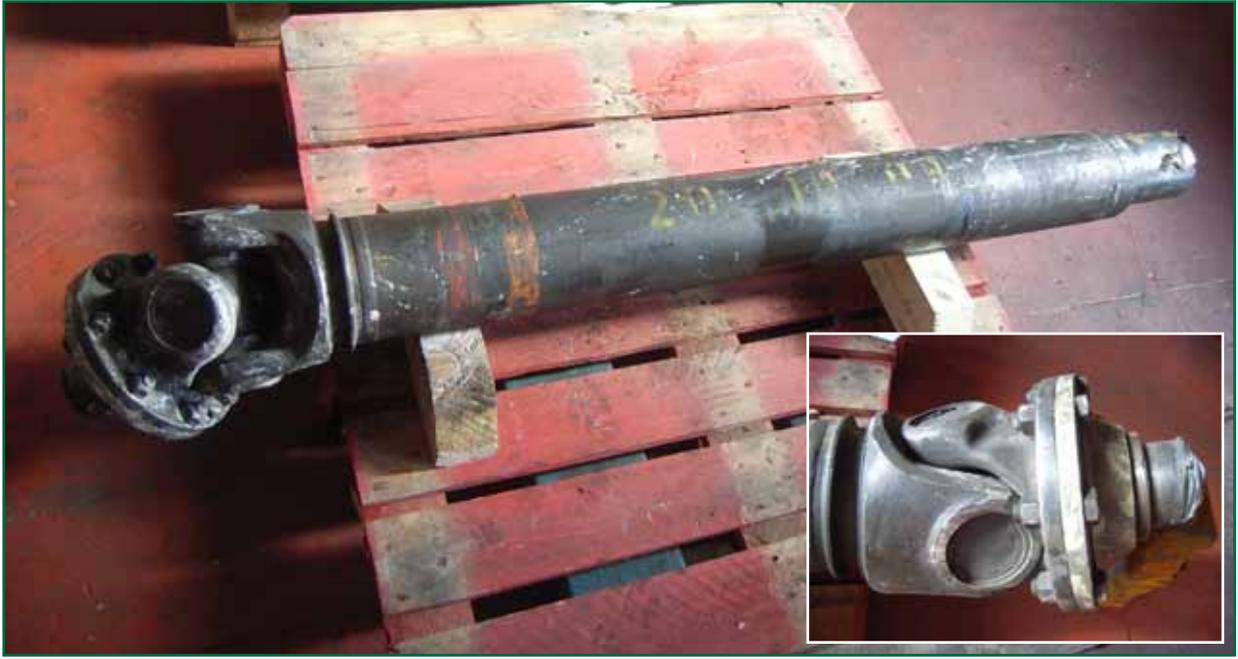
Figure 6: Recovered cardan shaft

- 54 As the driver was examining his train, the station staff contacted the signaller again to report that a large cardan shaft had been found in the four-foot of the up main line (figure 6 shows the recovered shaft). The signaller blocked the up main line to all traffic, the down main line already being blocked by the stationary train 5G01. The signaller then told the driver that a cardan shaft had been found on the track at Durham station.

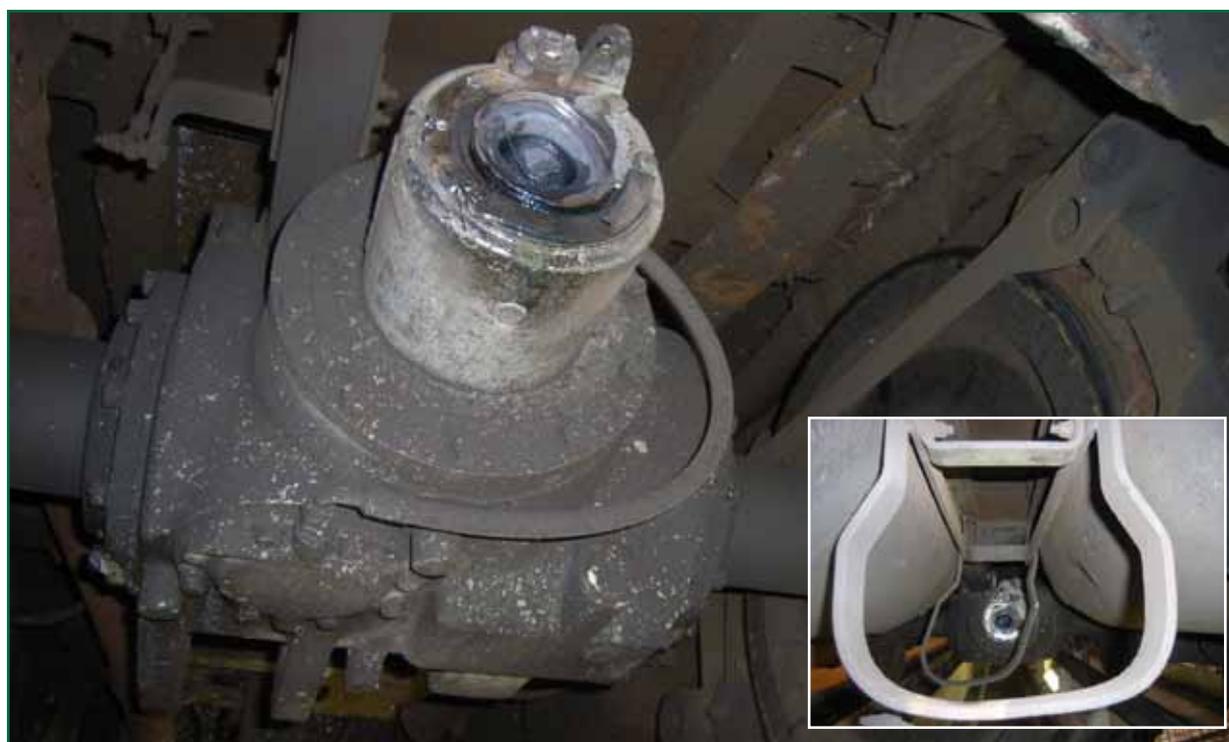
Figure 7: UT1140 as found on 11 April 2011

- 80 The examination of the unit carried out by the RAIB on 11 April 2011 showed that the safety loops had deformed and had been in contact with the cardan shaft. With the deformation of the safety loops, there was sufficient clearance to allow the cardan shaft to fall through (inset at figure 7).

120 Examination of the safety loops on 11 April 2011 found that they had deformed during the accident (inset at figure 7).

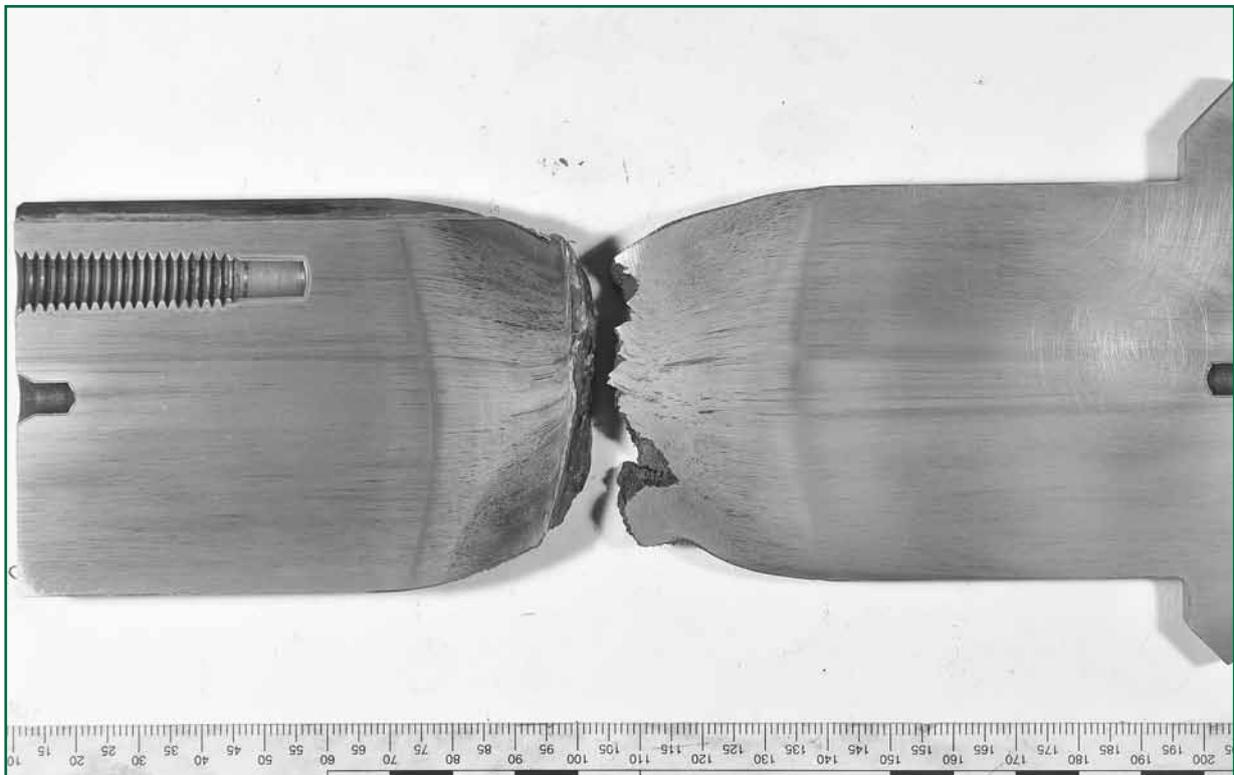
Figure 8: Section through the input shaft

- 81 **The seizure of the outer bearing led to the fracture of the input shaft which ultimately led to the detachment of the cardan shaft. The seizure of the outer bearing was a causal factor.**
- 82 The RAIB commissioned a metallurgical examination of the failed components in the input housing assembly. This examination located the fracture face of the input shaft marginally inboard of the outer bearing and showed evidence of heat input to the shaft with temperatures increasing towards the fracture face. The examination revealed that the input shaft had reached temperatures in excess of 850°C in the vicinity of the fracture. The shaft diameter also decreased steadily towards the fracture face (figure 8).

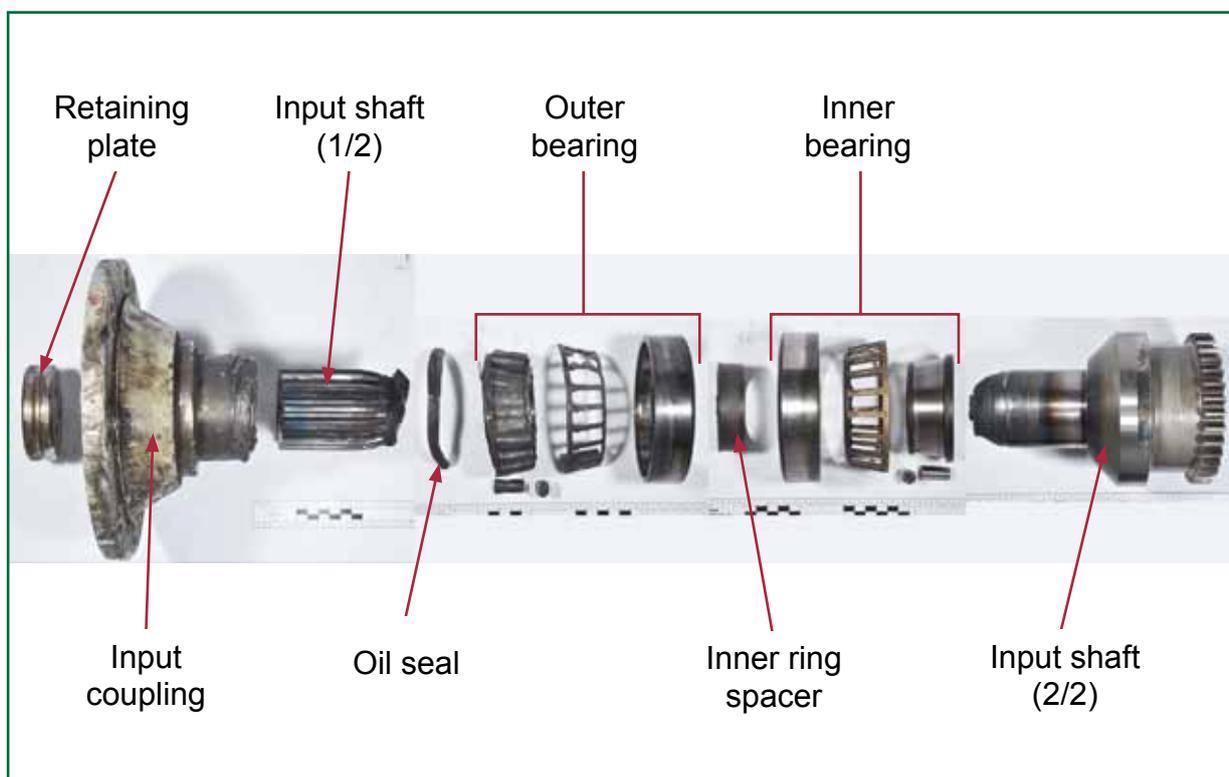
Figure 9: Components of the drive shaft input assembly following failure of the shaft

- 78 The release of the final drive end of the cardan shaft was due to the fracture of the input shaft within the input housing. The input shaft was found in two parts after the accident (figure 9): one part was still inside the final drive and the other was attached to the cardan shaft by the input coupling.

- 85 The input coupling (figure 9) showed significant damage to the surface that had been in contact with the inner ring of the outer bearing. The examination also revealed that this area had been exposed to temperatures in excess of 820°C.

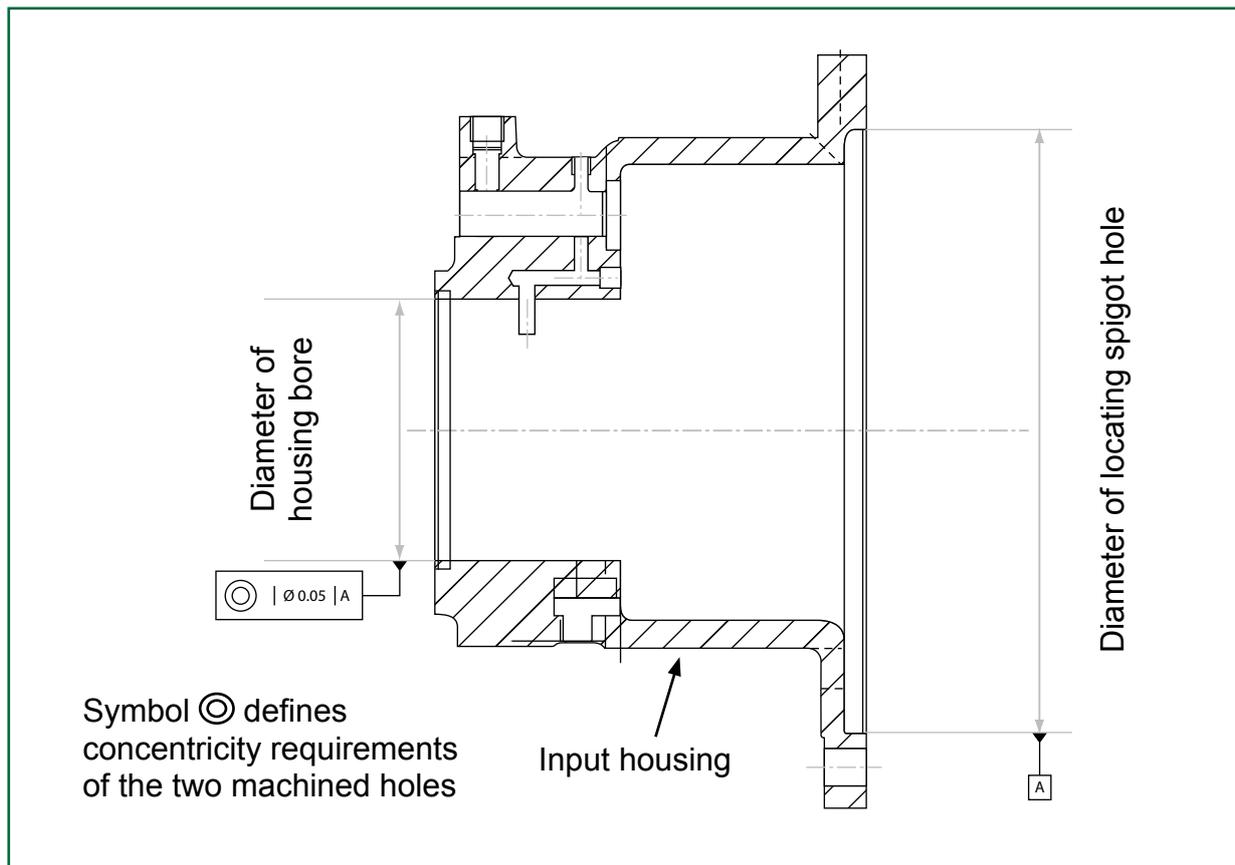
Figure 10: Concentricity of locating spigot hole relative to the housing bore for the bearings

- 95 During the controlled disassembly of UT1140, the *concentricity* of the axis of the spigot hole locating the input housing in relation to the axis of the housing bore for the bearings was measured and found to be approximately 0.5 mm. The original SCG drawing for the input housing shows that this dimension should have been controlled to be no greater than 0.05 mm (figure 10). The concentricity of the two axes was not controlled during the manufacturing of new input housings or when housing bores were re-sleeved due to excessive wear. The larger than expected concentricity resulted in the input shaft and pinion shaft being misaligned. This is confirmed by the inclined wear pattern found on the selector fork on UT1140 which is indicative of the level of permanent misalignment between the input and pinion shafts.

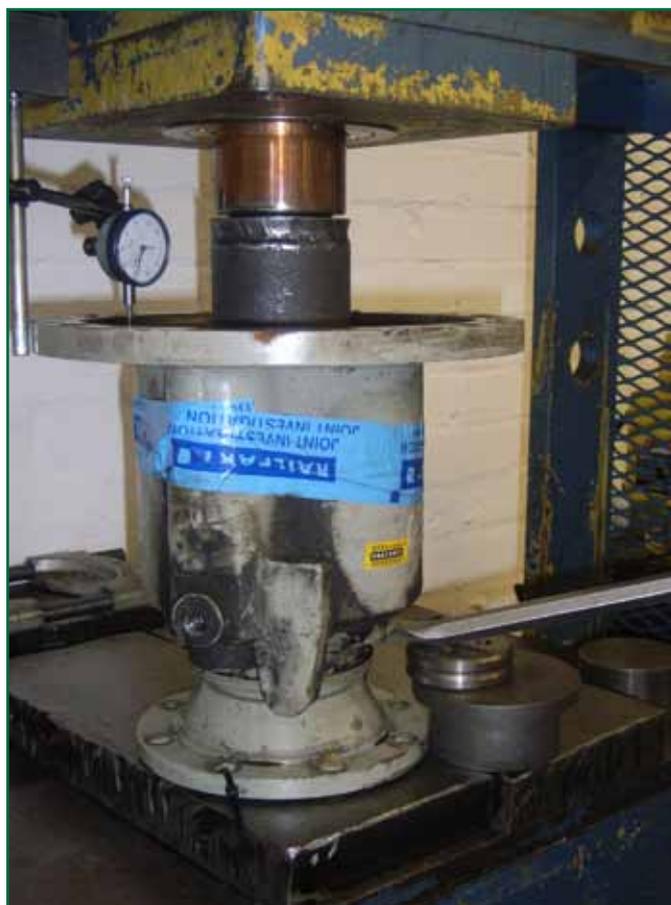
Figure 11: End float measuring technique

- 101 The end float measuring technique described in WI-27 involves the input housing assembly being located under a press (figure 11). The press clamps the input shaft stack and the fitter displaces the input housing using a crowbar wedged in between the support and the housing. The fitter uses a dial gauge to measure the achievable displacement. The gauge has a 0 - 0.1" (0 - 2.5 mm) scale and the fitter measures displacement within the range 0.002" - 0.004" (51 μm - 102 μm). The end float measuring technique is a sensitive operation with the output depending on the dexterity of the fitter.

- 102 The RAIB witnessed a series of tests done by the industry to establish whether this method was able to determine the end float accurately. These tests suggest that housing tilt might have been measured by the method instead of true end float. The potential inaccuracy of the measuring method has led the RAIB to conclude that it is possible that this technique contributed to the under provision of end float.
