Rail Accident Investigation Branch

Rail Accident Report

Two incidents involving track workers between Clapham Junction and Earlsfield 8 March 2011

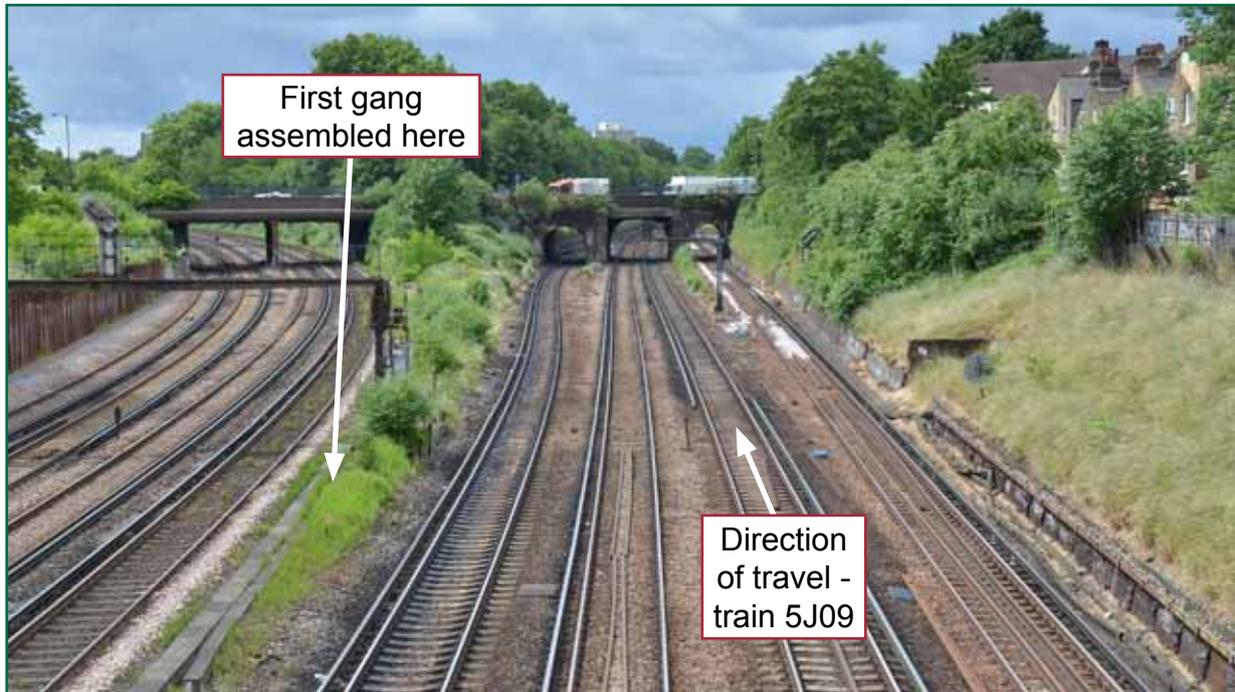
Figure 2: View of Wessex lines at 4 miles 14 chains, showing where the first gang assembled after the first incident at 05:46 hrs

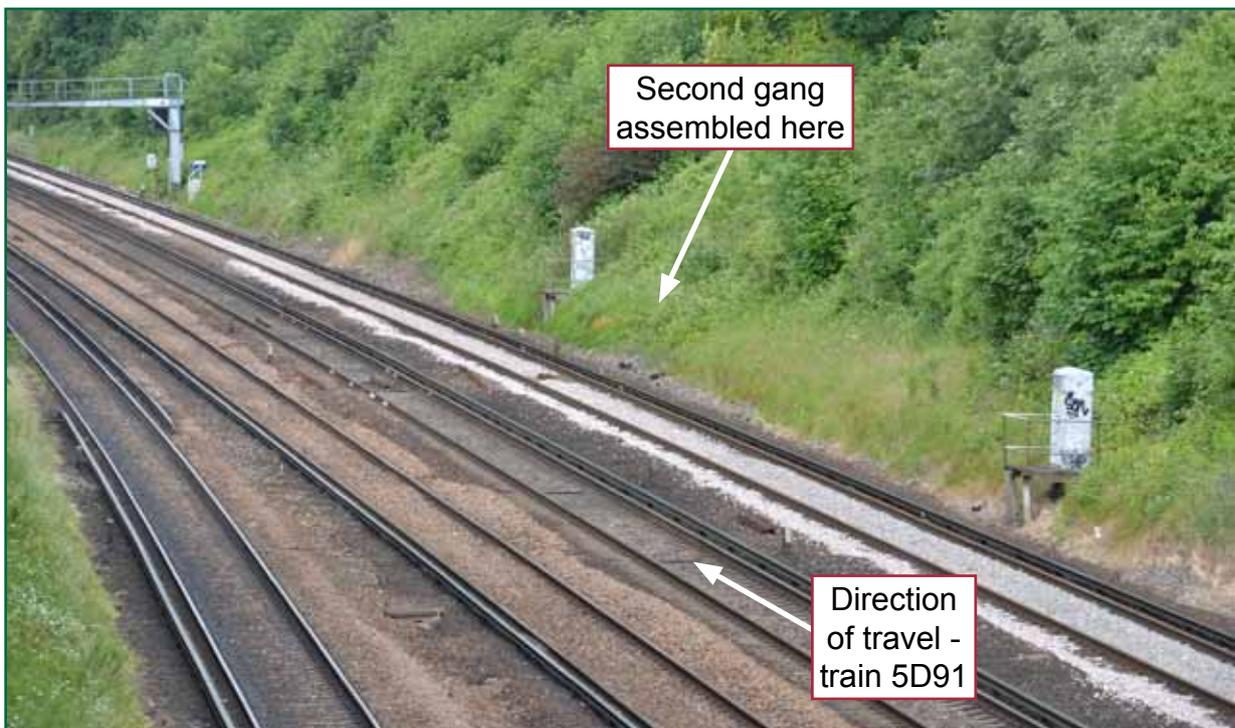
Figure 3: View of Wessex lines at 4 miles 76 chains, showing where the second gang assembled after their near-miss incident at 06:10 hrs

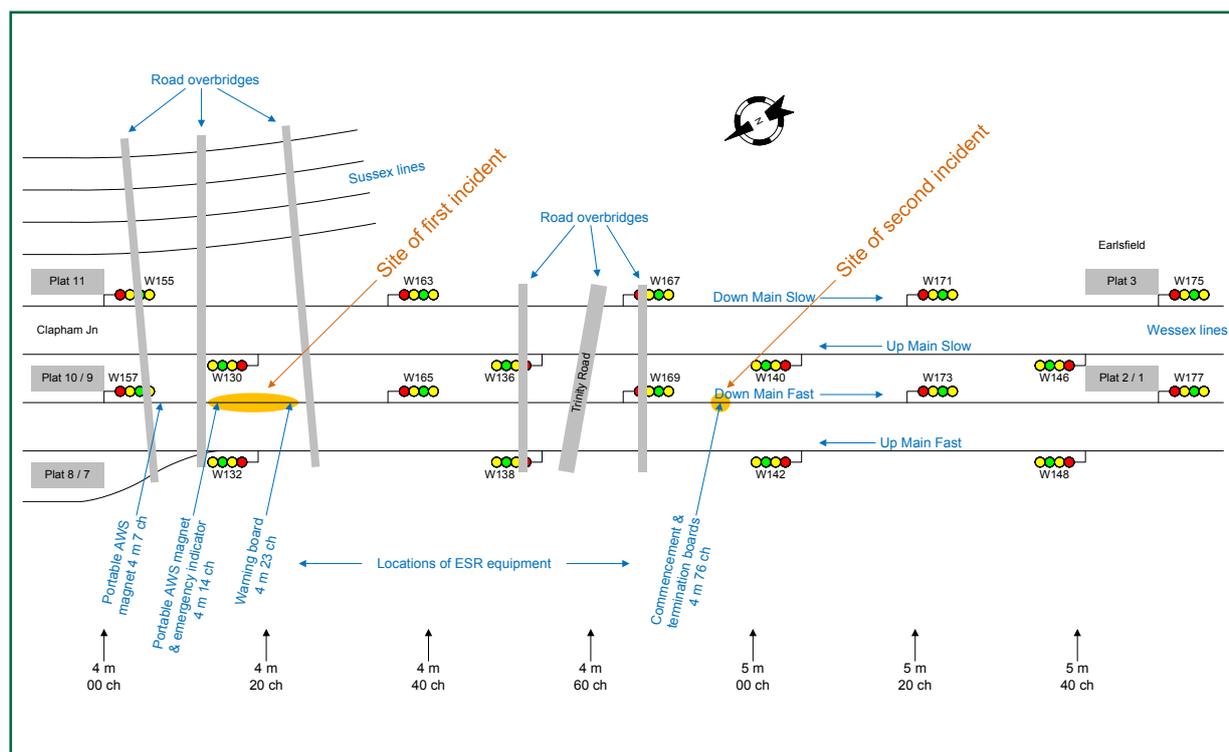
Figure 5b: Layout of the ESR equipment installed on the Down Main Fast line on 8 March 2011

- 119 The driver of train 5D91 received the warnings triggered by the portable AWS magnets and observed the emergency indicator shown in figure 5b; the warning board was probably not visible as it had fallen over (paragraph 39). He did not immediately tell the signaller about the missing warning board as required by module SP of the Rule Book (if necessary stopping his train specially). He had been accelerating as he passed the ESR equipment, using step 2 of the traction controller¹⁴. About 350 metres further on, just before he passed signal number W165, he increased his traction demand to step 4, and continued until he observed COSS B's gang about 670 metres later (paragraph 44).
