Rail Accident Investigation Branch

# Rail Accident Report

## **Bridge strike and road vehicle incursion onto the roof of a passing train near Oxshott Station 5 November 2010**

# Bridge strike and road vehicle incursion onto the roof of a passing train near Oxshott Station 5 November 2010

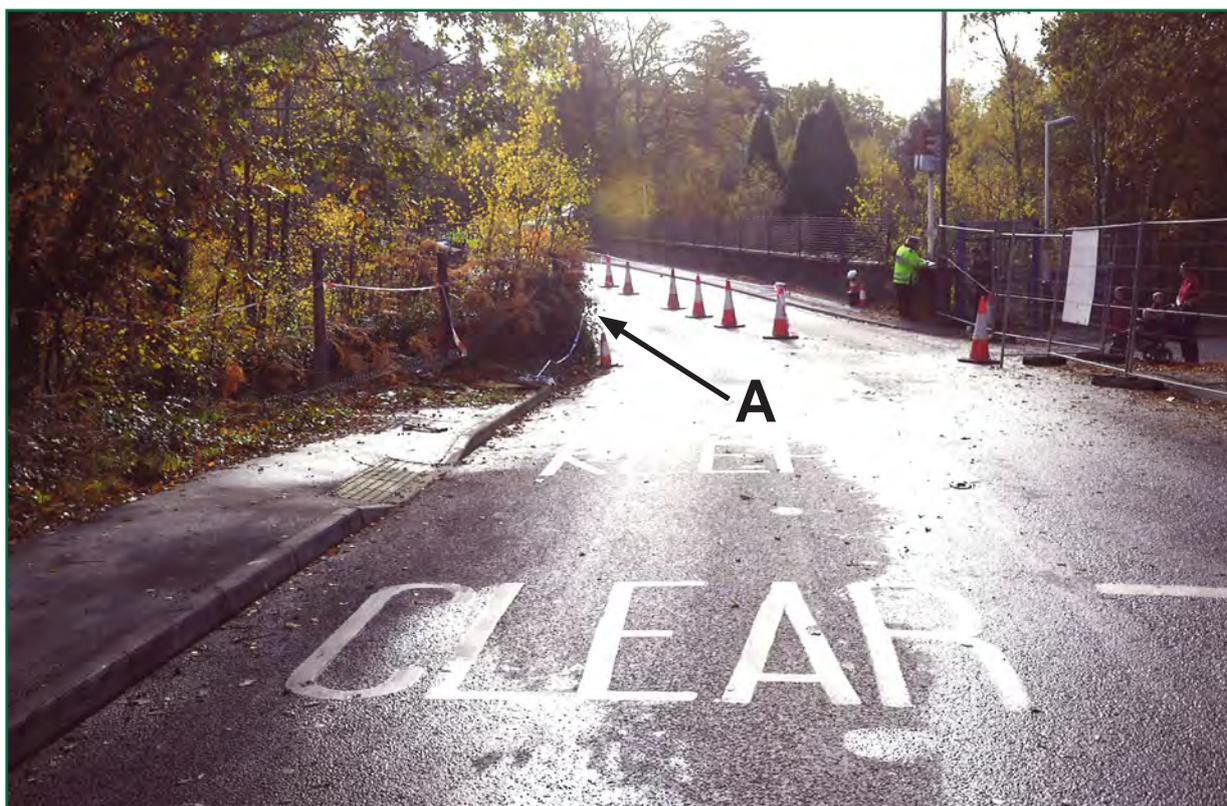
Figure 2: View of approach to bridge 11 for southbound traffic showing left-hand bend. The parapet end struck by the lorry is hidden by vegetation, and is marked 'A' (photograph courtesy of Surrey Police)

50 The parapet end was obscured by vegetation growth on the inside of the bend (figure 2), and a reflective marker at the parapet end was missing after its supporting post had collapsed as a result of previous damage. These defects were not identified during routine highway safety inspections and as a consequence, no corrective action had been taken or was planned.

Surrey County Council should reinforce the requirement for regular checks to be made (for example, as part of safety inspections carried out by staff on the condition of highways) of the ends of parapets on bridges over railways to ensure that, where provided, markers or markings are maintained in good condition and free from obstruction by vegetation or other material. Any signs of damage should be reported to the risk owner for appropriate action (paragraph 98a).

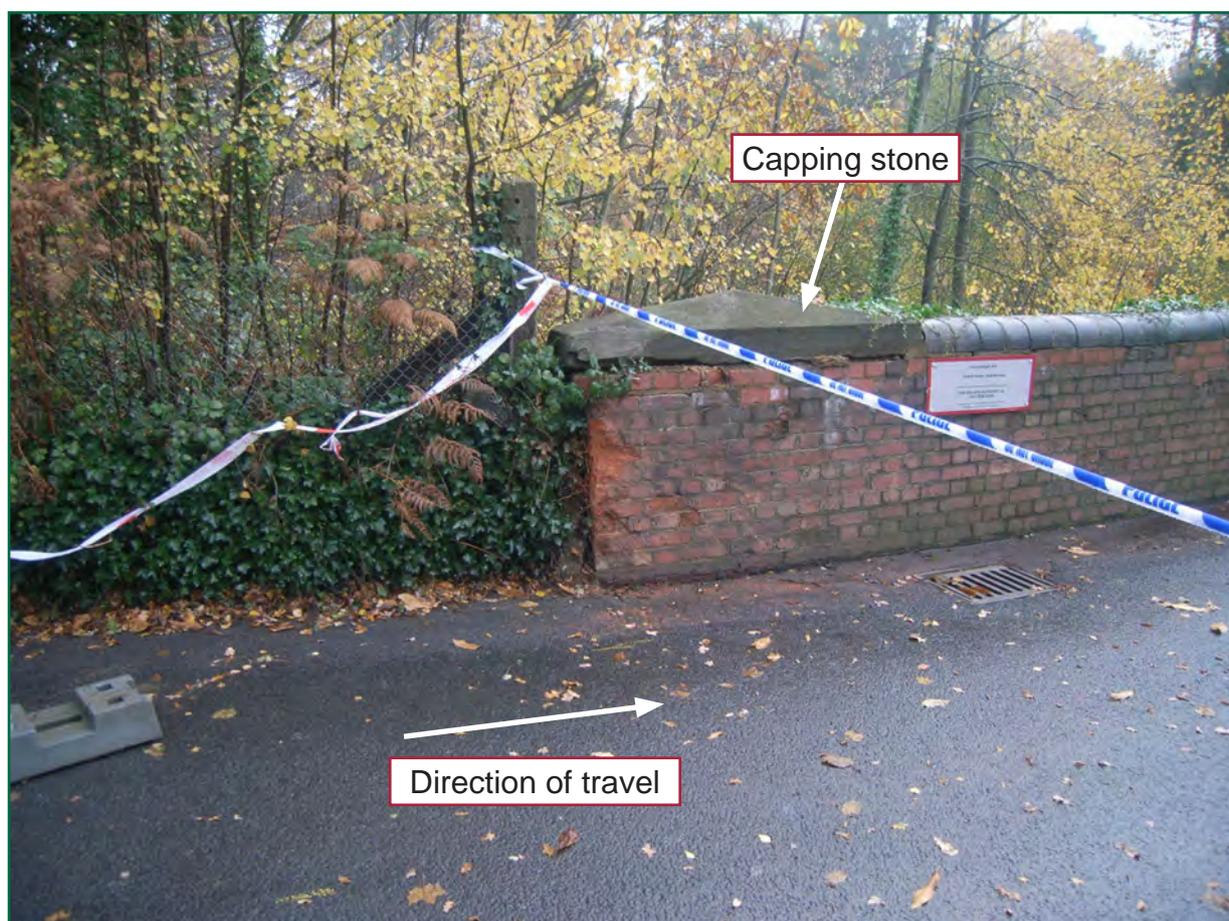
- 30 Train 2G46 departed from Oxshott station on time at 15:28 hrs. In the 38 seconds which elapsed between the train leaving the station and it being hit by the lorry, it had accelerated to 28 mph (45 km/h). Although there were only 36 passengers on the train, 14 passengers and the train's guard were travelling in coach 5 and ten passengers were travelling in coach 6, both of which were affected by the accident. There were two passengers travelling in coach 7 and none in coach 8.
- 31 The lorry approached Bridge 11 southbound on the A244, travelling at less than 30 mph (48 km/h) and followed by several vehicles. As the lorry negotiated the left-hand bend onto the bridge, its front left-hand wheel struck the north end of the bridge's east parapet. The rear of the vehicle also made contact with the parapet end (figure 4).

Figure 4: North end of the east parapet which was struck by the lorry

- 60 Contact with the wall retarded the left-hand side of the vehicle and caused it to turn to the left. Witnesses separately observed the front and rear of the lorry making contact with the parapet end, and the lorry rocking as it veered to the left.

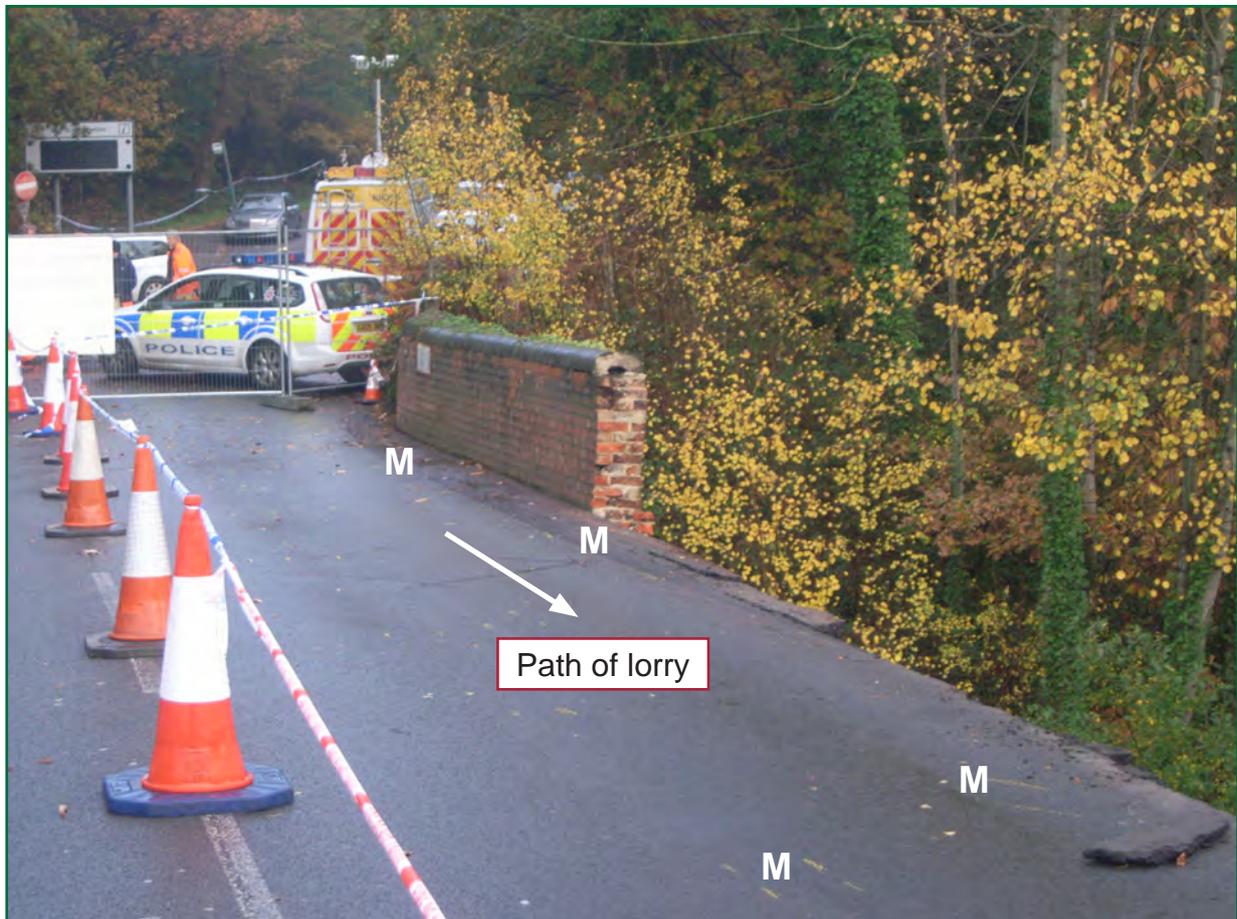
- 32 Skid marks on the road surface indicate that the lorry continued to travel close to, and parallel with, the east parapet for a further 10-15 metres. The lorry then steered slightly to the left and collided with the side of the parapet. The parapet broke off below road level, leaving an unprotected edge (figures 5, 6 and 12). The lorry's left-hand wheels slipped over the edge, dragging the vehicle sideways to the left.

Figure 5: Photograph of bridge deck showing missing section of parapet and skid marks denoted 'M'

- 65 After striking the parapet end, the lorry struck the parapet for a second time at a point 10-15 m from its north end at a shallow angle (less than 5°). This imposed a sustained force causing the brickwork to break along horizontal mortar joints approximately 0.5 m below road level. The parapet failed in a predictable manner by shearing at its weakest point. This does not suggest a specific plane of weakness other than the natural weakness of the mortar joints.

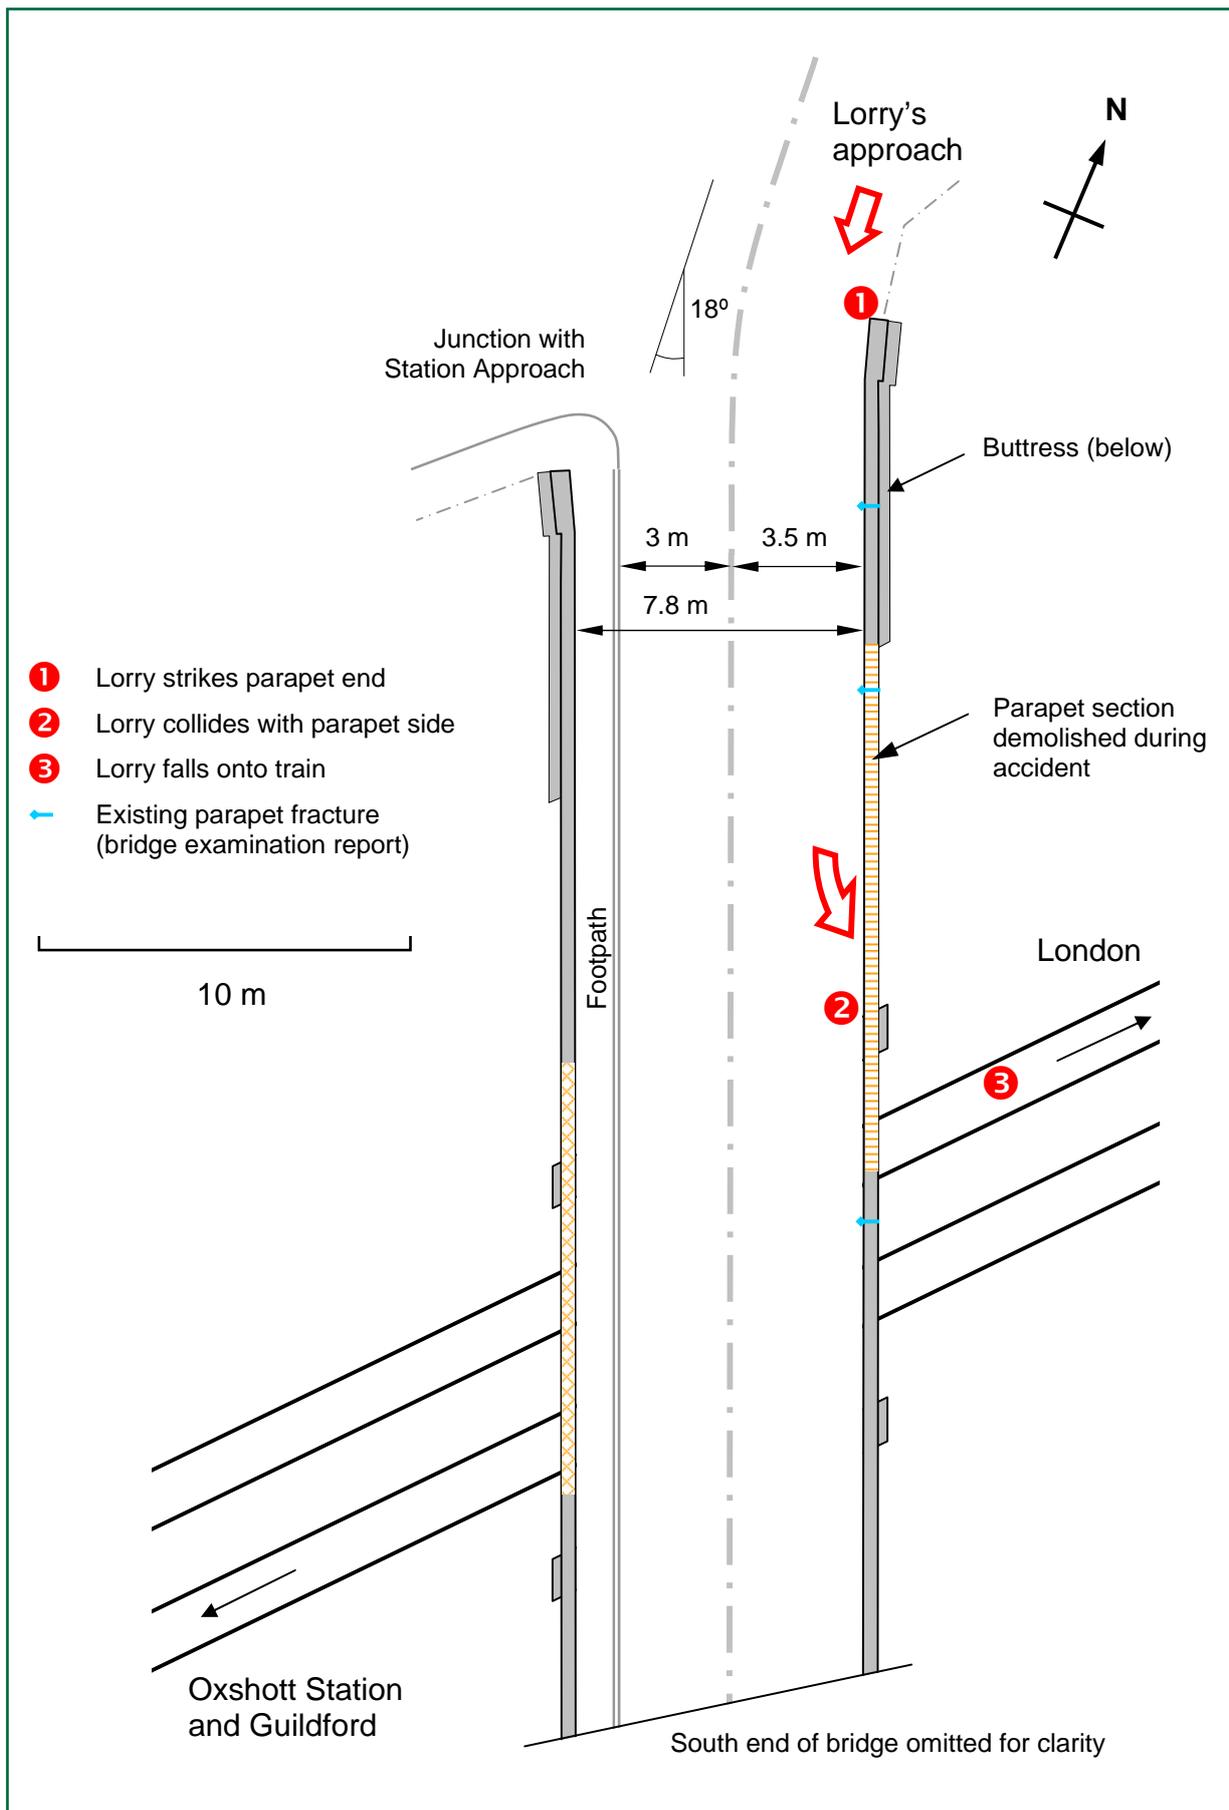
Figure 6: Schematic diagram of bridge deck showing path of lorry

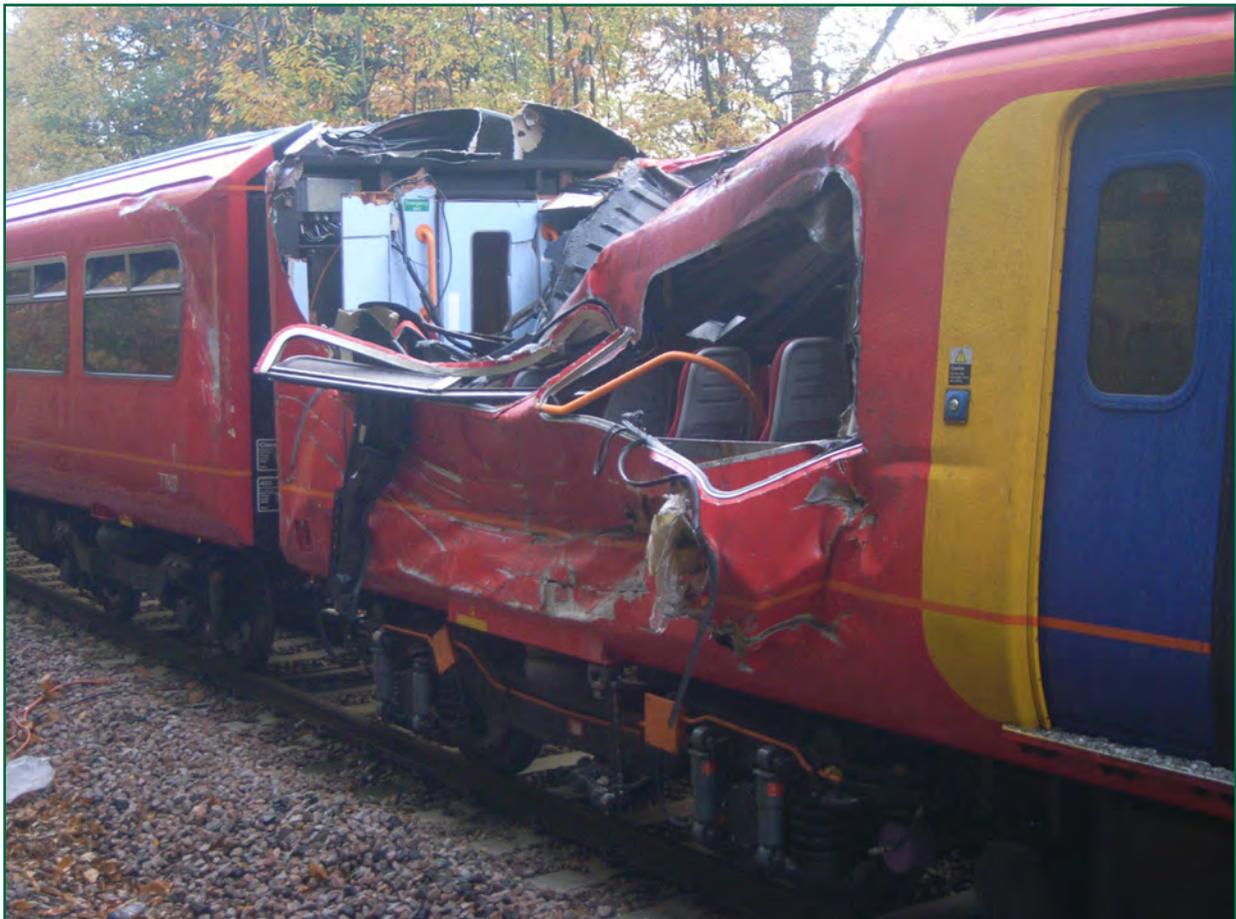
Figure 7: View of coach 6 (leading end) which sustained a vertical impact from the falling lorry

- The roof structure on coach 6 took the brunt of the impact with the lorry which landed on the leading end of the vehicle offset to the left-hand side in the direction of travel. As a result of the impact, there was extensive damage to the roof and bodyside structure on coach 6.

- The welded connection between the cantrail and corner pillar at the leading edge of coach 6 failed at an early stage in the deformation, leaving the corner pillar relatively undamaged. This prevented the corner pillar assisting in absorbing energy. This is unlikely to have made a significant difference to the overall damage in the context of the energy of this impact. There was no evidence of excessive corrosion which would have weakened the joint.

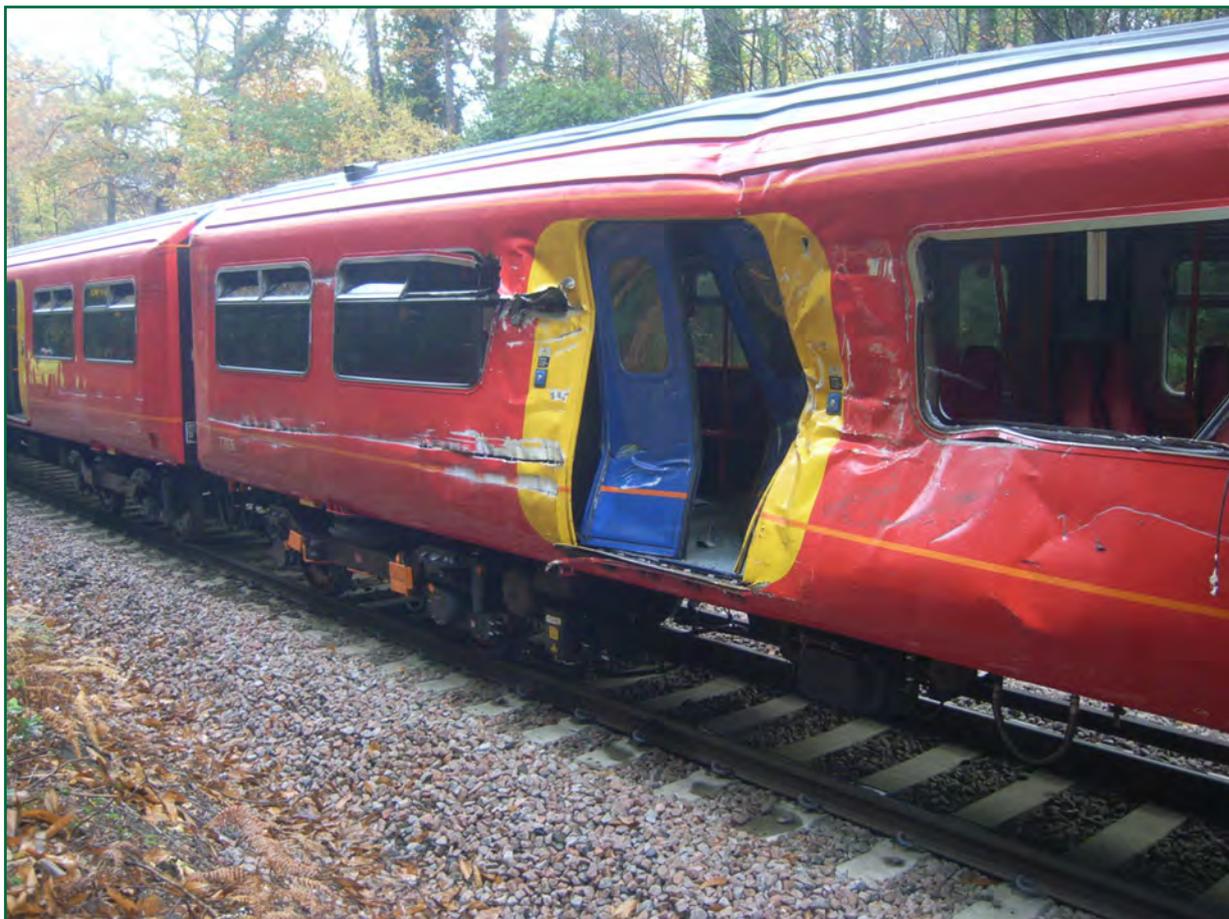
- 38 The most severe secondary impact occurred to coach 8. The disintegrating lorry chassis made contact with the leading doors of coach 8 causing significant damage and intrusion into the passenger area (figure 8).

- 39 The lateral force imposed on coach 8 was sufficient to move the track approximately 350 mm to the right, and towards the down line (figure 8). The rear bogie of coach 8 was knocked off the rails and landed 300 mm to the right. The train remained upright throughout.

Figure 8: View of coach 8 which sustained a side impact from the disintegrating lorry chassis

- f. Coaches 7 and 8 suffered significant bodyside damage as they made contact with the lorry chassis which was lying close to the track after the initial vertical impact. In vehicle 8, a complete assembly of a straight grab pole and glazed partition at the leading left-hand doorway became detached from the bodyside and was propelled across the vehicle. The detachment of the glazed partition arose directly from damage caused by the lorry penetrating and pushing in the side of the vehicle. The forces required to fracture the grab pole fixings to the floor and ceiling were in excess of the current design load case for grab poles, specified in current structural standards for the vehicle interior (Railway Group Standard GM/RT2100 Issue 4). The design *loadcase* is based on maximum forces that could be applied to the grab pole by passengers and not from impacts with external objects.

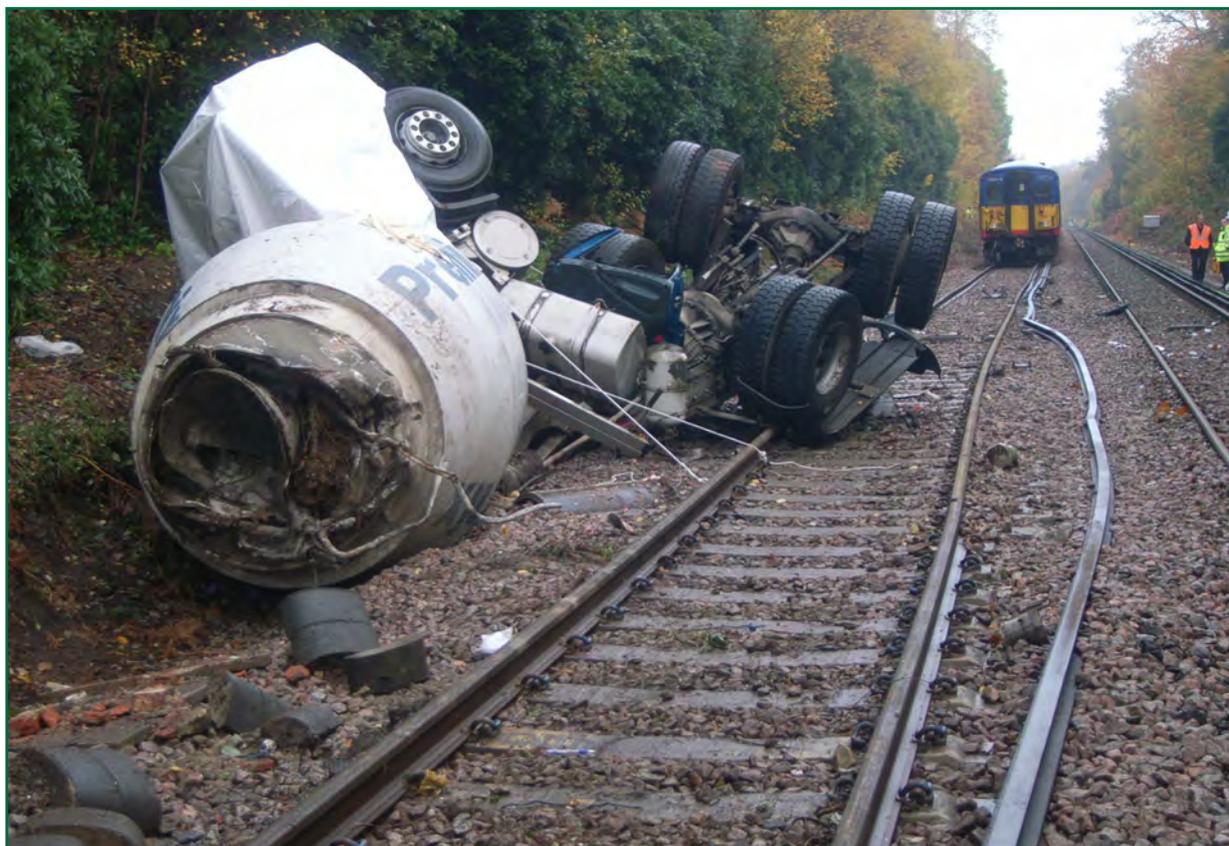
Figure 9: View of damaged lorry and train. Note displaced track and conductor rail

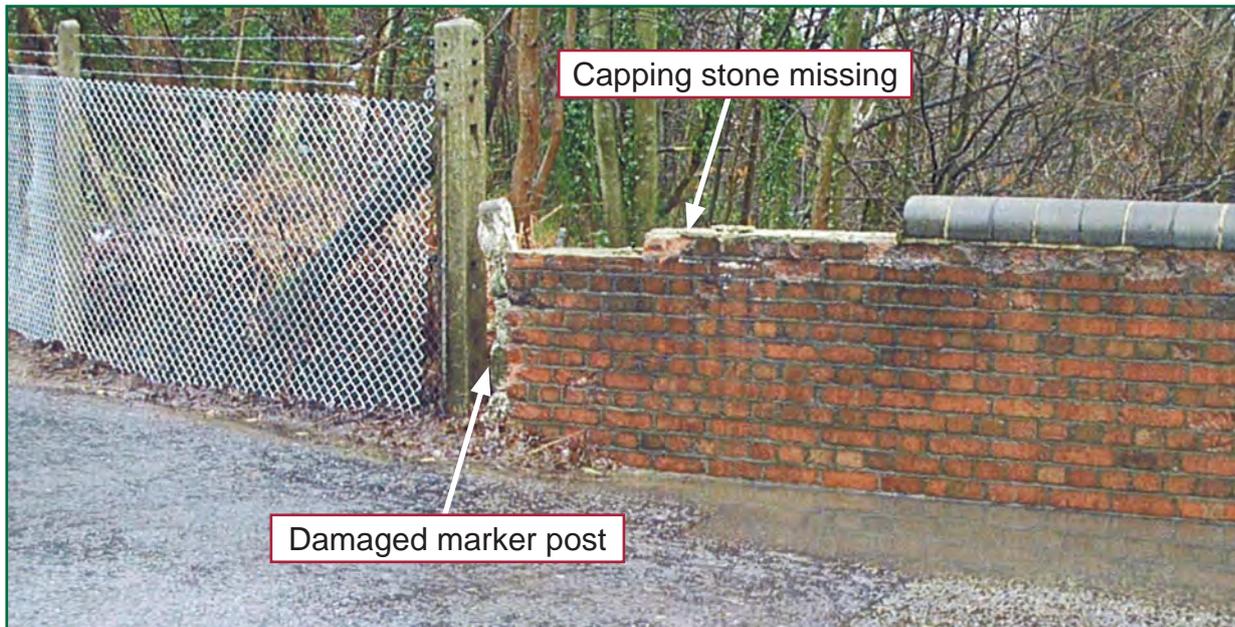
- 55 The reflective marker was present although its supporting post was in poor condition in a photograph taken for Network Rail in January 2004 (figure 10). It was still present in a photograph taken when the bridge had its detailed examination in August 2006. However, there is no reference to signing or vegetation in the three-monthly highway safety inspection reports between August 2006 and August 2010, and the RAIB has not been able to determine for how long the reflective marker had been missing prior to the incident.

- 74 The same capping stone was knocked off during a collision between a car and the parapet end in December 2003. A bridge strike report, commissioned as a consequence of this event, included a photograph noting 'new and longstanding damage' to the parapet end (figure 10).

- 75 Network Rail therefore had evidence that the same parapet end had been struck at least twice prior to January 2004, and again between October 2005 and August 2006. Repeated instances of damage by road vehicles should have triggered some investigation as to cause, and discussion with the highway authority. However, Network Rail's structures engineers had difficulty in recognising repeated patterns of damage because, until September 2007, paper records were used as the primary means of managing the structures portfolio and these were stored remotely.

Figure 10: Photograph of the north end of the east parapet showing 'new and longstanding damage' after a similar collision in December 2003 (photograph January 2004, courtesy of Network Rail)

Network Rail should include, within its annual examination of rail overbridges, the requirement for the structures examiner to identify and record any highway features which may increase the risk to the railway such as absence, obscuration or poor condition of parapet end markers. Network Rail should also improve its management arrangements for reporting such issues to the relevant highway authority, and when it becomes aware of damage to structures caused by road vehicles (paragraph 98b).

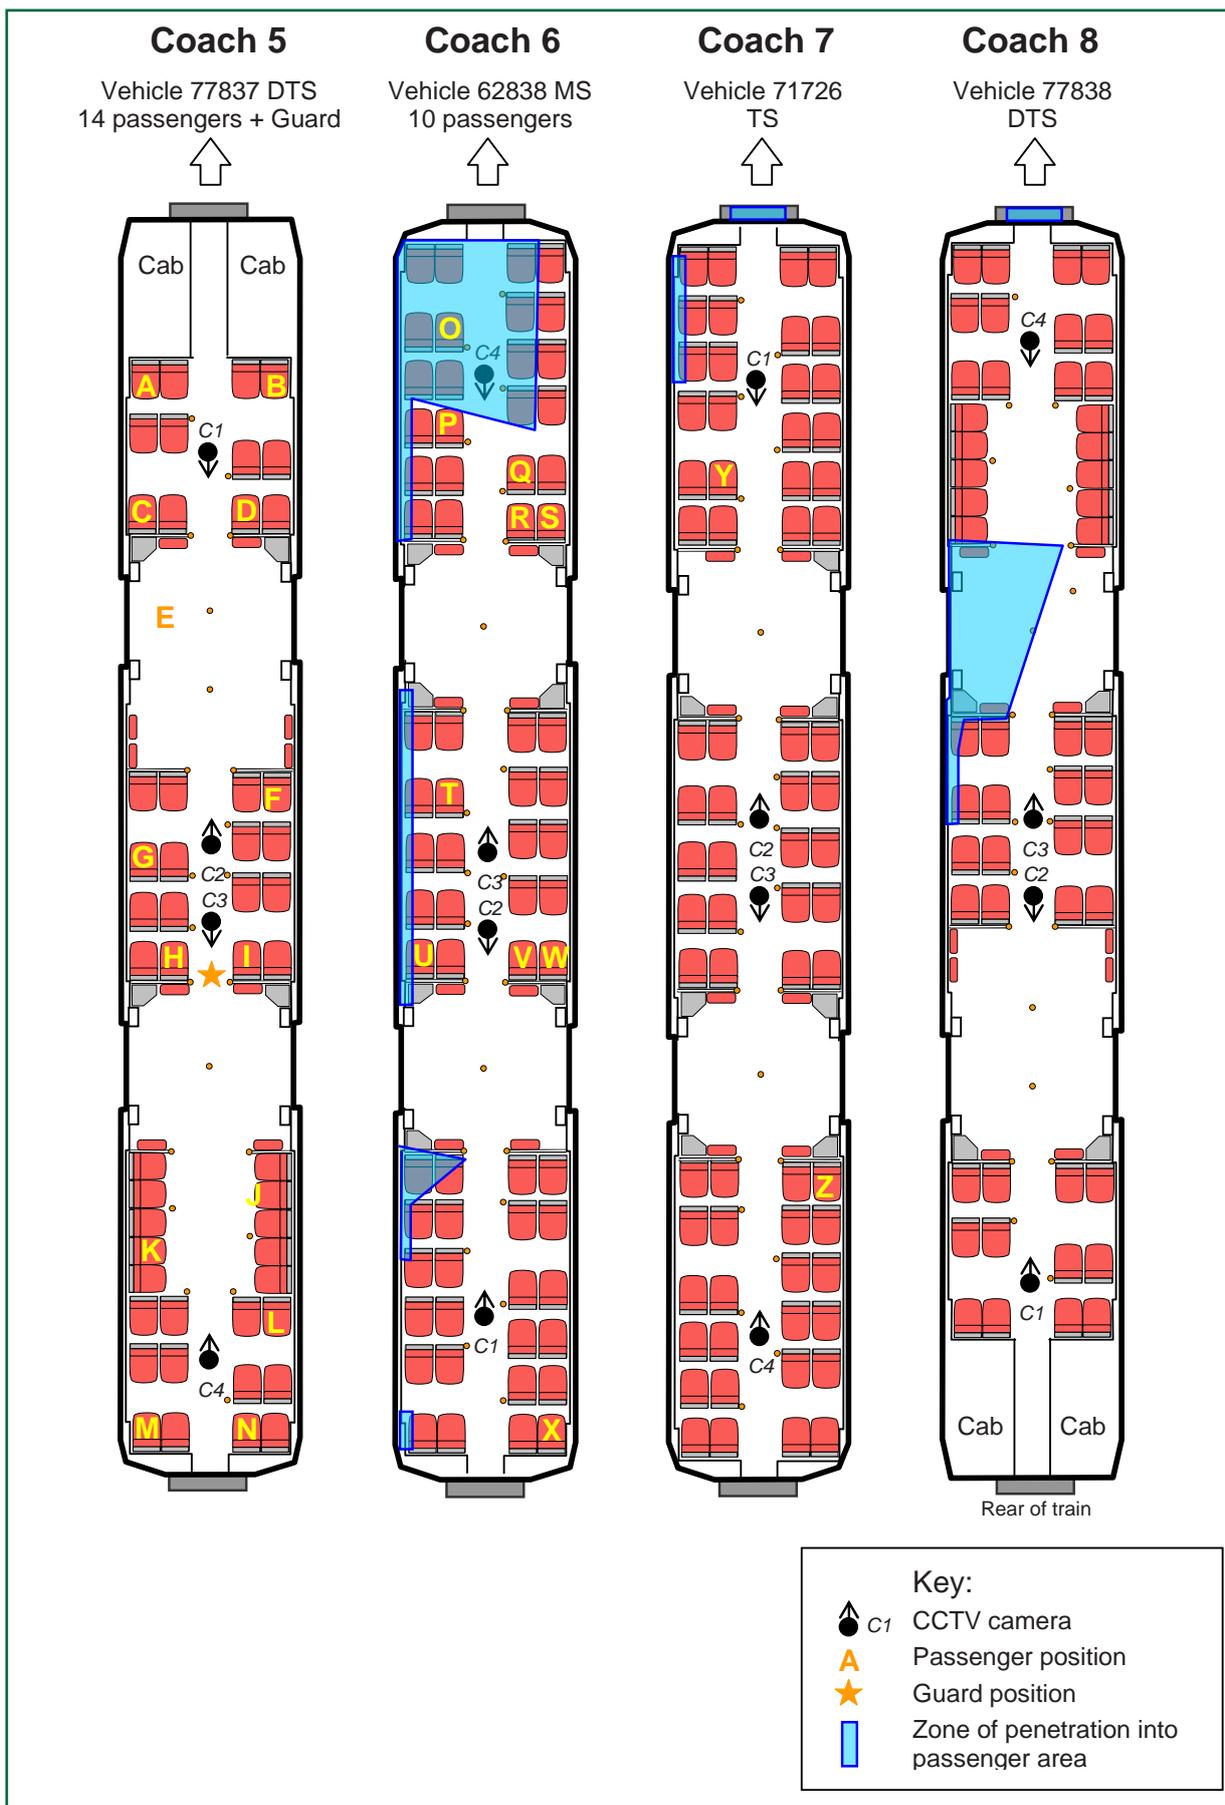
- 36 Four of the five passengers travelling in the leading end of coach 6 were able to escape from the damaged part of the train without assistance. The fifth passenger was trapped. This person, a 60 year old male, sustained serious injuries including fractures to his lumbar vertebrae and hip. A further ten seats in coach 6 were affected by bodywork distortion or flying debris. None of these seats was occupied (figure 11).

Figure 11: Diagram indicating the extent of damage to unit 455913 and the position of passengers on the train

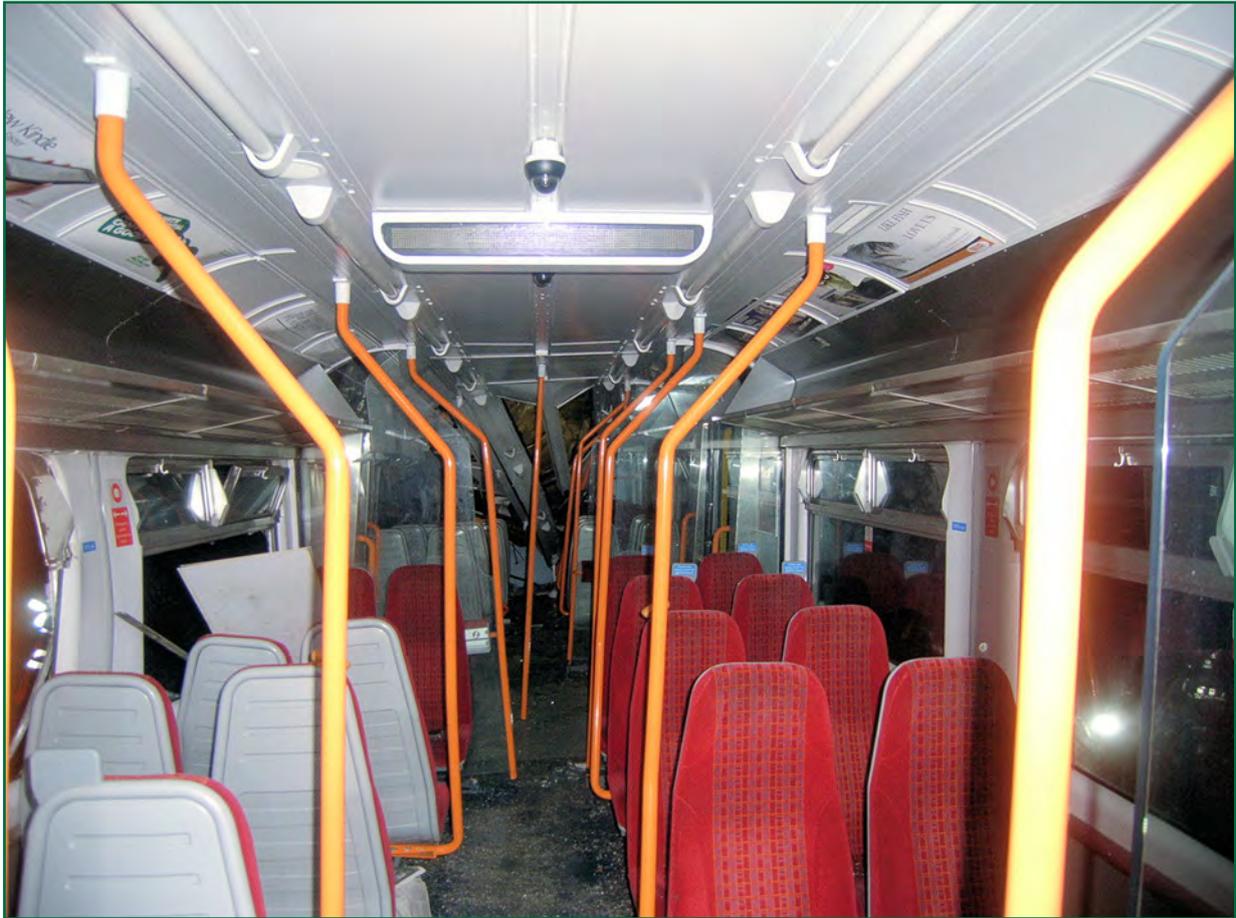
Figure 12: Internal view of coach 6 looking towards the front of the train

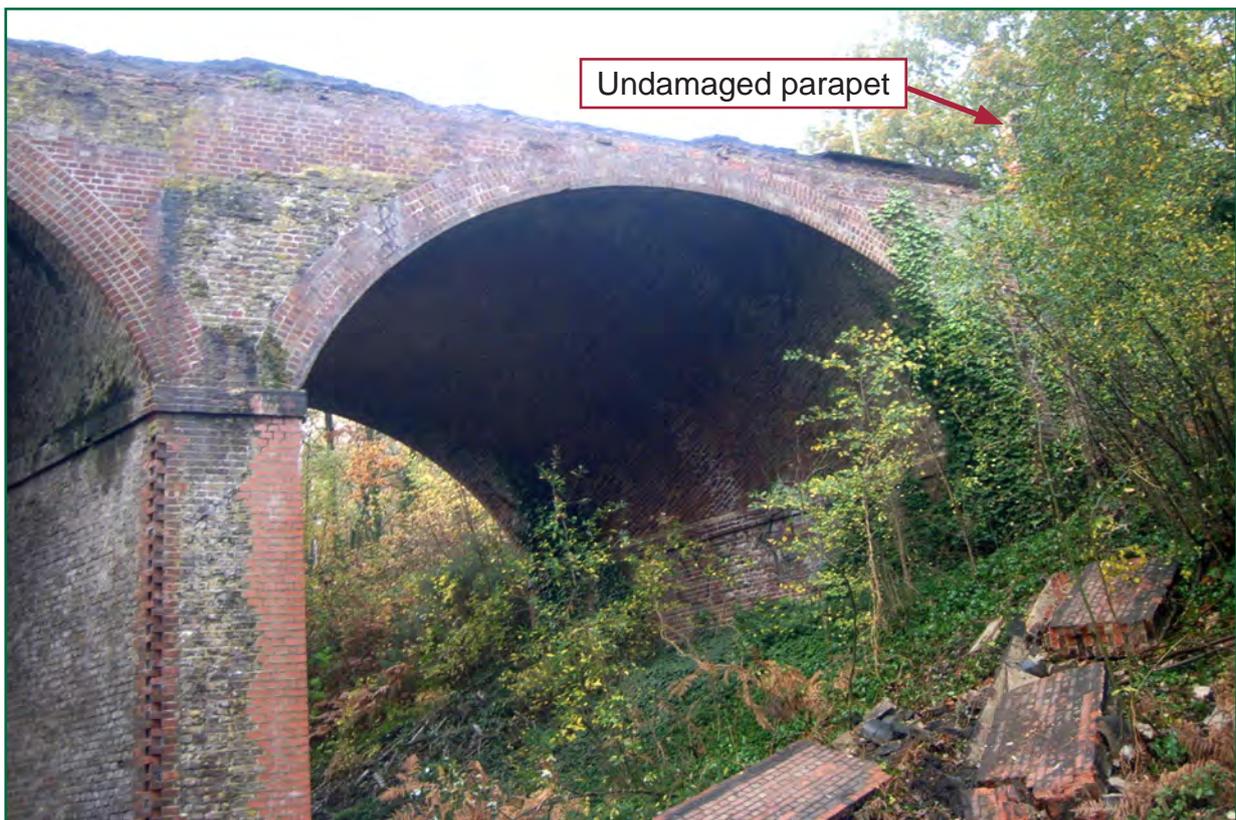
- 33 The impact of the lorry demolished a 14.3 m section of parapet which fell from the bridge. Most of the brickwork fell onto the cutting slope, but some sections struck the roof and left-hand side of coach 5 of the train which was passing beneath the bridge at the same time. Within this coach, bags were knocked from overhead luggage racks, although there was no penetration of the passenger area or injury caused.
- 34 The lorry struck the upper left-hand corner (*cantrail*) of Coach 6 ahead of the leading doors (figure 7). The cantrail became detached from the *corner pillar* at the front of the coach and moved downwards and inwards with the deforming roof. This deformation caused the lorry to rapidly fall off the train to the left and onto the ground beside the track.

Figure 13: View of bridge and missing parapet from track level. The parapet fell in sections weighing up to 1800 kg
