Rail Accident Investigation Branch

Rail Accident Report

**Collision between an articulated tanker and a passenger train at Sewage Works Lane user worked crossing, near Sudbury, Suffolk
17 August 2010**

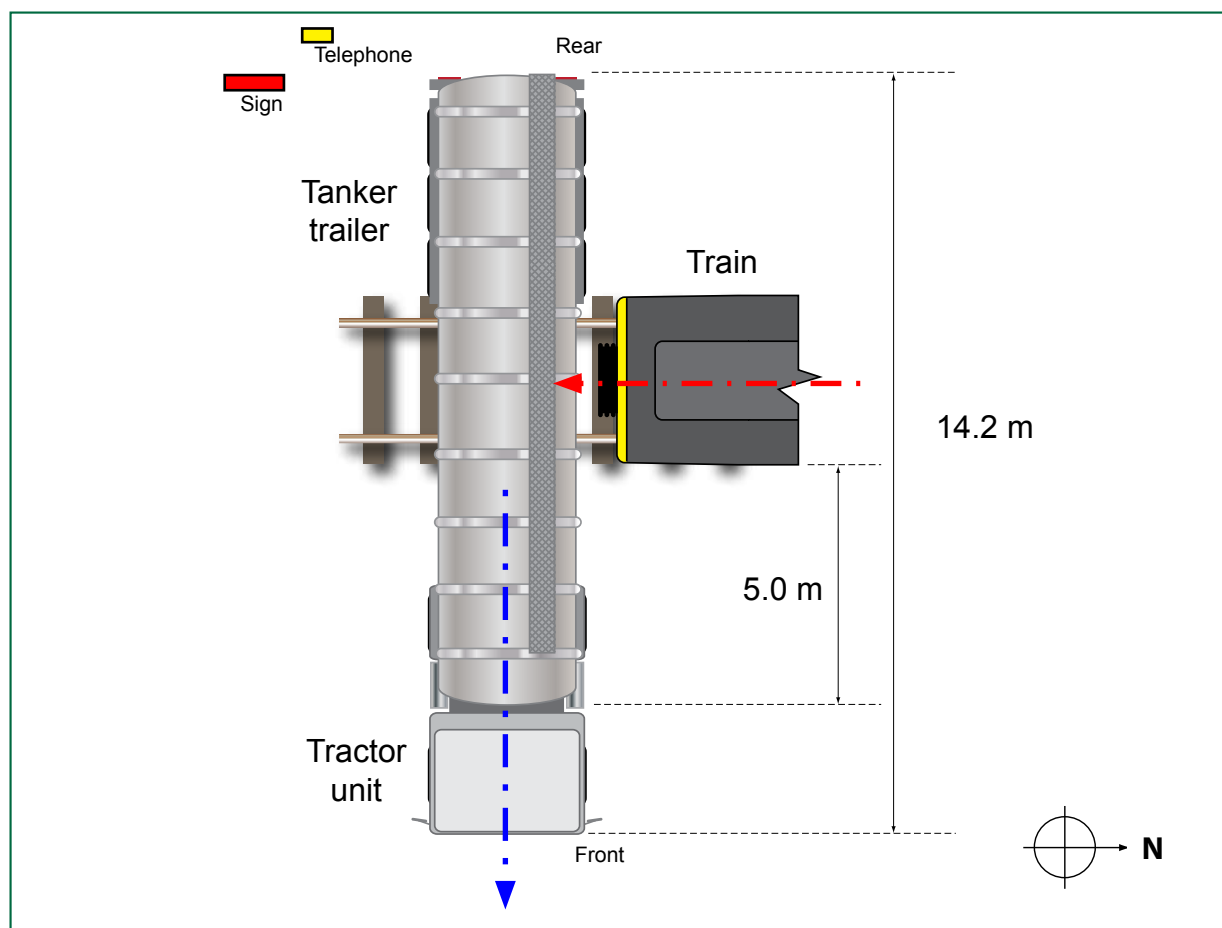
Figure 6: Diagram of point of impact.

- 36 The point of impact on the tanker was approximately 5 metres from the front of the tank and approximately 8.5 metres from the front of the tractor unit (figure 6). The tractor unit detached from the trailer as a result of the impact and the tank being conveyed on the trailer was breached, causing the contents to cascade over the train. The front of the leading coach of the train was severely damaged by the impact and the coach derailed, but remained upright at an angle, stopping approximately 35 metres beyond the crossing. The rear coach remained on the rails but suffered minor external damage. Both coaches had internal damage to doors, tables and fixings with some of the damage arising from passenger impact. The derailed coach damaged a short parapet alongside the track, with diesel fuel and effluent spilling into a pedestrian/cattle underpass (paragraph 16) below and onto the track.

- 82 The damage inflicted on the tanker by the train provides a clear indication of where the tanker was on the crossing when it was struck. The left side of the damage (as viewed from the train) was approximately 5 metres from the front of the tank and approximately 8.5 metres from the front of the tractor unit.

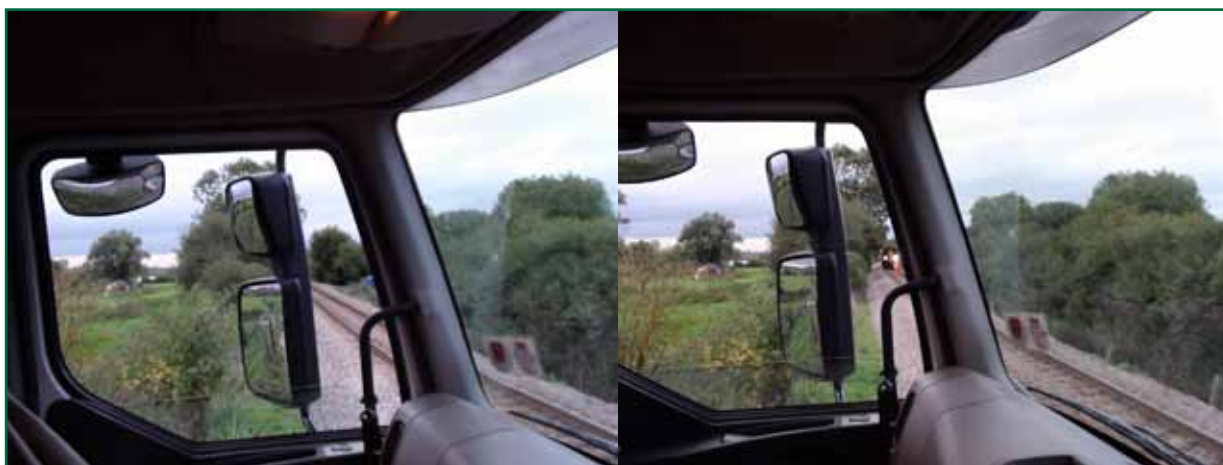
- 89 The tanker driver said that he did not see the approaching train. The RAIB's tests on 3 October 2010 showed that it is possible that the array of mirrors located on the nearside of the tractor unit might obstruct the tanker driver's view of an approaching train (see figures 8 -10). However, the obstruction is easily overcome by the tanker driver moving his head backwards or forwards, an action that he would have been used to performing when joining or crossing a main road from a side road.

Figure 10: Effect on tanker driver's view of an approaching train caused by the mirror cluster on near-side of tanker (Photographs from the sighting tests on 3 October 2010)

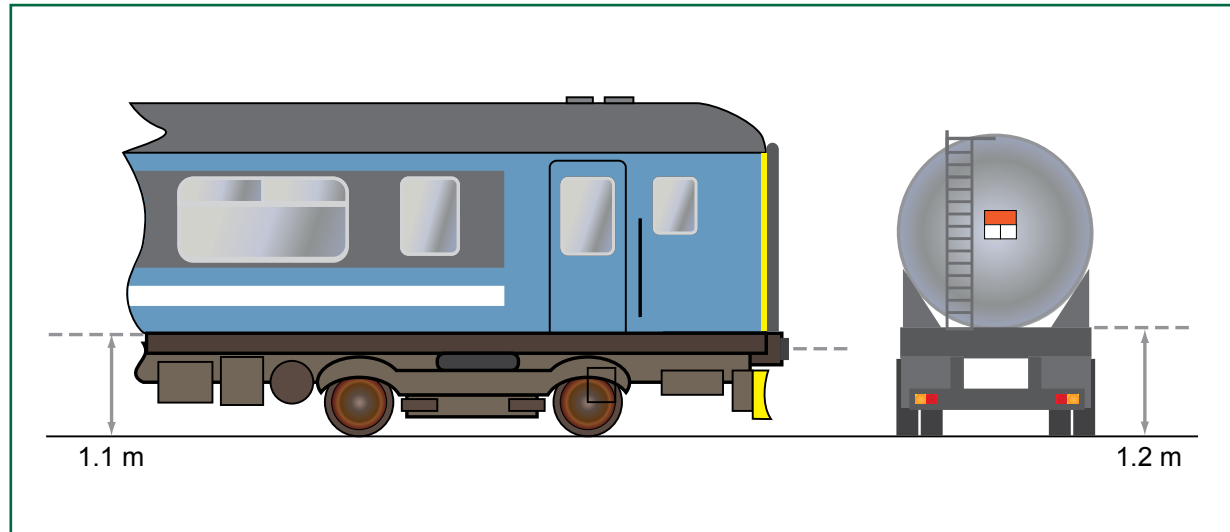
169 In the accident at Sewage Works Lane UWC, the bottom of the tanker barrel was 1.2 metres above the road and at approximately the same height as the floor on the Class 156 unit. As a result, the tanker came halfway up the height of the train body as shown in figure 12 (this type of collision is known as an 'over-riding collision' as the point of impact is above the level at which the energy absorbing devices are normally located on a railway vehicle).

Figure 12: Diagram showing the relative height of Class 156 and sewage tanker

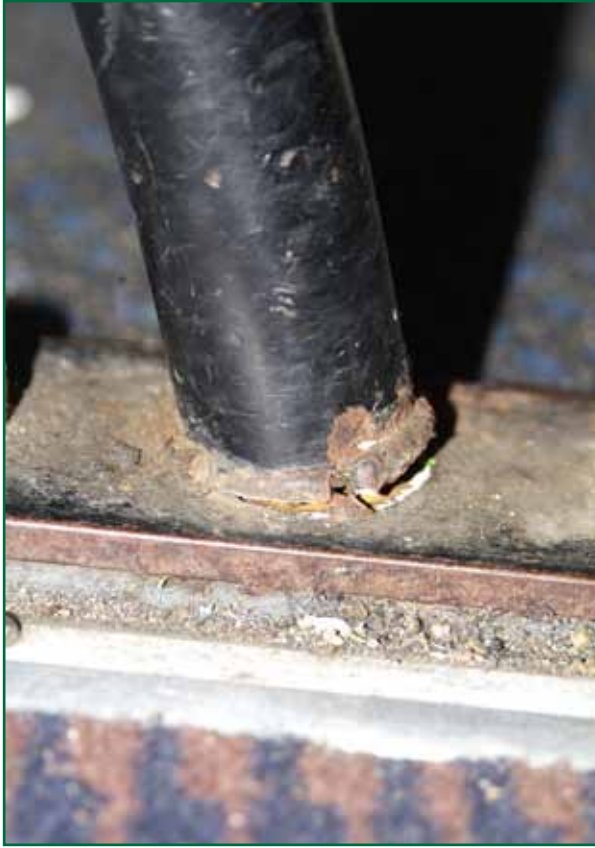
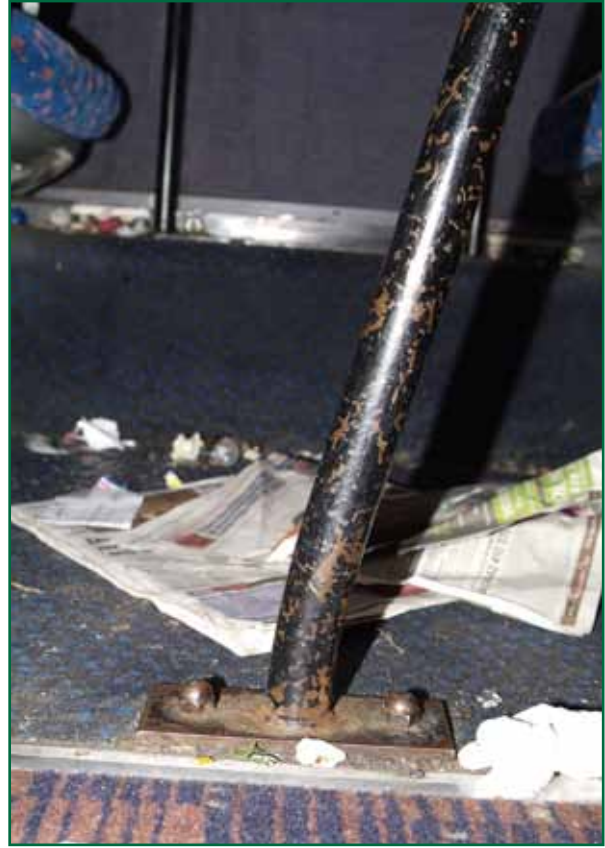
176 The front leg connection to the floor exhibited two types of deformation as shown in figures 15 and 16. In seven cases, the table leg bent and deformed plastically without material failure. In two cases, the table leg failed at the weld to the base plate. This meant that the table leg provided little or no energy absorption due to the inadequate weld strength.

Figures 15 and 16: Damaged legs at base of interior tables within the vehicles

177 Overall, the performance of the tables resulted in the potential for survival space to be compromised and the severity of the injuries to be increased.

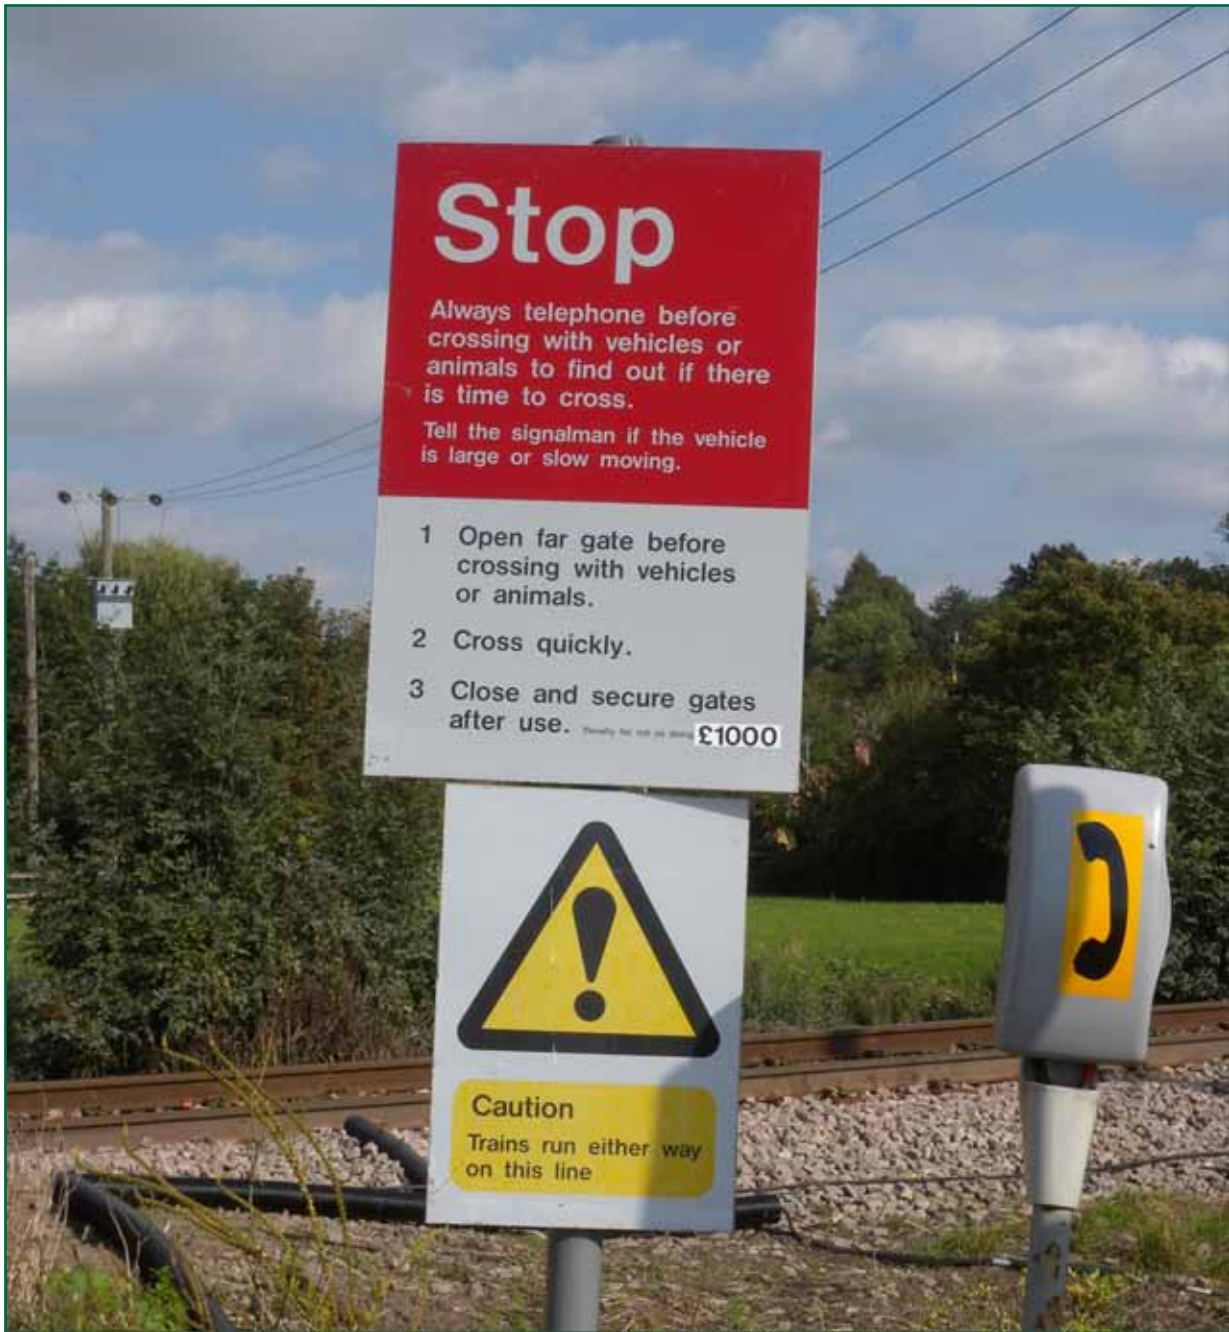
Figure 20: Sign at Sewage Works Lane UWC

187 The signage at Sewage Works Lane UWC presented information in an unclear manner that did not promote safe use. This was a cause of some of the incidents of road vehicle users not calling the signaller to obtain permission to cross the railway.

191 However, witness evidence indicates that the wording and layout of the signs at Sewage Works Lane UWC (figure 20) had caused other individuals to cross the railway without calling the signaller for permission (including one individual who used the crossing shortly before the accident). Of particular note is the mixture of numbered and un-numbered instructions. If a user read only the numbered items, they would miss the requirement to call the signaller before crossing with a road vehicle. Some users had their attention drawn to the text in bold and focused on the fine associated with failure to close the gates. Overall, the sign at this location was unclear and the requirement for all vehicles to call the signaller was lost within the large amount of other text.
