Rail Accident Investigation Branch

Rail Accident Report

Runaway of an engineering train from Highgate 13 August 2010

13 August 2010

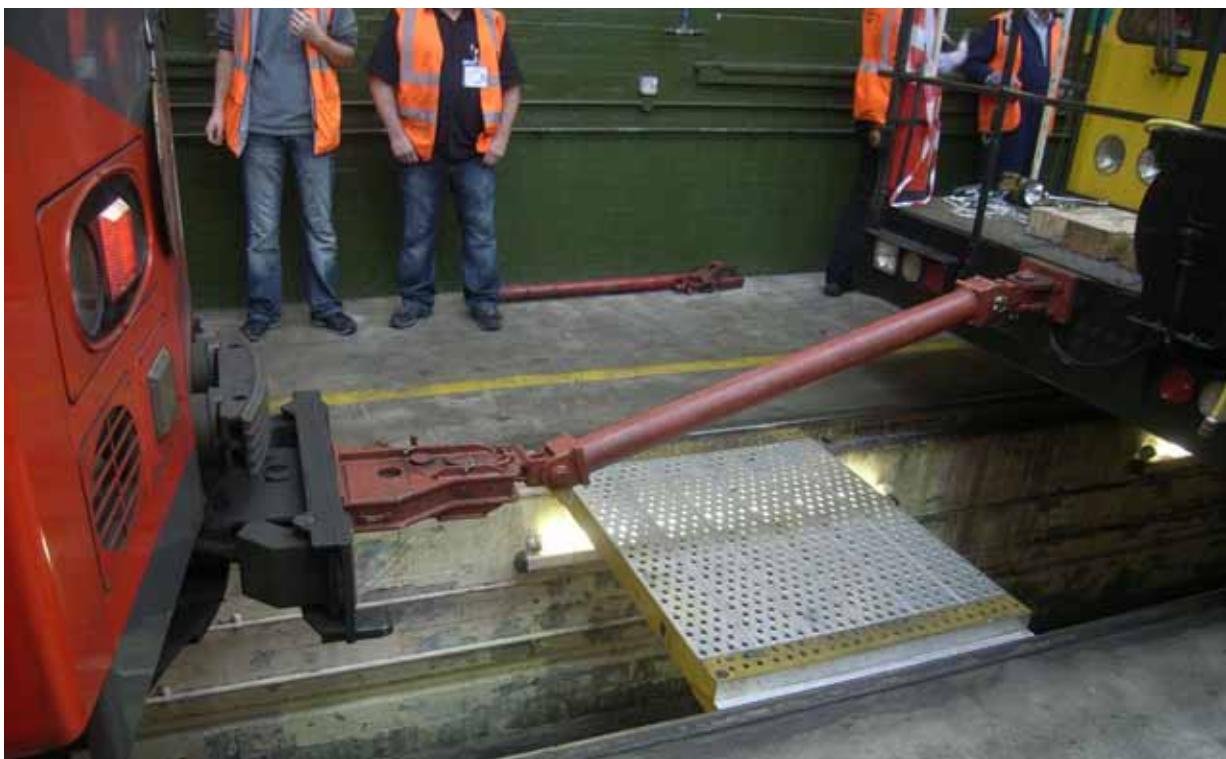
Figure 9: Emergency coupler.

117 The emergency coupler broke due to overstressing of a tow bar hinge assembly. This was a causal factor.

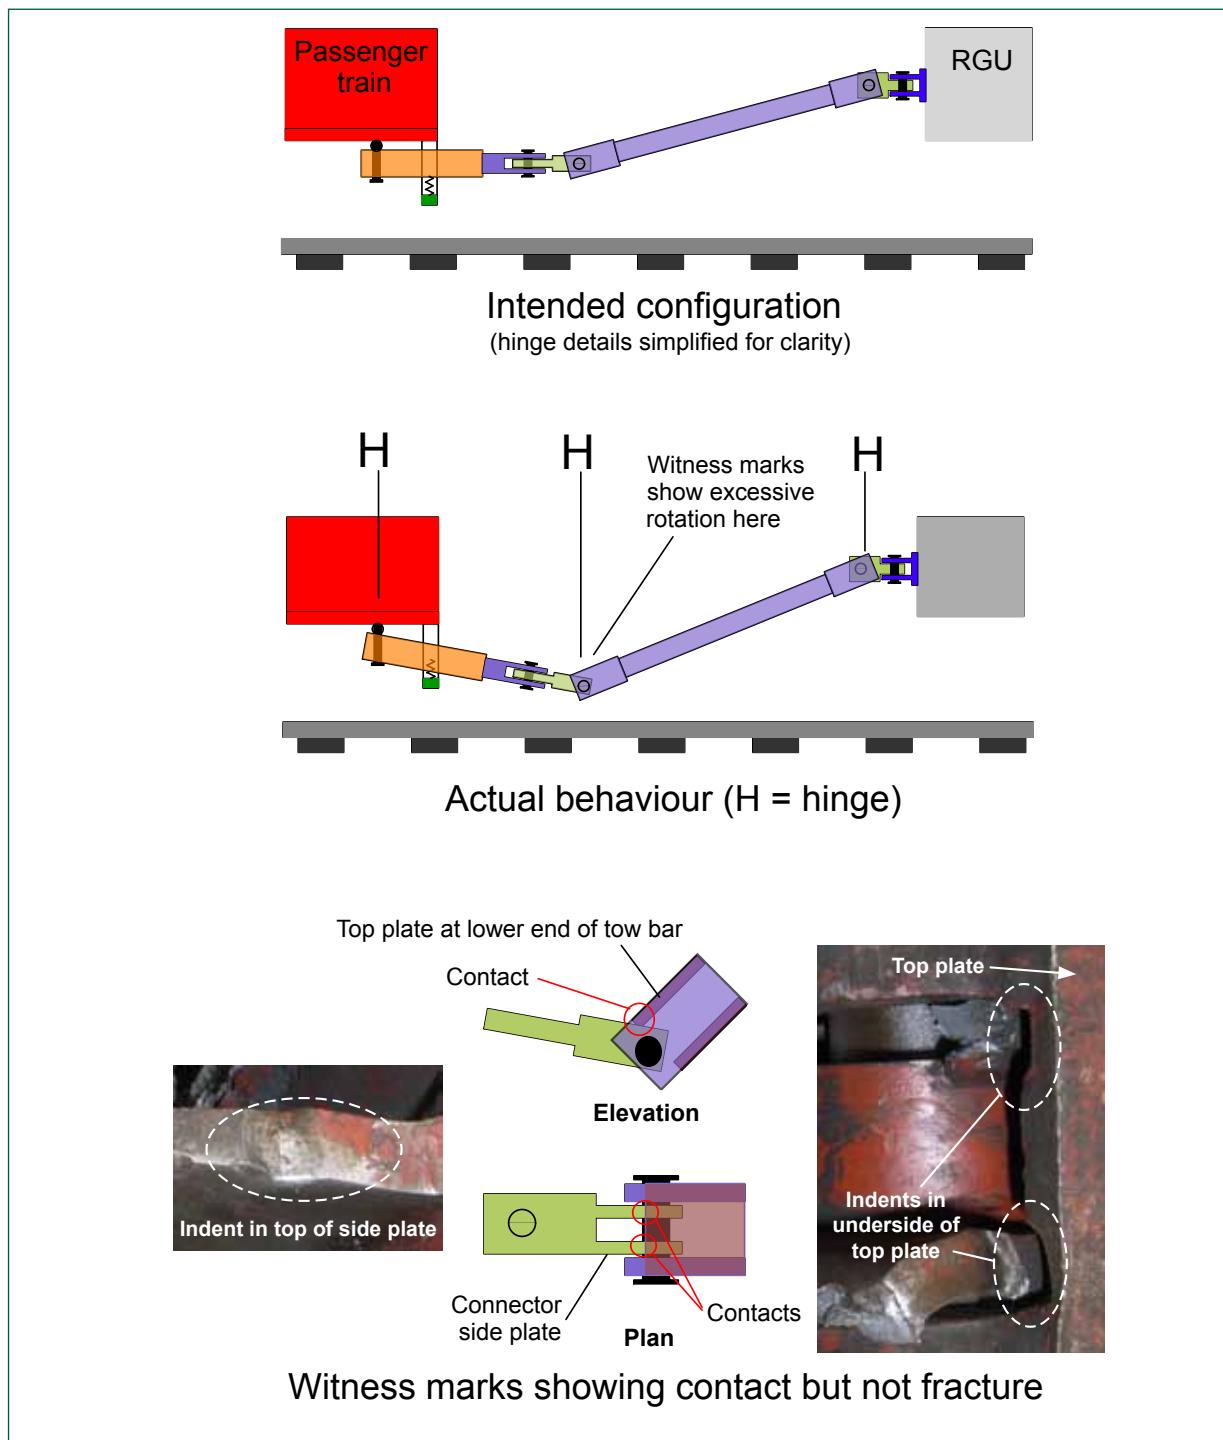
Figure 13: Vertical coupling deflection (phase 1 of breakage).

125 The excessive downward deflection of the coupling in phase 1 was due to the presence of three hinges allowing vertical rotation at the top of the tow bar, the lower end of the tow bar and the wedgelock/car body fixing (figure 13). The nature, but not the maximum extent, of this deflection is illustrated by the still images extracted from a video made by Tube Lines during testing after the July 2010 incident (figure 14). This type of deflection was also described by witnesses to the attempted push recovery during the July 2010 incident and was seen during tests by the RAIB after the Highgate incident. The extent of this movement is evidenced by marks on the metal plate which extends over the pin at the lower end of the tow bar (figure 13).

126 The RAIB has calculated that the maximum vertical deflection was probably just sufficient for the lower end of the tow bar to have touched the *negative rail* (centre rail) as reported by staff who observed the attempted push recovery during the July 2010 incident. There were no marks indicating that the coupler struck the negative rail at Highgate. Contact may have occurred without leaving marks, as the area of tow bar likely to touch the rail had been wrapped with an insulating mat intended to prevent an electrical hazard if the coupler touched the negative rail (paragraph 167). Alternatively, the lateral deflection of phase 2 may have meant that the relevant part of the tow bar was not directly above the negative rail.

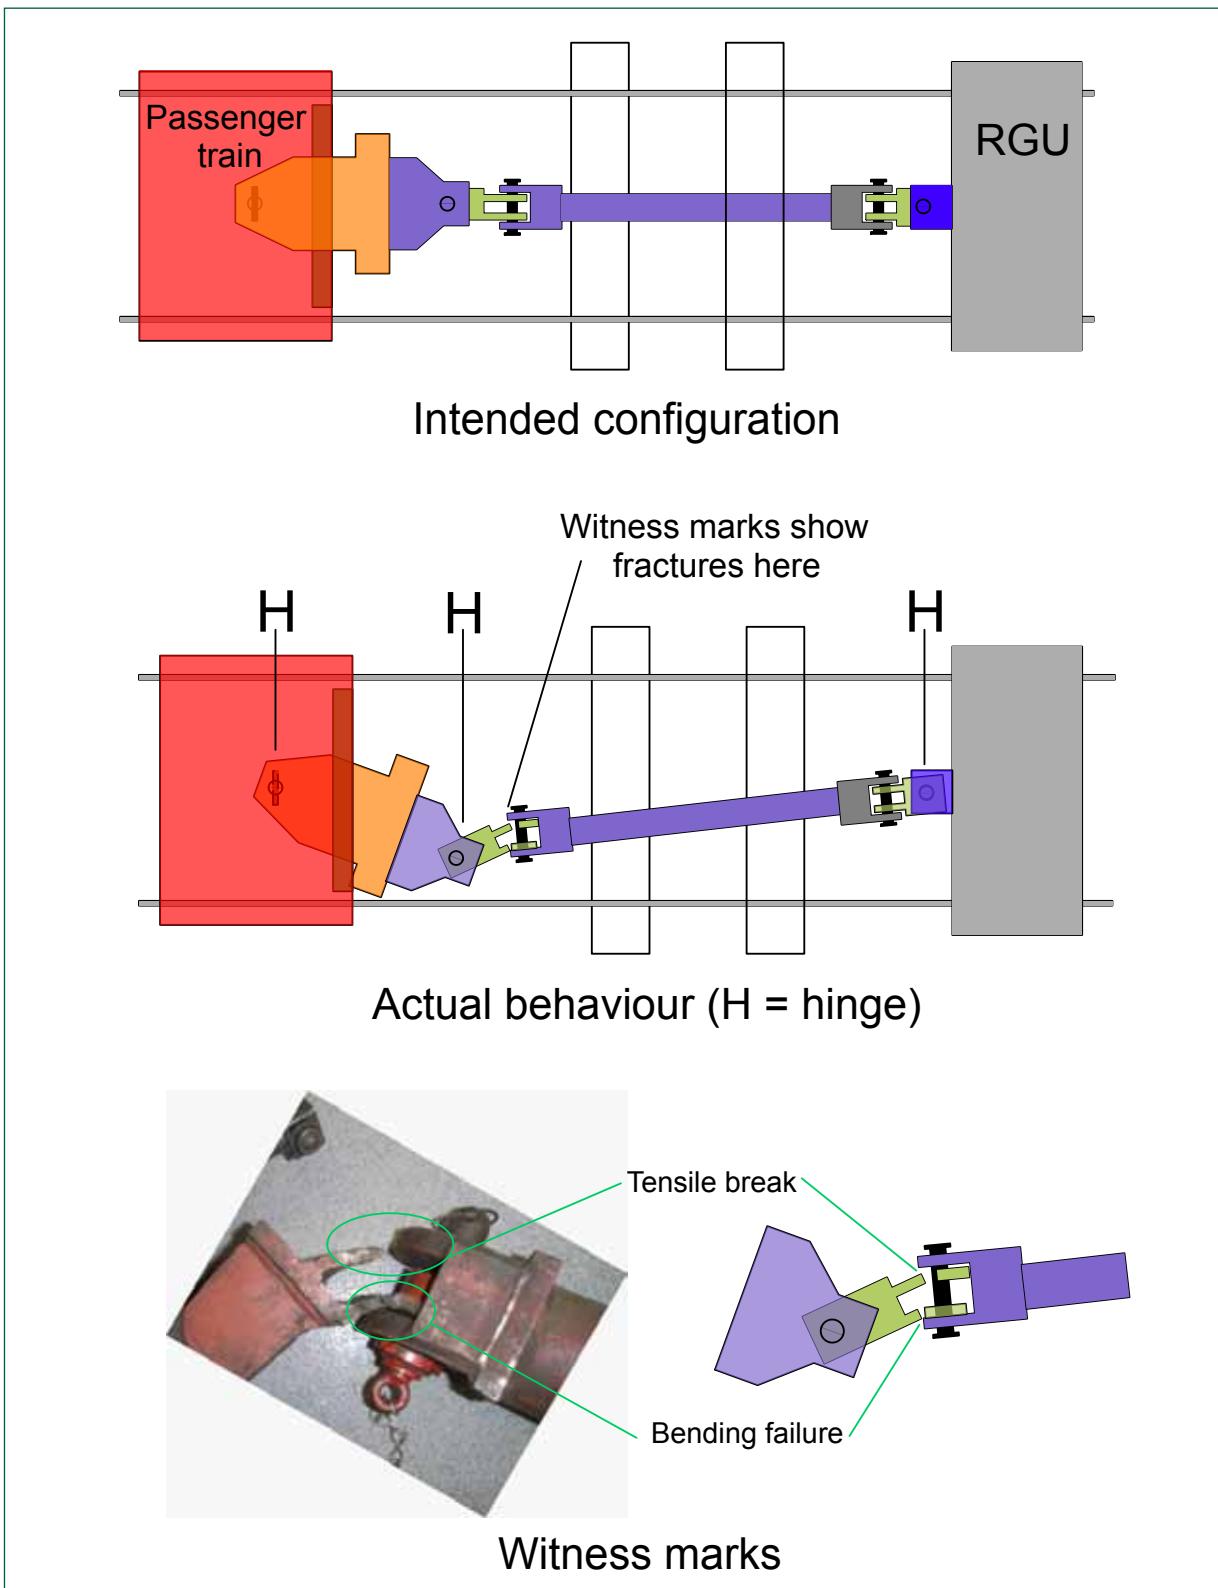
Figure 15: Lateral coupling deflection (phase 2 of breakage).

127 The excessive lateral deflection of the coupling in phase 2 is again due to the presence of three hinges. These allow lateral rotation at the clevis pin, at the adaptor box/tow bar connection and at the wedgelock/car body fixing (figure 15). This movement was observed during the push recovery in July 2010 and in the RAIB testing (figure 16). It is also evidenced by the way in which the two plates at the lower end of the tow bar fractured during the Highgate incident (figure 15).

- 128 The RAIB inspected the fracture faces shortly after the incident and concluded that the fracture was caused by a sudden overload event. There were no indications of fatigue failure and no significant manufacturing defects could be seen. RAIB has calculated that, during the emergency brake application, the coupling was subject to a compressive load of about 5.7 tonnes; significantly more than the 3.5 tonnes at which the coupler would be expected to fail in the deflected phase 2 configuration.

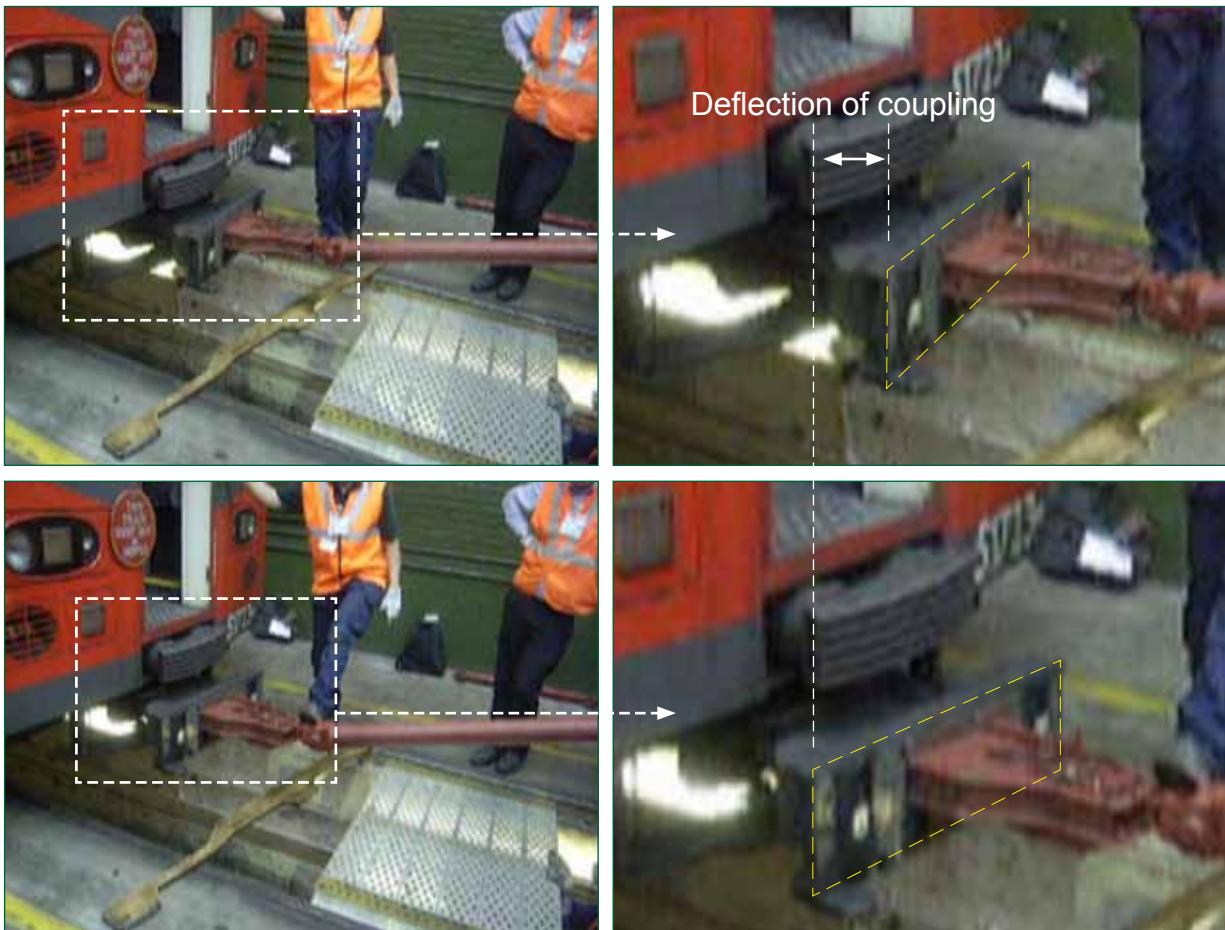
Figure 16: Lateral coupling deflection observed during post-incident RAIB testing.

- 163 It is uncertain why the excessive horizontal deflection of the emergency coupler (phase 2, figure 15) was not observed during the acceptance testing. It is possible that friction between the diesel locomotive's wedgelock coupler and the supporting bar was sufficient to prevent horizontal rotation of the wedgelock. The possible absence of an emergency brake application during the tests may also have been a factor.

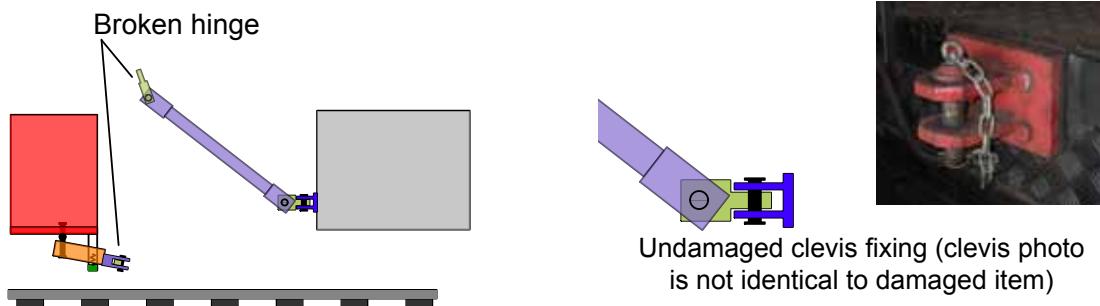
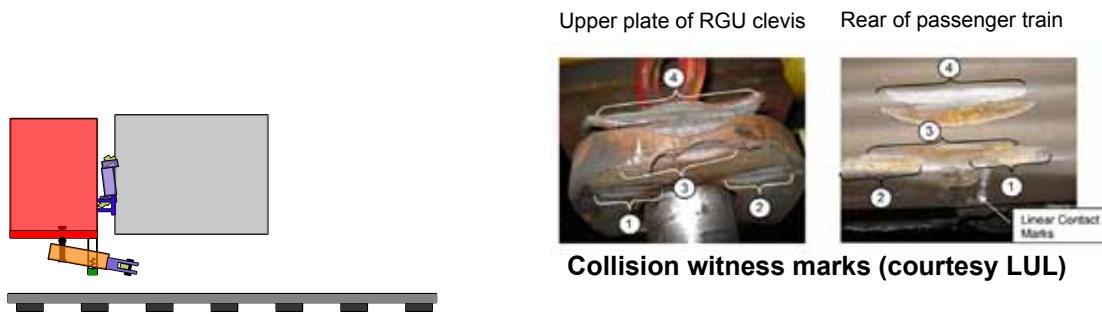
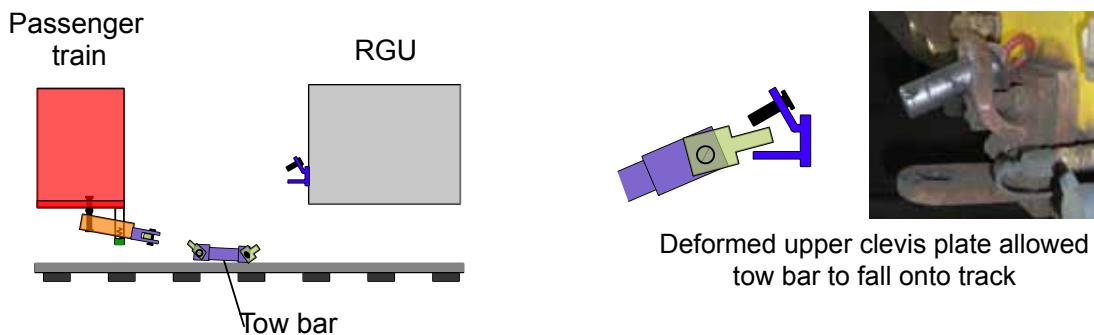
Figure 17: Upward tow bar movement (phase 3 of breakage).

- 129 Phase 3 included the rapid upward movement of the tow bar and a collision between the RGU and the assisting train. The upward movement was observed by staff at Highgate; the collision is evidenced by the marks on the trains shown on figure 17. The upper RGU clevis plate deformed during the collision and allowed the tow bar to fall onto the track (figure 17). RAIB has not attempted to model phase 3 in detail.

Energy stored in compressed coupling components causes tow bar to flip upwards

Collision - the upper clevis plate is initially horizontal (witness marks 3 & 4), and is pushed upwards during the collision (witness marks 1 & 2)

Tow bar falls onto track (may occur during phase 3B); RGU rolls backwards

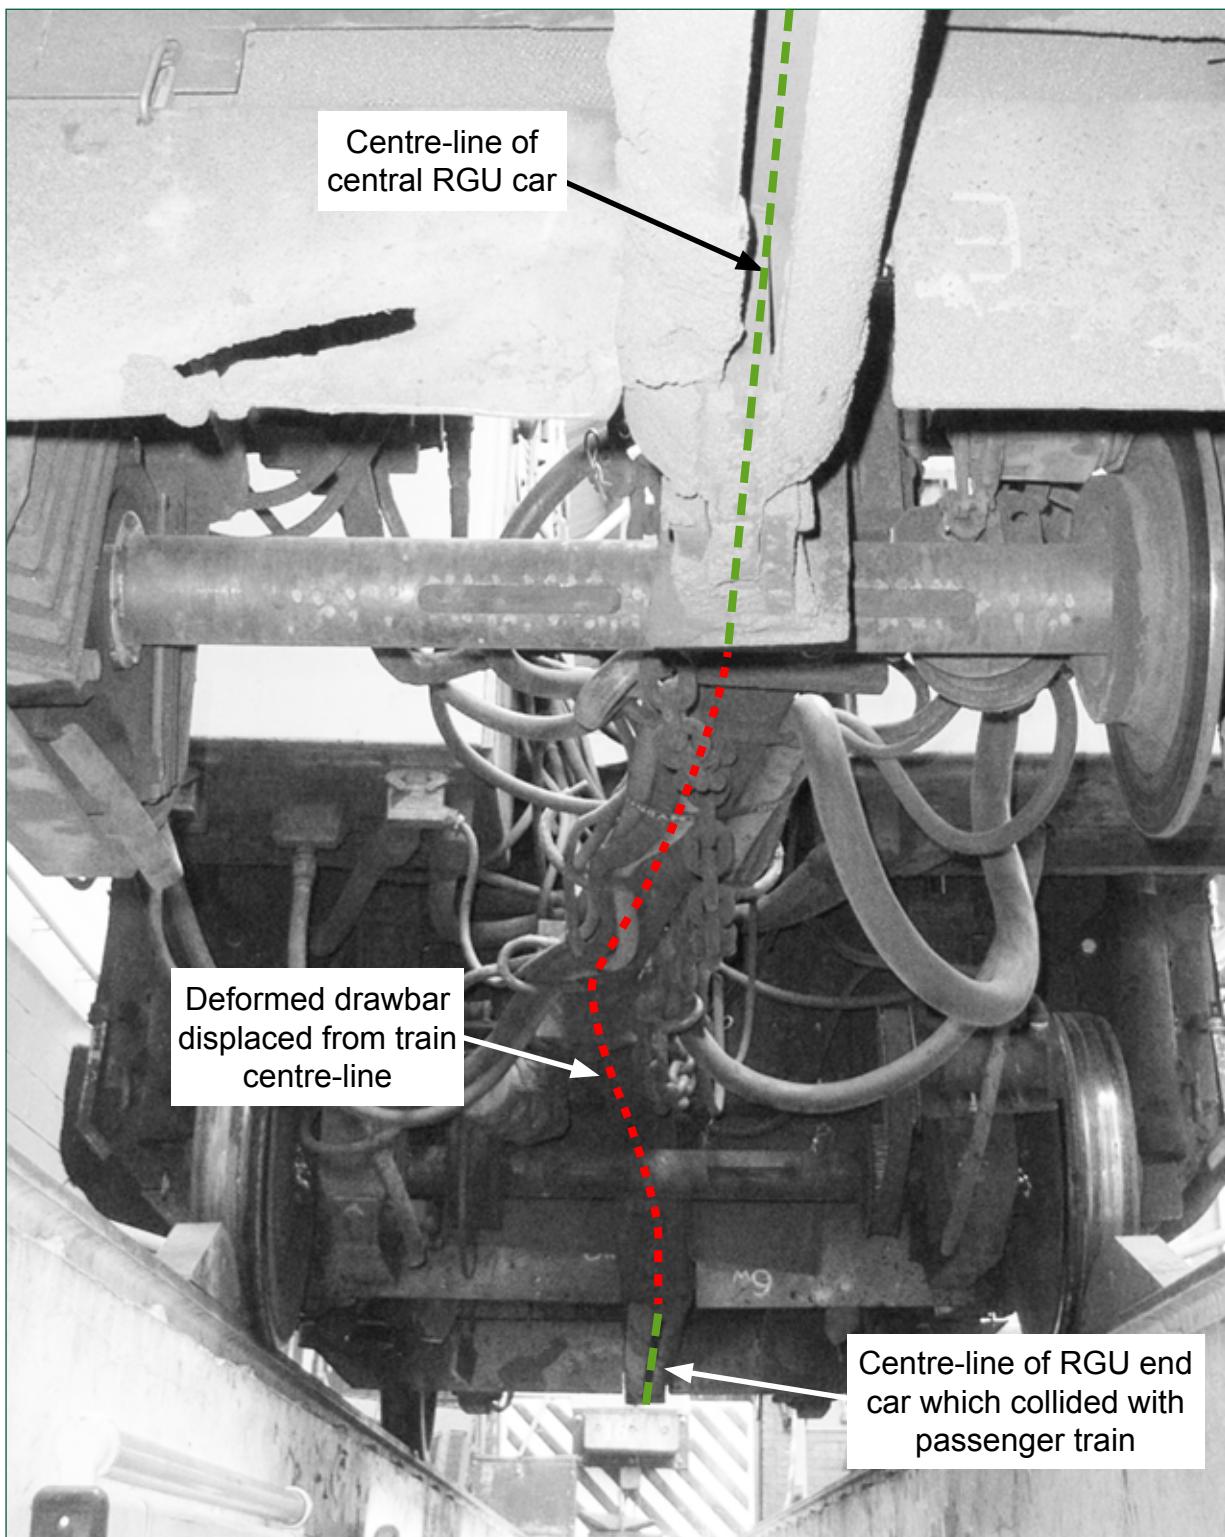
Figure 18: Deformed drawbar on RGU.

131 After the incident, significant deformation was found in the drawbar linking two of the RGU cars (figure 18). The drawbar damage may have been caused during the incident. It is not likely that the damage existed before the incident because it would probably have been detected during the daily inspection of the RGU. Even if the damage existed before the coupling broke, it would not have played any part in the emergency coupler failure.
