RAIB Bulletin 08/2010

Serious injury to a loader at Hoo Junction, Kent 14 April 2010

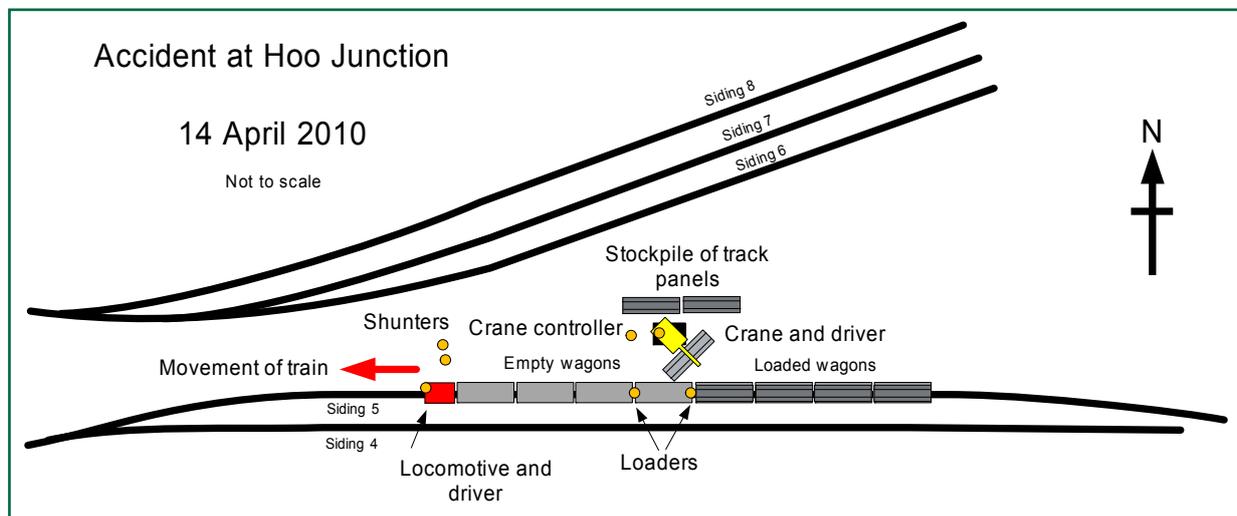
Figure 1: Position of train and people involved

- 4 The work of loading then resumed, but as the first panel was placed on a wagon, the whole train began to move towards the London (west) end of the siding. The loader who was standing on the east end of the wagon was struck by the panel and his legs were trapped under it. The train stopped after moving about three metres.
- 5 The crane driver saw what had happened and lifted and swung the panel away to release the trapped man, who fell from the wagon to the ground. The swinging panel smashed a window in the crane cab.
