RAIB Bulletin 06/2010

Runaway and collision on the Welshpool and Llanfair Light Railway, 3 March 2010

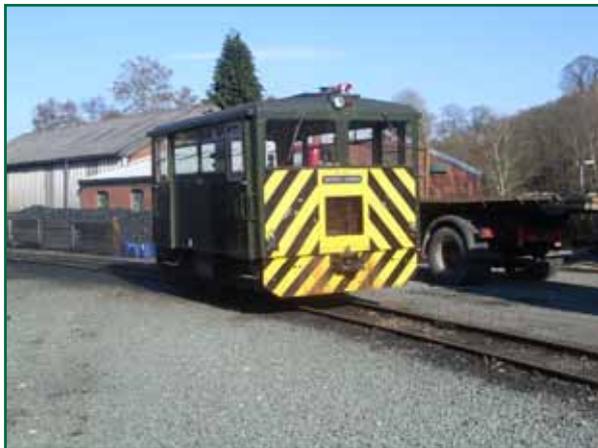
Figure 1: The Wasp

1. At 11:10 hrs on Wednesday 3 March a diesel personnel carrier, known as “the Wasp” (figure 1), pulling a match wagon ran away from near to the top of Sylfaen Summit on the Welshpool and Llanfair Light Railway. It ran away on a continuous gradient for approximately 2.1 miles, reaching an estimated maximum speed of 30 mph and passing over two open level crossings. At approximately 11:20 hrs it arrived at Welshpool Raven Square station and collided with five wagons stabled in the platform, causing the Wasp, its match wagon and three of the stabled wagons to derail (figure 2), the latter suffering major structural deformation. Two of the three people on the Wasp received minor injuries.

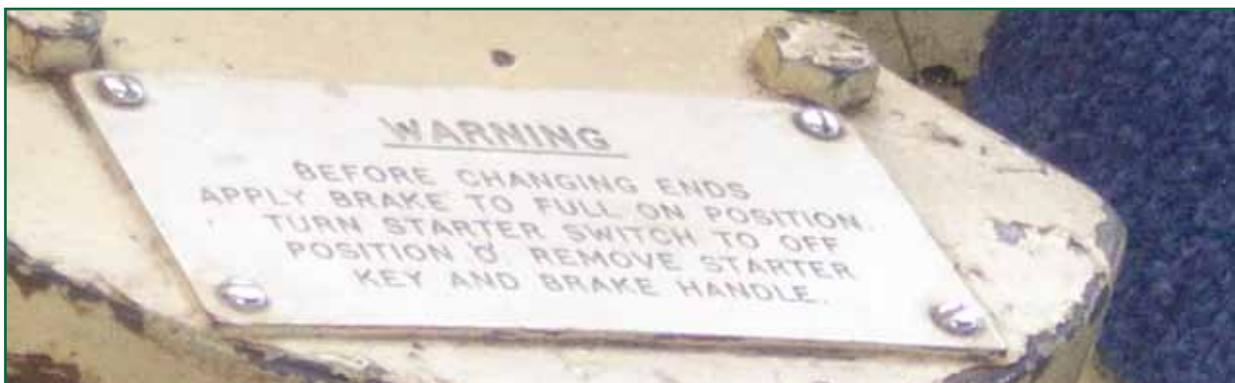
Figure 4: Warning label on brake controller

4. The Wasp has one brake handle and one desk key. When changing driving desks, the brake handle and desk key have to be removed for use in the other desk. The brake controller in the desk needs to be left in the “on” position for the brake controller at the other end to be able to apply the air brake. A mechanical interlock arrangement is fitted with the aim of ensuring this. Figure 4 shows the warning label on the brake controller reminding drivers of this. Figure 5 shows the brake controller and interlock features. The brake handle is fitted with a collar so that it can only be withdrawn through the hole at the “on” position. When the desk key is removed an interlock pin is raised pneumatically, this is designed to hold the controller in the “on” position.

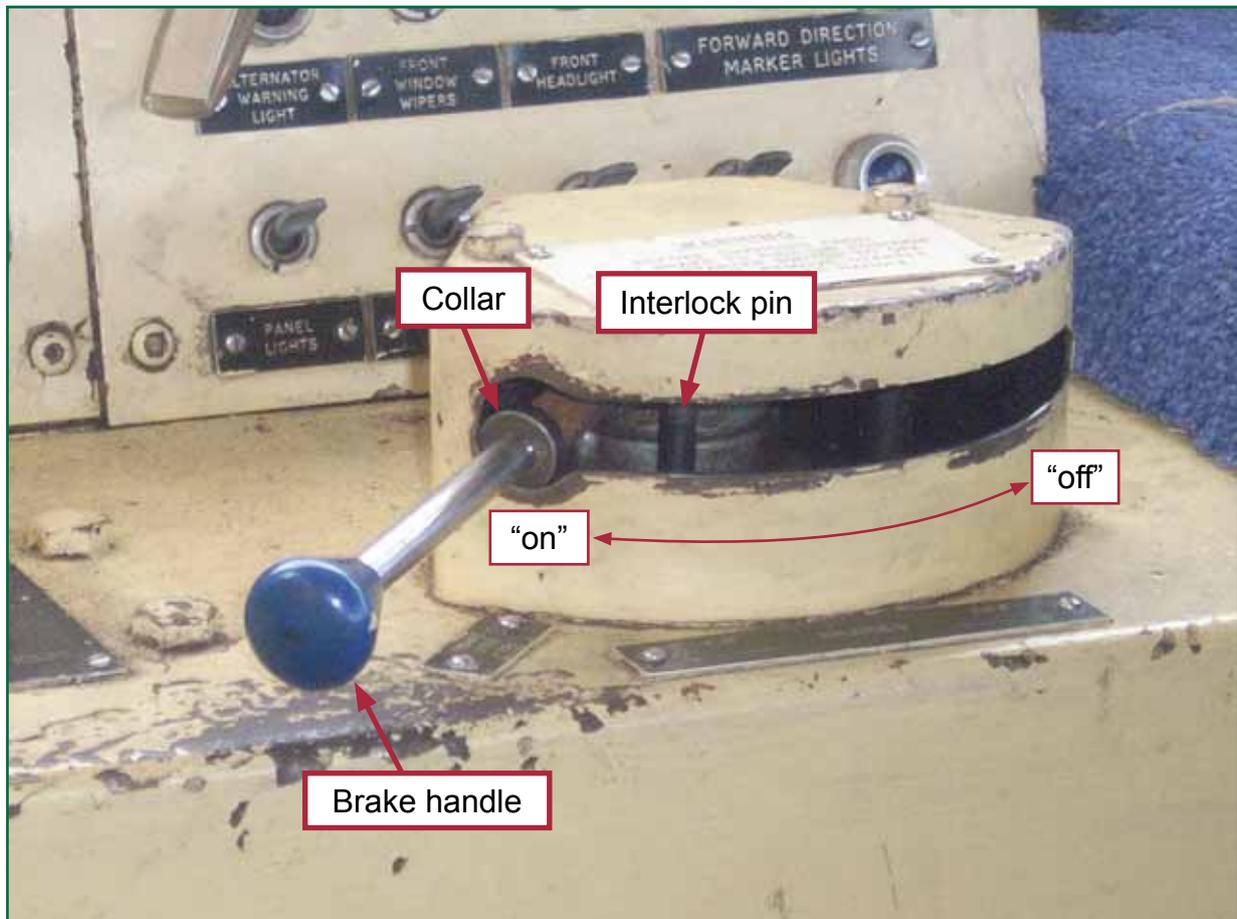
Figure 5: Brake controller and interlock features

5. The RAIB found that the Welshpool end brake controller had not been left in the “on” position and had been locked in the “off” position. Furthermore, it found that the design of the interlock arrangement was such that it could be bypassed relatively easily. The brake controller could be moved to the “off” position with the brake handle partially withdrawn. The handle could then be fully removed, and, when the desk key is withdrawn, the interlock pin would lock the brake controller in the “off” position. In this condition there was no means of applying the air brake to stop the Wasp using the brake controller at the Llanfair end.

8. The RAIB has identified the following learning point for heritage and other industrial railways:
 - A failure to fully understand the design of, and potential hazards from, braking systems and associated controls on vehicles and on-track plant (including the ways in which the actions of an operator could lead to him inadvertently overriding safety interlock systems) can result in single point failures going unrecognised and therefore not being protected against.
