RAIB Bulletin 10/2010

Train collision with level crossing gate, Stow Park, Lincolnshire, 20 February 2010

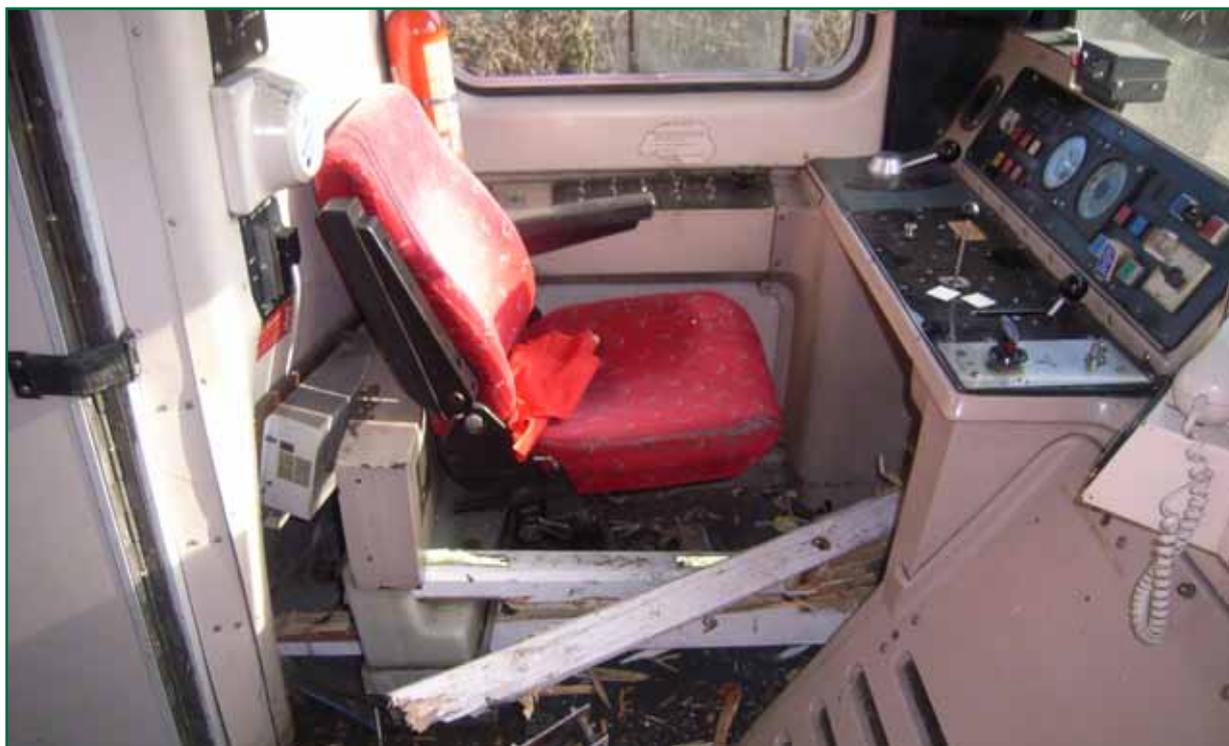
Figure 1: Cab interior following collision with level crossing gate

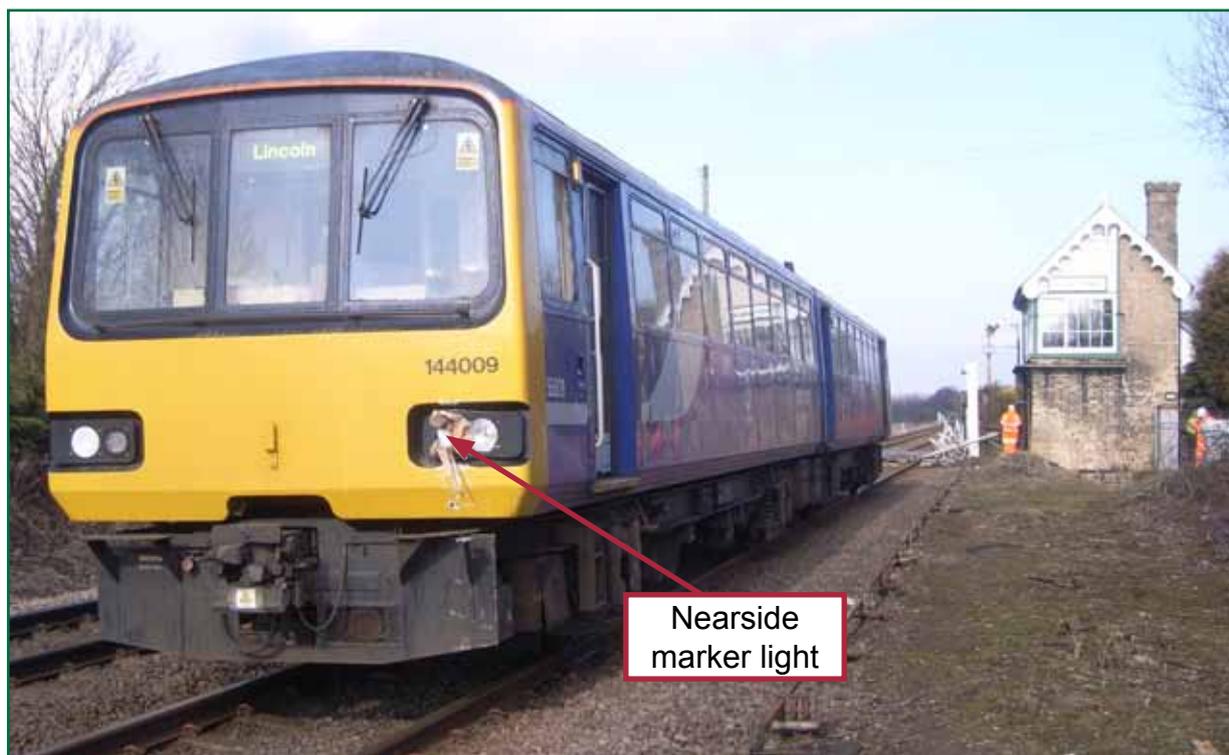
- 1 At 06:45 hrs on Saturday 20 February 2010, the 05:39 hrs train from Sheffield to Lincoln, formed of two-car diesel multiple unit number 144009, struck the up¹ side gate at Stow Park level crossing, which had become partly open, at a speed of about 49 mph (79 km/h).
- 2 The timber crossing gate was destroyed by the collision and the upper rail of the gate penetrated the cab of the train through the nearside marker light fitting. This caused minor injuries to the driver's legs and damage to the electrical cubicle mounted behind the driver's seat (figure 1). The driver narrowly avoided being seriously injured by the penetrating pieces of timber from the gate and none of the five passengers on the train were injured.
- 3 The driver applied the emergency brake and the train stopped about 60 metres past the crossing (figure 2).

Figure 2: Train involved in the accident at Stow Park crossing

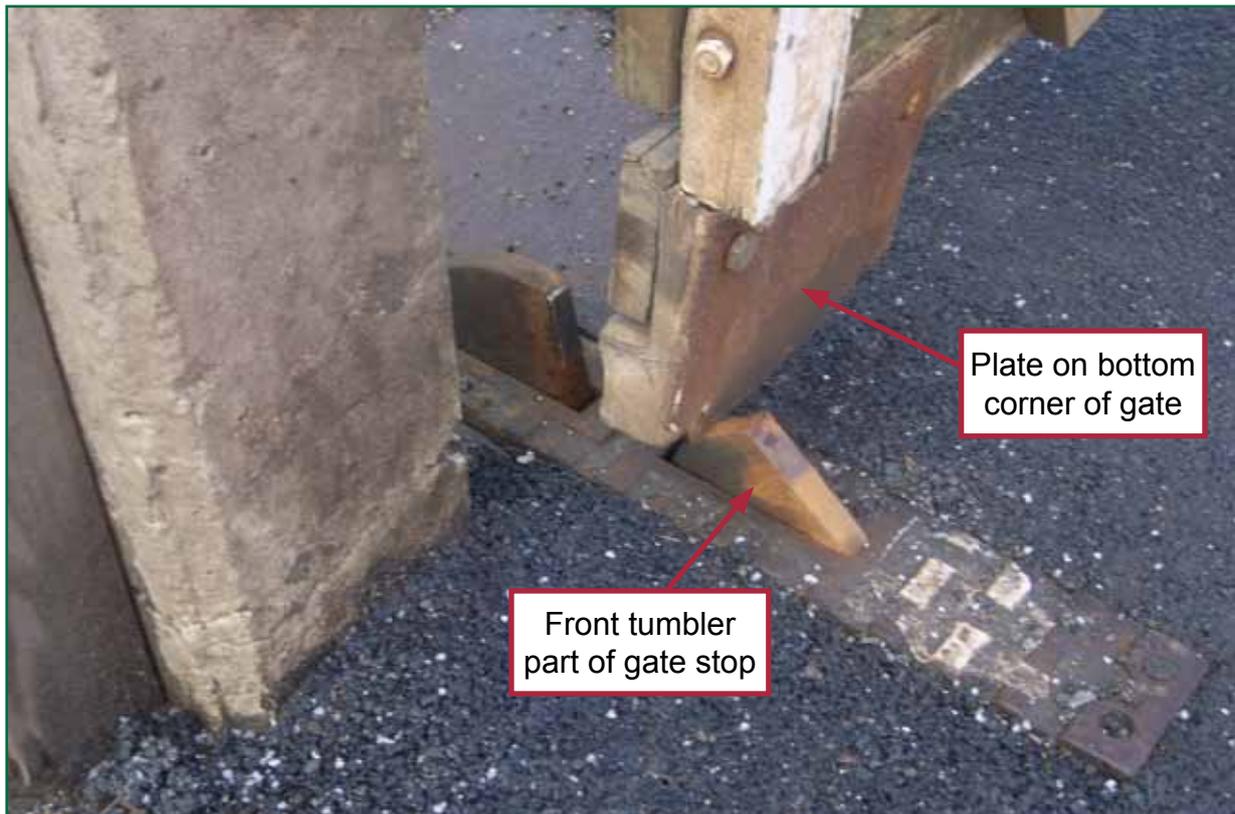
- 7 In order for the gates to be retained in position, and to prevent them swinging back, there has to be sufficient overlap between the front tumbler of the gate stop and the bottom corner of the gate (figure 3). This has to be maintained to take account of all normal changes in temperature occurring during the year which affects the height of the bottom corner of the gate.

Figure 3: Down side gate stop with gate in position across the road

- 9 The RAIB's investigation found that the up side gate was not securely held in position across the road because there was insufficient overlap between the front tumbler part of the gate stop and the bottom corner of the gate. The gate had therefore been able to swing back into the path of the train.

- 14 The probable cause of the accident was that the travel of the up side gate stop had been reduced when the crank was replaced and it no longer rose sufficiently far above the surface of the road to reliably prevent the gate from being able to ride over the gate stop and swing back across the railway. The low temperature of the previous night was also likely to have been a factor in causing the height of the bottom corner of the gate to increase (paragraph 7).

- 15 Since the accident occurred, Network Rail has renewed the up side gate and adjusted the gate drive. It has also removed the backboard to the mirror, and shortened the post on which the mirror was mounted, to improve the signaller's view of the up side gate stop.
