# Rail Accident Report

**Fatal accident at Moreton-on-Lugg,  
near Hereford,  
16 January 2010**

# Fatal accident at Moreton-on-Lugg, near Hereford, 16 January 2010

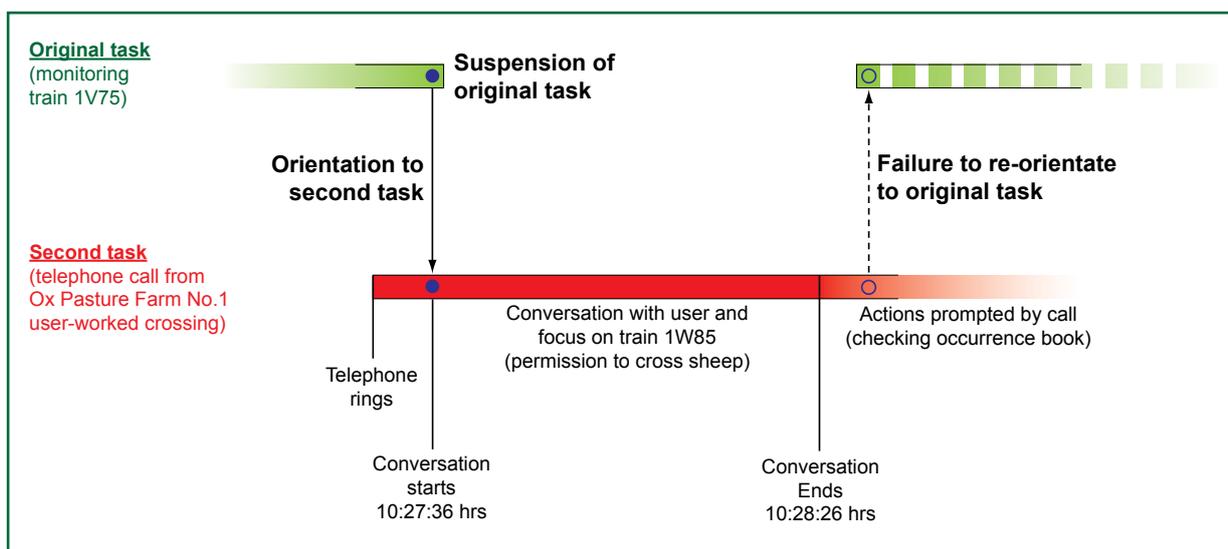
Figure 11: Interruption resulting from the second call from Ox Pasture Farm No.1 user-worked crossing

Figure 11 is a simplified diagram of the interruption caused by the second call from Ox Pasture Farm No.1 user-worked crossing.

- 100 Factors leading to an interruption differ for each individual and also each specific circumstance. However, there is a variety of evidence (discussed further in paragraphs 103 to 117) that, together, helps explain why the second call on 16 January 2010 interrupted the signaller and caused him to completely suspend monitoring the passage of train 1V75:
- It captured his attention: to the signaller, the request was unusual and unanticipated, and the conversation focused his attention on another train, 1W85.

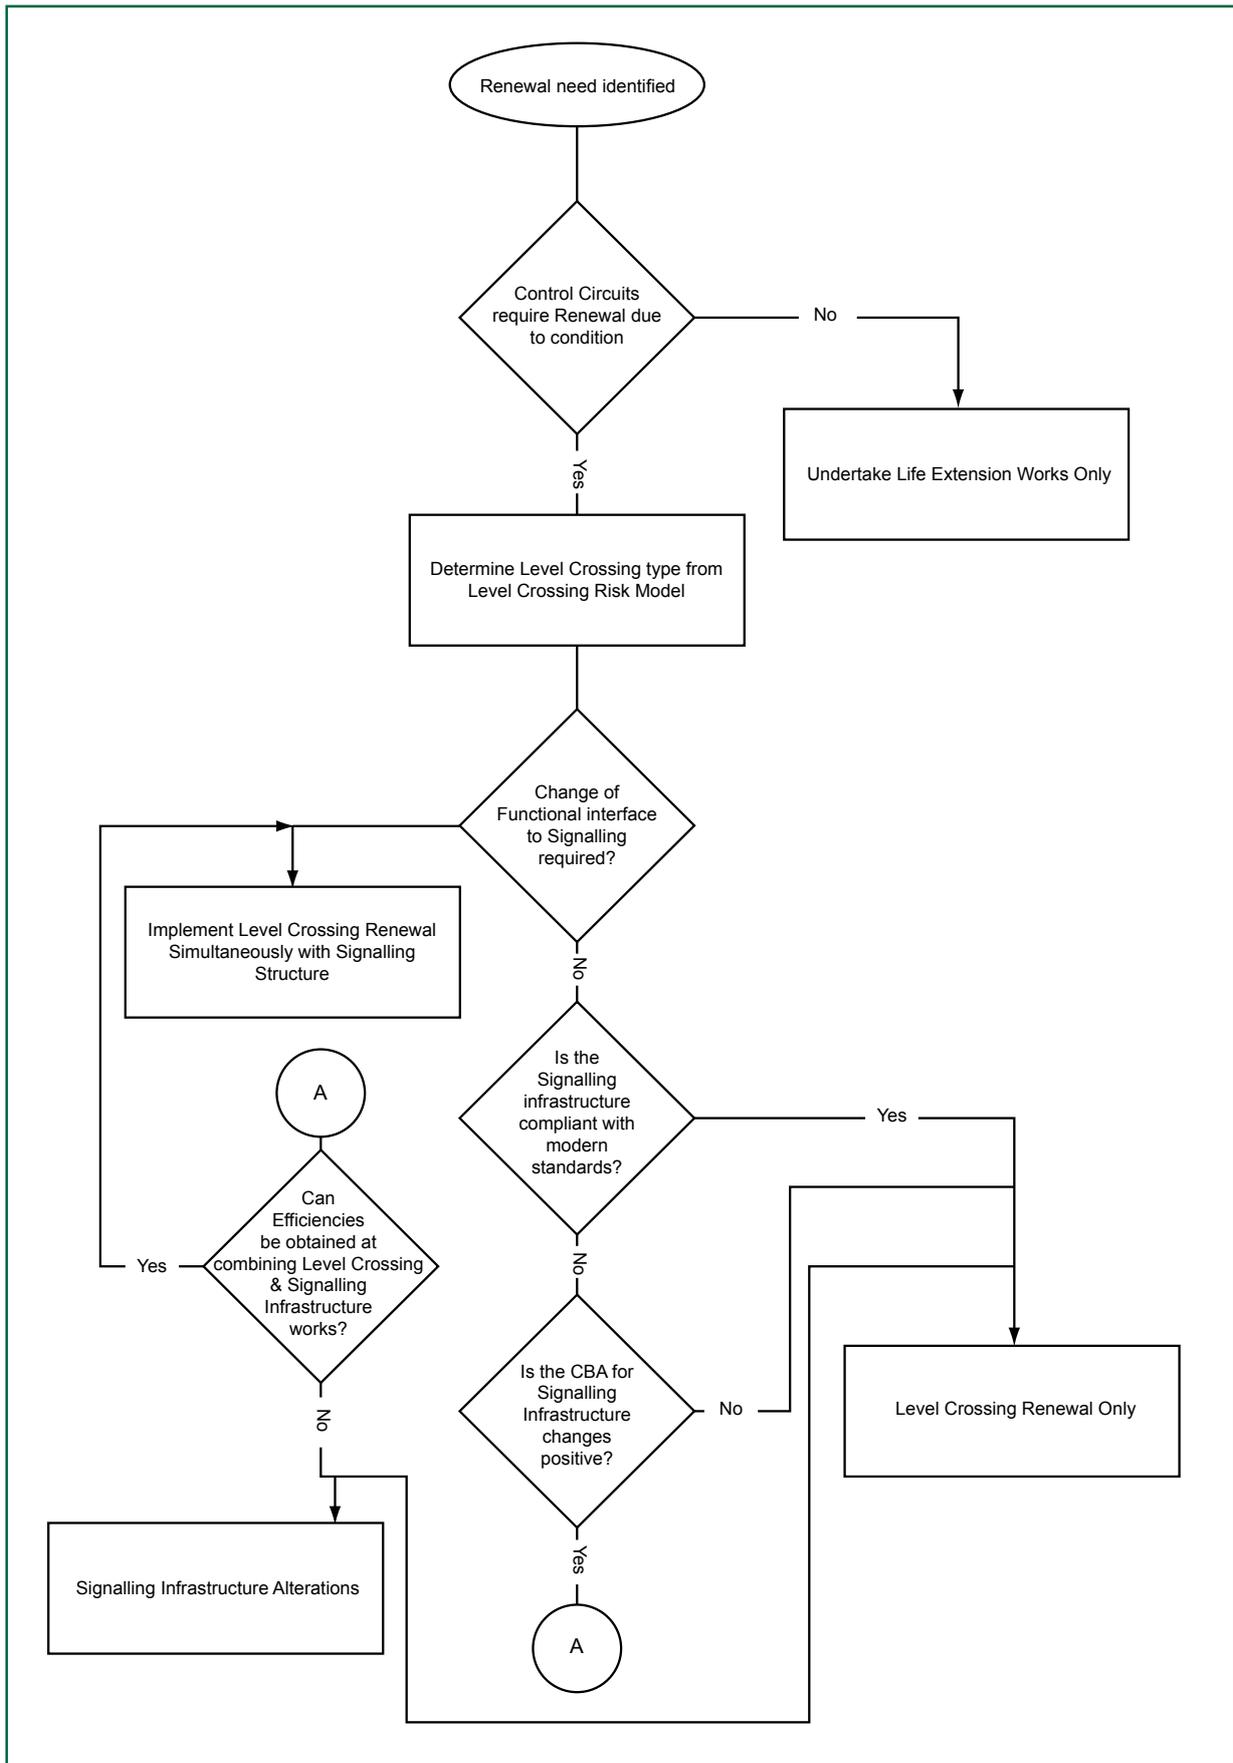
Figure 12: Level Crossing renewal flowchart produced by Network Rail for discussion in 2007 (note: the term 'life extension works' is used instead of partial renewal)

- 145 The decision to carry out a partial renewal, as a strategy to improve value for money, limited the signalling renewal work at Moreton-on-Lugg to 'like-for-like' equipment replacement. This contributed to there being no industry requirement to do a risk assessment to consider the safety benefit of an upgrade to bring the wider signalling system into compliance with current engineering standards.
