# Rail Accident Report

## Collision at Exeter St Davids station 4 January 2010

Report 10/2010  
June 2010

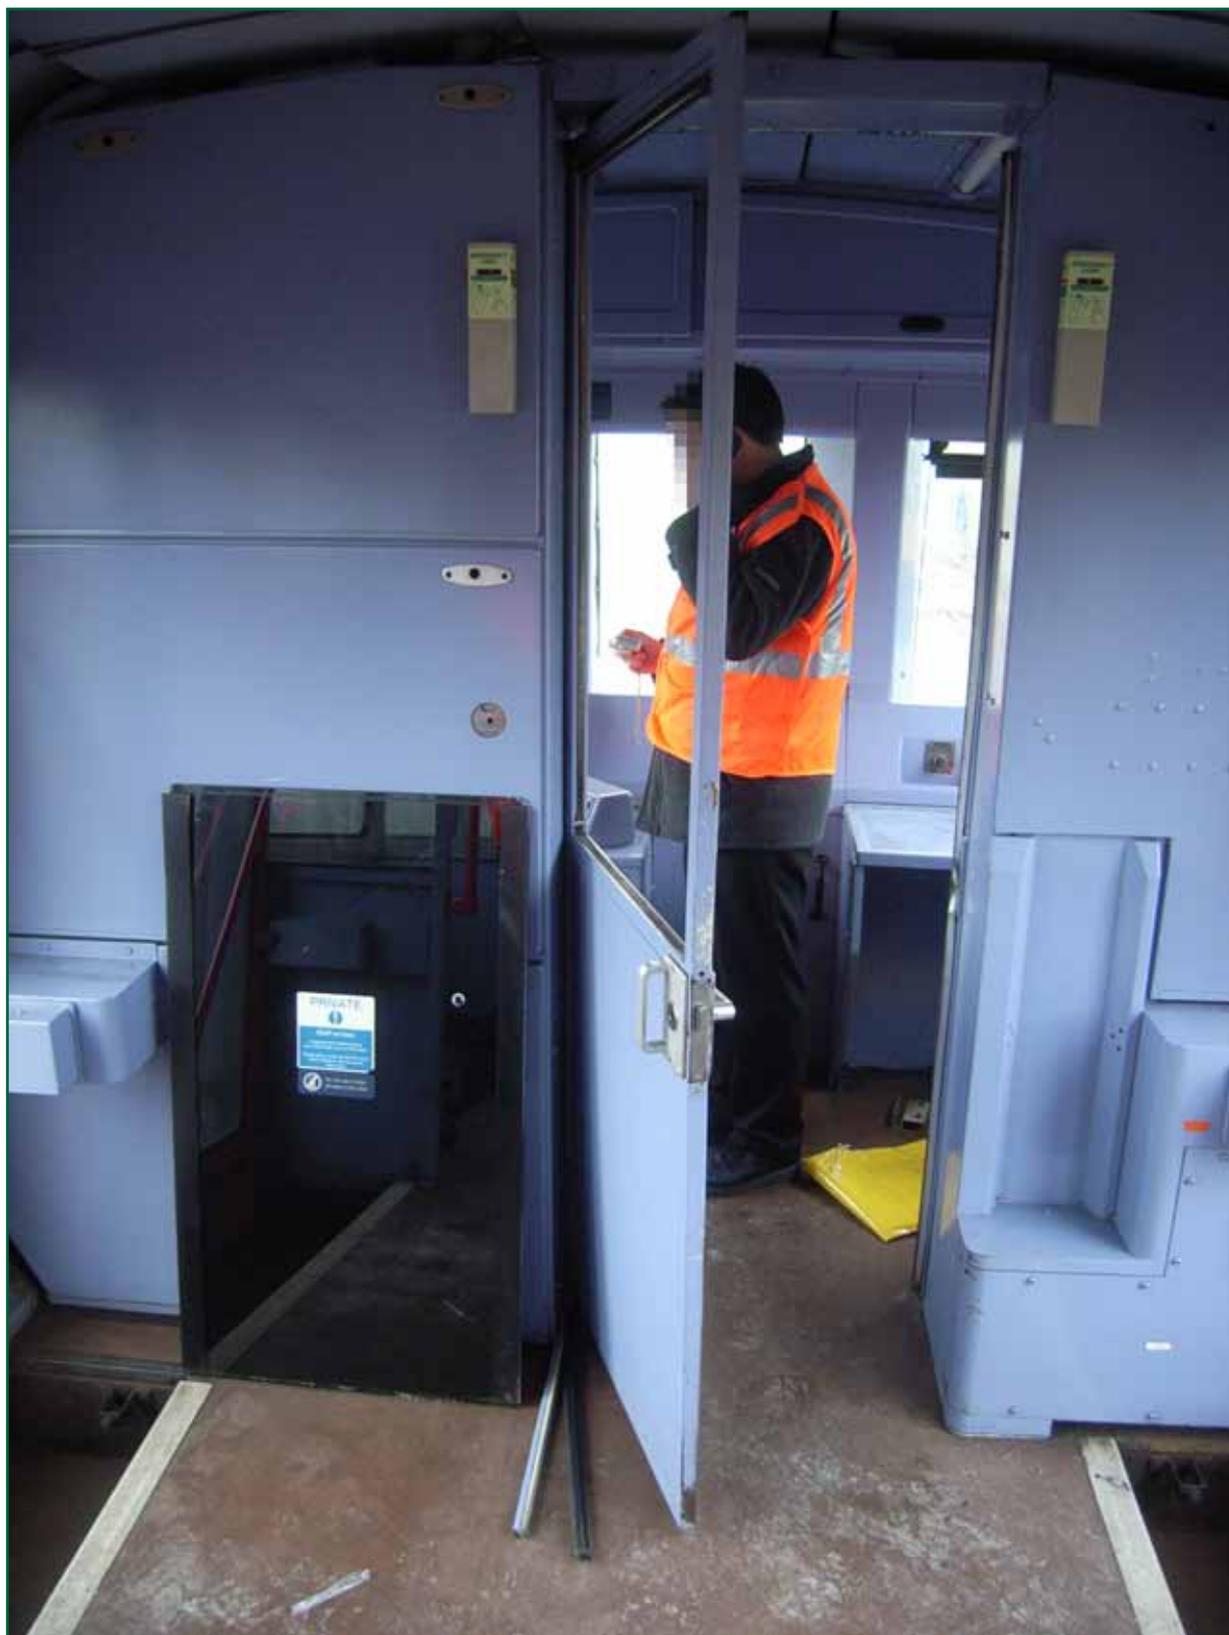
- 72 The damage to both trains was minor. However, on the class 142 unit, a large window located in the door giving access to the rear driving cab from the passenger saloon became detached from its frame and fell to the floor as a result of the impact (see figure 4). At the time of the collision there were no people in the vicinity of the window.
- 73 It was established that the glass unit sits in a bottom channel that is held in place by six welds which secure it into the door window frame. Of the six welds, two were in good condition, two were incomplete and exhibited signs of rust, and two had failed completely before the accident. The force of the collision overloaded the welds allowing the bottom channel to detach from the door frame and the glass unit to slide out (see figure 5). This created the potential for an injury for anyone who had been in the vicinity.

Figure 4: Glass window ejected from door following collision

- 80 Following the accident, FGW issued an urgent safety advice in accordance with Railway Group Standard GE/RT8250 'Reporting High Risk Defects' to inform other operators of class 142 units of the door glass detachment weld issue.
- 81 In the light of this action addressing the factor identified in paragraph 79a, the RAIB has decided not to issue a further recommendation.

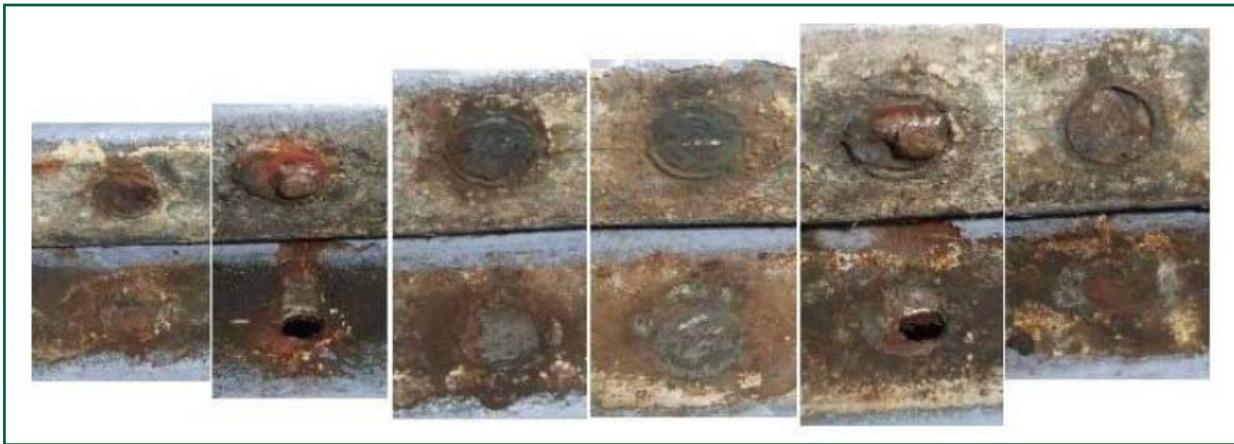
Figure 5: Failed welds (channel weld portion in top images and doorframe in bottom images) (Images courtesy of FGW)

- 79 Although not linked to the accident at Exeter St Davids on 4 January 2010, the RAIB observes that:
- a. the failure of the welds holding the window in the door giving access to the rear driving cab from the passenger saloon and subsequent detachment of the glass on the class 142 unit created the potential for an injury for anyone who had been in the vicinity (paragraph 73, see paragraph 80);
  - b. not all train operators systematically identify in their route risk assessments the potential hazards associated with low adhesion where there may be a need for trains to stop immediately beyond a level crossing (paragraph 75, **Recommendation 1**).
