Rail Accident Investigation Branch

Rail Accident Report

Derailment at Hampton Loade, Severn Valley Railway 28 September 2009

Report 07/2010
April 2010

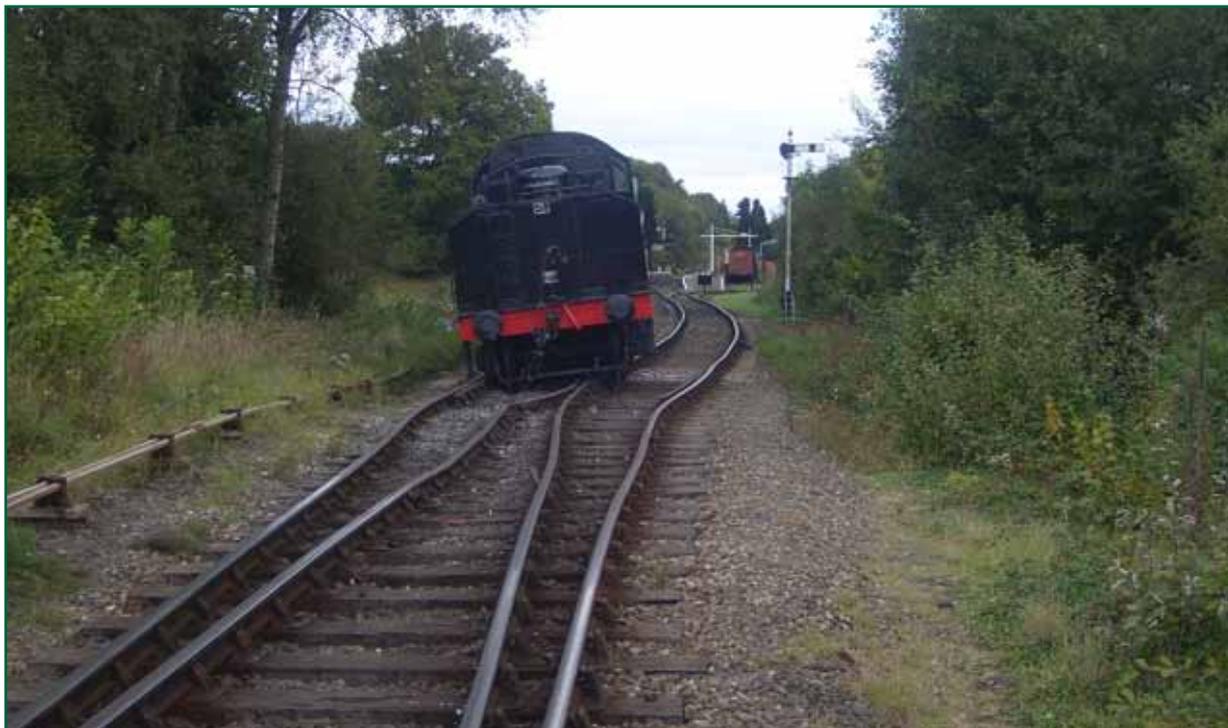
- 21 The locomotive was running chimney first towards Bridgnorth. As the train was approaching Hampton Loade the locomotive crew heard an unusual sound from the tender and applied the brakes. The train was still slowing down as it reached the points into the loop when the tender pitched over to one side.
- 22 The train came to a stand with the tender on the points (figure 3).

Figure 3: The derailed tender following removal of the train's coaches

- 23 Nobody was injured in the accident. All wheels of the tender derailed causing the leading and centre axle to be bent, damage to 35 metres of plain track and irreparable damage to the points.
- 24 The railway between Highley and Bridgnorth was closed for five days and the loop at Hampton Loade was put out of use pending installation of a new set of points.

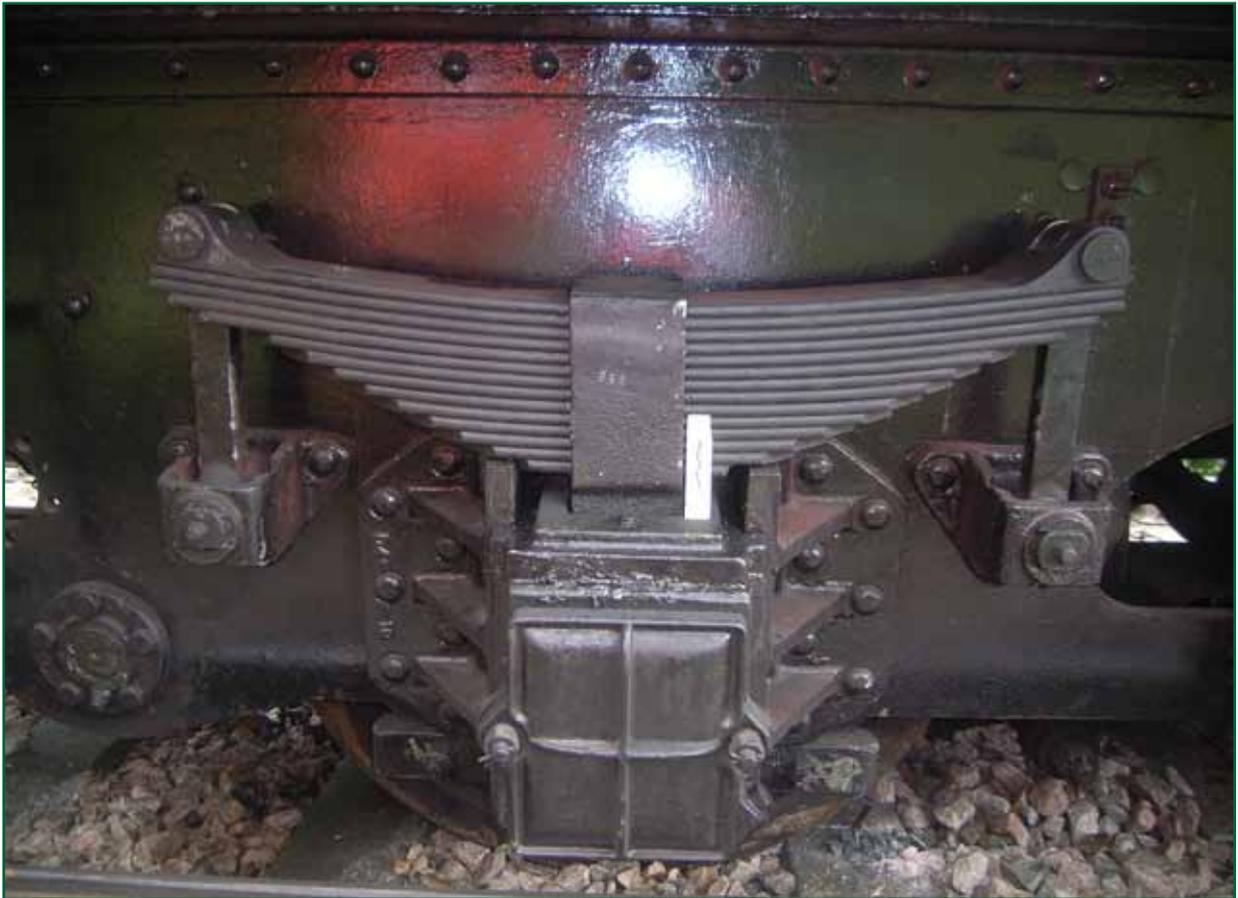
- 34 The new spring fitted to the leading left-hand wheel on 24 September 2009 was of a different design to the springs on the other five tender wheels (figure 4). Figure 5 shows the spring on the leading right side (the photographs in figures 4 and 5 were taken while the tender was derailed with all the weight of this axle on the right-hand side wheel). The new spring had 14 leaves, each ½" (12.7 mm) thick. The original spring had 15 leaves, each 7/16" (11.1 mm) thick. The other springs fitted to the tender also had leaves 7/16" (11.1 mm) thick except for the top leaf in each spring. The springs fitted to the centre axle of the tender both had top leaves ½" (12.7 mm) thick. On the rear axle the spring on the left side had a top leaf 5/8" (15.9 mm) thick and the spring on the right had a 7/16" (11.1 mm) thick top leaf.

Figure 4: New spring fitted to leading left side of tender

- 41 When the free height of the springs was measured, the new spring on the front left side had a greater free height than the others (257 mm compared to 217 mm – 229 mm for the original springs). This meant that it had to be compressed further to fit the tender. The RAIB calculated the theoretical weight on each wheel based on the measured spring stiffness and the initial free height plus packing thickness of each spring. The results of this calculation were in agreement with the wheel loads measured following the derailment (see figure 6) and showed that the effect of the increased preload of this spring led to that wheel carrying a disproportionately high load whilst the load on the other wheel on the axle was reduced to almost zero.

- 70 The SVR have replaced all of the springs on the locomotive tender with ones that have been tested and declared by the spring manufacturer to be suitable for use as a set. On completion of this work the wheel weight distribution was checked.

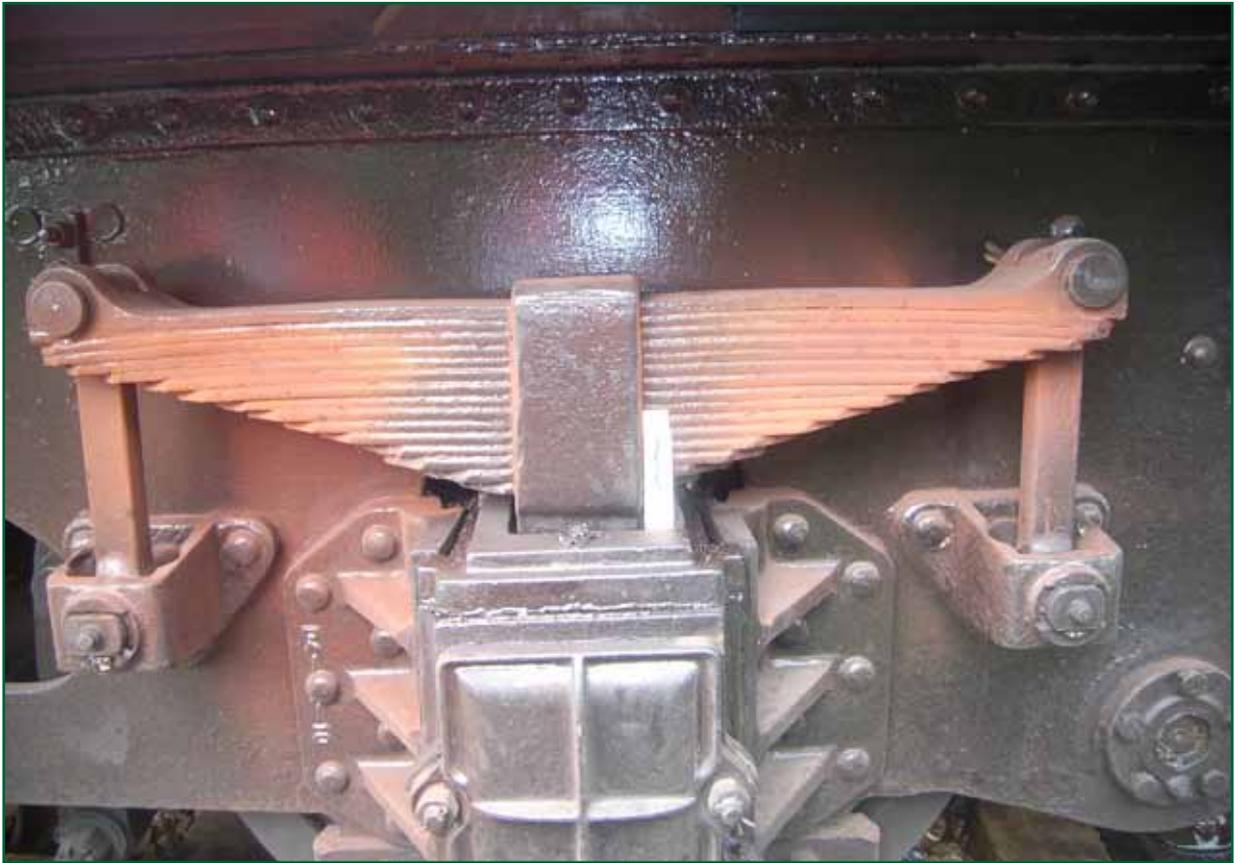
Figure 5: Existing spring fitted to leading right side of tender

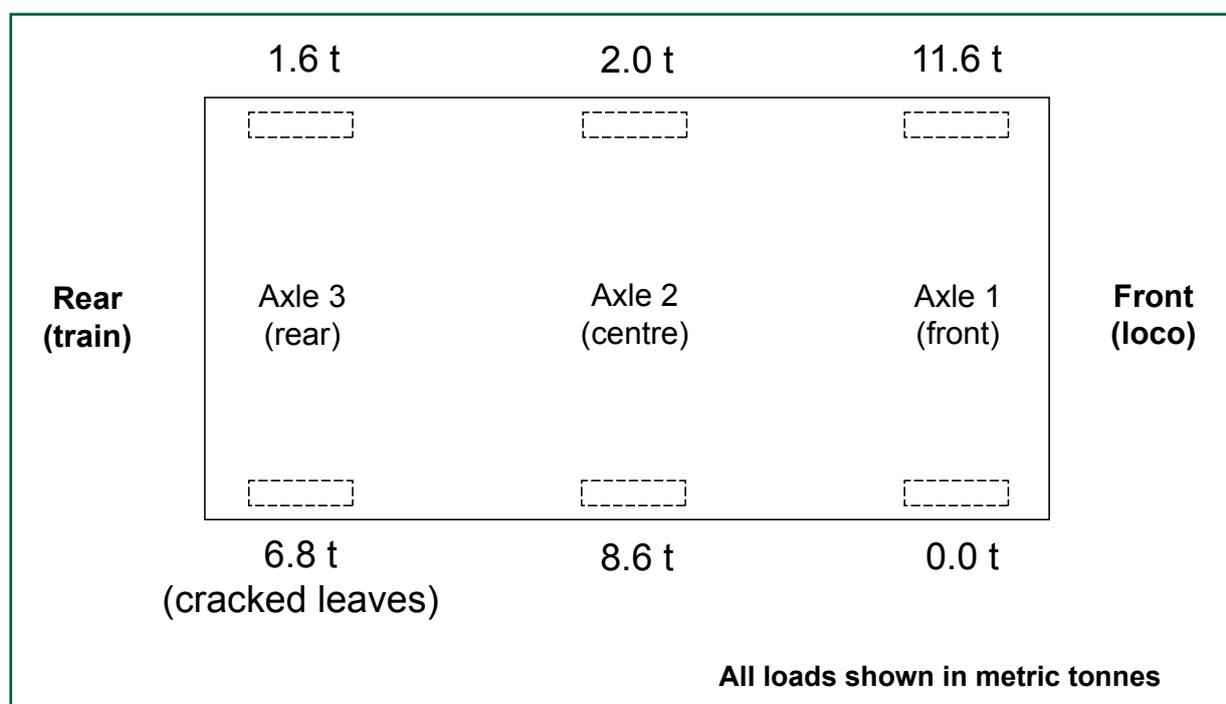
- 35 The RAIB measured the loads on each wheel of the tender after the locomotive had been recovered to the SVR maintenance shed at Bridgnorth. The results are given in figure 6. The high load on the leading left wheel would typically cause the wheel at the rear right side of the tender to also have a high load, in order to maintain the static equilibrium of the tender. However, in this case the centre wheel on the right side had a higher load than the rear wheel. When dismantled, the spring at the rear right side had three cracked leaves. This reduced its stiffness and would have led to a lower wheel load than would otherwise be the case.

- 36 The wheel loads shown in figure 6 were recorded after the tender had been rerailed and taken to Bridgnorth. It is likely that it suffered some damage to its suspension in the derailment, as evidenced by the bent front and centre axles, so the load on the leading right wheel was likely to have been reduced, but not zero, at the time of the derailment. If it had been zero before the incident it is likely that the tender would have derailed on any left-hand curve. The extent of the bend in the front axle was such that, when rotated, the wheel rim run out was approximately $\frac{1}{4}$ " (6 mm).

Figure 6: Plan showing wheel loads on tender following re-railing

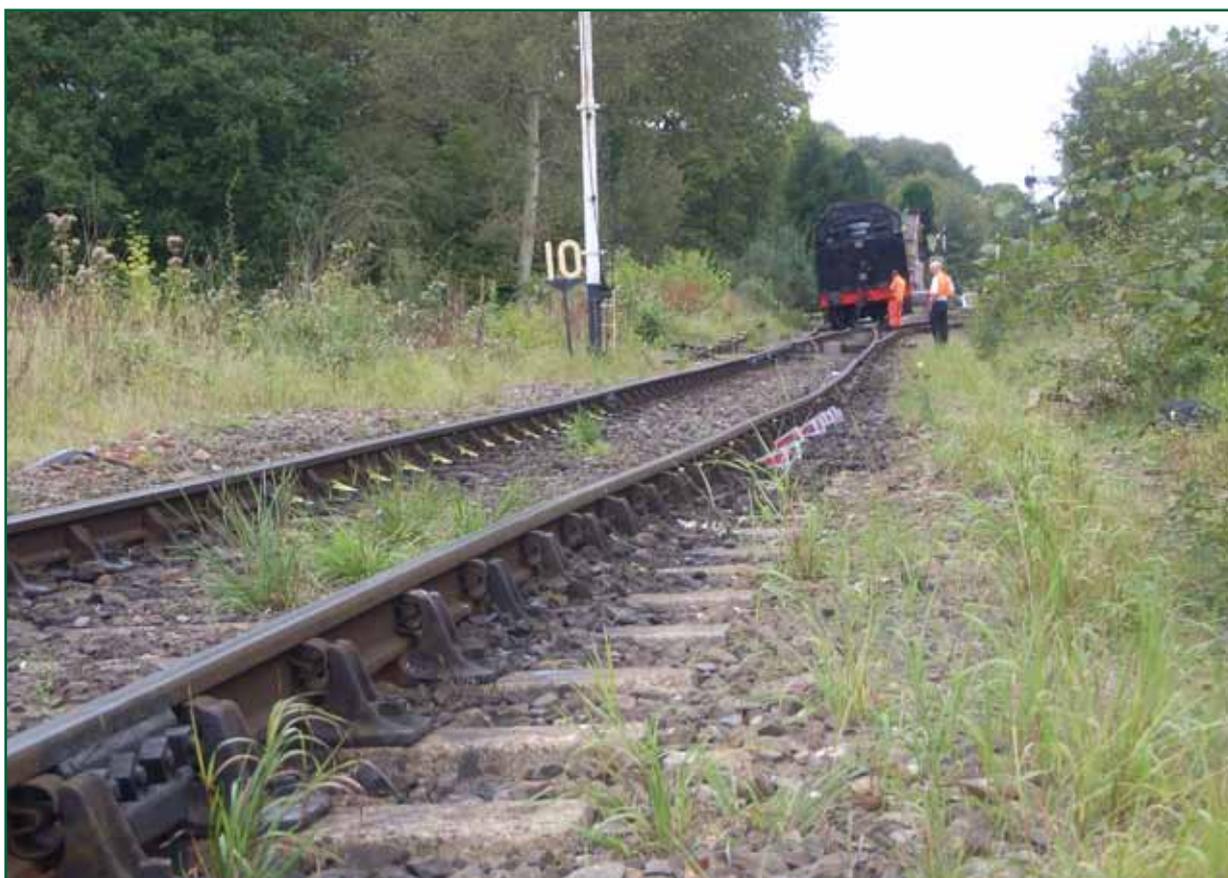
Figure 7: Site of the derailment

- 49 The section of track on which the tender derailed was surveyed by the RAIB after the derailment. The *cant* and *gauge* of the track was measured in the unloaded state and the extent of *voiding* beneath the sleepers was measured as the coaches were taken back over that section of track. Figure 7 shows a general view of the track at the site of the derailment.

- 50 The static track twist was found to be 1 in 94, measured over a 3 m base. The Network Rail limit for track twist over 3 m is 1 in 90. If a track twist of 1 in 94 had been found on Network Rail tracks it would have been considered a defect requiring attention within 36 hours.

- 69 The SVR relaid the track at the site of the derailment and have subsequently commissioned a geotechnical site investigation to determine the reason for the track movements there. The embankment has been reconstructed and new track and points installed.
