Rail Accident Investigation Branch

# Rail Accident Report

**Fatal accident at Norbreck, Blackpool  
5 August 2009**

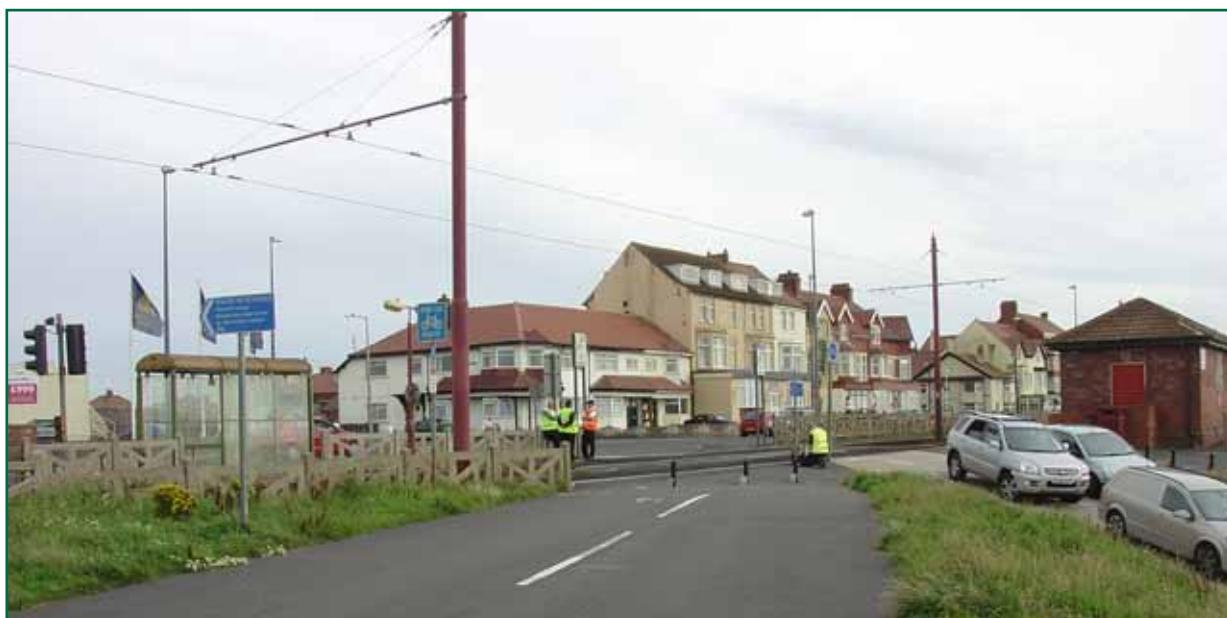
Figure 3: View of crossing approaching from northerly cycle/footpath

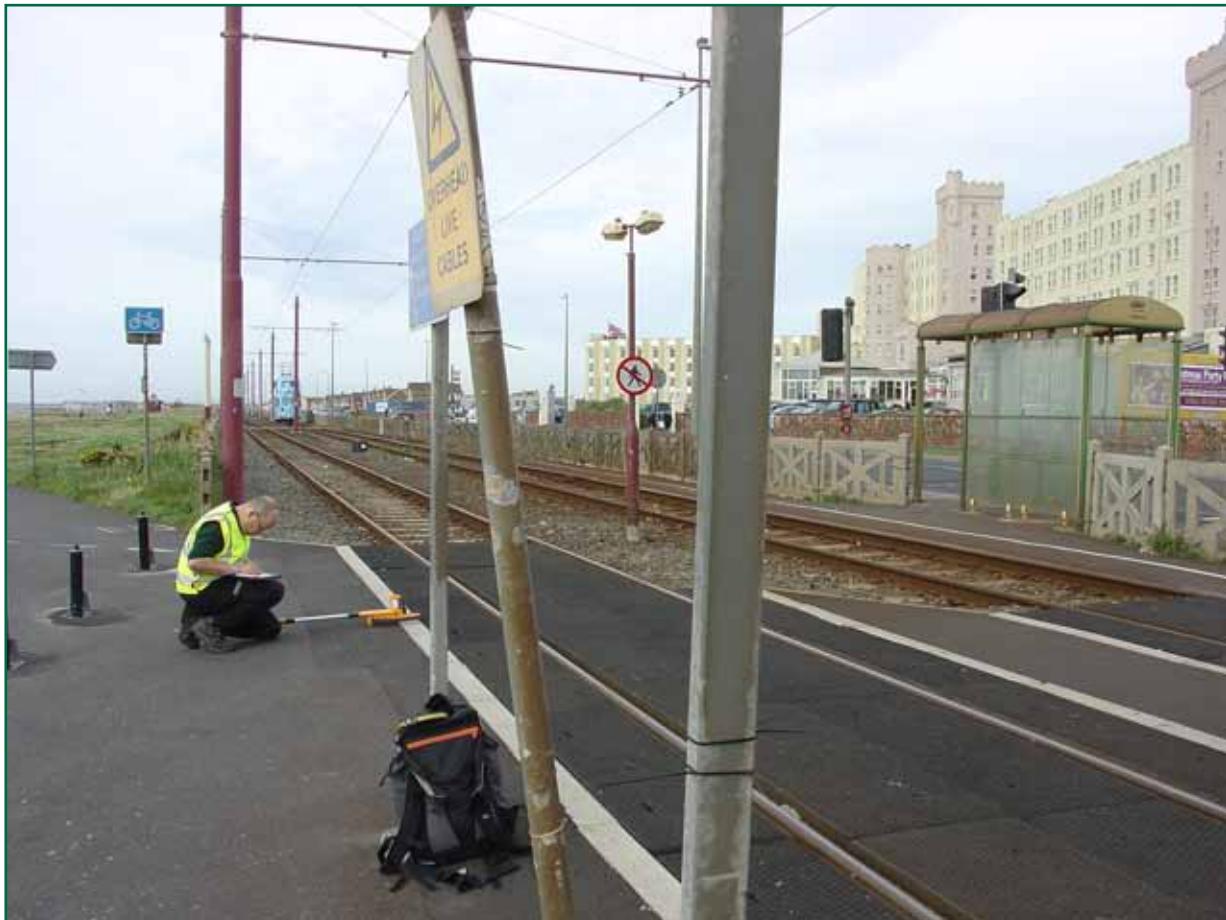
- 20 As the pedestrians approached the roadway crossing, whilst still clear of the tramlines, the husband looked and saw the tram approaching from the north and estimated it to be close to the foot crossing. Expecting it to stop at the tram-stop, he and his wife continued walking side-by-side and started to cross the tracks; he was on the left-hand side, nearest to the approaching tram (figure 4).

*Figure 4: Northward view from the west side of the roadway crossing – southbound tram-stop shelter and southbound tram 719 shown approaching just to the north of the foot crossing*

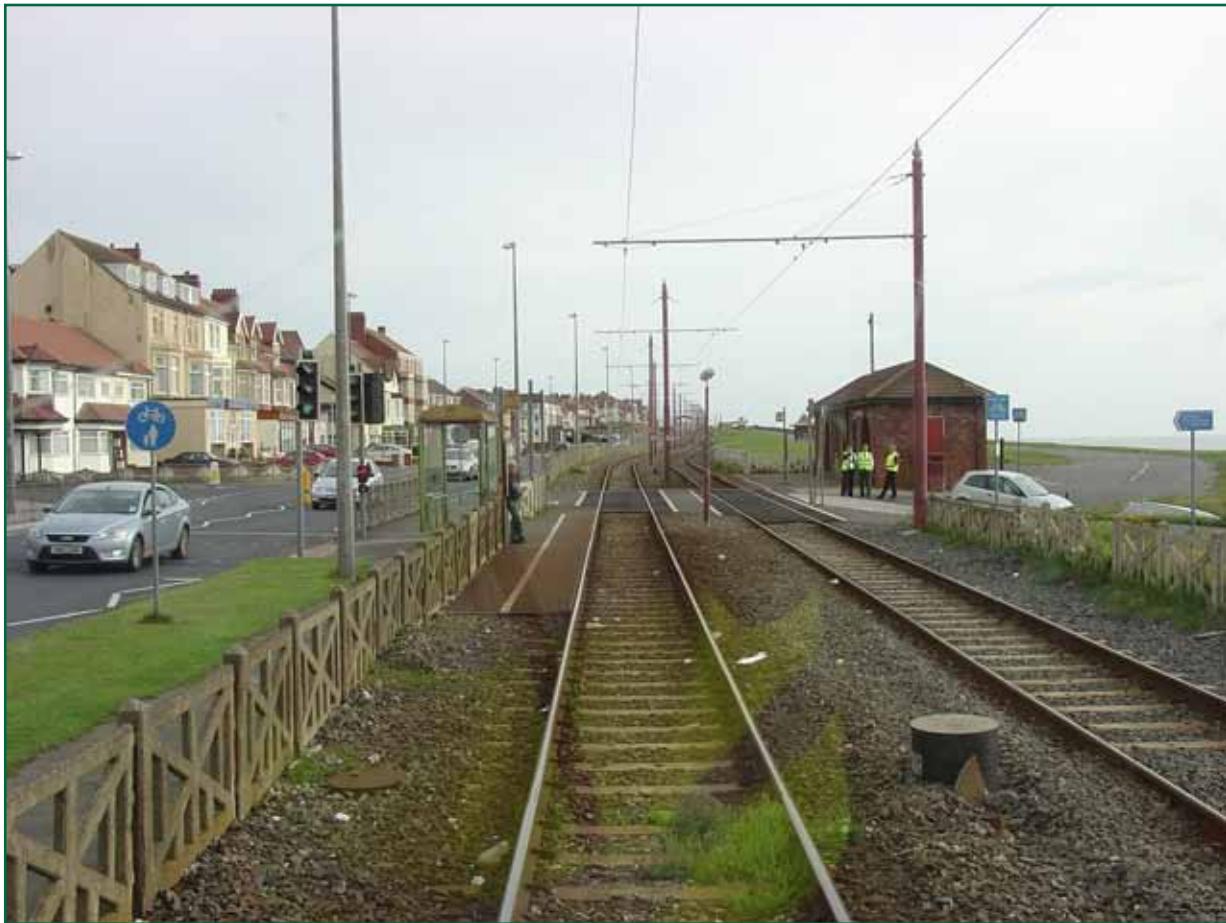
- 21 The tram approached the tram-stop having slowed from the line speed of 30 mph (48 km/h) to around 20 mph (32 km/h). The driver decided that as the people in the tram shelter did not put out their hands or move towards the tramlines, they did not want to catch the tram, and continued through the tram-stop without stopping (figure 5). These issues are discussed in more detail in the analysis section of the report.
- 22 On transferring his attention from the tram-stop to the roadway crossing ahead, the driver sighted the couple crossing the tramway from his right to left. He sounded the tram horn, and applied full air and electric brakes. The husband stopped clear of the southbound track but his wife stepped into the tram's path. She was struck by the front offside (right side) of the tram as she started to cross the southbound track.

Figure 5: Tram driver's eye view of the southbound approach to Norbreck tram-stop

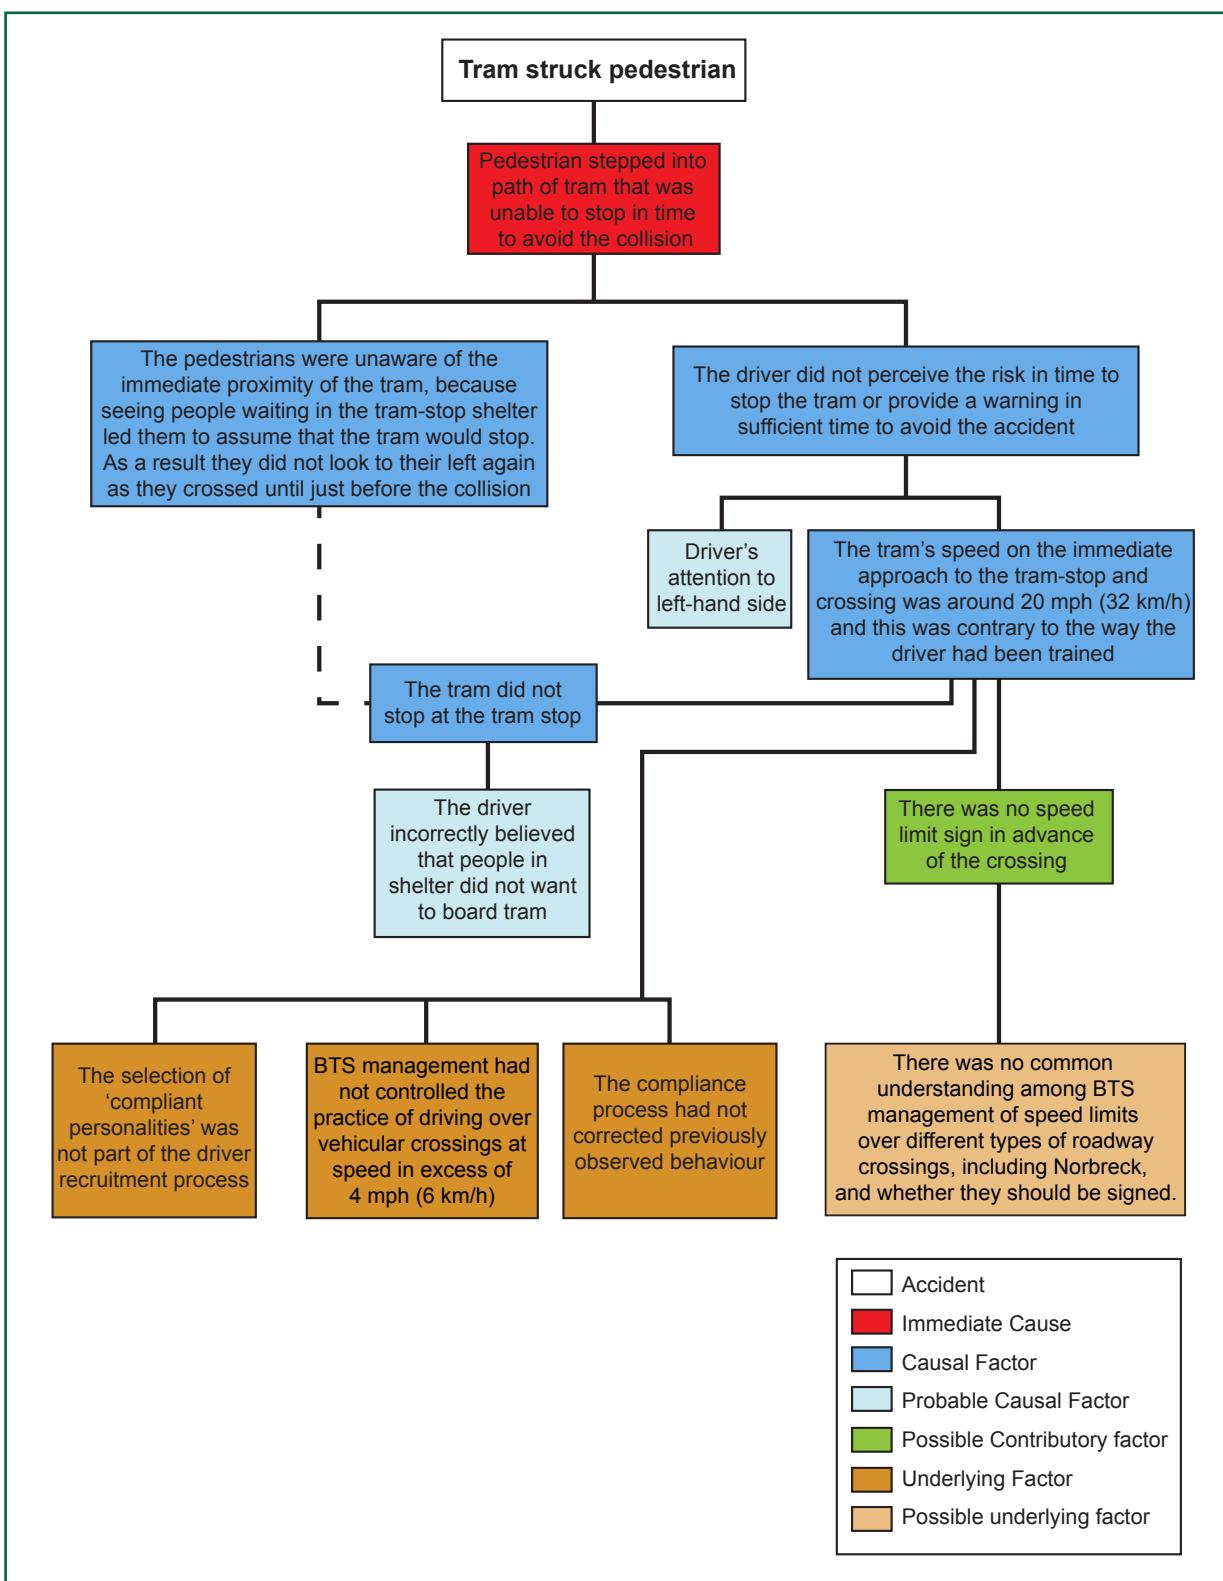
- 30 The RAIB identified four causal factors and two probable causal factors. The causal factors relate to:
  - the tram driver not perceiving the risk in sufficient time;
  - the speed of the tram and its relationship to the driver's training;
  - the tram not stopping at the tram-stop; and
  - the couple's assumptions about the tram's position.The probable causal factors relate to:
  - the tram driver's attention towards the tram-stop;
  - the tram driver's assumptions about the people in the tram shelter; and
  - the feasibility that the tram driver's inexperience played a part.
- 31 Figure 6 shows how these factors fit together. The following paragraphs then explore each of them.

Figure 6: Diagram of causal factors

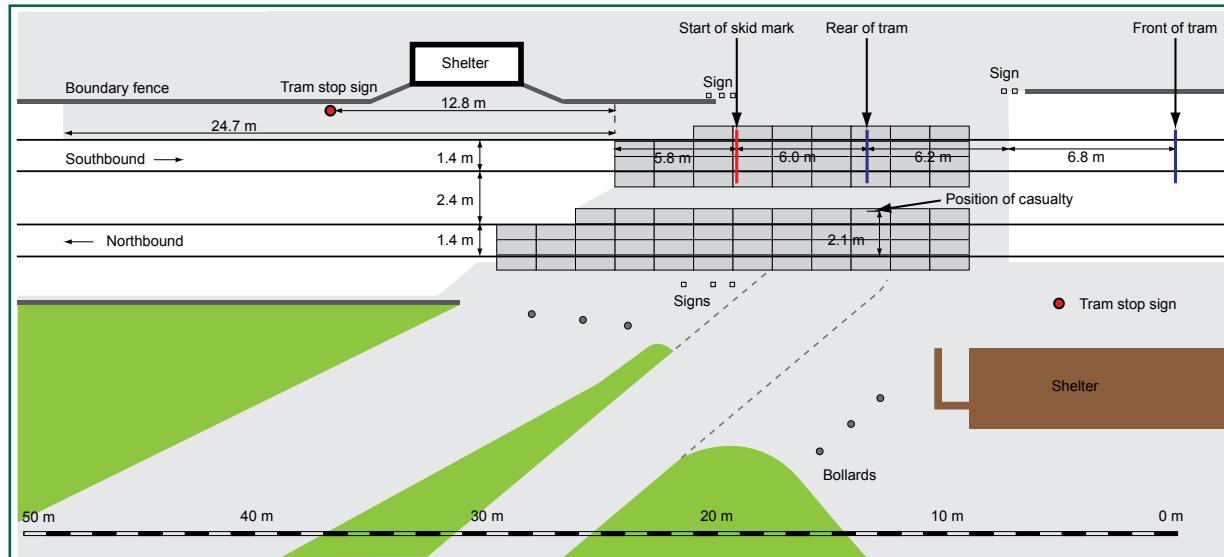
Figure 7: Layout of Norbreck tram-stop and crossing

- 42 At this range of speeds, the range of distances from the front of the tram when it started braking and sounding the horn to the front of the tram after it had stopped was between around 26 and 40 metres. This corresponds to a likely time from the horn being first sounded to collision of between 1.5 and 2.7 seconds. If a 1 second driver reaction time is allowed for<sup>5</sup>, the driver saw the pedestrians and perceived the need to brake when the front of the tram was between 35 and 50 metres before the point where it stopped. Figure 7 can be used to identify where those positions would be.
