Rail Accident Investigation Branch

Rail Accident Report

Derailment of a passenger train near Cummersdale, Cumbria 1 June 2009

Report 06/2010
March 2010

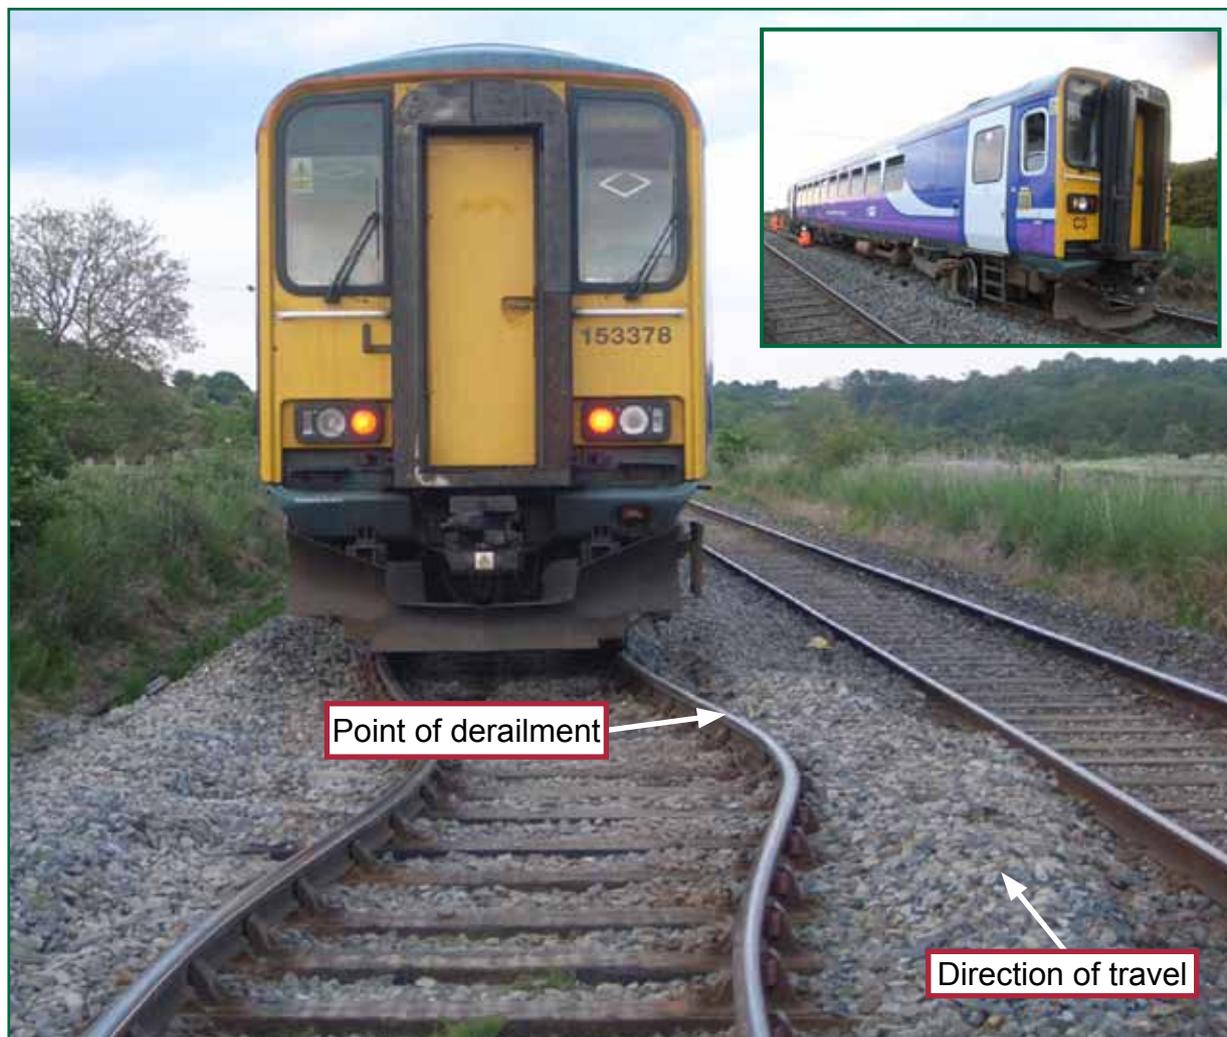
- 6 There were no injuries among the 15 passengers and two crew on board. Damage to the single car train was principally around the leading bogie and surrounding vehicle body. Damage to the track arising directly from the track buckle and derailment was confined to a length of about 30 metres around the point of derailment. However, more extensive repairs to stabilise the track over a distance of approximately 1.6 km were carried out. Figure 2 shows the track buckle and derailed train.

Figure 2: The derailed train showing the track buckle and the rear of the train 2C31 and (inset) the front of the train and derailed leading bogie

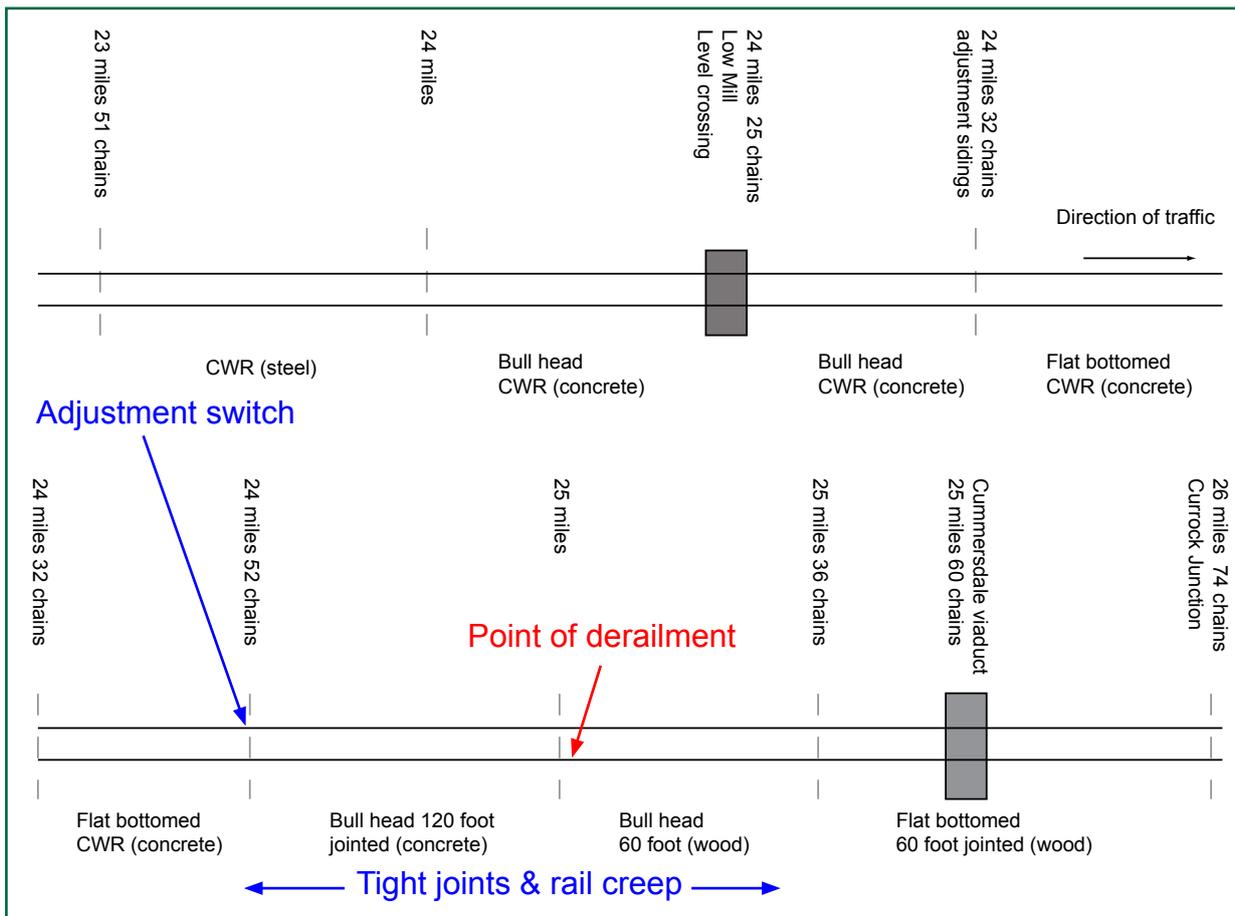
Figure 3: Track schematic showing variation in construction in relation to point of derailment

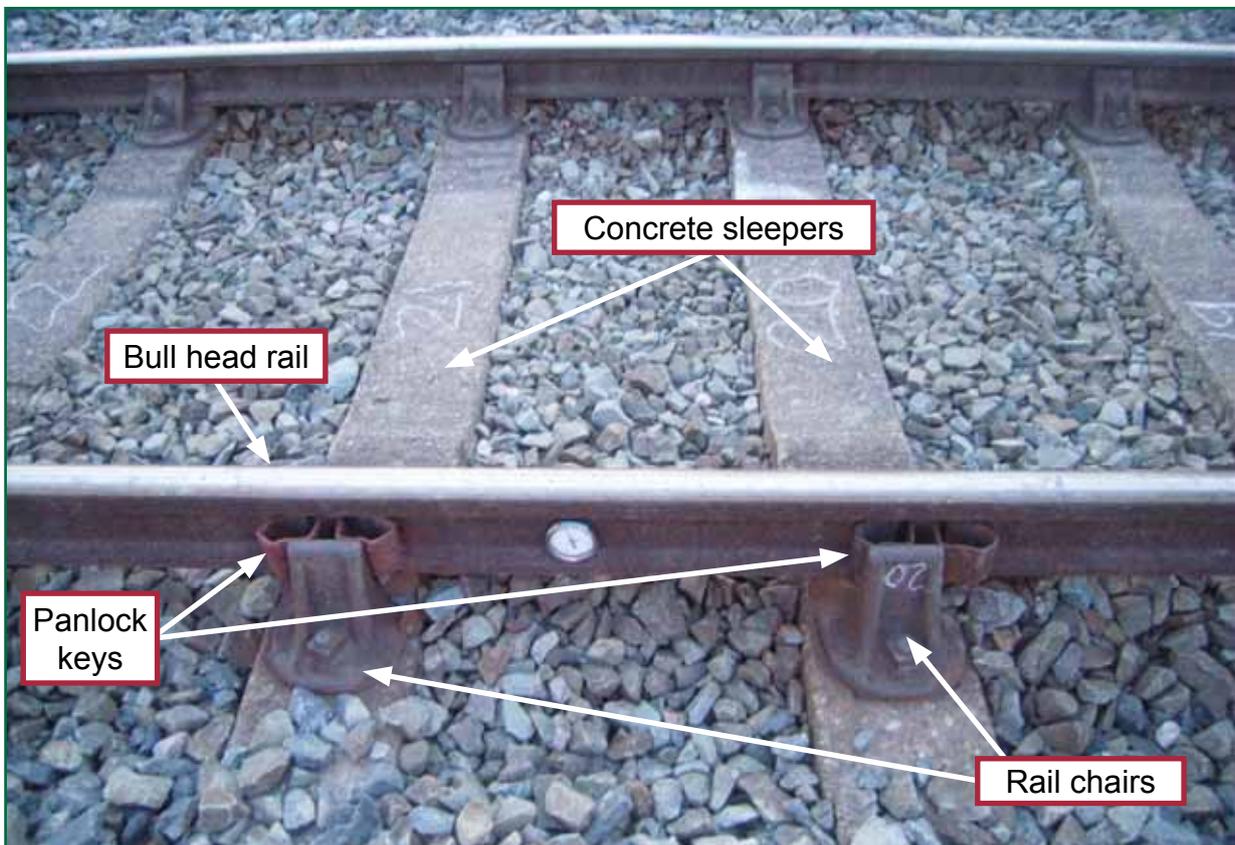
Figure 4: Construction of the down line on approach to the point of derailment

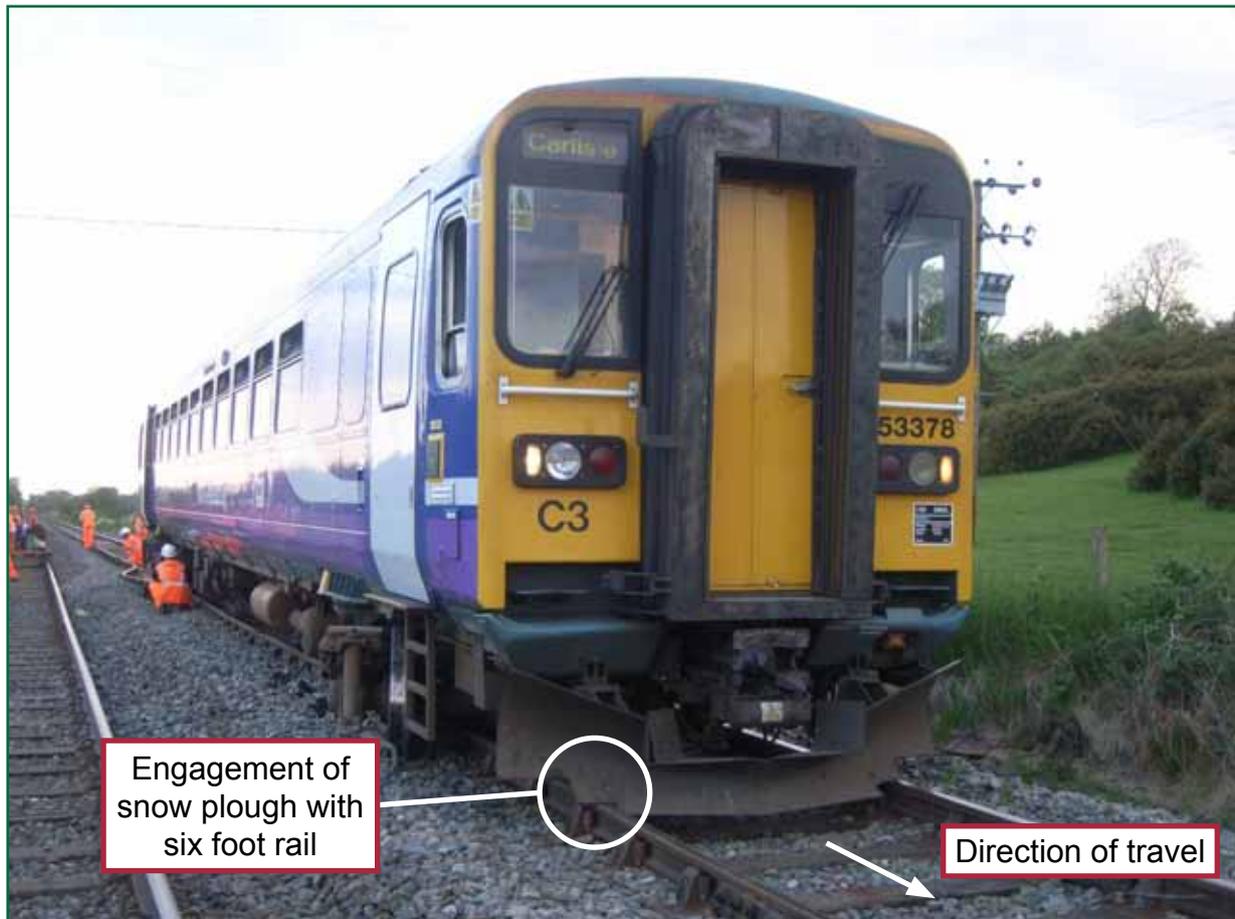
Figure 5: Leading end of unit 153378, showing positions of right-hand wheels and engagement of snow plough with right-hand rail

- The derailed vehicle stayed close to the down line partly because a recess in the lower right-hand edge of the snow plough engaged with the six-foot rail and provided guidance for the leading end of the vehicle. The RAIB has previously made recommendations on examining the practicability of design elements on the bogie which limit the degree of deviation from the track, following other derailments⁹,¹⁰. The RSSB, to which those recommendations were addressed, reported that its conclusion from an initial technical study was that the current risk is as low as reasonably practicable and therefore no changes to vehicle design standards could be recommended; however consideration should be given to providing infrastructure based protection at sensitive locations.

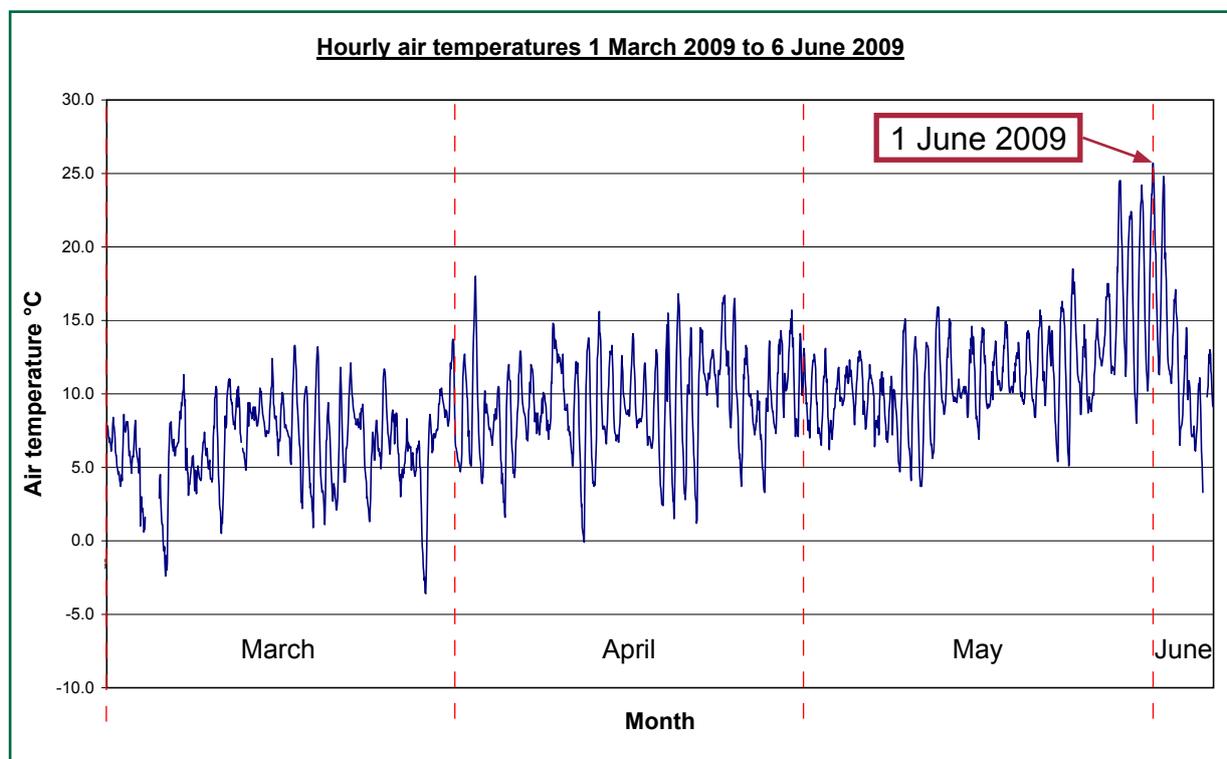
- 41 Air temperature data for the southern Carlisle area shows that during the first half of 2009, the maximum was reached on 1 June 2009, peaking at 25.5°C. This temperature is not abnormal. The variation of temperature between 1 March and 6 June 2009 is shown in figure 6.

Figure 6: Air temperatures for South Carlisle area 1 March - 6 June 2009

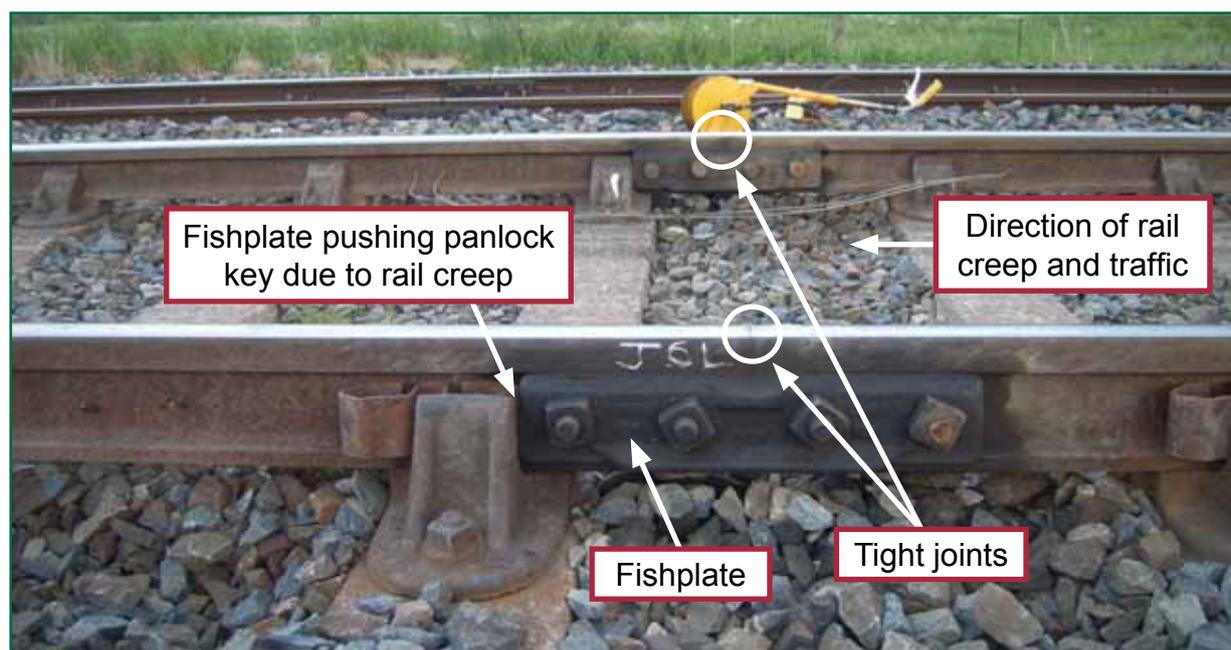
- 50 The control of rail creep at the derailment site had not been effective, resulting in accelerated closure of the installed expansion gaps and this was a causal factor.
- 51 There was clear evidence of extensive rail creep at several joints on the approach to the point of derailment. Figure 7 shows the degree of rail creep at one of these joints on the down line. The rail joint, which should be in the middle of the space between the sleepers, had moved longitudinally in the direction of traffic such that it was bearing on and pushing out the Panlock key. The effect of rail creep could be seen on most of the joints on the approach to the point of derailment, although some of the movement seen after the derailment could have resulted from the formation of the track buckle itself.

Figure 7: Tight joints and rail creep at the Cummersdale site

- 54 Tight joints observed in the vicinity of the derailment site were not reported because patrollers and maintainers were not aware of the sensitivity of this site to joint closure and buckling. Had they been reported, timely remedial action might have been taken and this was a probable causal factor.

- 107 Network Rail repaired the track at the derailment site, carried out rail adjustment, installed additional rail anchors and removed Panlock keys to minimise the risk of further track buckles. It also made organisational changes and carried out briefings to front line staff on relevant track standards.
