RAIB Bulletin 07/2009

Freight train derailed in May 2009

The events described above took place at Sudforth Lane, North Yorkshire on 1 May 2009.

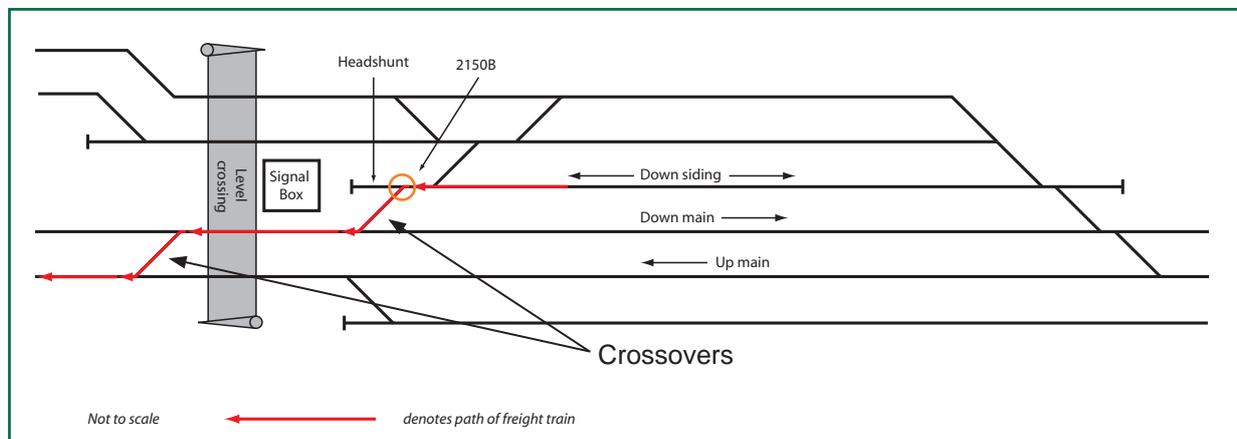
- 1 In May 2009, two wagons of a freight train derailed at a set of points in a siding which formed the entrance to a crossover leading to a main line. The train ran on beyond the point of derailment such that the Down main line at that location was blocked by the two derailed wagons and the adjacent Up main line was blocked by the leading portion of the train which was not derailed.
- 2 The train involved comprised a locomotive and 19 empty coal hopper wagons. It was making a signalled shunting move from the Down siding over a crossover onto the Down main line and then over another crossover onto the Up main line (Figure 1). It was travelling at a speed of around 10 mph (16 km/h) at the time. The permitted line speed over the crossover was 15 mph (24 km/h).

Figure 1: Layout of track and path of the freight train

- 3 After approximately half the train had passed over 2150B facing points, the 11th and 12th wagons became derailed. The 11th wagon was derailed by both bogies and the 12th wagon was derailed by its leading bogie. During the derailment the coupling between the derailed wagons parted and the brakes were applied automatically at the same time as the driver applied the train brake, having been made aware of the derailment by the shunter.
- 4 The derailed vehicles suffered damage to the wheels and to the coupling, drawhooks and buffers at the interface between the 11th and 12th wagons. There was damage to the track on the crossover and the straight route beyond 2150B points into the head shunt. No one was injured in the incident.

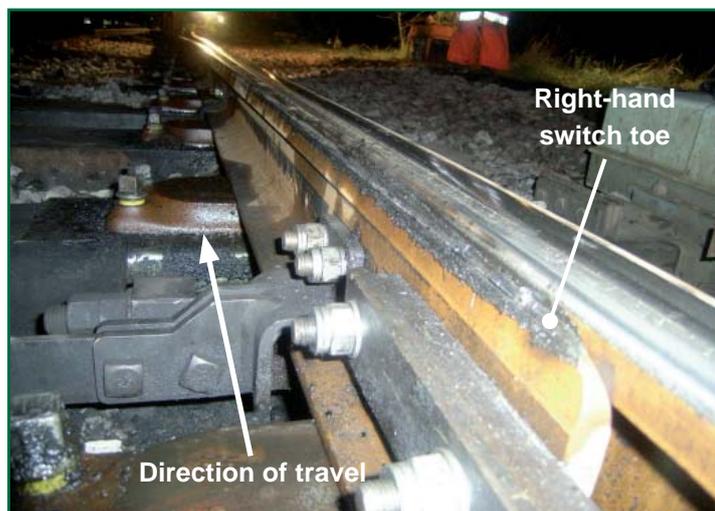
- The initial point of derailment was traced to the switch toes of 2150B points (Figure 2). The switch blades were set in the correct position for the train's intended movement but derailment marks at this location indicated that a wheelset had flange climbed onto the top of the right-hand switch rail and had run for approximately 7m before falling onto the ballast and sleepers of the straight route into the head shunt (Figure 3). This was the initiating event.

Figure 2: Right-hand switch of 2150B points

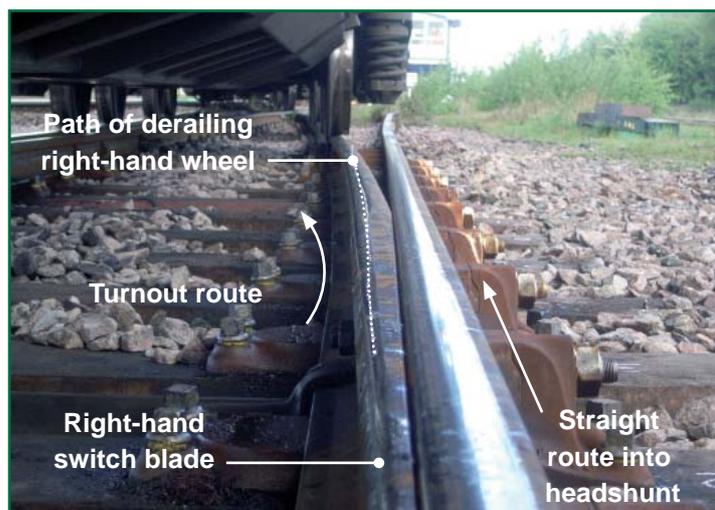
Figure 3: Path of right-hand wheel of first wheelset to derail

- Vehicle examinations on site suggested that the first wheelset to derail was the leading wheelset of the trailing bogie on the 11th wagon (bogie 11T). Derailment of this wheelset was followed by derailment of the trailing wheelset of this bogie approximately 19m later, resulting in bogie 11T running completely derailed along the head shunt. Meanwhile the leading bogie of the 12th wagon (bogie 12L) had traversed 2150B points correctly and was taking the turnout route (Figure 3). As bogies, 11T and 12L, moved along diverging routes, the lateral forces generated caused bogie 12L to be pulled into derailment and bogie 11T to be pulled back off the head shunt route. Subsequently the leading bogie of the 11th wagon (bogie 11L) also derailed, probably as a result of the yaw angle developed by 11th wagon. The 11th and 12th wagons came to rest approximately 96m and 68m respectively from the toes of 2150B points along the turnout route.

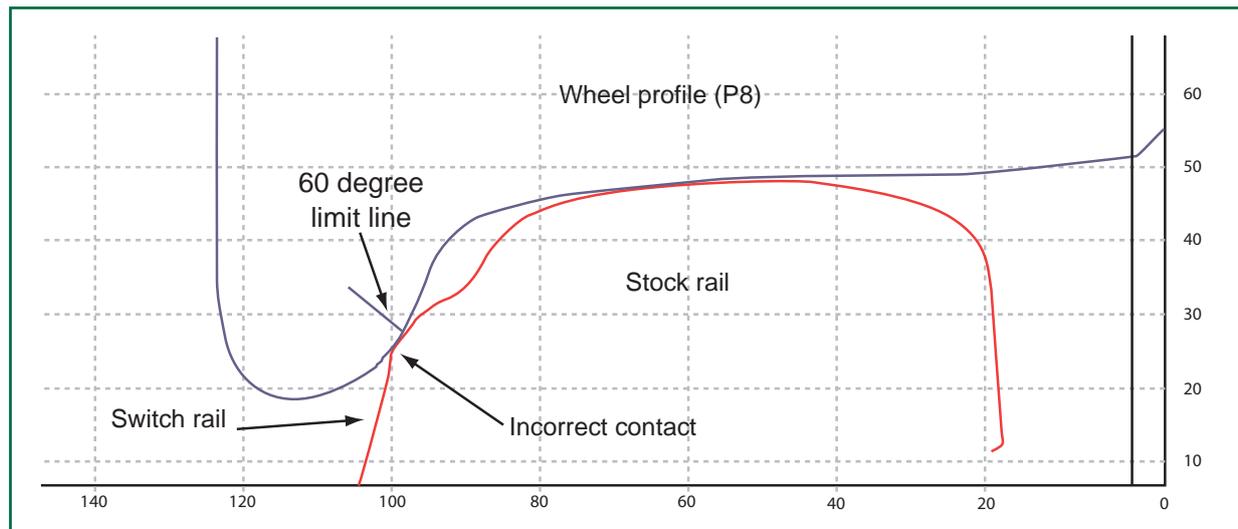
- 7 Inspection of the right-hand switch of 2150B points against the requirements of Network Rail standard NR/L2/TRK/053 “Inspection and repair to reduce the risk of derailment at switches”, revealed that contact between a P8 wheel profile gauge and the switch rail on the right-hand side occurred below the 60 degree limit line (Figure 4) for a distance of more than 200 mm along the switch blade. The switch blade therefore failed the requirement that contact must not occur below the 60 degree line. Both switch rails of 2150B points were new, having been replaced on 25 April 2009. Following the incident, hand grinding was undertaken to steepen the angle of the right hand switch blade to comply with the above standard, thereby reducing the risk of derailment by flange climb.

Figure 4: Measured profiles of the right-hand switch and stock rail against a P8 wheel profile, showing incorrect contact below the permitted (60 degree limit) line

- robustness of manufacturing quality assurance checks undertaken on the replacement switches at 2150B points to ensure that the switch blade geometry was correct prior to installation; and

- applicability to new switches of previous RAIB recommendations, following the derailments at Waterloo (11 September and 24 October 2006) and Glasgow Exhibition Centre (3 September 2007), regarding checks to NR standard NR/L2/TRK/053, in particular whether new switches should be checked to relevant parts of this standard after installation, before being opened for traffic.
