Rail Accident Investigation Branch

Rail Accident Report

Near-miss at Hanger Lane junction 27 March 2009

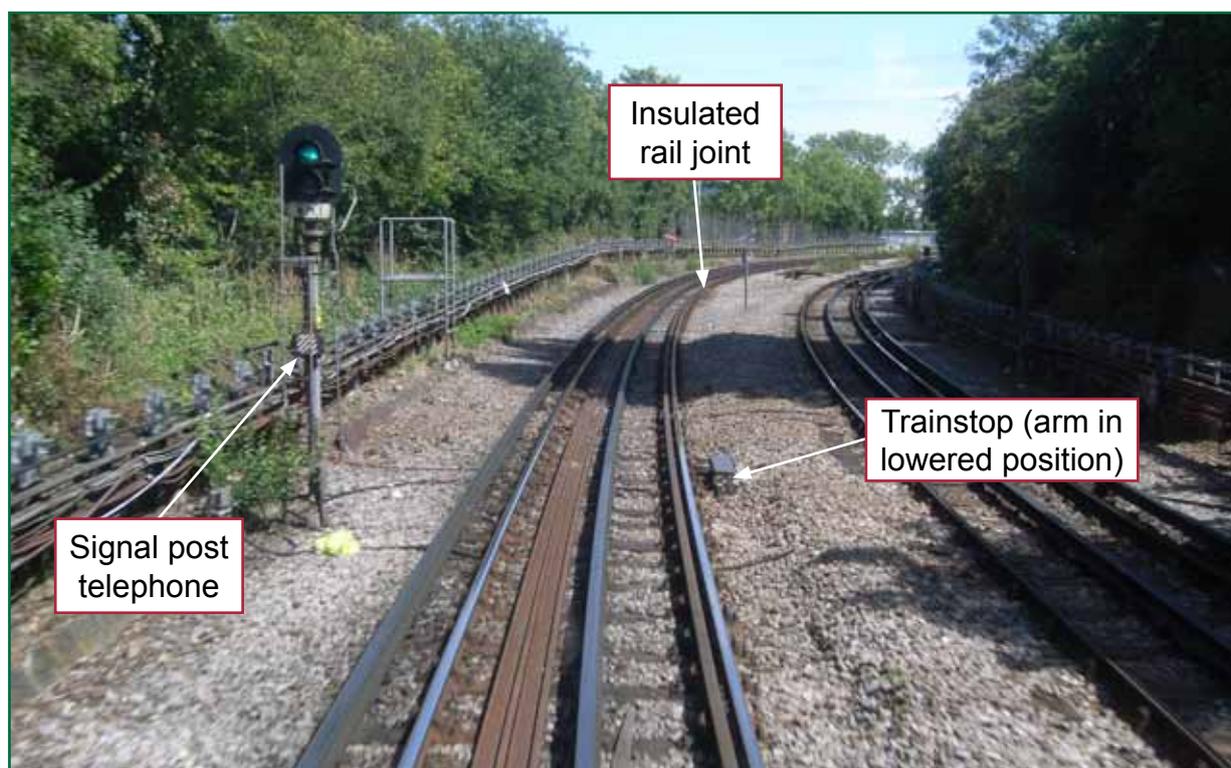
Figure 6: Signal WM1, with Hanger Lane junction in the distance

27 The *insulated rail joint* for signal WM1 is located 43.6 metres in advance of (ie beyond) it, as shown in figure 6. This separation is much greater than that found at more modern installations for historical reasons. If a train passed signal WM1 at danger, it would have to travel at least 43.6 metres in order to occupy the next track circuit before the infringement was detected by the signalling system and displayed to the signaller. It could then continue for a further 76 metres before reaching the junction (figure 7). If a train passed signal WM1 at danger but stopped within 43.6 metres, the overrun would not show on the track diagrams in the control room or affect other signals at the junction.

- 119 The relatively long distance (43.6 metres) between the signal and the insulated rail joint also meant that the signalling system did not detect that train 103 had passed signal WM1 at danger. In a modern signalling layout, where the insulated rail joint would be much closer to the signal, the wheels of train 103 may have crossed onto the next track circuit. This would have caused signal WM20/21 to remain at red, and in doing so, would have stopped train 316 on its approach to the junction.

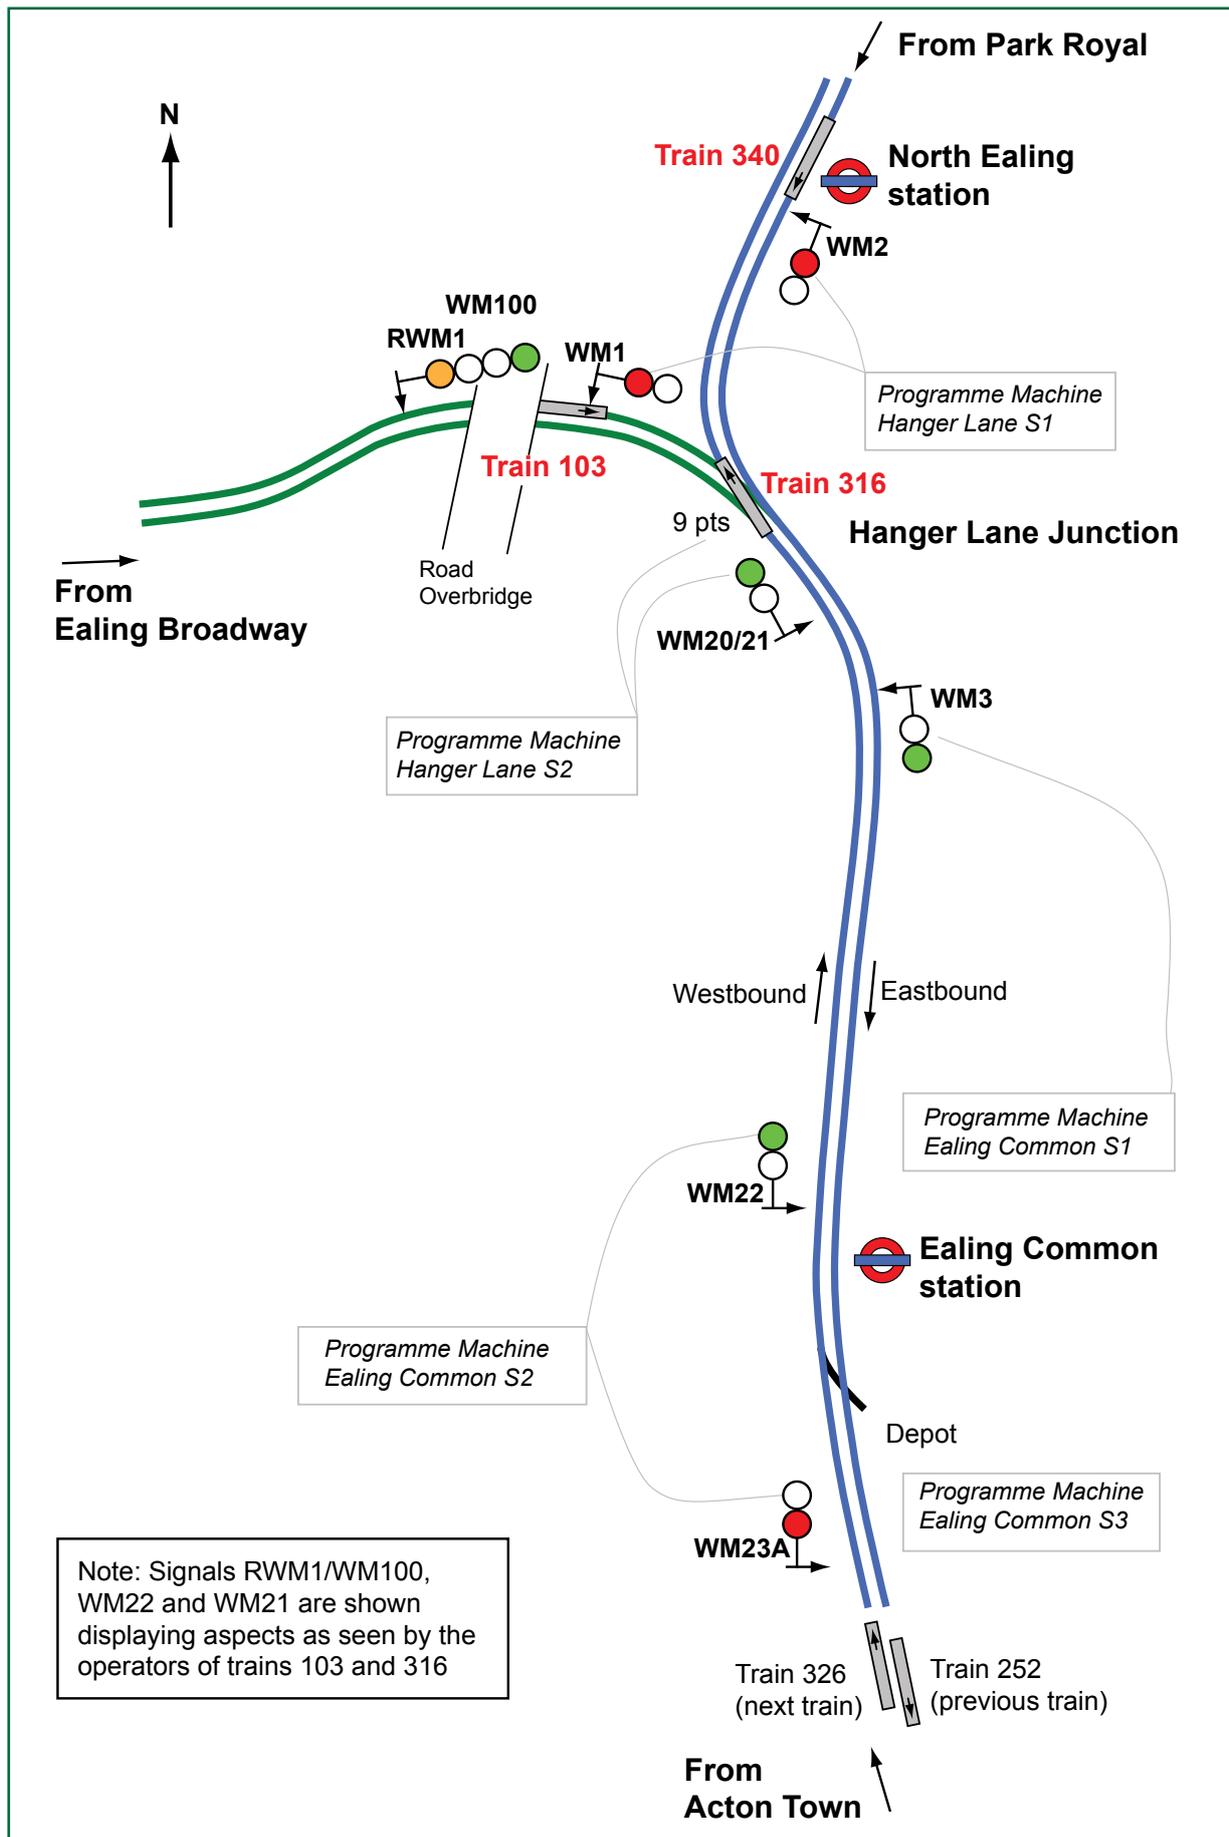
Figure 8: Schematic map showing layout of junction and location of trains at 17:28:34 hrs (during incident)

- 17 Before the train operator had moved his train, he observed a westbound Piccadilly Line service (train 316) passing over Hanger Lane junction ahead of him on a conflicting path. Although the trains were separated by a distance of at least 115 metres, there was the potential for a collision to occur as one train was proceeding on clear signals and the other had authority from the signaller to proceed.

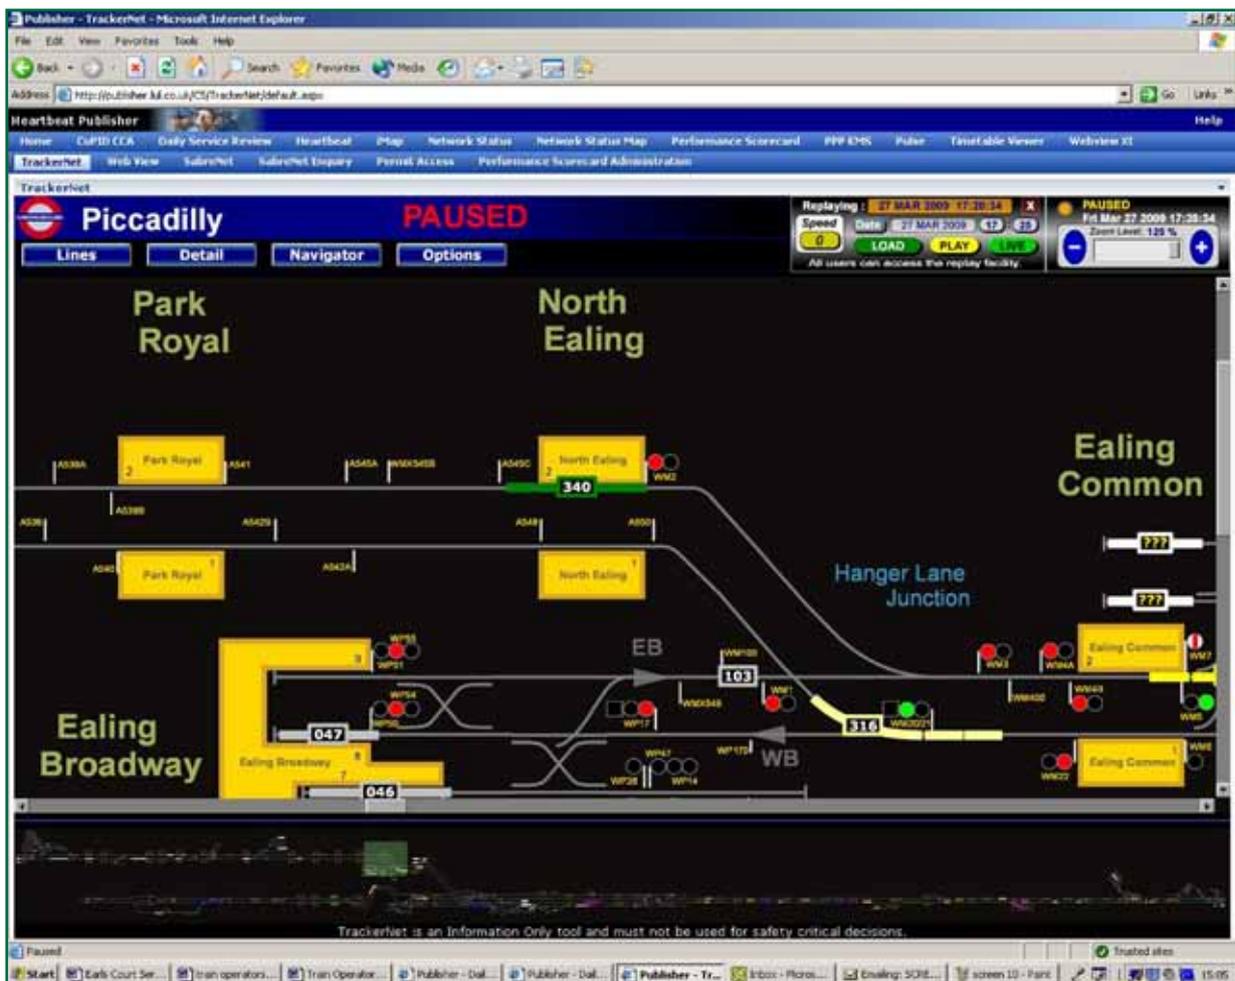
Figure 11: Trackernet screen image at 17:28:34 hrs showing train 316 crossing junction ahead of train 103

- 52 At this time, the operator of train 103 was preparing to move his train forwards. As he looked ahead, he observed the rear section of a Piccadilly Line train crossing ahead of him which Tracknet records confirm as train 316. Believing that he had authority to cross the junction, he immediately initiated a radio call to the controller.
