# RAIB Bulletin 02/2009

## Tamping machine derailed in September 2008

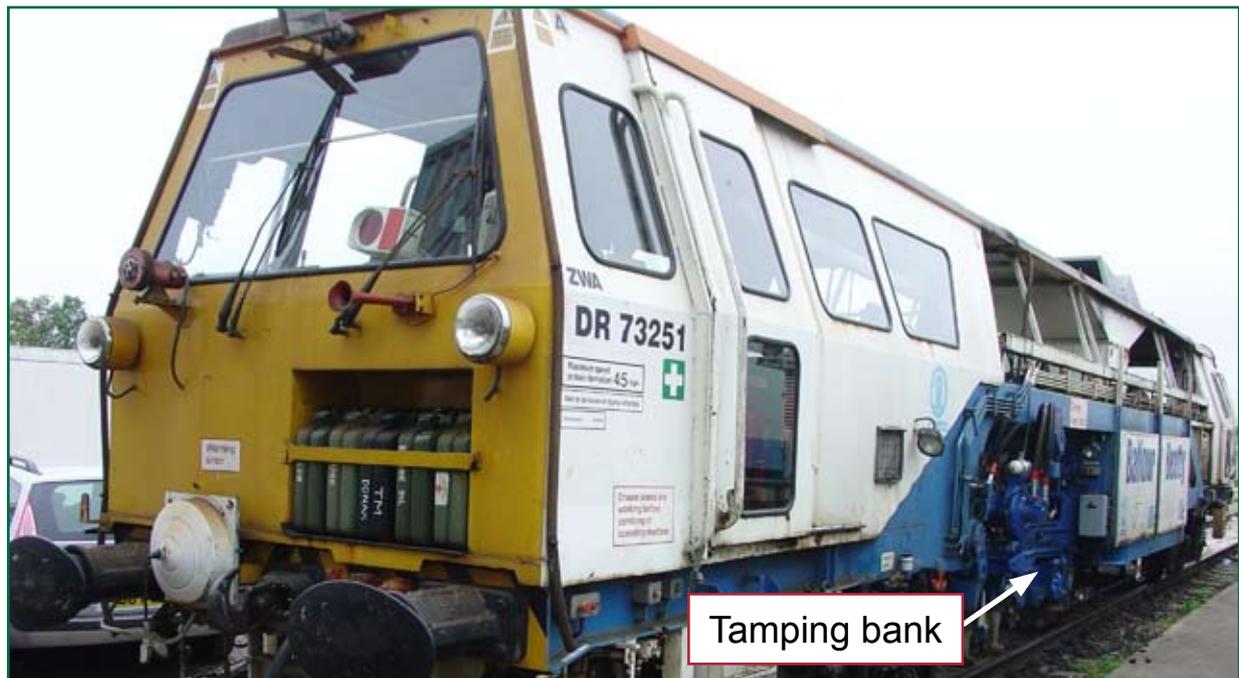
1. In September 2008 a Plasser 07 tamping machine (Figure 1) was proceeding from a stabling point to a worksite when it became derailed as it passed over a set of *trailing points* on the running line. Neither of the two operators travelling on the machine was injured, and no other train was in the vicinity, so there was no immediate risk to any other train.

4. The cause of the derailment was the uncontrolled lowering of one tamping bank; as a result the *tamping tines* had become lodged under the head of the *stock rail* in the points, forcing the tamper laterally, and derailing it.

Figure 1: Plasser 07 series tamping machine showing position of the tamping banks

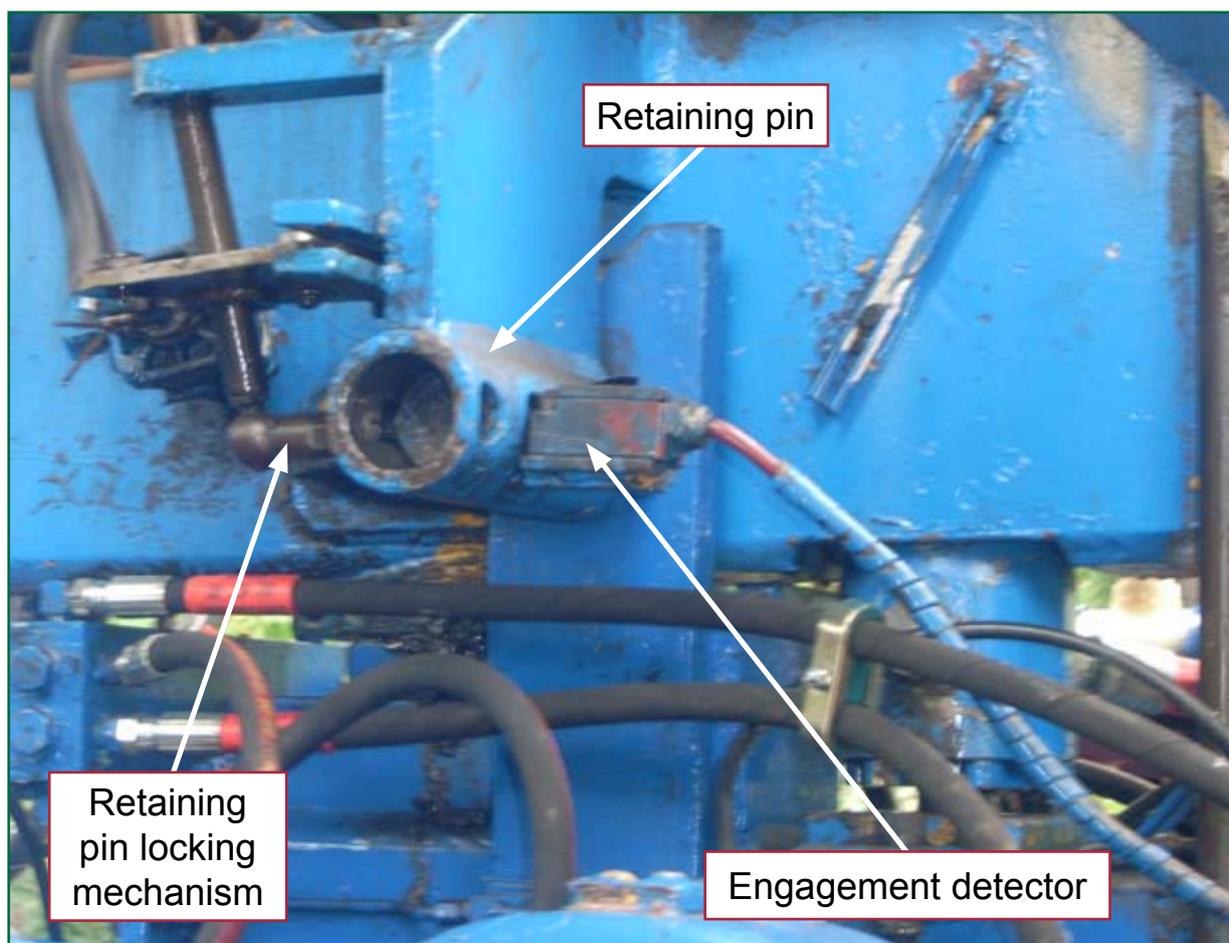
5. Apart from damage arising from the derailment, the tamping machine was found to be in good order.
6. The RAIB concluded that the left hand tamping bank retaining pin had not been fully engaged before the transit move from the stabling point. This resulted in the securing pin vibrating loose and the subsequent dropping of the bank.

7. Investigation showed that it was possible to locate the tamper bank retaining pins in such a way that, although they appeared to be fully engaged, they were not inserted far enough into the locating hole in the machine's frame to be locked in place. Observation of this condition, as part of the required preparation for moving the tamper from the depot to the worksite which took place at approximately 22:30 hrs, was made more difficult by the limited illumination of the pins and locking mechanism during hours of darkness.

8. Under these circumstances, when the tamping machine was stationary, the weight of the tamping bank kept each pin in position. As the tamping machine moved on its journey, and particularly through turnouts, the resulting vibration intermittently relieved the weight of the banks and the unlocked pin was able to move laterally until it released the tamper bank, allowing it to lower.

Figure 2: Tamper bank securing pin and locking mechanism

- The companies that own and operate Plasser 07 tampers should be aware of the difficulty of observing that the tamping banks are secure under low lighting conditions, and should train their maintaining and operating staff in the correct observation of the retaining pins.

- Those companies which anticipate retaining the Plasser 07 tamper in longer term use should consider the possibility of modifying the tampers to ensure that the main drive cannot be engaged unless the tamper banks are proved to be secured.
12. The RAIB has written to the company that owns and operates the tamping machine involved in the derailment, informing it of the RAIB's conclusions and decisions.
  13. The findings of this bulletin are drawn to the attention of other owners and operators of Plasser 07 series tamping machines so that they can consider and take action to implement the learning points accordingly.

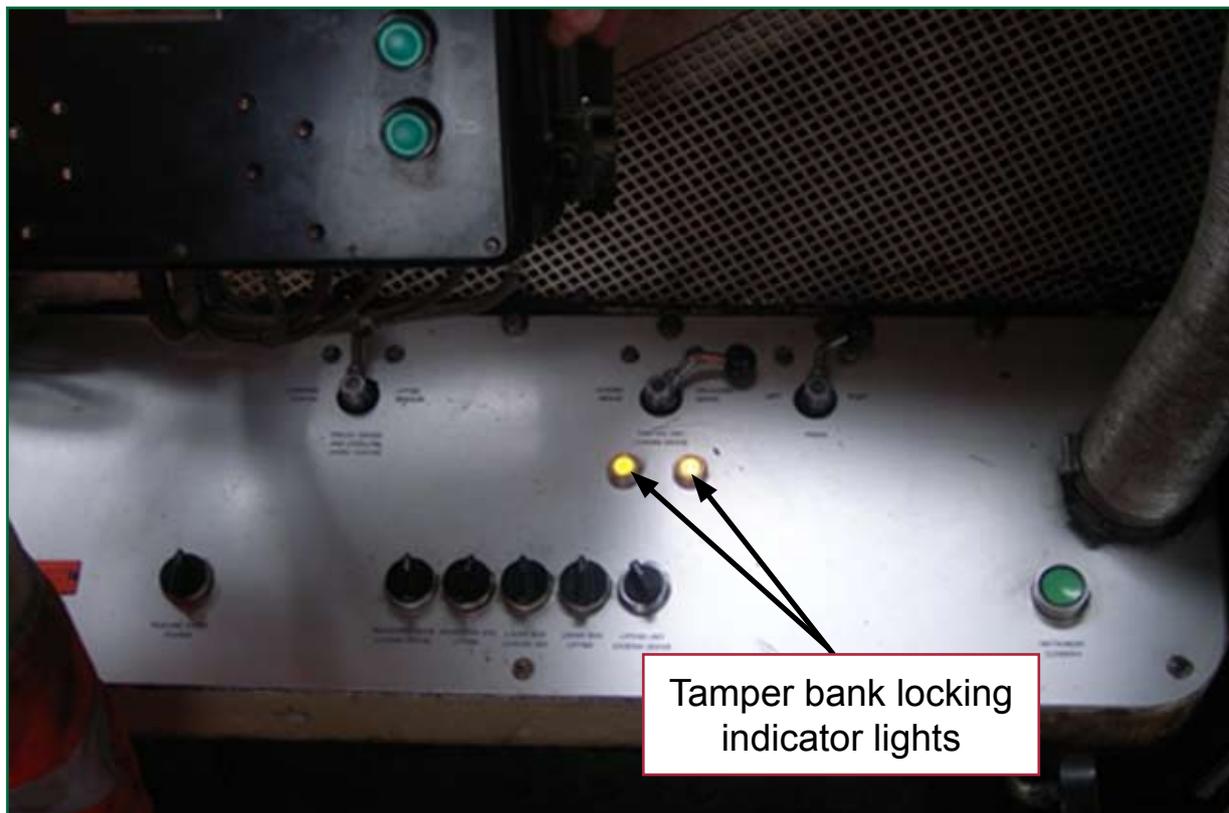
9. A light, activated by the locking mechanism, is fitted to the operating console, though not at either driving position, to indicate to the operator whether or not the tamping banks are securely retained for transit. The interpretation of the indication varies between machines (on some machines the lamp being illuminated indicates secure retention, whilst on others the lamp being extinguished indicates the same thing). This has led to a sense of uncertainty in the minds of the tamper operators. On the machine concerned, the lights were extinguished to indicate that the banks were securely retained.

Figure 3: Tamper bank locking indicator lights

11. These are:
- The indications given by the machine's systems to the operating personnel should be consistent and unambiguous, and also should be 'fail safe'. This would mean that illuminated lamps would indicate that the tamper banks are securely retained.
