Rail Accident Investigation Branch

Rail Accident Report

**Collision with debris from bridge GE19 near
London Liverpool Street
28 May 2008**

Report 22/2009
August 2009

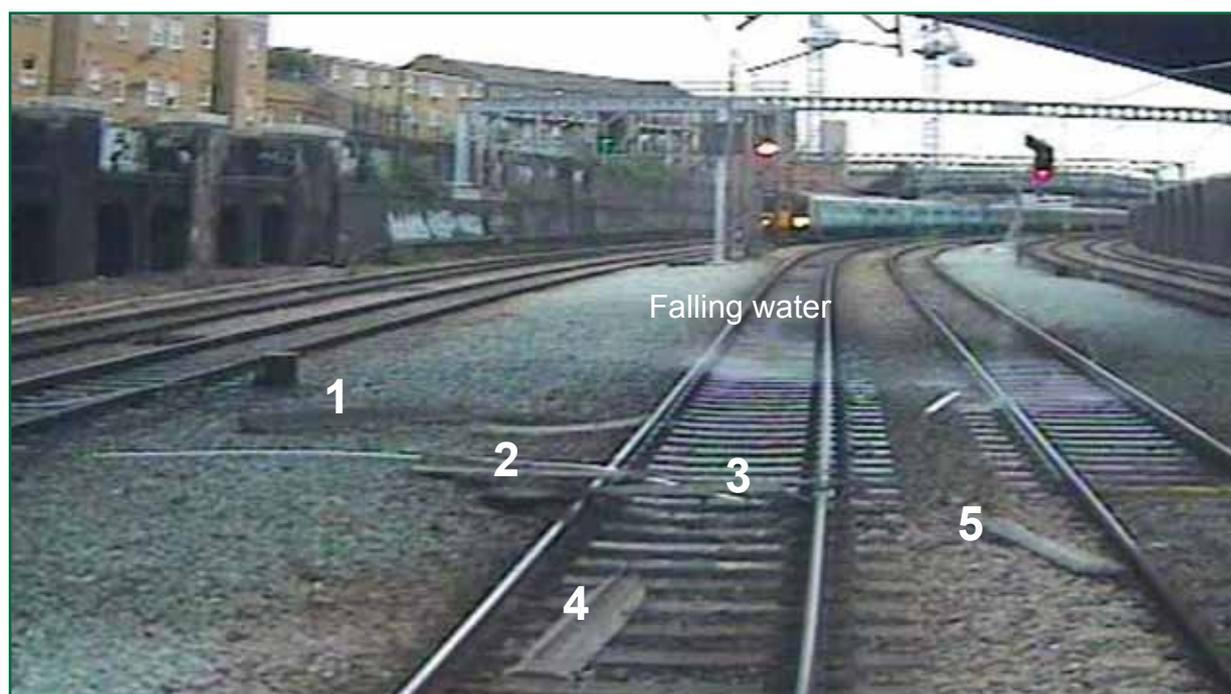
Figure 5: Image from CCTV equipment on train 1K12 showing debris on track immediately before the collision. The position of the five pre-cast concrete permanent formwork planks is indicated

- 42 The driver made an emergency brake application four seconds later, but was unable to avoid running through the debris (Figure 5). The driver then briefly lost forward vision due to falling water hitting his windscreen, and his cab was struck by an object hanging from the overhead catenary. This was later found to be a strip of wet hessian originating from the deck.
- 43 One plank was dragged forwards under the leading bogie for a distance of approximately 50 metres (Figure 6). The train came to a halt close to a signal, after travelling 77 metres (84 yards) with the emergency brake applied. This was within normal parameters after activation of the emergency brake.

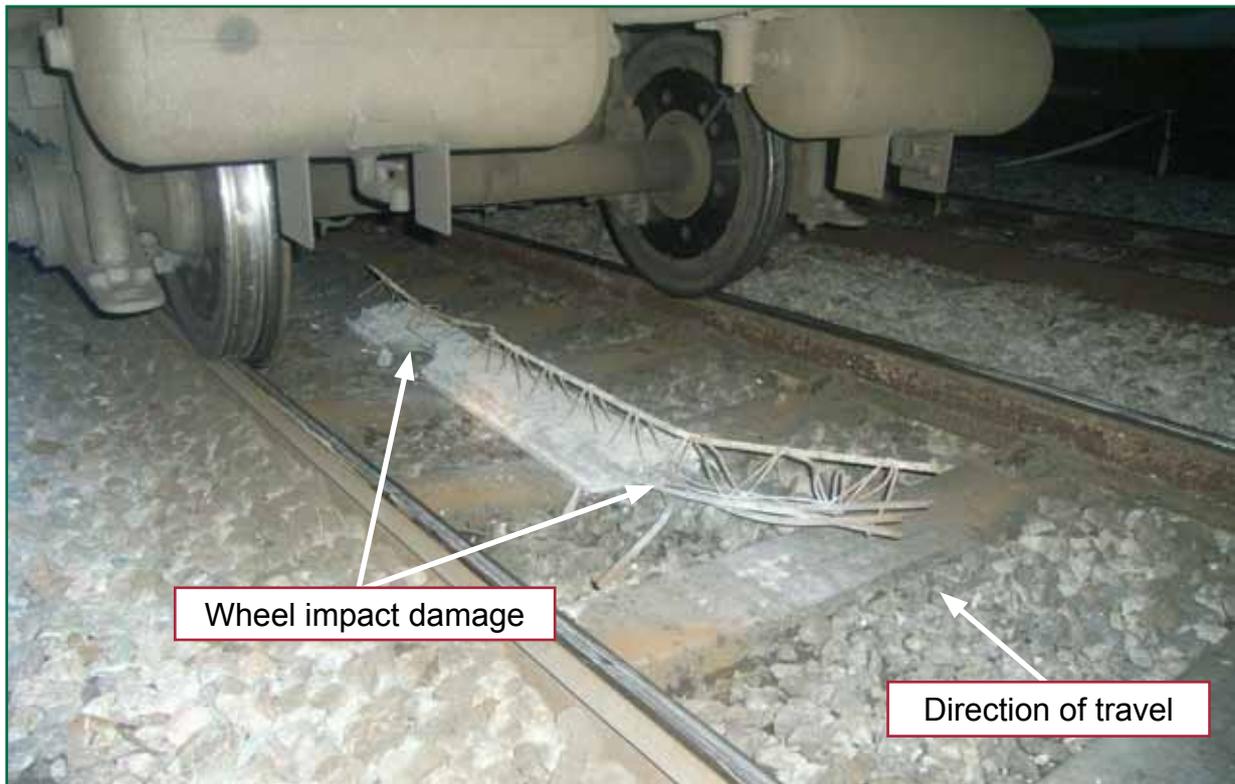
Figure 6: Damaged permanent formwork plank after being dragged forwards under train 1K12

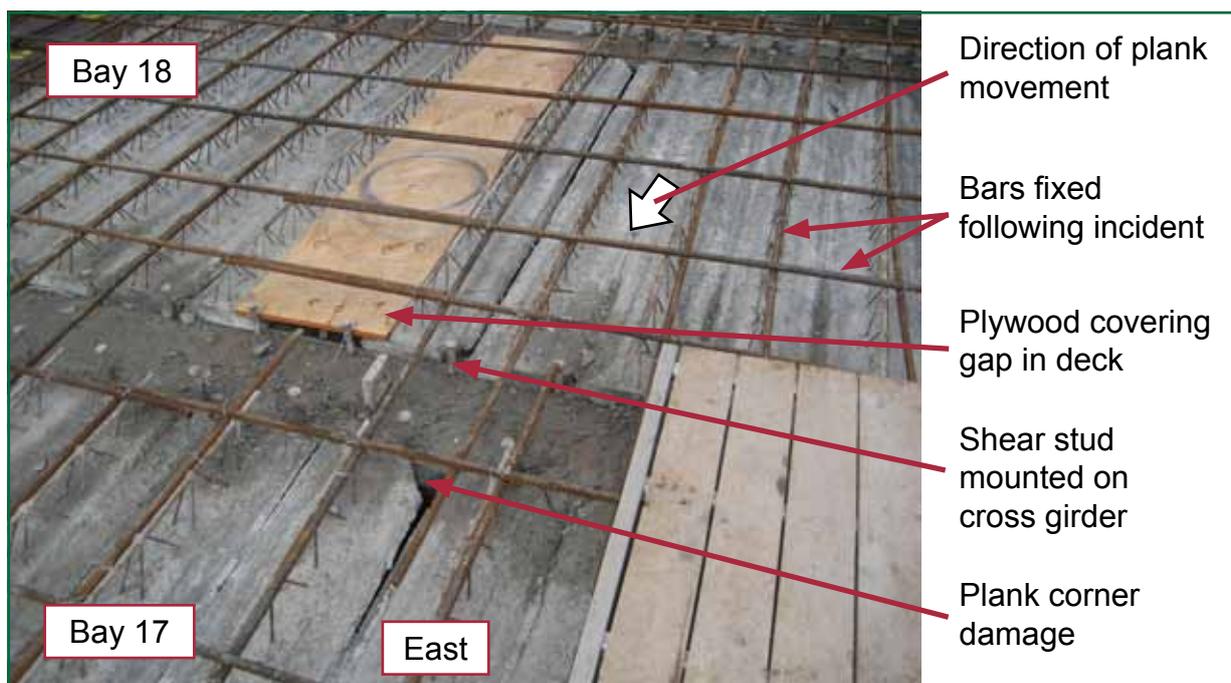
Figure 10: Photograph showing damage to deck (photograph TfL)

- 95 Five planks were missing from bay 18, together with a similar number of uPVC strips used to span gaps between groups of planks. One plank in bay 21 was considered too dangerous to leave in position and was removed by BB-CJV staff. Elsewhere, the deck was fractured allowing rain water, which had previously been observed collecting in bay 15 at depths of up to 50 mm, to escape.
- 96 A damage survey identified that 75 planks needed replacement, having either diagonal cracks or knocked-off corners (Figures 10 and 11).

- 82 BB-CJV commenced works to secure the deck following an initial inspection by the RAIB. These works involved removing or repositioning loose planks, installing plywood sheets over holes and other gaps in the deck, and placing additional steel bars to lace the permanent formwork planks together (Figure 10).

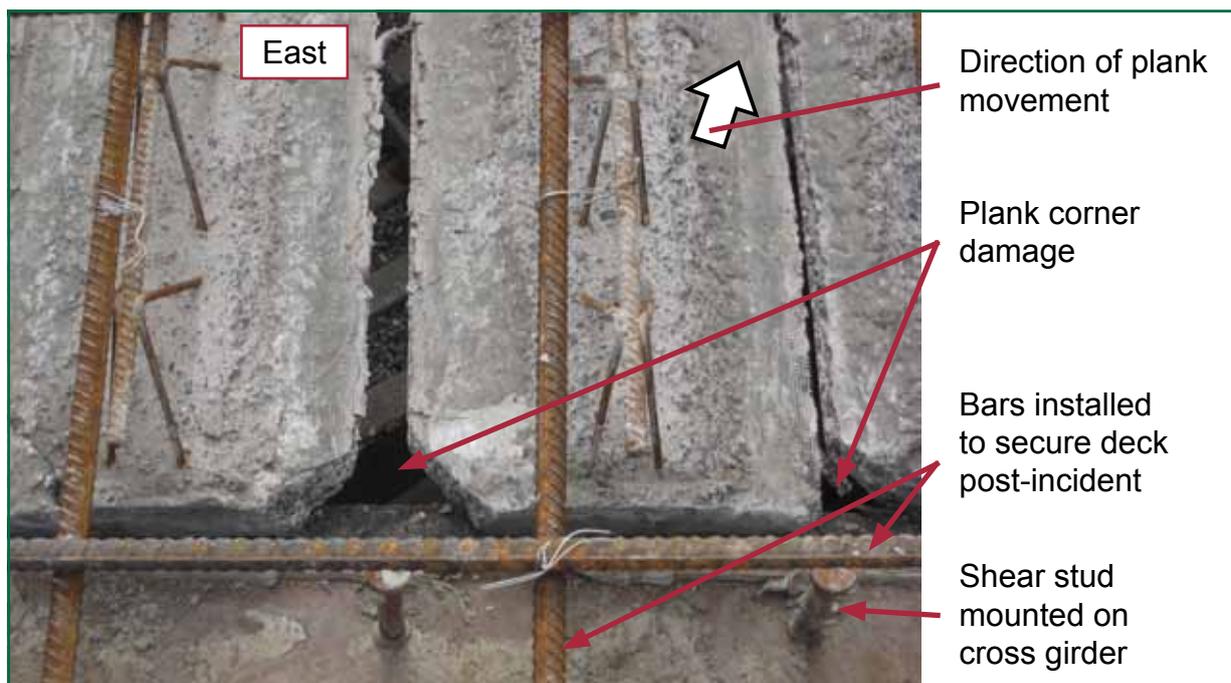
- 94 The passage of the shock wave through the structure resulted in the displacement of 228 permanent formwork planks, this being more than half of the total number. Bays 16-24, towards the mid-span of the structure, were most affected. Many of the displaced planks had moved longitudinally downhill (i.e. to the east), and laterally to the south. In some cases, planks had moved by over 100 mm.

Figure 11: Photograph of damage to permanent formwork planks. The track is visible through the gap (Photograph TfL)

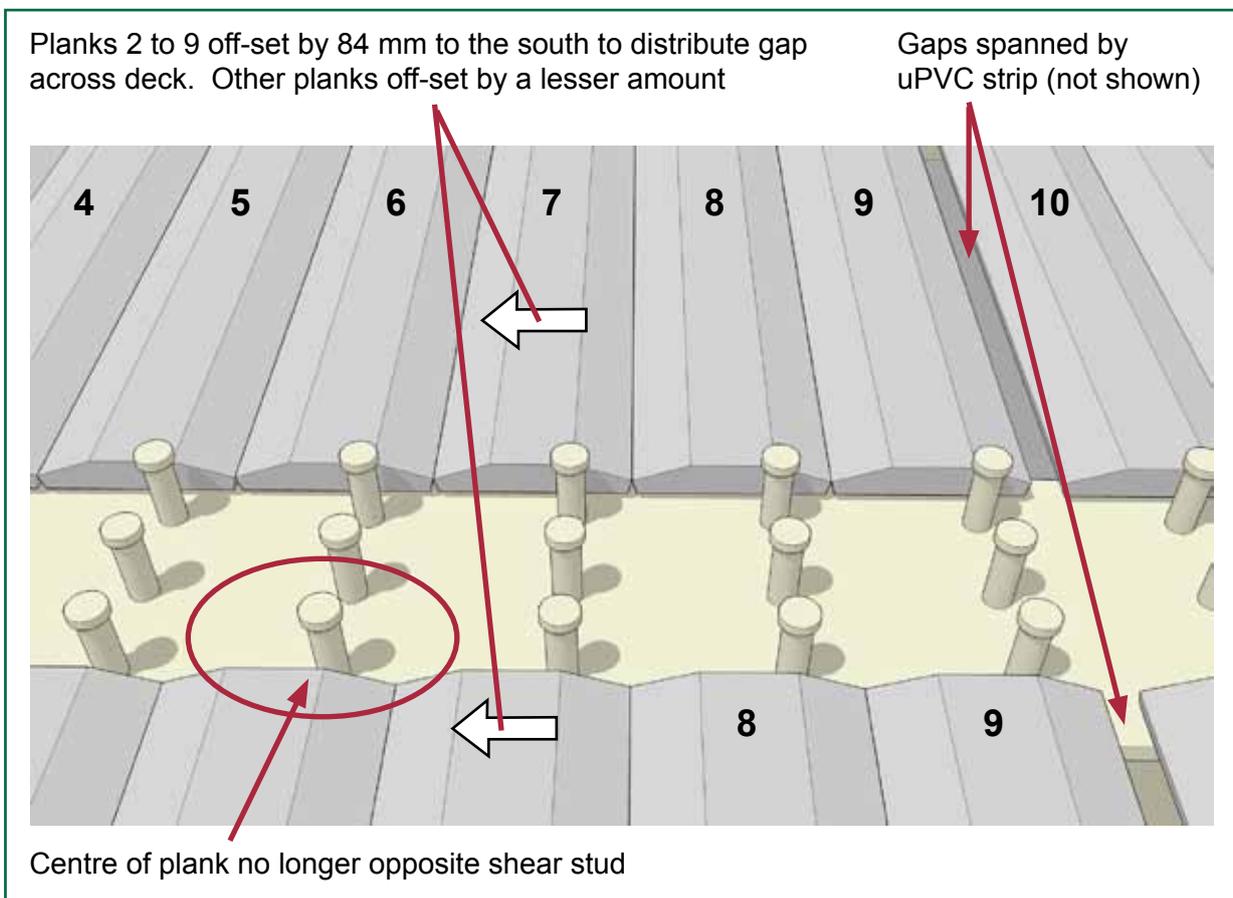
- 163 BB-CJV's decision to amend the deck layout was taken without reference to Benaim or London Rail. This modification affected the relationship between the planks and the shear studs, particularly towards the outer edges of the deck where the off-set was greatest. Planks 2 to 9, located as a group towards the southern edge of each deck bay were most affected, with each plank being off-set by 84 mm from its original position (Figure 17). This was sufficient to place the unreinforced edge of the plank in closest proximity to the adjacent shear stud, the centre of the stud being 66 mm from the edge of the plank (paragraph 121).

Figure 17: Schematic diagram showing a typical deck bay, and the modified relationship between shear studs and permanent formwork planks.

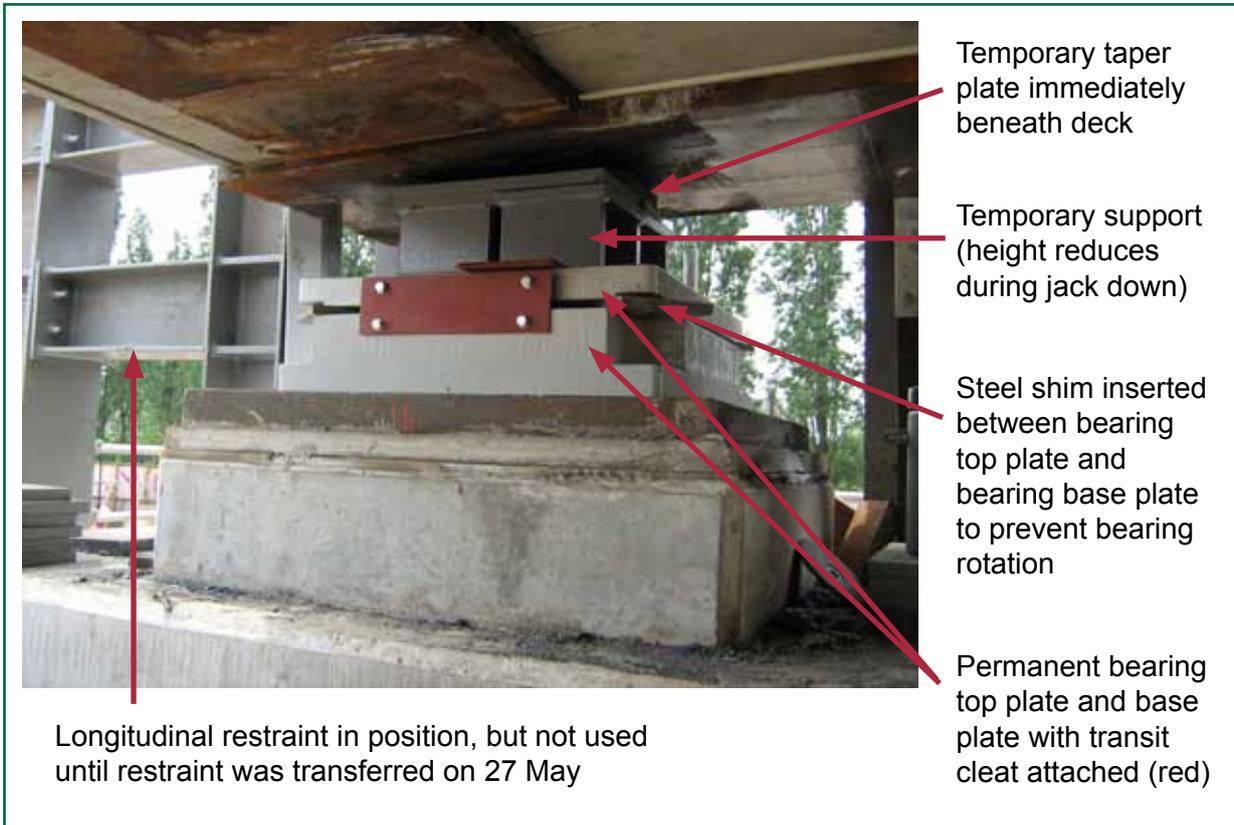
- 179 Jack down of the east end of the deck commenced by lowering it from 650 mm to 450 mm on 22 May and to 250 mm on the following day where it remained until 28 May (Figure 20). The deck was lowered one end at a time using a pair of manually controlled hydraulic jacks. The lateral restraints were retained to reduce the risk of unintended deck movement and steel wedges were placed between the bearing top plate and base plate to prevent rotation of the bearing.

Figure 20: Photograph of south-east bearing during jack down (photo TfL).

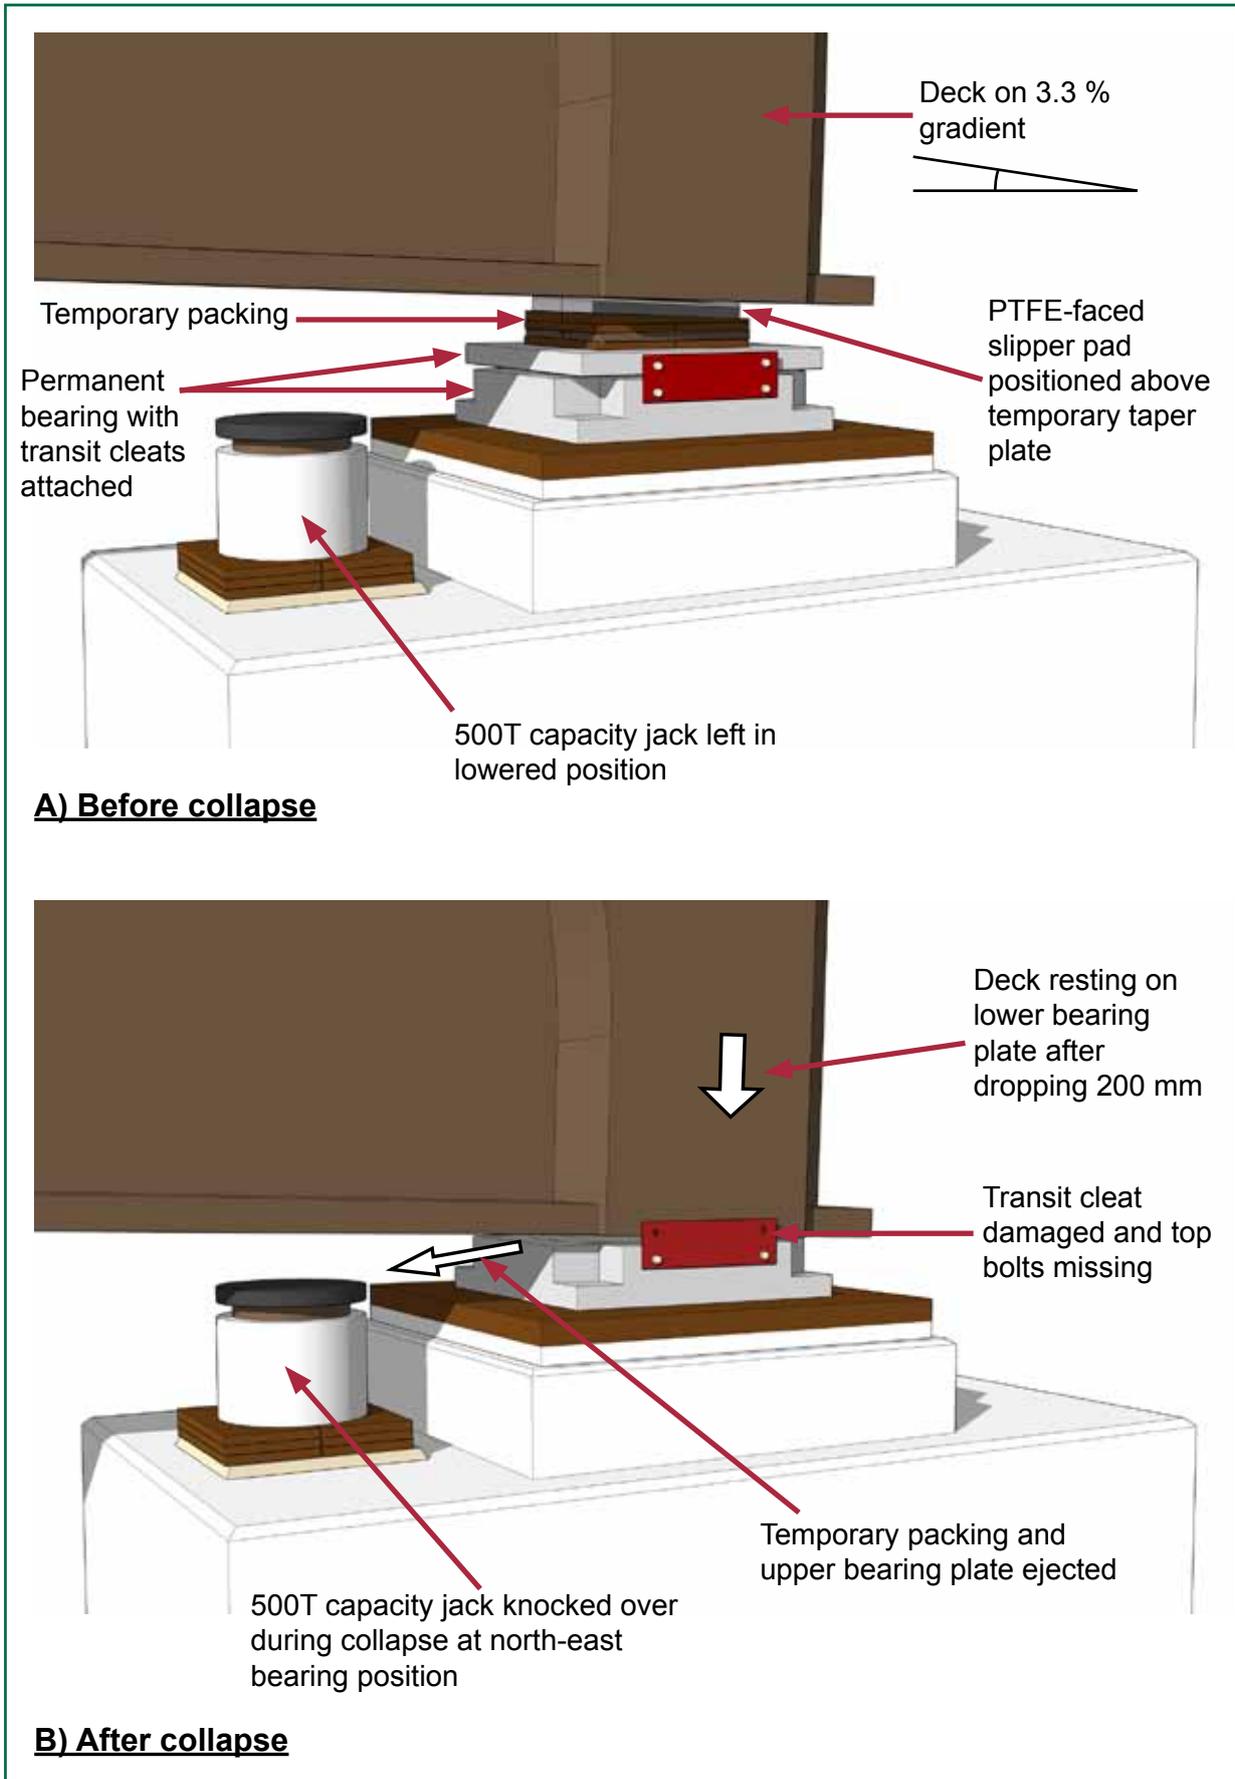
- 92 A loss of support at the north-east and south-east bearings resulted in the east end of the deck dropping by 200 mm and this caused a shockwave to pass through the structure. The deck came to rest supported on the *base plate* of both permanent bearings.

Figure 21: Schematic diagrams of south-east bearing and temporary support before and after collapse

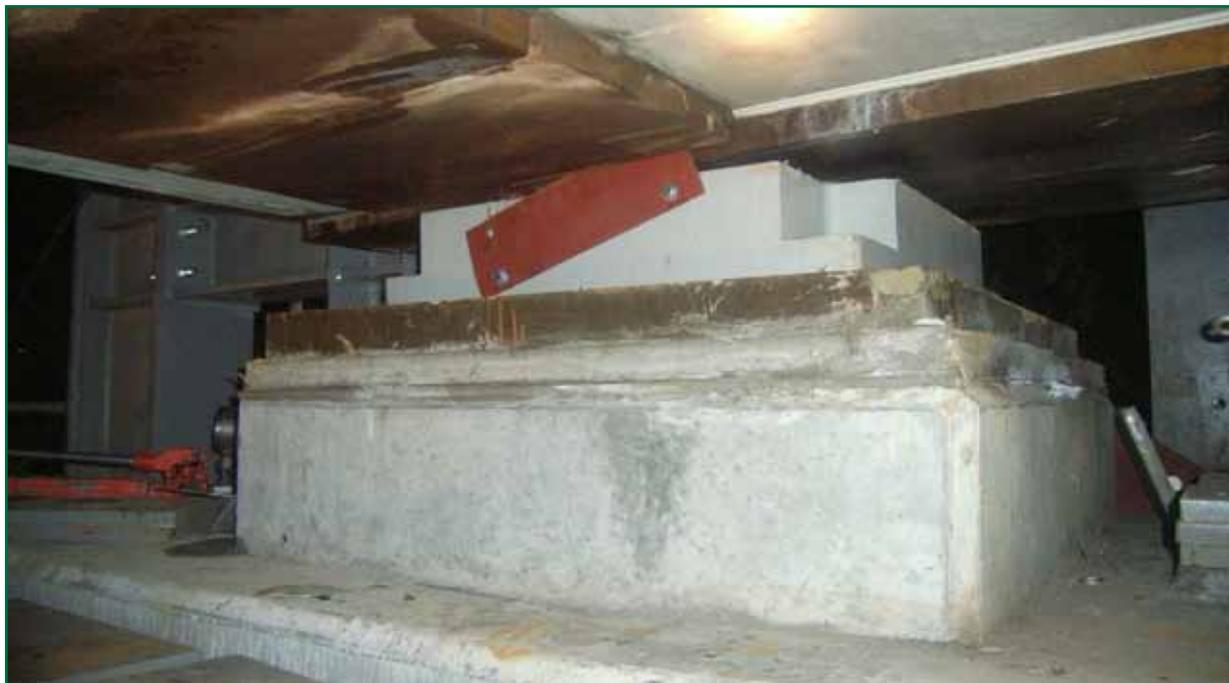
239 Figure 22 shows the south-east bearing four hours after the collapse, and this can be compared with the photograph shown in Figure 20. The transit cleat (painted red) remains connected to the base plate of the bearing by a single bolt.

Figure 22: South-east bearing following collapse showing a failed transit cleat.

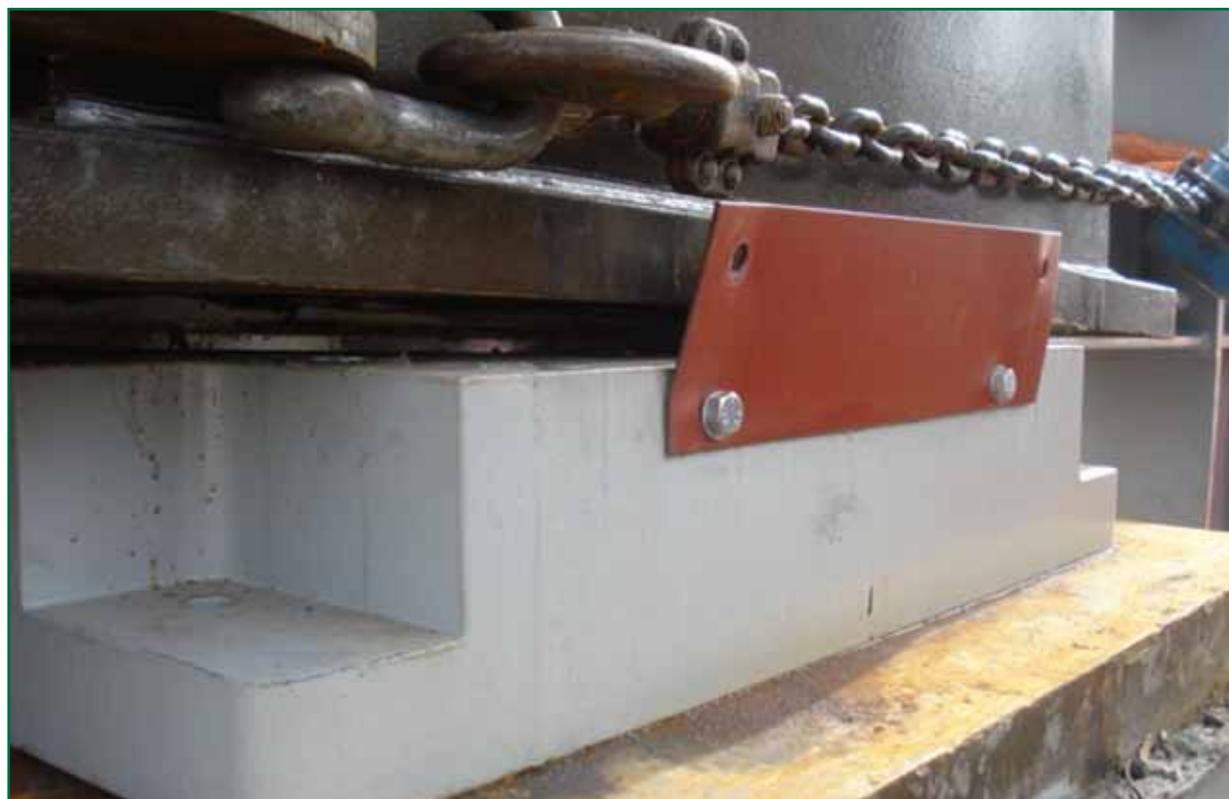
240 Figure 23 shows the opposite transit cleat, still attached to the base plate of the bearing after the collapse. The cleat shows evidence of distortion caused by bolt rotation, indicating that the bolts failed rather than the cleat itself.

Figure 23: Failed transit cleat on south-east bearing (photograph BB-CJV)

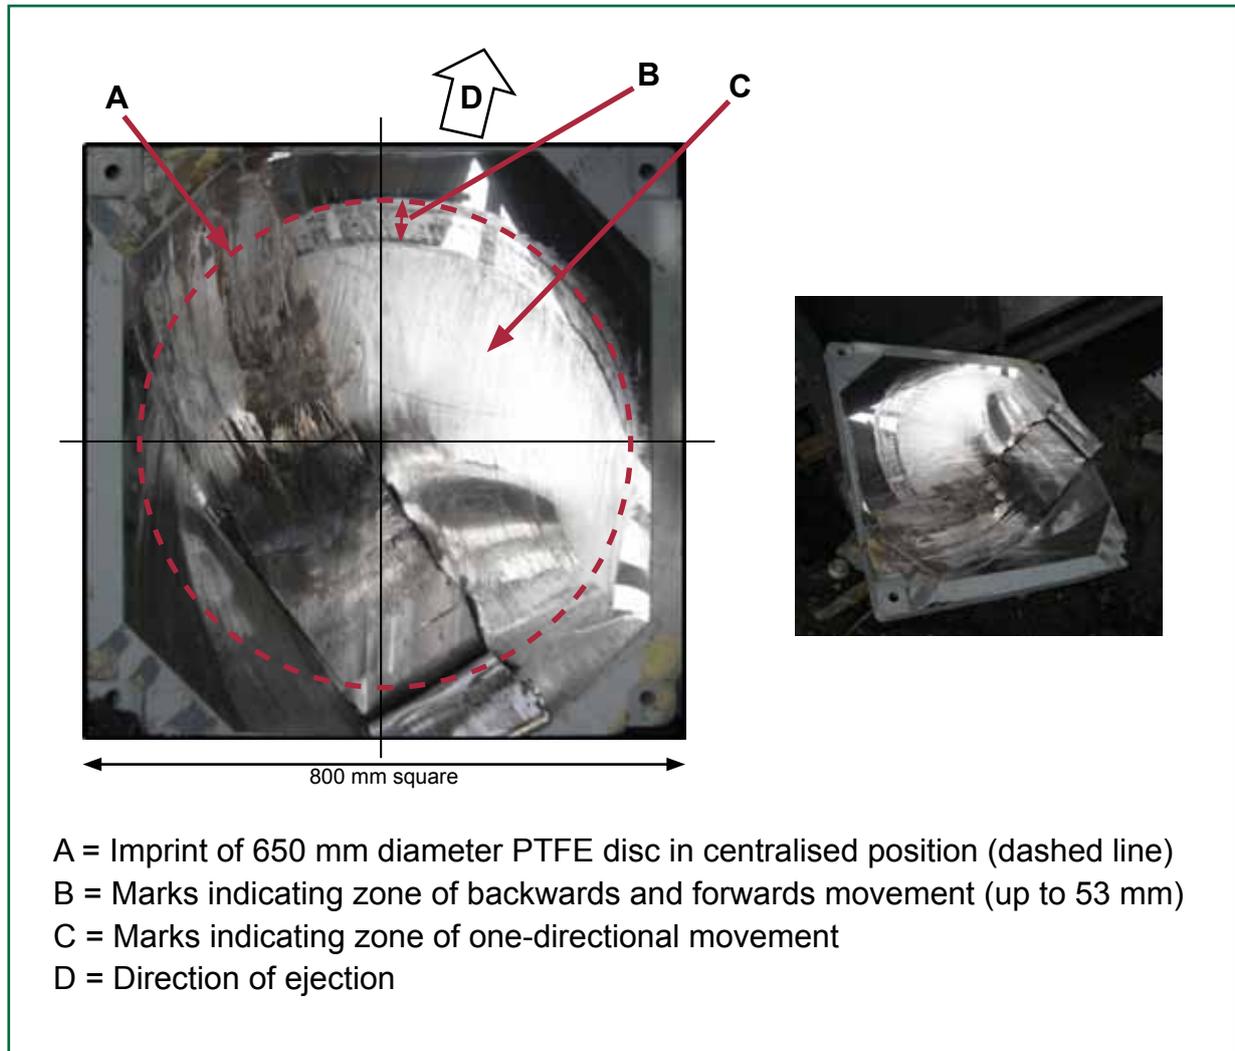
241 Figure 24 shows the stainless steel underside of the south-eastern bearing top plate following ejection, with one corner partly embedded in the ground. The imprint of the PTFE disc attached to the bearing base plate can be seen in the grease markings in its centralised position (ie prior to the failure of the transit cleat connections). Significantly, all subsequent movement has occurred in the same direction suggesting that the bearings were installed while the deck steelwork was thermally extended (paragraph 218).

Figure 24: re-orientated photograph of the underside of the south-east bearing top plate, showing major dimensions and (inset) as-found.

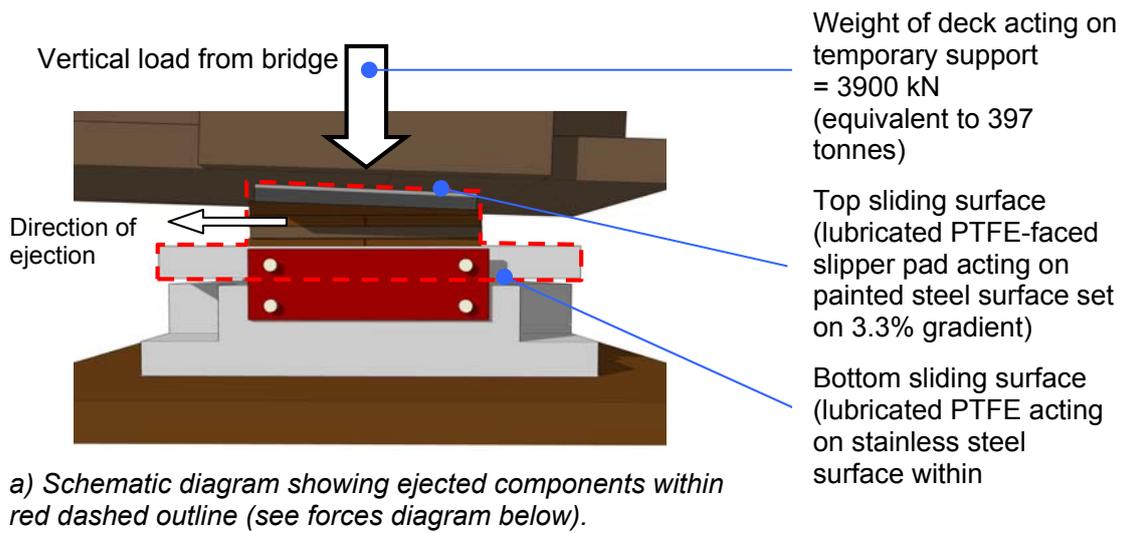
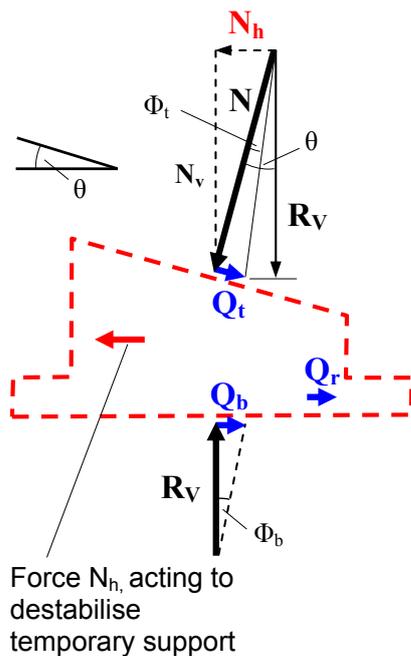
- 249 Following the completion of work on 28 May, the deck remained supported on slipper pads at each corner (paragraph 189). The orientation of the slipper pads resulted in an out-of-balance force being exerted on to the temporary supports; the weight of the deck exerting a sustained horizontal force on the wedge. At the east abutment where there were two potential sliding surfaces, movement was resisted only by friction at the PTFE surfaces and any residual capacity in the transit cleat connections.

The load from the bridge deck acting on the top sliding surface (N) can be separated into vertical and horizontal components, N_v and N_h , where N_h is the horizontal component acting to destabilise the temporary support.

R_v	Primary vertical reaction from vertical load of bridge = 3900 kN
θ	Gradient of top of temporary support (3.3% is equivalent to an angle of 1.9°)
N	Load from bridge acting perpendicular to top sliding surface ($R_v / \cos \theta$) = 3902 kN
N_h	Horizontal component of N , acting to destabilise temporary support ($R_v \tan \theta$) = 130 kN
N_v	Vertical component of N
Q_t	Friction restraint from top sliding surface = $0.017 R_v = 66$ kN (reducing to 33 kN)
Φ_t	Angle related to coefficient of friction of top sliding surface, where $\tan \Phi_t =$ coefficient of friction (μ_t)
Q_b	Friction restraint from bottom sliding surface = $0.026 R_v = 101$ kN (reducing to 51 kN)
Φ_b	Angle related to coefficient of friction of bottom sliding surface, where $\tan \Phi_b =$ coefficient of friction (μ_b).
Q_r	Mechanical restraint provided by up to four top plate transit cleat bolts = 0 to 48 kN
