# Rail Accident Report

## Freight train collision at Leigh-on-Sea 26 April 2008

# Freight train collision at Leigh-on-Sea, 26 April 2008

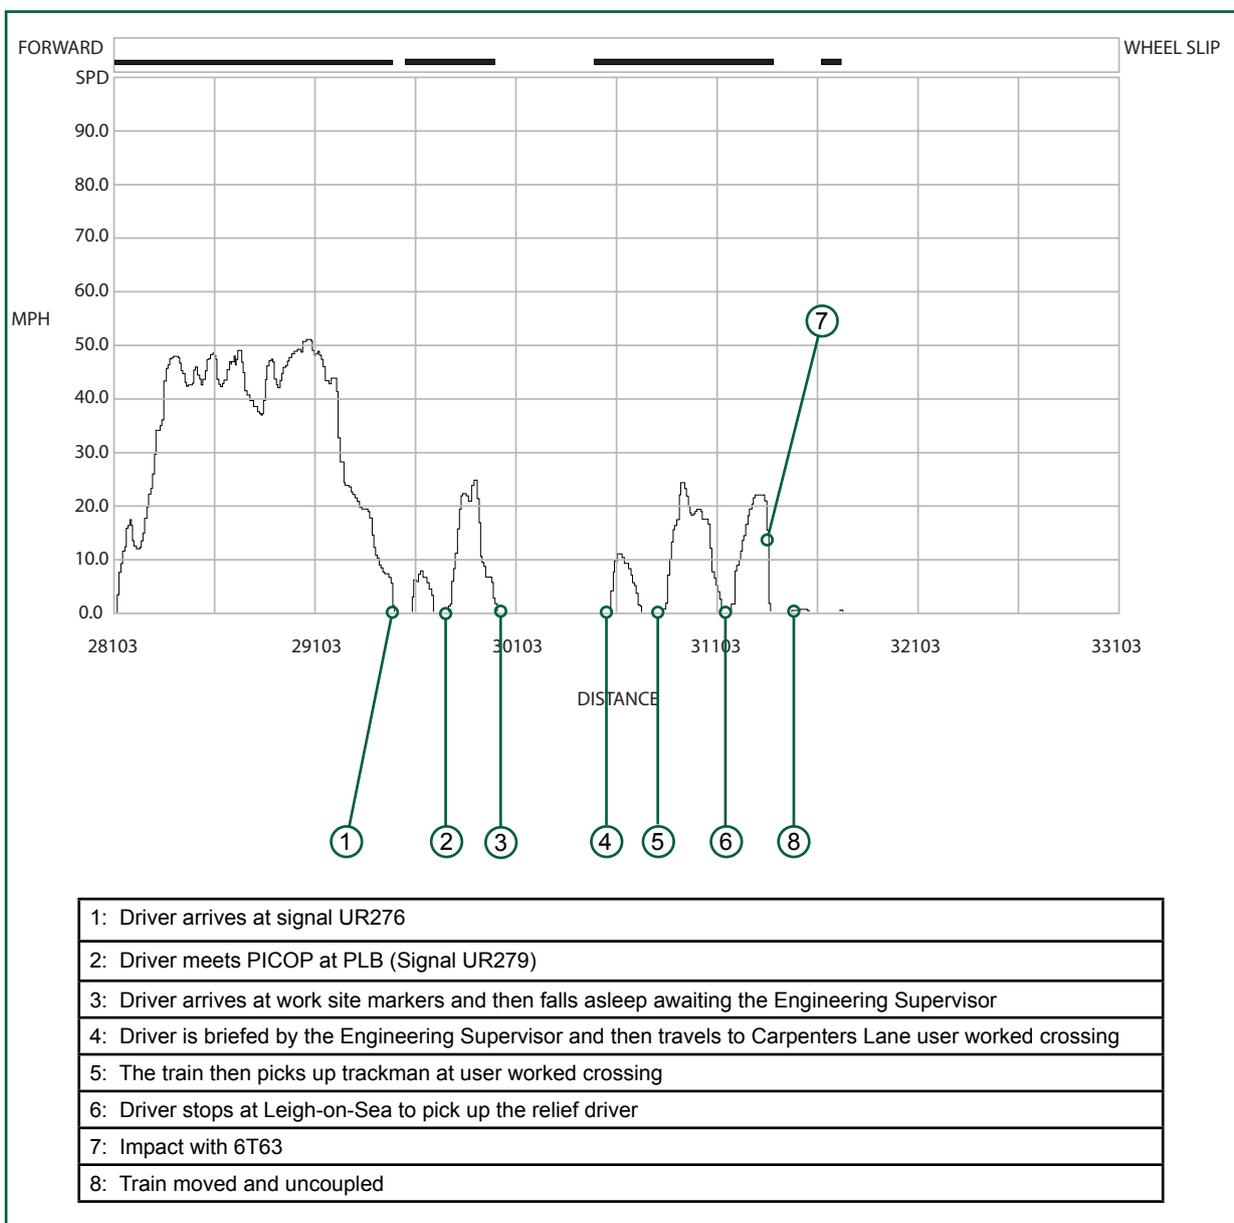
- 50 The OTDR, from which all train speeds were recovered, confirmed the train had stopped at Carpenters Lane user worked crossing.
- 51 At 06:23 hrs the train left Leigh-on-Sea station; the driver increased the train's speed to 20 to 25 mph (32 to 40 km/h). As the train entered the left-hand curve on the approach to Chalkwell station, the driver, relief driver and trackman observed the flashing tail lamp on the rear wagon of train 6T63.
- 52 The driver applied the brake at 22 mph (35 km/h) at 06:27:15 hrs. Four seconds later he applied the emergency brake; the driver, relief and trackman anticipated the collision and braced themselves. The train travelled a further 31.3 metres before colliding with the rear of train 6T63 at 06:27 hrs whilst travelling at 15.7 mph (24 km/h). The train travelled a further 7.6 metres after the impact.

Figure 5: OTDR diagram from train 6T64 showing train speeds and locations within the Leigh-on-Sea possession and work site

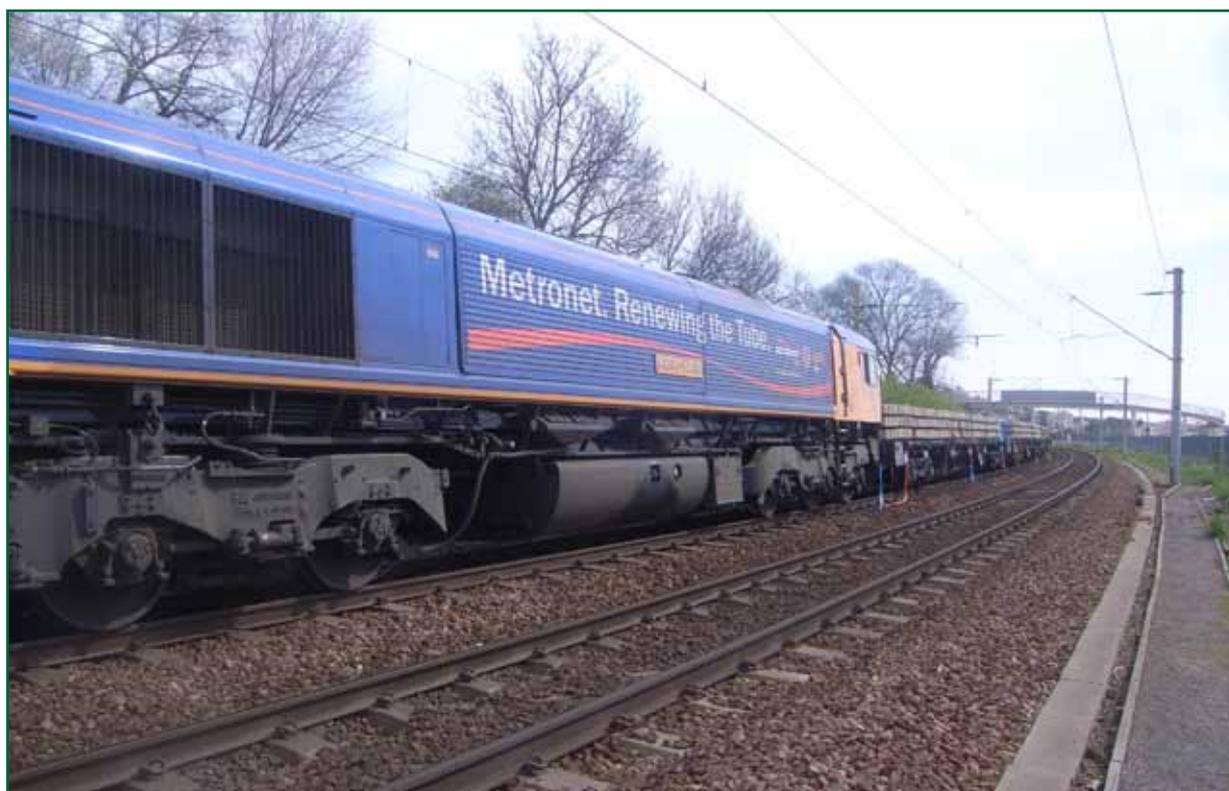
53 The front buffers of locomotive 66719 of train 6T64 were compressed and damaged. The central spines on two FEA wagons, 640658 and 640633, were severely damaged and caused the wagons to become raised off the rails as a result of the impact. The remaining wagons were undamaged.

55 The driver examined the leading locomotive on train 6T64. He noted the collision had damaged the front buffers. He was not aware of any other damage to the train. The incident was not reported by the driver, relief driver or trackman immediately after the collision.

Figure 6: Front Locomotive of 6T64 after collision with the rear wagon of 6T63

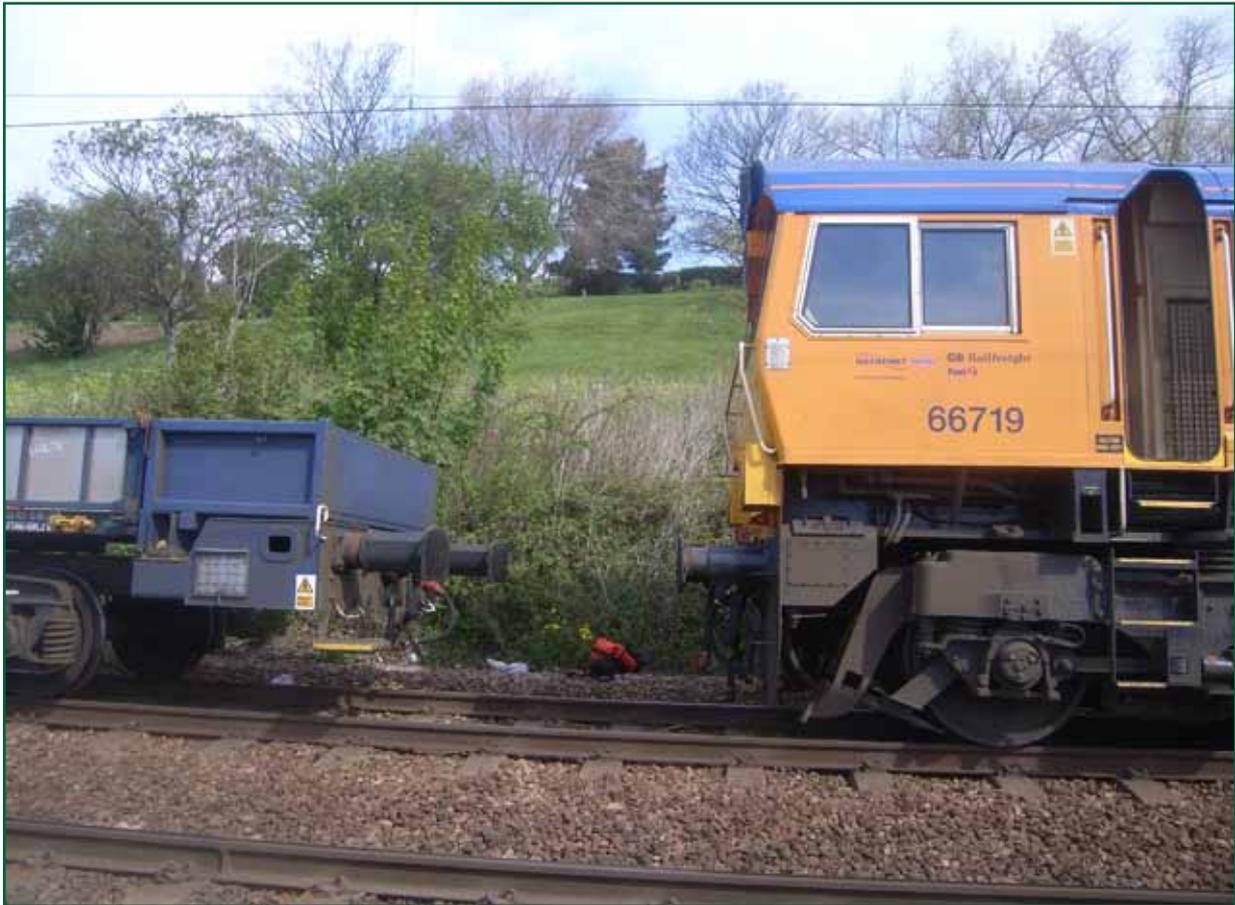
Figure 7: Rear cab of front locomotive of 6T64 after collision

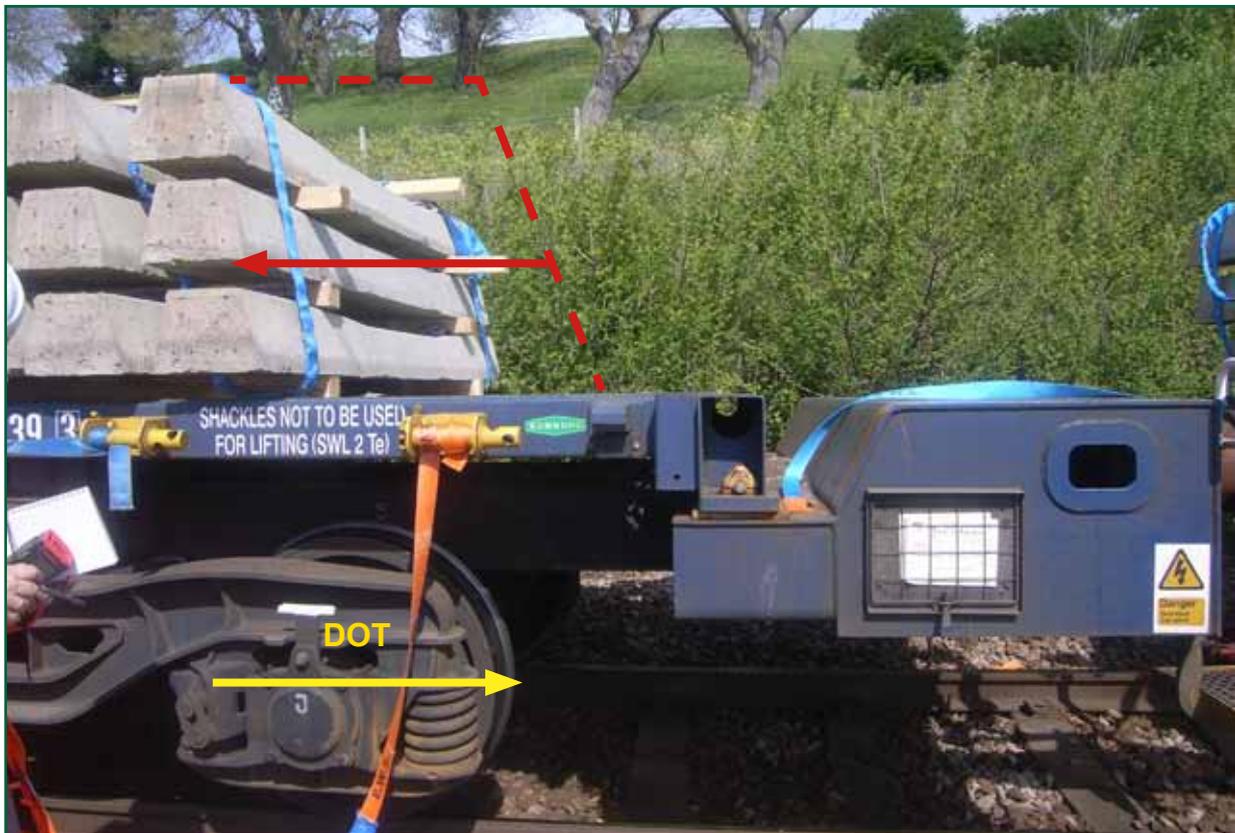
Figure 8: Rear wagon of 6T63 showing the direction of travel (yellow arrow) and the movement of the load (sleepers) from its original position to its final position after the collision (red dotted line)

- 183 The driver's fatigue and state of sleep inertia continued after the incident, when he observed the retaining straps on the wagons of train 6T63 to be insecure. The driver believed that another member of staff had mistakenly left the straps insecure and if he was later requested by the Engineering Supervisor to take charge of 6T63 he would have to reconnect the straps. The driver's level of fatigue and confusion at this point was such that he did not realise that the straps that were hanging down had been severed by the movement of the sleepers on the wagons during the collision (paragraph 56).

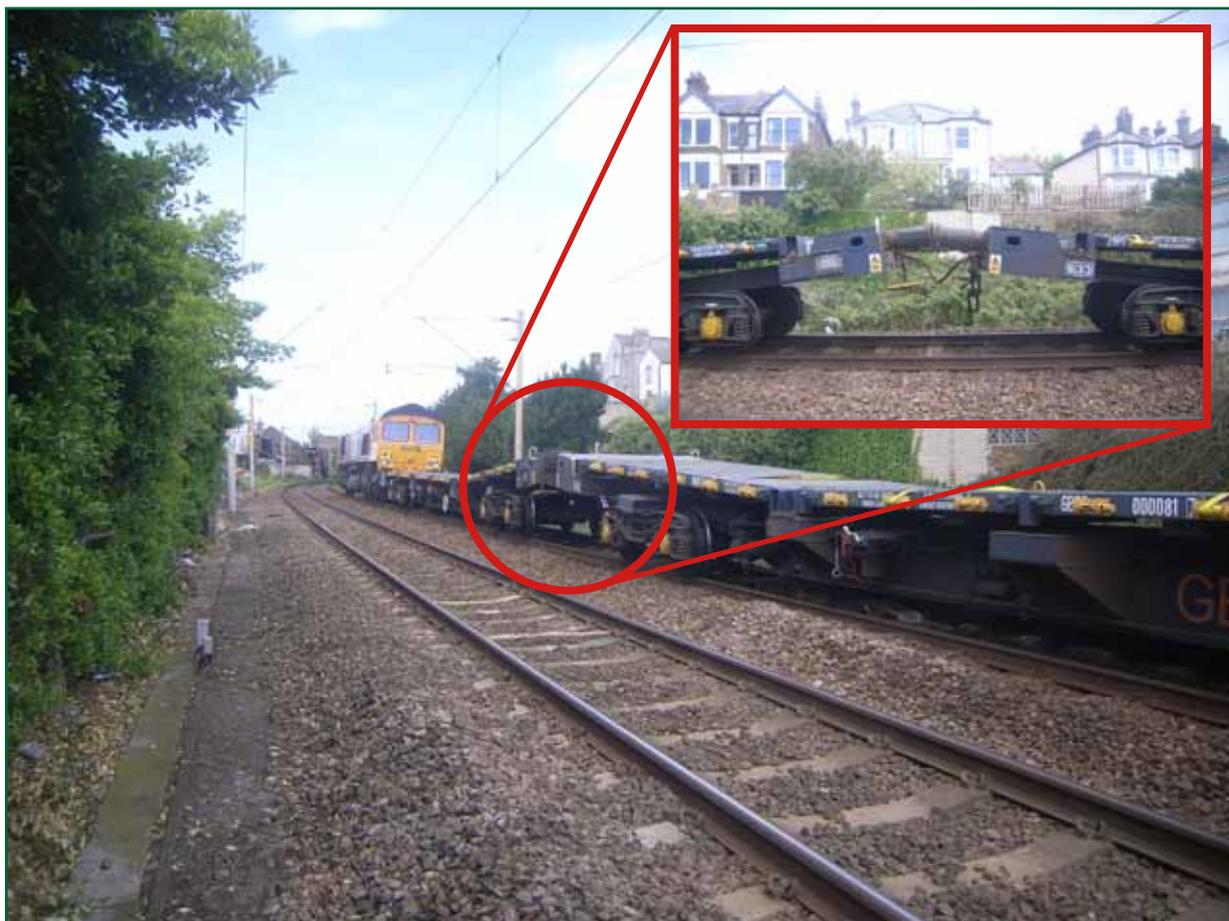
Figure 9: Photograph and (inset photograph) of train 6T64 and FEA wagon damage sustained as a result of the collision

- 59 At 06:51 hrs the relief driver telephoned the Engineering Supervisor when he observed the two severely damaged FEA wagons at the rear of train 6T64.

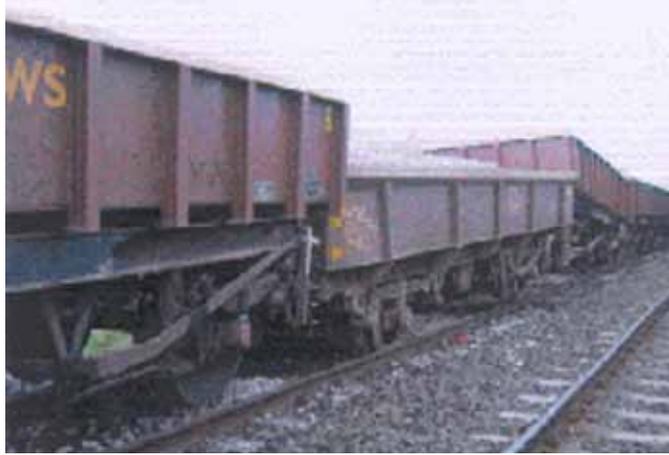
- 6 The incident occurred when an engineers' train 6P27, consisting of a locomotive and 40 loaded ballast wagons collided with wagons of another train, 6P26, standing in a work site in a possession (Figure 12).
- 7 The train had travelled just over one mile (1.6 km) from the work site marker boards, reaching speeds of up to 17 mph (27 km/h). It was alleged that there was no tail lamp on the stationary vehicles at the time of the collision, and the locomotive driver did not see the rear of the train until it was too late to stop. The collision occurred at 5 mph (8 km/h); there were no injuries. The investigation concluded that the cause of the incident was the train driver travelling within a long possession and the driver not having accurate knowledge of the train location. The speed of the train was such that the driver was unable to stop short of the obstruction.

*Figure 12: Image of derailed rear wagons of train 6P26 caused by the collision*
