Rail Accident Investigation Branch

Rail Accident Report

**Fatal accident at West Lodge crossing, Haltwhistle
22 January 2008**

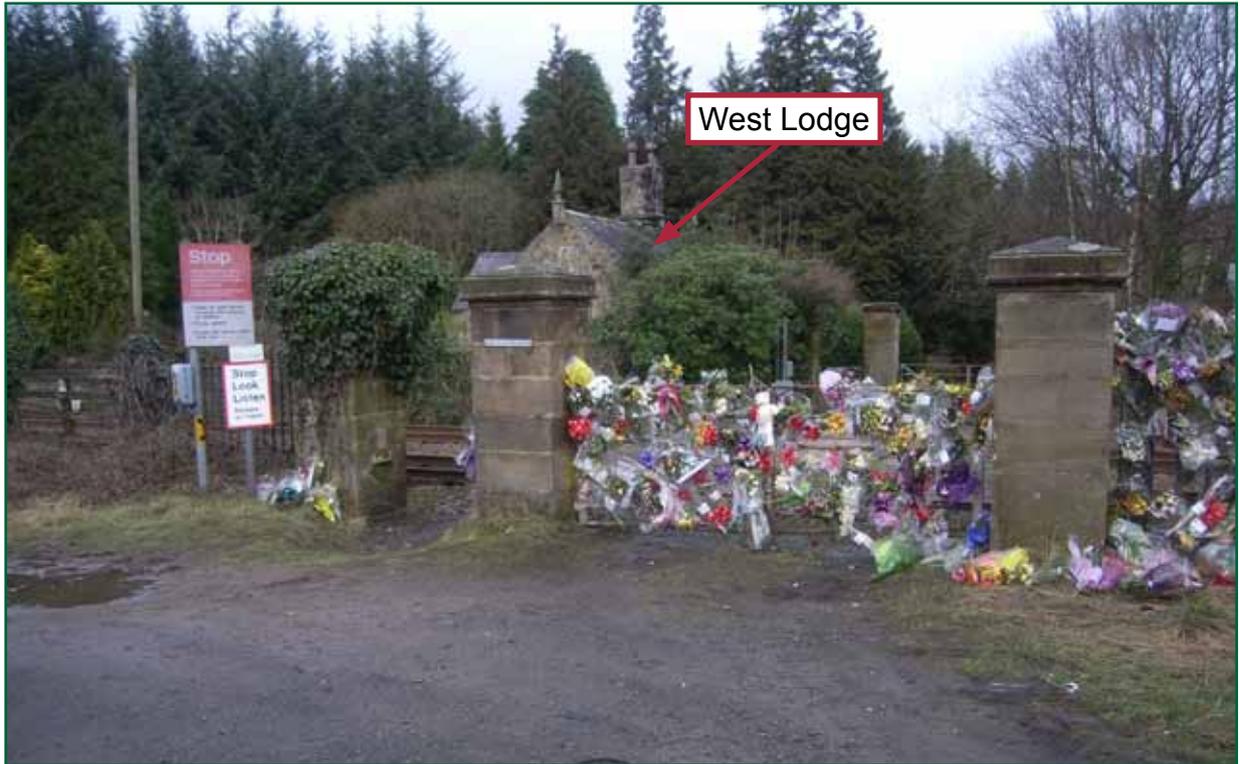
- 13 The approach from the A69 is narrow and has no slip road. It is difficult to drive off the A69 when it is busy with traffic and correctly position a vehicle to drive over the crossing. A vehicle that is incorrectly positioned or longer than 3.5 metres may foul the vehicle gates that open 3.5 metres into an approach that is 7 metres long (Figures 3 and 6).

Figure 3: West Lodge crossing viewed from the A69

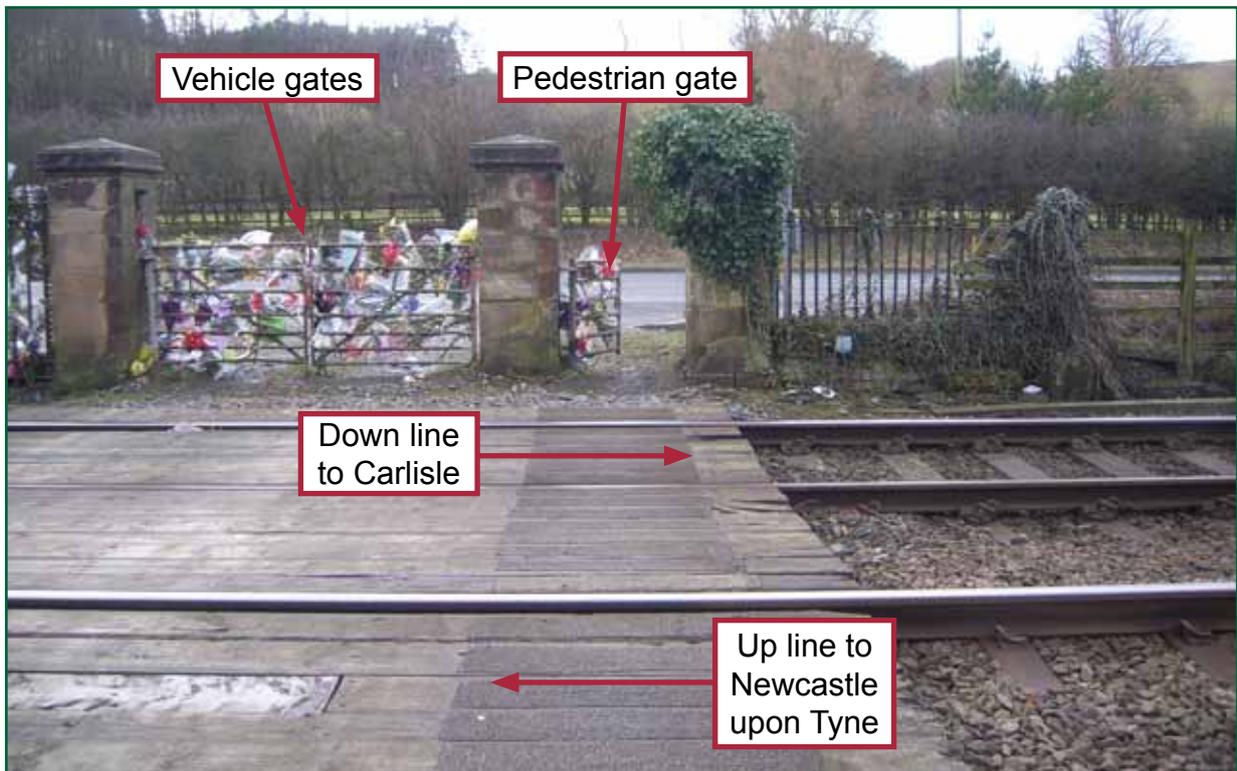
- 12 The crossing had pedestrian and vehicle gates and warning signs that stated 'always telephone before crossing with vehicles or animals to find out if there is time to cross' and 'stop, look, listen' and 'beware of trains'. It is not fitted with any system to give indication of a train's approach (Figures 3, 4 and 8).

Figure 4: The crossing viewed from West Lodge

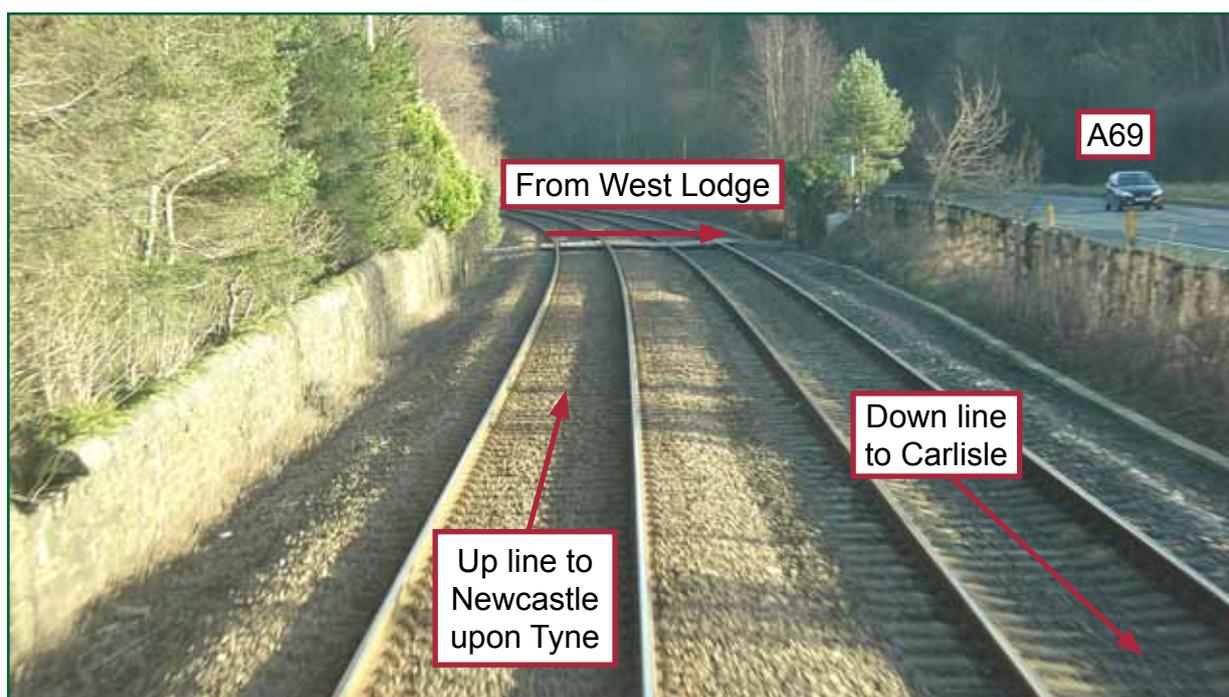
Figure 5: West Lodge crossing seen in daylight from the driving cab of a train

- 23 At 17:13 hrs the train driver saw a person appear from trackside vegetation to his left (Figure 5); he sounded the warning horn immediately and continuously as the person walked the few steps to the crossing and onto the up line.

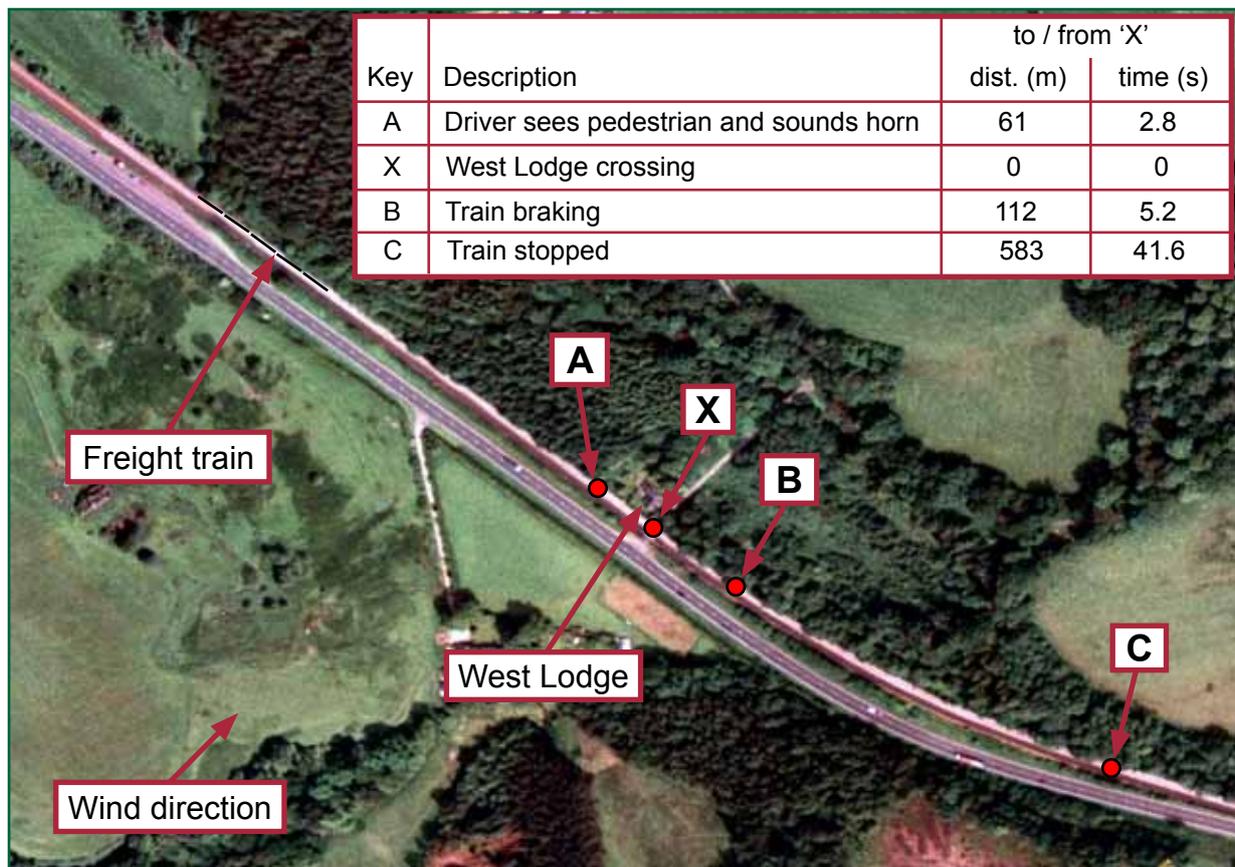
- 26 The train came to a stand 583 metres beyond, and out of sight of, the crossing (Figure 6). From here, the train driver used his mobile phone to call the Network Rail signaller and report the accident. The signaller stopped all trains on the up and down lines and contacted the emergency services. The residents of West Lodge were aware of the accident and they too called the emergency services.

Figure 6: Aerial view of the accident location (image courtesy of getmapping.com)

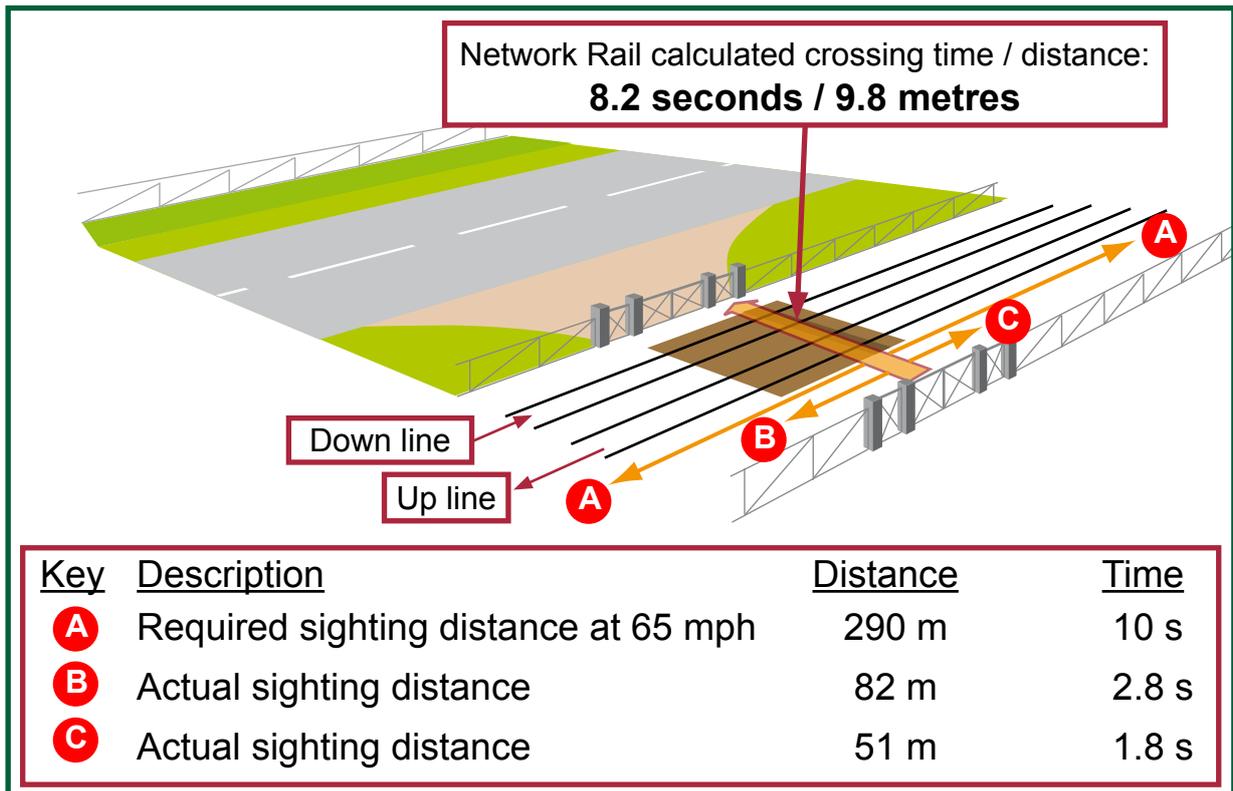
- b. at 2.4 metres from the nearest rail (the decision point defined in Network Rail's crossing assessments) the sighting distance was 51 metres to the north-west and 82 metres to the south-east, giving warning times of 1.8 seconds and 2.8 seconds respectively (Figure 7).

- 48 From the West Lodge decision point, a user's sighting distance, and thus warning time, were less than laid down in ORR guidance and required by Network Rail's inspection process (paragraphs 71 - 73). Sighting distance was reduced by track curvature and vegetation.

Figure 7: Sighting distances from the West Lodge decision point

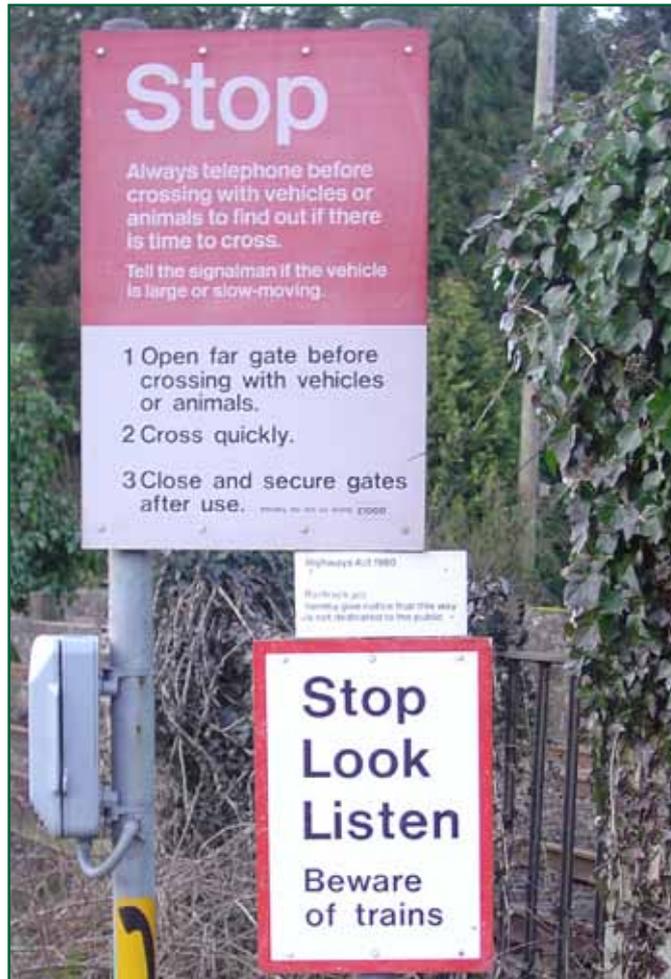
Figure 8: Warning signs at West Lodge crossing

- 49 Warning signs at West Lodge crossing state that users with vehicles or animals should always use the telephone to contact the signaller and find out if there is time to cross; pedestrians are required to stop, look and listen for trains and cross when it is safe to do so (Figure 8). The signs do not require pedestrians to contact the signaller.

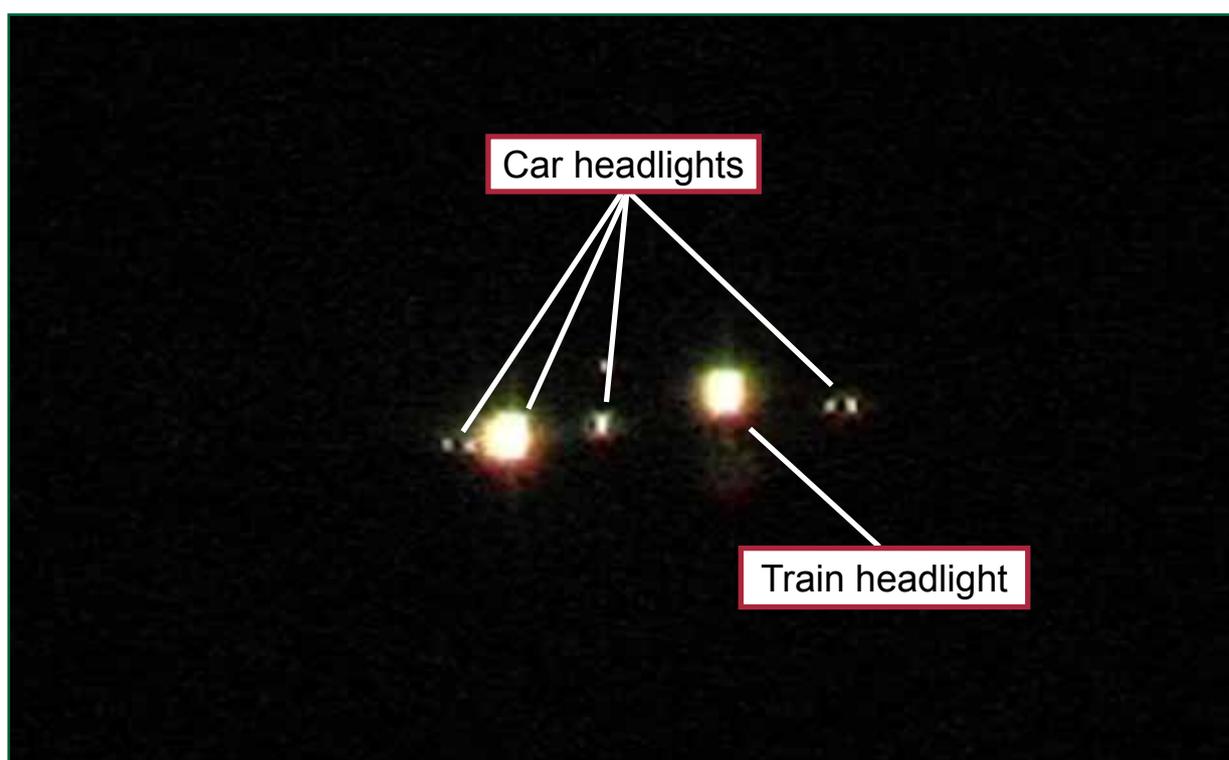
- 50 At West Lodge crossing in daylight, a user can recognise an approaching train as its appearance is different from the vehicles on the A69; in darkness, the headlights of a train are not easily recognised among those of road vehicles.
- 51 The headlights of a train are most difficult to recognise among those of road vehicles when sighting north-west from West Lodge, the direction from which the freight train came, as the railway and the A69 run adjacent and aligned (Figure 9).

Figure 9: Train approaching West Lodge crossing in darkness

- 52 Sunset on Tuesday 22 January 2008 was at 16:25 hrs. At 17:13 hrs, the time of the accident, dense cloud obscured the sky, the crossing was in complete darkness and the road was busy with traffic.
- 53 The RAIB assessed sighting at the time the accident had occurred and in similar environmental conditions on the day after the accident. It was evident that in darkness and when the A69 is busy with traffic, a user would be unlikely to recognise a train's headlights among those of road vehicles until the train was within a second or two of the crossing.

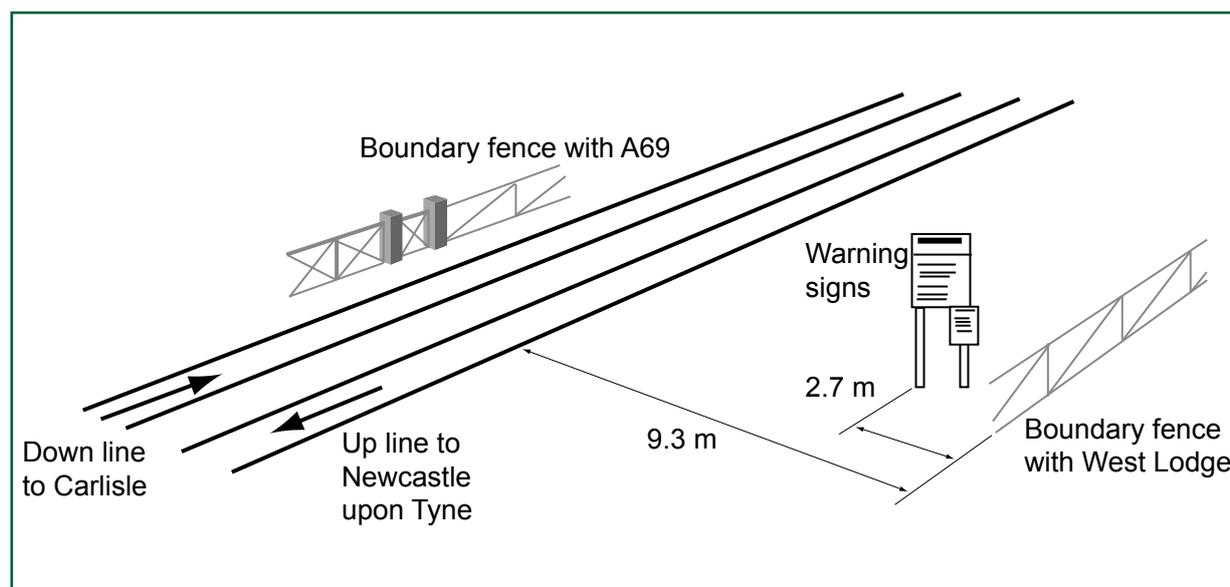
- 65 RSSB human factors risk number 90 recognises that a user's detection of a hazard improves when information is available in close proximity to the hazard itself. This is also recognised by the ORR guidance that states that the '[decision point]...is where guidance on crossing safely is visible and at which a decision to cross or wait can be made in safety.'
- 66 At the decision point on the West Lodge side of the crossing, the warning signs and guidance are not visible as they are 6.6 metres back from the track. The decision point itself is not physically marked or indicated to the crossing user (Figure 10).

Figure 10: Warning sign location

- 67 Users are less likely to be aware of and prepared for a crossing if they do not see the warning signs at the decision point.
