Rail Accident Investigation Branch

Rail Accident Report

**Near miss involving railway staff and a train
between Bishop's Stortford and Stansted
Mountfitchet, Essex
20 January 2008**

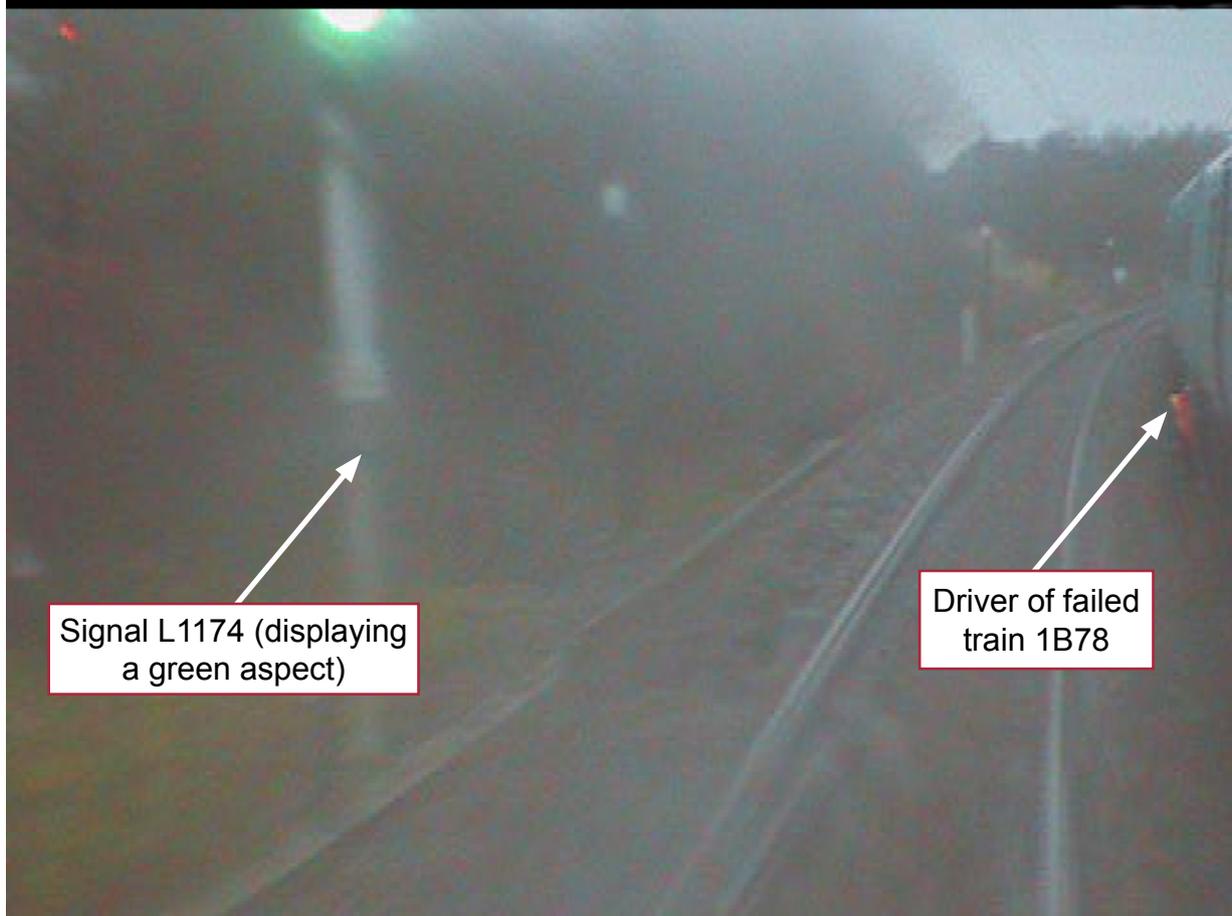
Figure 4: View from the driving cab of 2H43 at the time of the incident

- 43 At 16:20:47, the driver of train 2H43 saw the driver of train 1B78 standing in the six-foot, by the third coach of his failed train, and another person underneath the failed train. Train 2H43 was now travelling at 70 mph (112 km/h). The driver of train 2H43 applied his emergency brake and sounded his horn and the train passed the driver of train 1B78, who lay down on top of the ballast to avoid being struck. See Figure 4.
