Rail Accident Investigation Branch

Rail Accident Report

Runaway of a road-rail vehicle at Glen Garry 5 December 2007

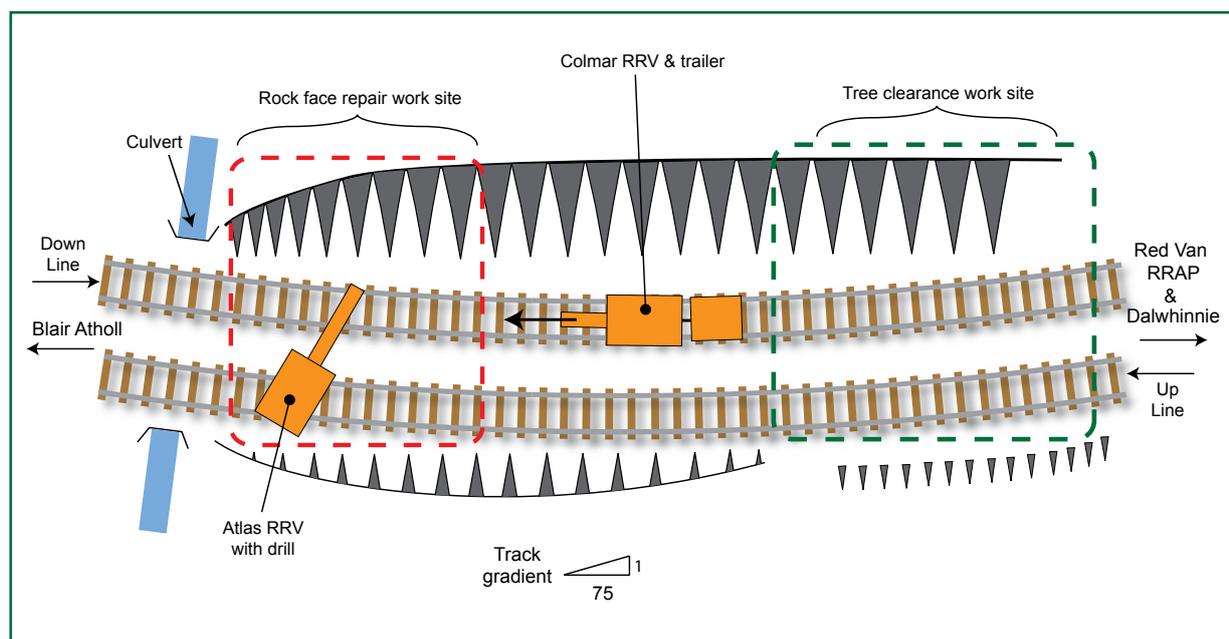
Figure 2: Sketch plan of the site of the incident

Introduction

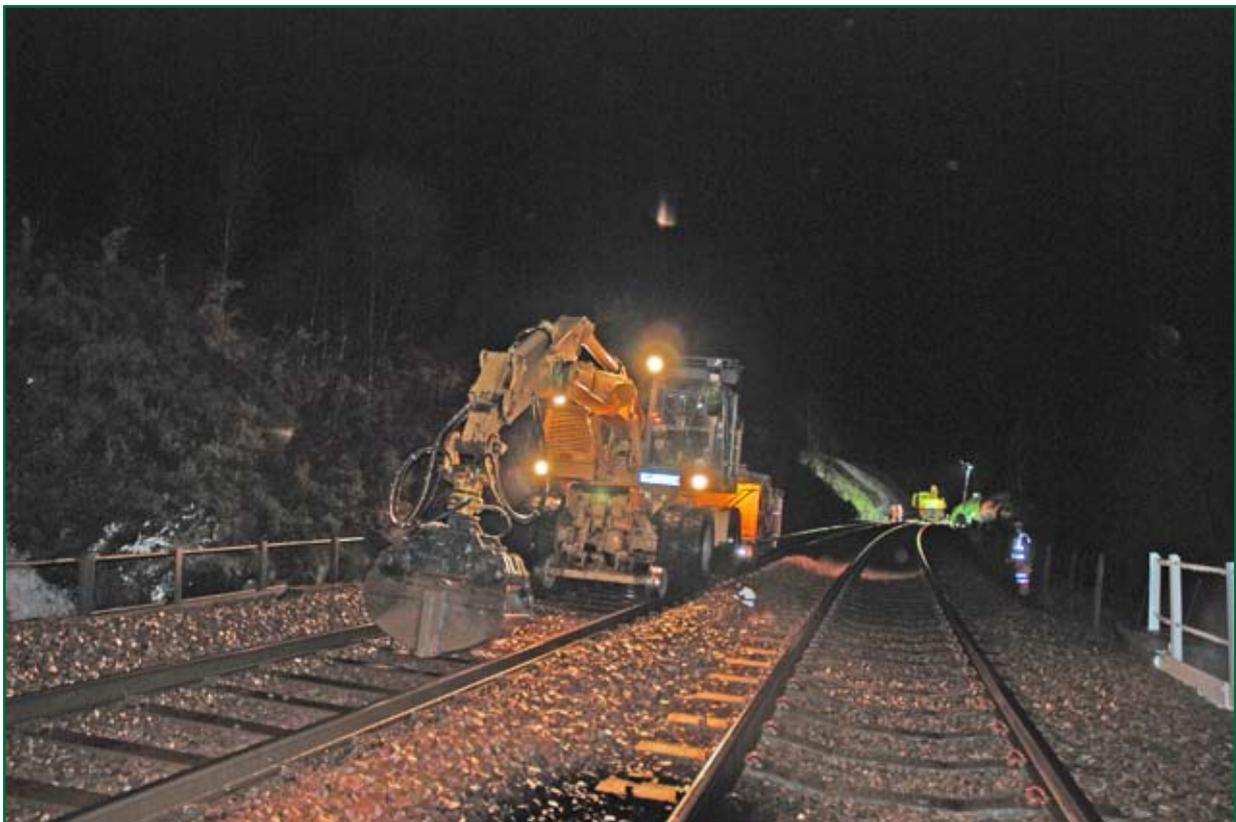
Figure 3: Colmar RRV and trailer immediately after incident (photo courtesy of Edmund Nuttall Ltd).

- 21 The RRV and trailer ran into the work area as staff ran out of the way. The boom of the moving RRV was out in front of the machine and in line with the boom of the drilling rig RRV. The drilling rig RRV operator saw this and quickly raised his boom to allow the other RRV to pass beneath it. A minor collision between the two RRVs occurred which damaged the cab body work on both machines and broke the windows in the drilling rig RRV. The moving RRV continued for a further 90 m before coming to a stand. Figure 3 shows that RRV and its trailer in their final stopping position.

- 22 Nobody was injured in the incident. However, if the warning by the abseiler and rapid evasive action by all of the staff involved had not been taken, a serious accident could have ensued.

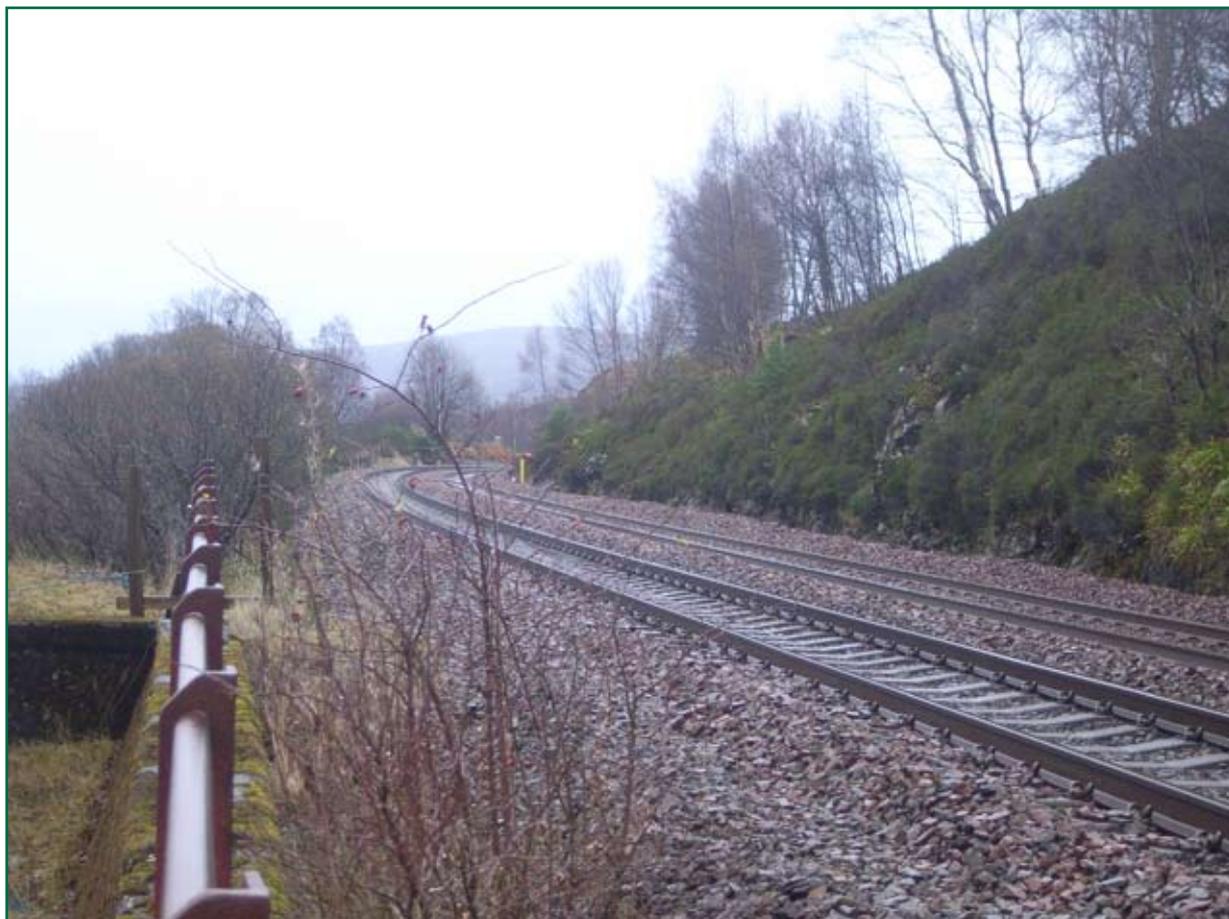
Figure 7: View towards the rock drilling site from the approximate location of the vegetation chipping site

- 18 Vegetation clearance work had taken place earlier in the shift and this involved dragging trees and branches across the down line. This may have contaminated the rail head with tree debris (paragraph 39). The presence of contamination could not be verified positively as the rail head condition was not examined after the incident.

- 45 During the time that it had taken for the Colmar RRV to on-track with its trailer, and to load the trailer with the materials and equipment, the Unimog RRV chipper had filled its chippings container and set off towards Red Van road rail access point on the up line, passing the Colmar RRV on its way. Figure 7 shows the view towards the work site from the approximate location of the chipping work.

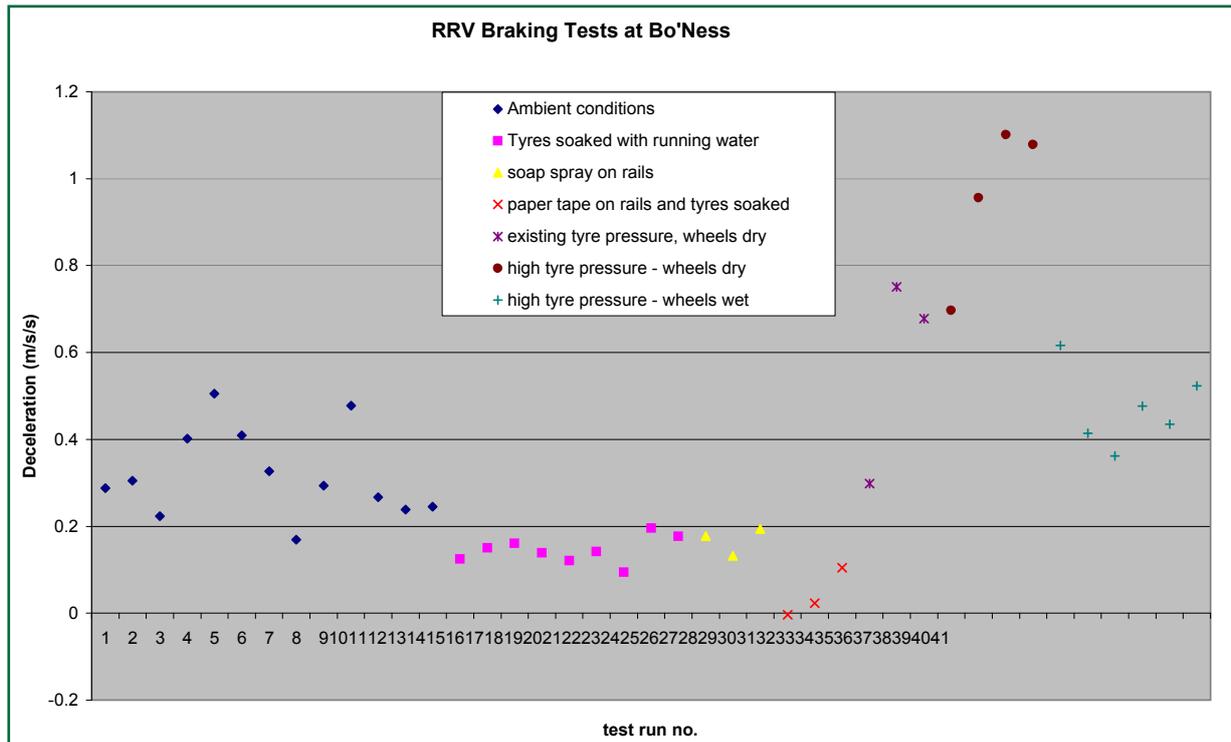
Figure 9: Deceleration rates for Colmar RRV and trailer on 1:66 gradient from tests at Bo'ness

- 101 The results of the braking tests on the gradient are shown in Figure 9 as deceleration rates. Calculations were made using the coefficients of friction derived from the test results to determine the maximum gradient on which the RRV could hold its load in wet and dry conditions with one or two trailers. These calculations indicated that the gradient at which the RRV would not be able to hold the weight of two trailers in the wet was between 1:25 and 1:34. Since RRVs of this type are allowed to operate with two trailers on gradients up to 1:30 without regard to the weather conditions, a hazard existed. Consequently, the RAIB issued an urgent safety advice to the industry on 21 December 2007 to bring this to their attention. One of the measures advised by the RAIB was to carry out a *running brake test* of the RRV/trailer consist when starting out, so that the operator has a feel for the conditions that prevail at the time. The full text of the urgent safety advice is given in Appendix C.

- 102 The tests with simulated leaf mulch on the gradient showed that the RRV and trailer was unable to stop on the contaminated rail, with slip occurring between the steel wheels and the rails. The coefficient of friction derived from the first test was 0.02, which is similar to friction values measured during braking tests on trains in low adhesion conditions. The paper tape, when used with trains, is quite robust but in the tests with the RRV it was found that the RRV wheels damaged the tape as they passed over it. Consequently, each of the following test runs encountered better adhesion conditions than the previous run as sections of paper tape were removed by each pass of the RRV. The friction coefficient therefore improved with each run; on the second run it was 0.03 and on the third it was 0.04. After each test run the RRV had to travel back up the gradient ready for the next run. When the RRV attempted to travel back over the paper tape it was found that the friction available between its wheels and the rails was insufficient to push the trailer up the slope.

- 104 The tests showed that the RRV with its trailer was able to stop on the gradient in wet conditions provided that the rails were not contaminated. If the rails were contaminated such that the friction was reduced to a similar level to that experienced by trains in poor adhesion conditions, the RRV would be unable to stop with its trailer and be unable to hold that trailer on the gradient.
