Rail Accident Investigation Branch

Rail Accident Report

Passenger train derailment near Fisherground on the Ravenglass & Eskdale Railway 12 May 2007

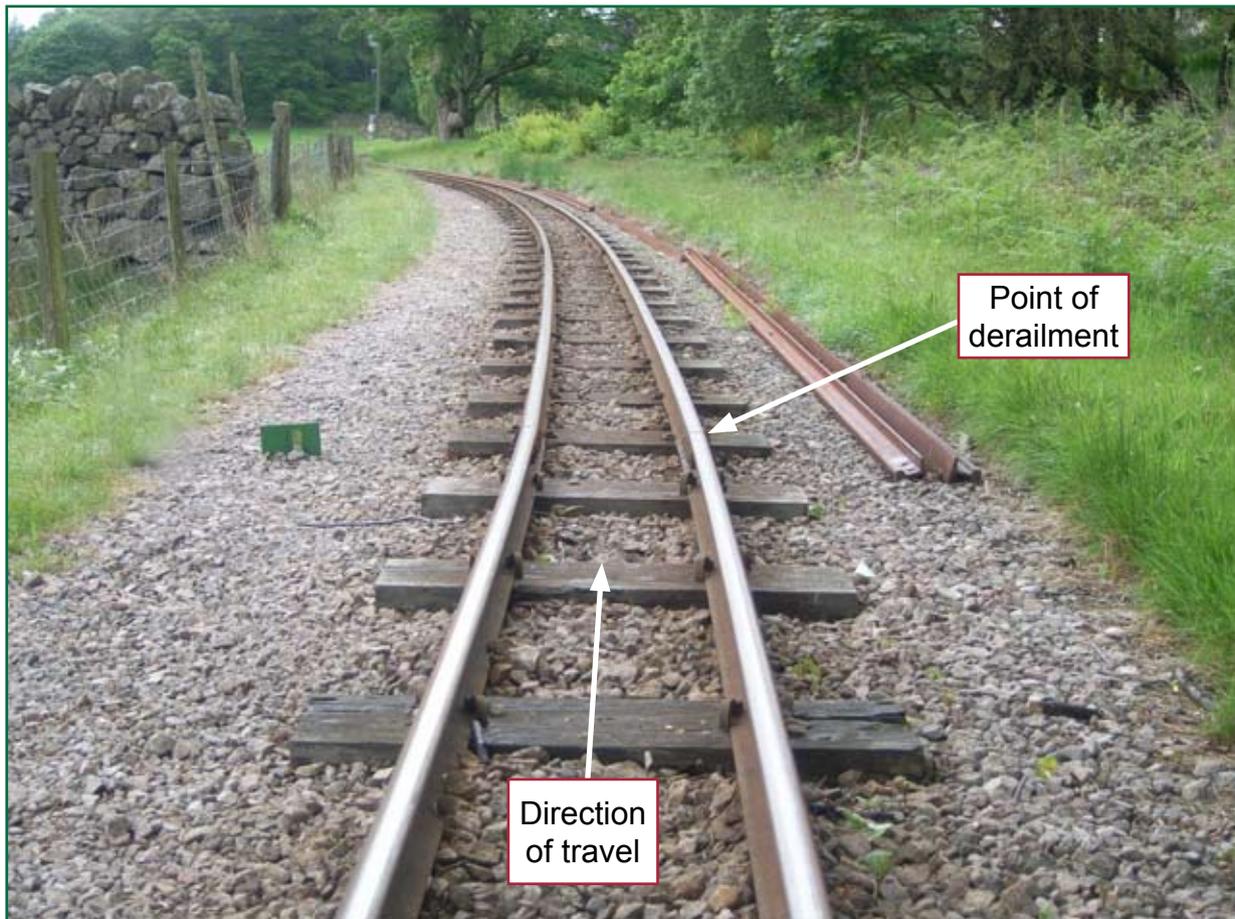
Figure 2: Site of derailment at Hollin How

- 26 Although the POD was at the start of a stretch of track which was awaiting renewal, there was no evidence of track vertical or lateral alignment problems nor voiding in the immediate vicinity of the POD, which could have directly caused or contributed to the derailment.

27 There was a rail joint in the sleeper bay just before the POD which had a dip of 4-5 mm on the right hand rail and 2-3 mm on the left hand rail causing a slight track twist at this point. A right rail dip of 4-5 mm is considered by R&ER to be at the upper range of acceptability given that the track was approaching relaying and already had a temporary speed restriction. Although the track twist at the rail joint was insufficient to have caused the derailment, it would have exacerbated any wheel unloading arising from a suspension collapse (paragraph 35).

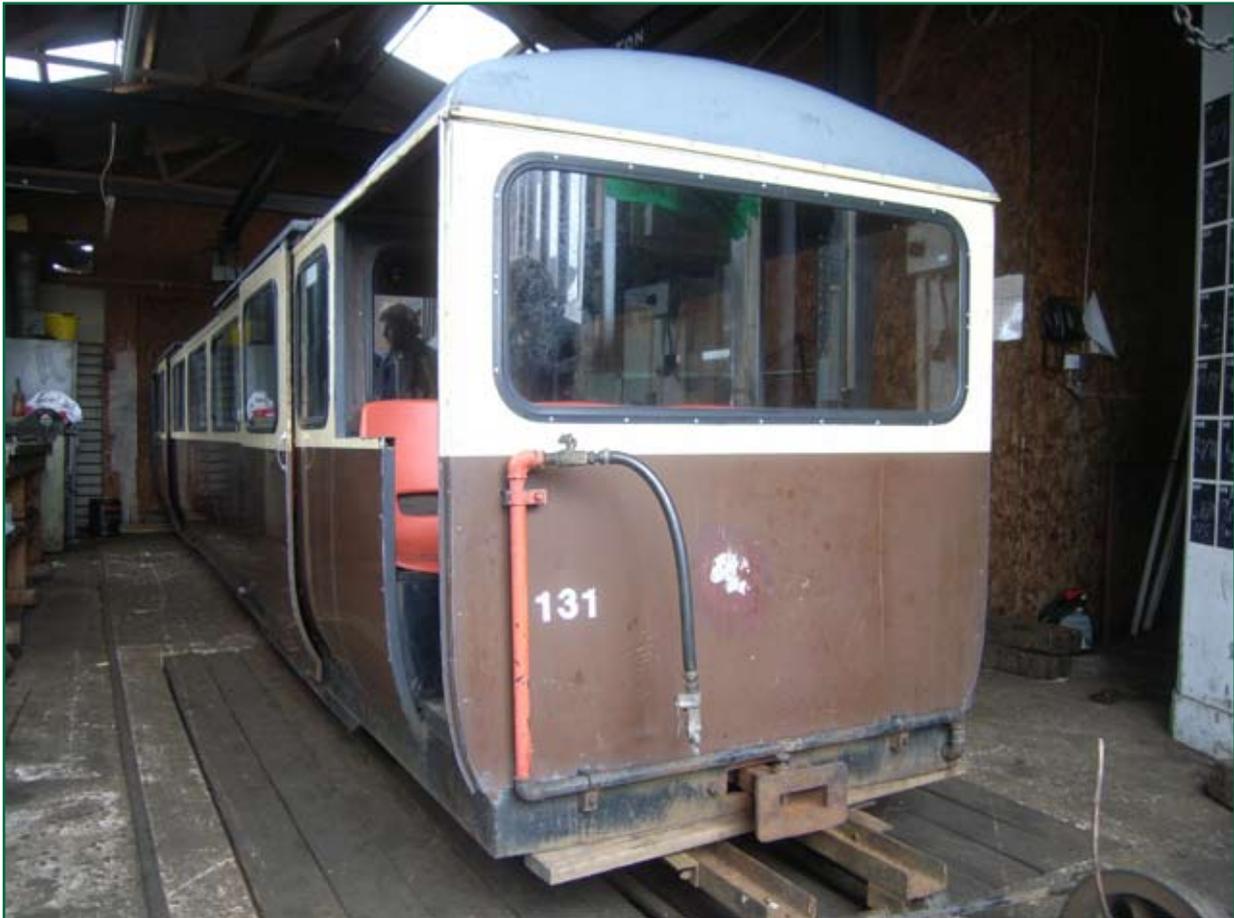
Figure 3: Maxi coach 131 with leading end (nearest) on skidder unit

- 19 The derailed coach was detached from the trailing coaches and the leading bogie was placed on a skidder unit (Figure 3). The trailing bogie was rerailed. The five remaining vehicles on site, including coach 131, were recovered back to Ravenglass later that evening.

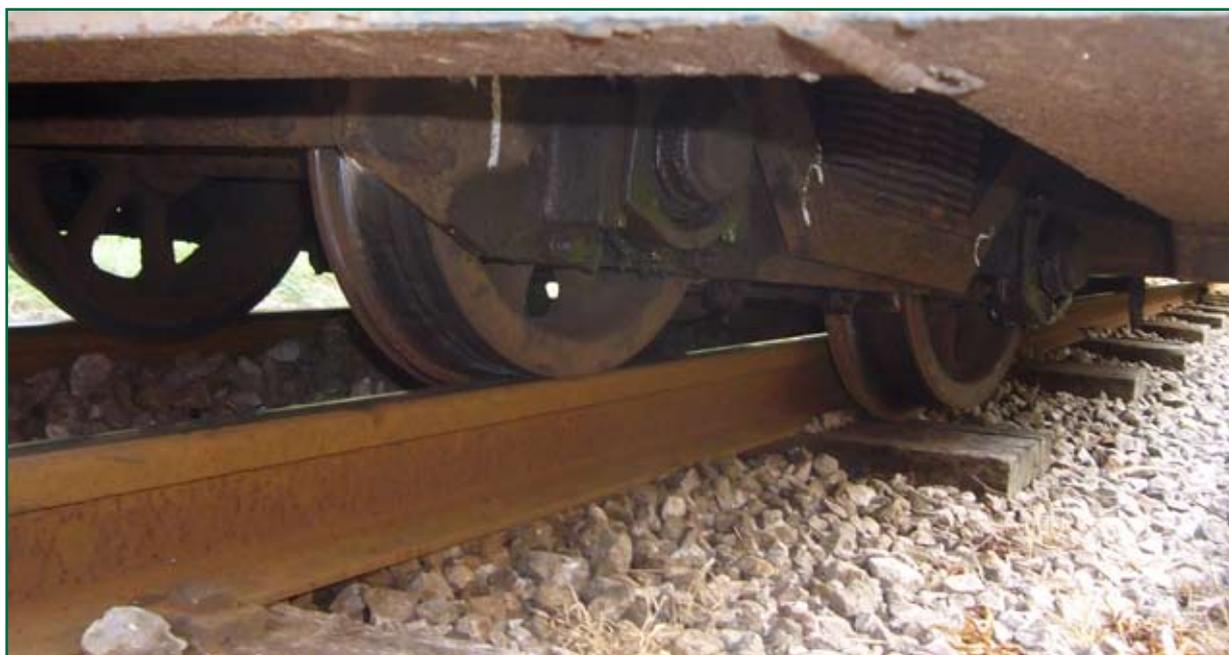
- 25 Track marks found shortly after the derailment showed that the leading right hand wheel of the trailing bogie on Maxi coach 131 had derailed by flange climb toward the outside of the curve (Figure 4), possibly aided by the prevailing dry wheel/rail conditions. The trailing wheelset of this bogie did not derail.

Figure 4: Derailed leading wheelset on trailing bogie of Maxi coach 131 on site at Hollin How (courtesy of R&ER)

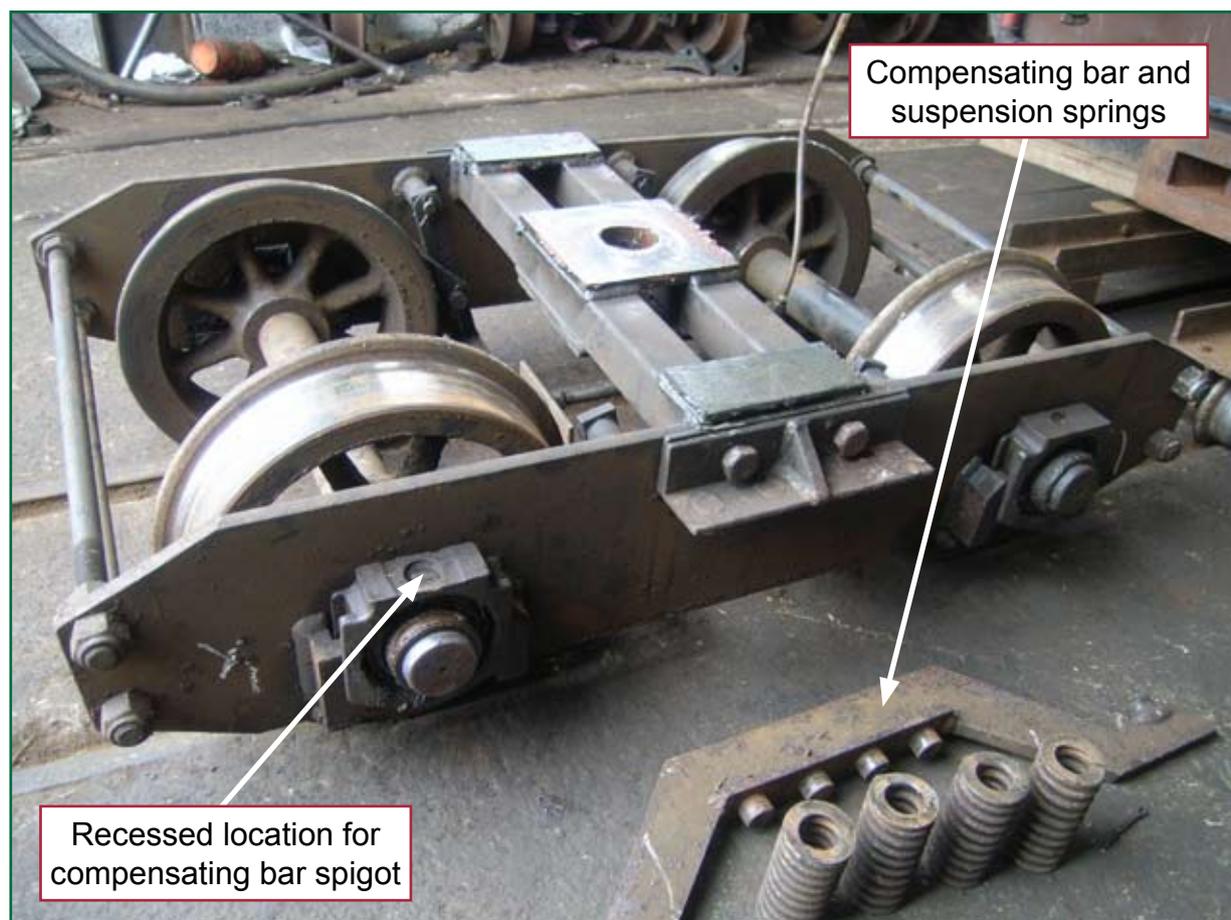
28 The compensating bar and the four coil springs on the left side of the leading bogie had fallen off 14 sleepers before the POD, causing the suspension on that side to collapse but without causing derailment of the leading bogie.

29 Each end of the compensating bar has a spigot which normally sits in a shallow locating recess on the top of the *axlebox* (Figure 5). The spigot at the leading end of the left hand compensating bar was severely scored with signs of overheating where it had been rubbing on the adjacent axle. The top of the axlebox also had signs of wear indicating that the spigot had been riding outside its recessed seat. The axle end showed corresponding signs of heavy wear confirming that the detachment of the bar and the subsequent drop onto the track was the initiating event rather than consequential.

Figure 5: Derailed leading bogie from Maxi coach 131 with compensating bar detached from left-hand side

- 32 Interview evidence indicated that the most likely cause of the compensating bar coming adrift at Hollin How was that it had not been properly seated in its axlebox locating recess when the bogie was reassembled. The work had been carried out under some time pressure due to the high workload at the time and the R&ER maintainer, who had over 20 years experience on this type of work, had not spotted the problem when the bogie was fitted to coach 131. The task sheet for the inspection contained only the result tables to be filled in as measurements were taken. There was no checklist for reassembly or any requirement for an independent check to be done following reassembly of the bogie.

- 33 Even with the spigot of the compensating bar sitting on the outer edge of the axlebox, the bogie can still be reassembled and will appear to run normally. However, in this condition the bar can shuffle along and fall off onto the axle end where it could ride for some time before falling off completely. This sequence of events appears to have been what happened in the lead up to the derailment and was confirmed by testing the bogie on coach 134 which was also found to have a displaced compensating bar. When suspension movements were induced by swaying the coach body from side to side, the compensating bar moved toward the outboard edge of the axlebox and had it been tested further, would have fallen onto the axle end.

- 43 R&ER have carried out the following actions since the derailment:
- Modified their bogie maintenance procedure to include an independent safety check by a competent person following bogie reassembly.

- Commenced fitting of retaining brackets to Maxi coach bogies and other bogie designs which feature compensating bars. The brackets are designed to keep the bars in place if they become dislodged from their axlebox housing for any reason.

1. Review and identify safety critical elements of engineering work on their bogies, including the re-fitting of compensating bars, and implement work procedures which include:
 - a primary check by the person undertaking the work; and
 - a secondary independent check signed off by a competent R&ER person to ensure that any problems are detected before entering service (paragraph 41).
2. Review their safety management system and operational procedures to identify if there are other areas where safety critical maintenance or design work is undertaken, or decisions are made, which should be subject to independent checking, and implement appropriate changes to procedures (paragraph 42).
