Rail Accident Investigation Branch

Rail Accident Report

Runaway and collision at Armathwaite 28 January 2007

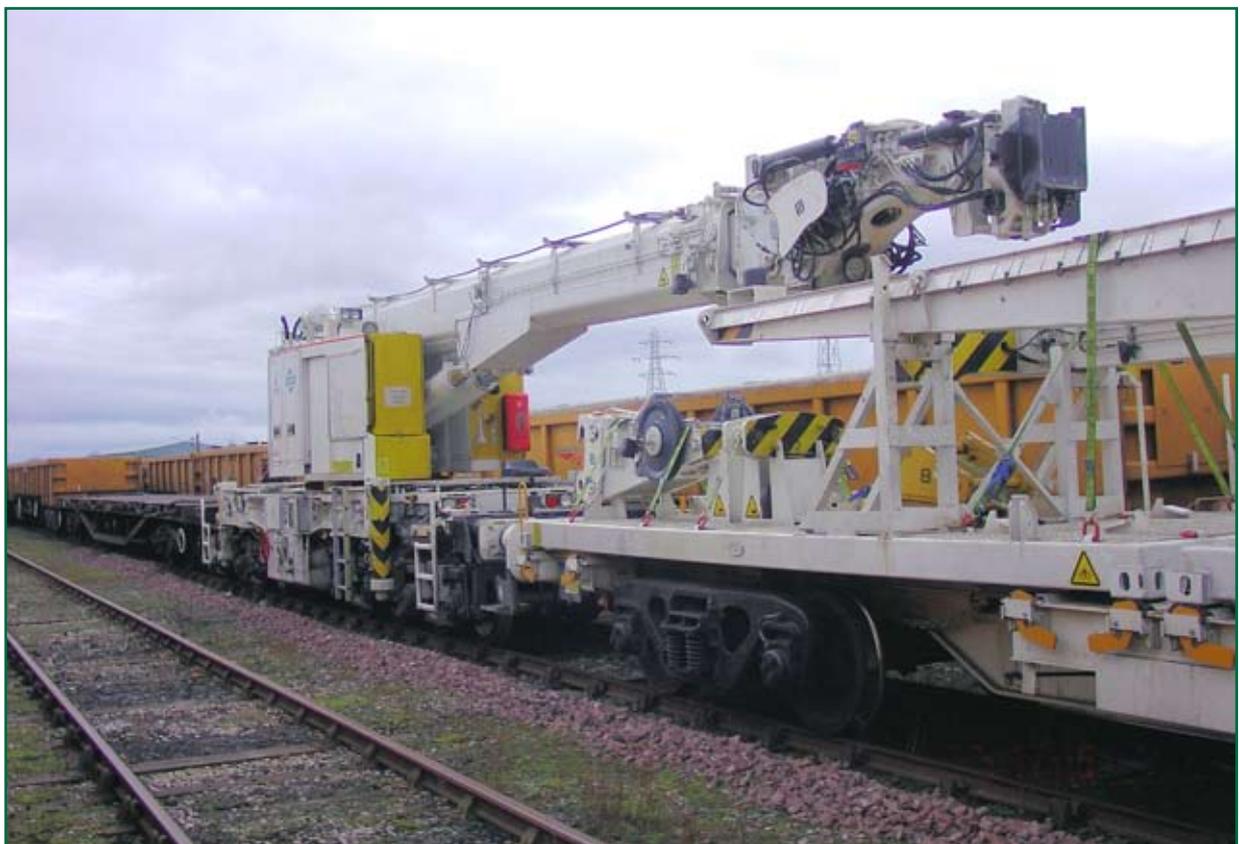
Figure 4: Kirow crane DKR81623 and its match wagon

- 25 A single match wagon accompanies the crane to provide storage for the lifting beam and any other materials required for working at site. Figure 4 shows the crane and its match wagon.

- 61 The derailment of the crane caused only minor damage: two bolts securing the *keeper bracket* for the rearmost bogie sheared causing it to become detached; the speedometer sensor was damaged; and a leaf spring on the rear bogie was dislodged. This damage was repaired as described in paragraphs 44 – 45.

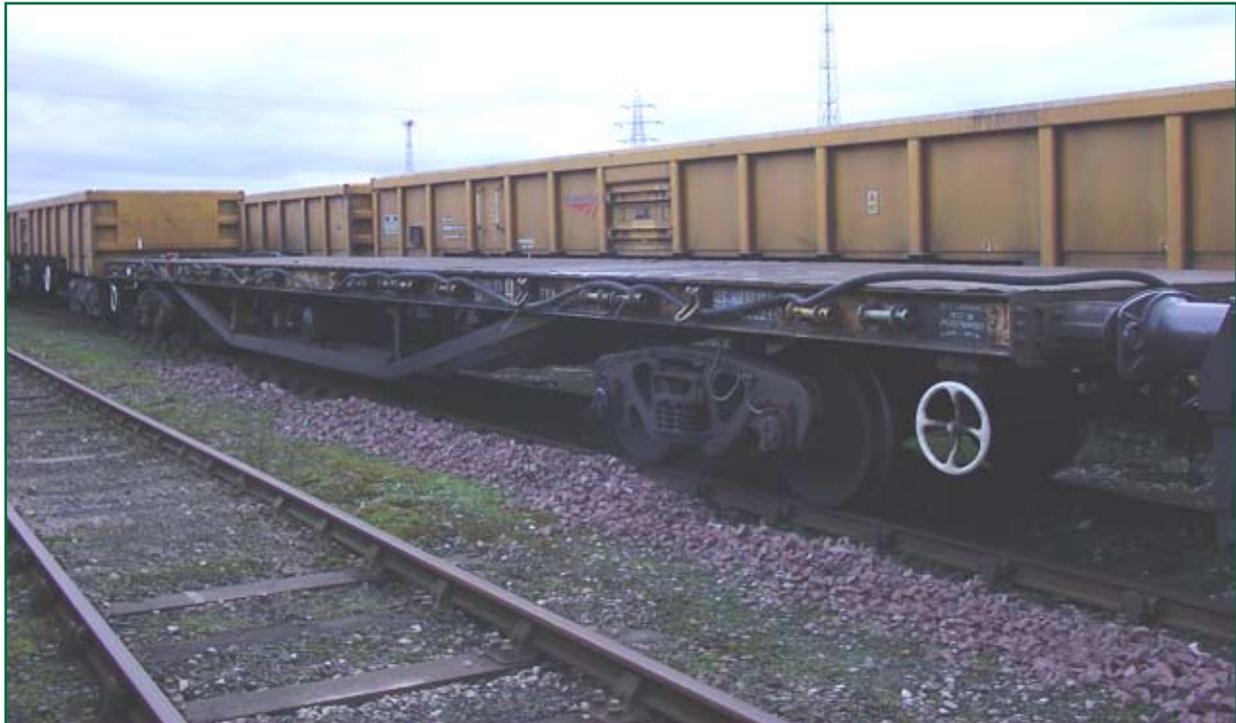
Figure 5: Salmon wagon DB996308

- 27 The salmon wagon is a bogie flat wagon with a *tare weight* of 24.84 tonnes that is normally used for carrying track panels to or from track renewals sites. At the time of the accident, the wagon in use for this purpose was numbered DB996308, and it was leased from EWS who were responsible for its maintenance. Figure 5 shows the salmon wagon.

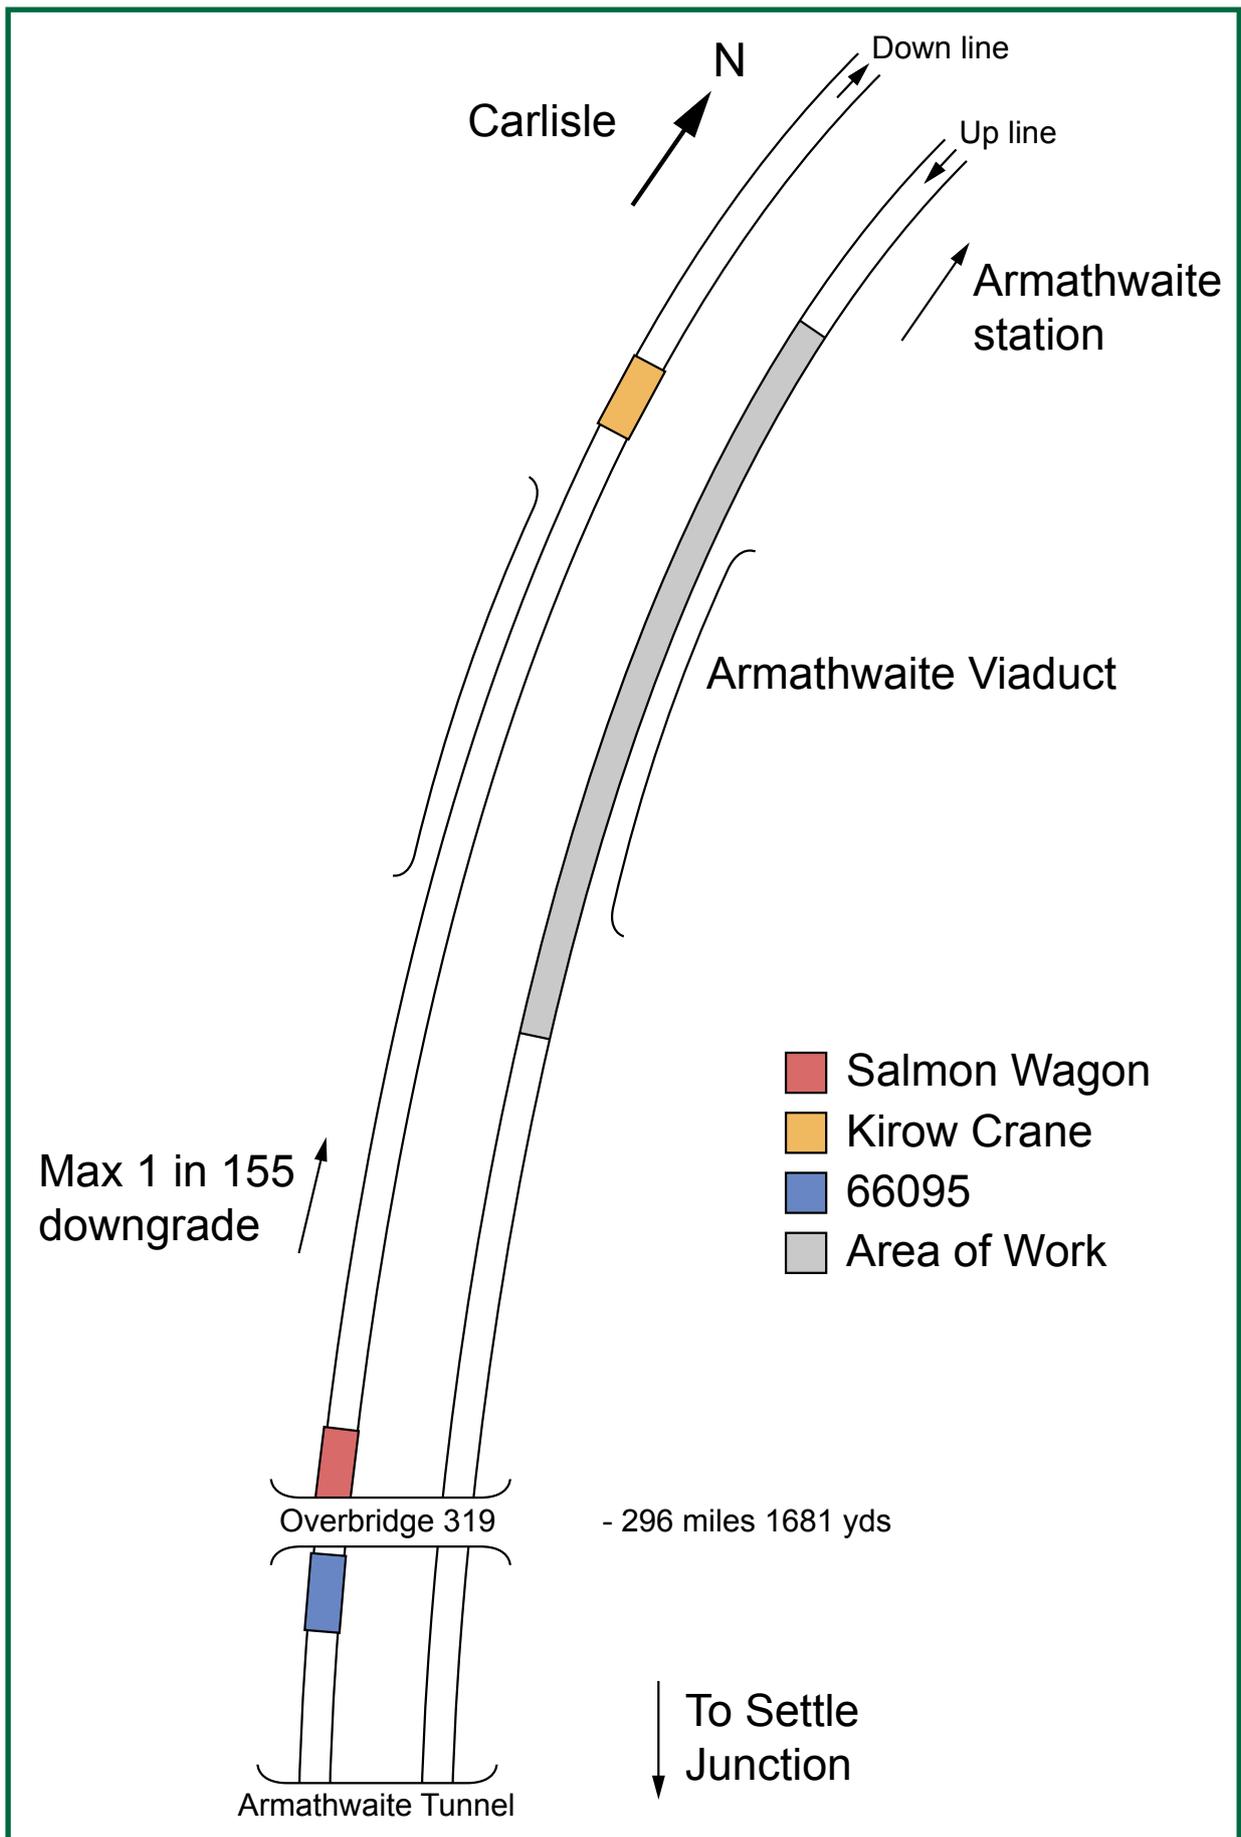
Figure 7: Location of vehicles at the worksite at the time the Kirow crane derailed

- 36 At 06:22 hrs on Sunday 28 February 2007, the crane derailed just north of Armathwaite viaduct. This was while it was lifting in new concrete sleepers and followed problems with the cant compensator system (see paragraph 58). Figure 7 shows the location of vehicles at the work site when the Kirow crane derailed.

- 58 The Kirow crane derailed while it was carrying 28 concrete sleepers by means of a lifting beam. This occurred after there had been several instances where the cant compensator system had locked up causing the crane's emergency brake to apply and an alarm to indicate. A cant compensator alarm should occur if the bogies and the superstructure are failing to respond properly to changes in cant to keep the crane's superstructure level. Investigation since the derailment of the crane by First Engineering and Kirow found that the alarms were spurious and caused by the cant compensator transducer being too sensitive.

- 59 After the last alarm, the crane operator manually reset the cant compensator and levelled the crane. However, because the load was still on the hook and the jib was *slewed*, the bogies compensated differently for the cant and this led to uneven loading of the wheelsets. A lightly loaded wheel on the high side of the cant caused the crane to derail.

- 107 The Kirow crane derailed because of a lightly loaded wheel on the high side of canted track (paragraph 59). This was caused because the crane operator incorrectly reset the cant compensator leading to the derailment of the crane. The crane operator had experienced several cant compensator alarms during the work which were spurious and caused by the cant compensator system being too sensitive. This is therefore a contributory factor.

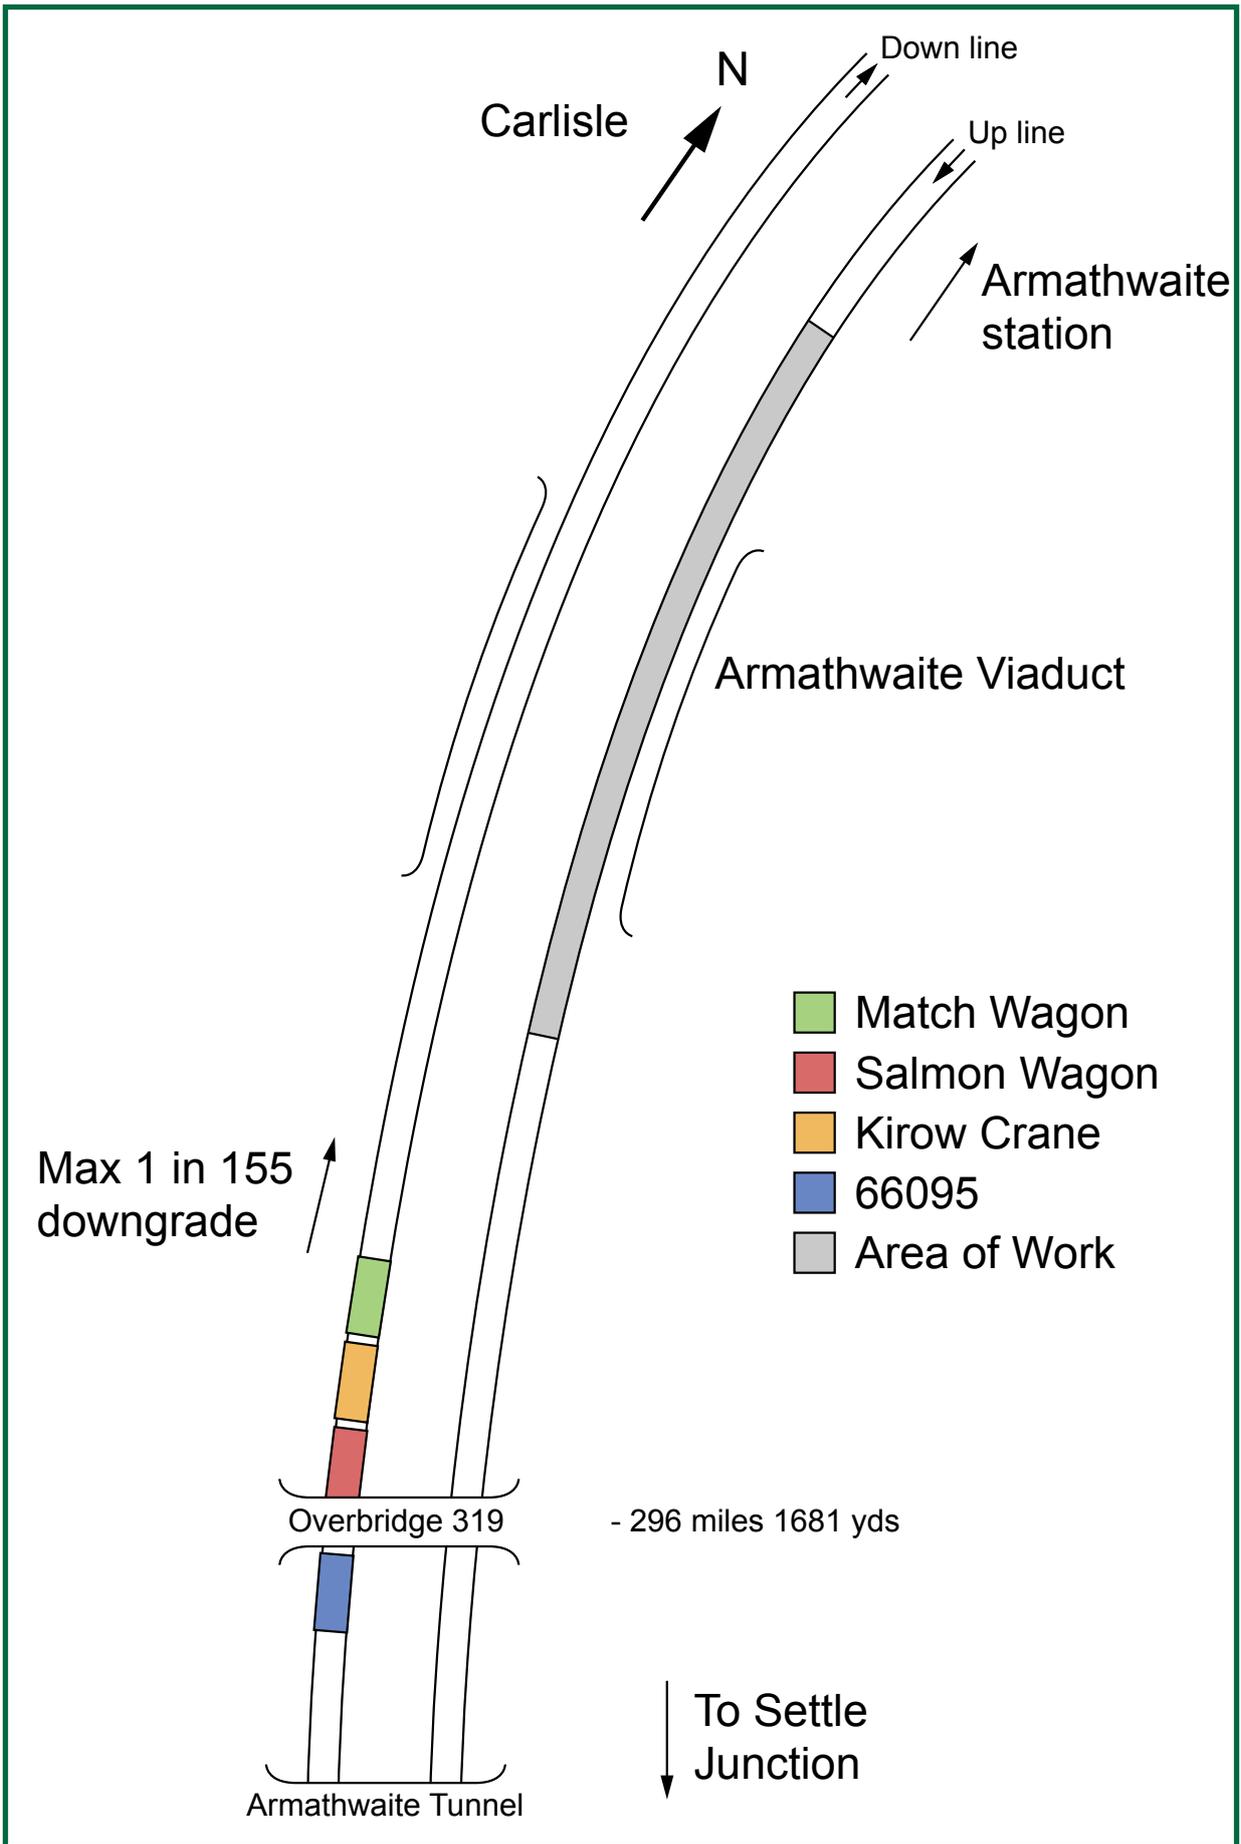
Figure 8: Location of vehicles at the time the crane was under repair

- 44 A few minutes later the First Engineering specialist engineer and another crane operator arrived at overbridge 319 on foot. At the same time, a First Engineering fitter, whose attendance had been arranged by the First Engineering specialist engineer, arrived from Glasgow with the parts necessary to repair the crane following its earlier derailment. Figure 8 shows the location of vehicles at the time the crane was under repair.

- 45 At around 12:50 hrs, the First Engineering specialist engineer advised the engineering supervisor that the crane had been repaired and was fit for further service. The crane was therefore uncoupled from the salmon wagon and the crane then driven back to where the work was taking place. After rigging the lifting beam and detaching the match wagon, the crane resumed lifting new sleepers into place.

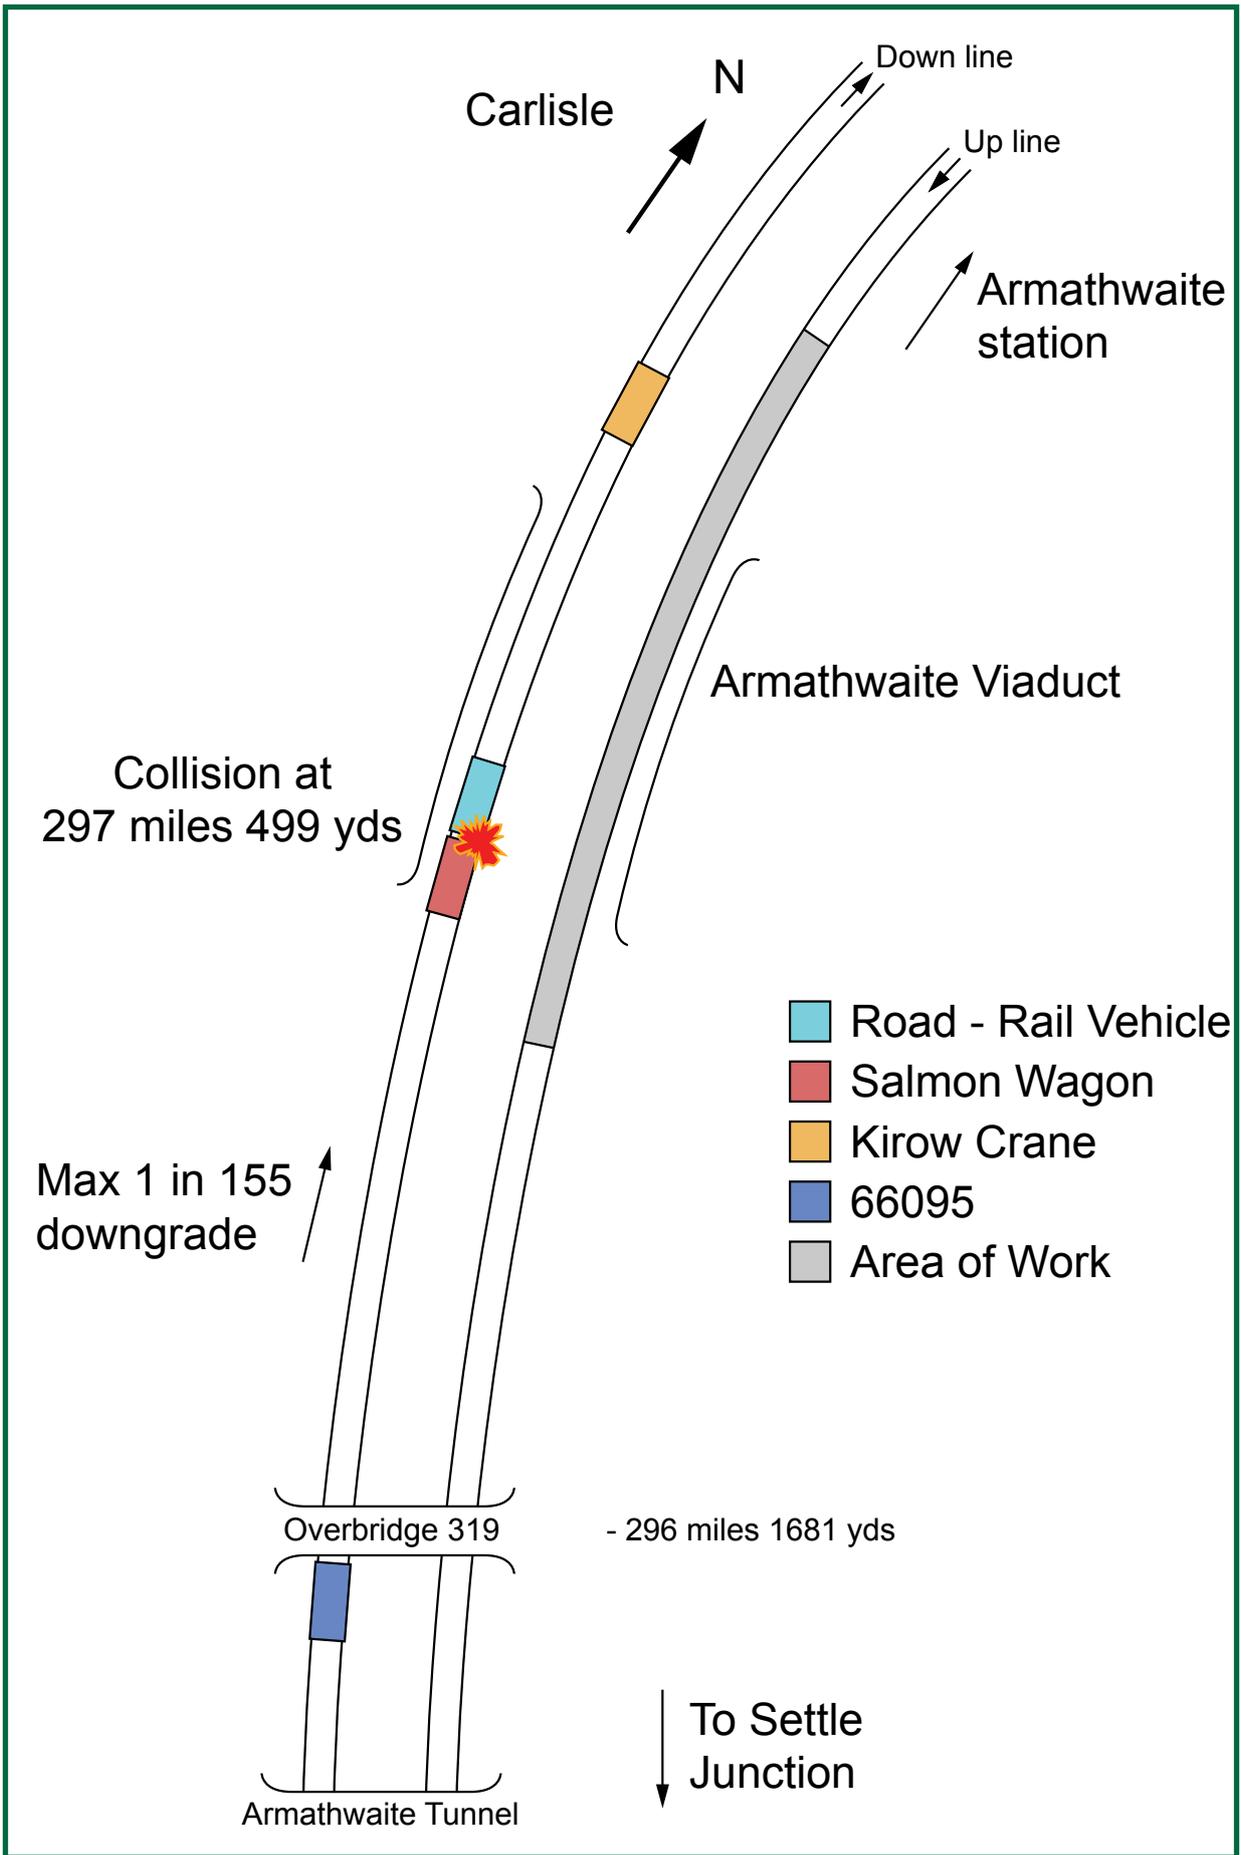
Figure 9: Location of the vehicles when the collision occurred

- 13 At about 14:15 hrs on Sunday 28 January 2007, a bogie flat wagon known as a salmon wagon ran away along the *down line* in the down direction near Armathwaite, Cumbria (Figure 1) and collided with a Case WX170 RRV positioning new rail with a thimble. This followed an accident earlier in the day, at 06:22 hrs, when a Kirow crane being used to lay new *sleepers* derailed.

- 97 Neither of the two handbrakes had been applied to the salmon wagon, and no scotches had been fitted to the wheels. There was nothing to prevent the wagon running away once the air had leaked out of the brake cylinders. Therefore, the immediate cause of the accident was that the wagon had not been secured on the gradient. This led to its runaway and ultimate collision.

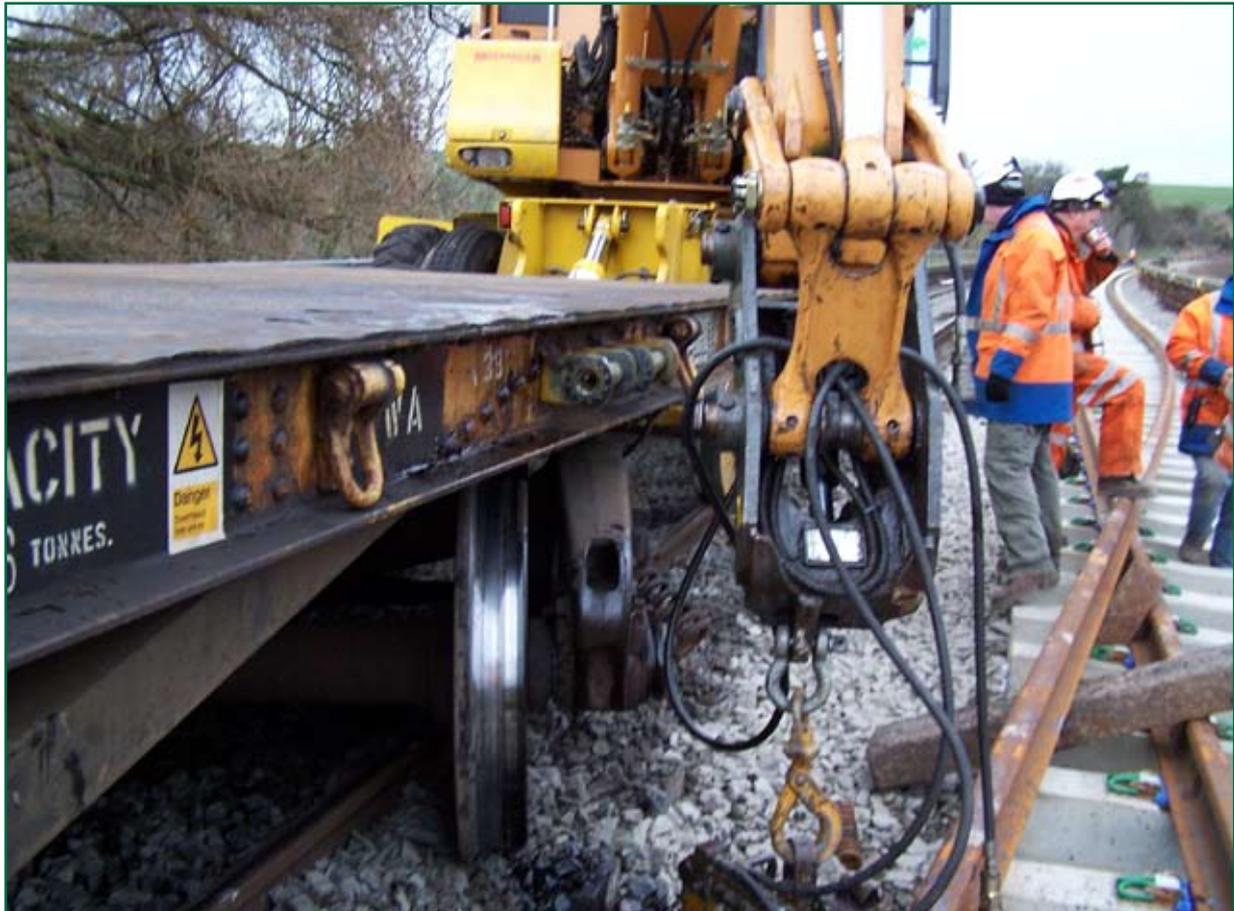
Figure 10: Consequences of the collision (by courtesy of Network Rail)

- 14 The impact following the runaway caused the leading bogie of the salmon wagon to derail. There were no injuries, apart from the operator of the RRV being shaken up, and little resultant damage to either the salmon wagon or the RRV.

- 49 From both witness evidence and subsequent calculations carried out by the RAIB, the speed at impact is likely to have been around 27 km/h (17 mph).
- 50 The impact caused the leading bogie of the salmon wagon to derail and pushed the RRV back along the railway by about 3 metres (3.28 yds).
- 51 The RRV was only superficially damaged, but the thimble being used to position the new rail was broken. Minor damage was caused to the salmon wagon including a snapped off brake pipe *air cock* and lamp bracket, and bogie springs in the leading derailed bogie that had come out of position. Figure 10 shows the consequences of the collision.
- 52 The RRV operator who had remained in his cab, although not injured, was shaken up as a result of the collision.

- 53 Work carried on at the work site to complete the renewal of the planned section of up line.
- 54 The salmon wagon was railed by 20:07 hrs the same day, and temporary repairs were carried out so that it could travel with the Kirow crane in train 6L62 as planned. Train 6L62 left the work site for Carlisle Yard at 05:30 hrs on 29 January 2007.
- 55 The possession was eventually given up at 08:45 hrs on 29 January 2007, three hours later than its booked finish time. This was caused by delays arising from the derailment of the Kirow crane and the collision between the salmon wagon and the RRV.

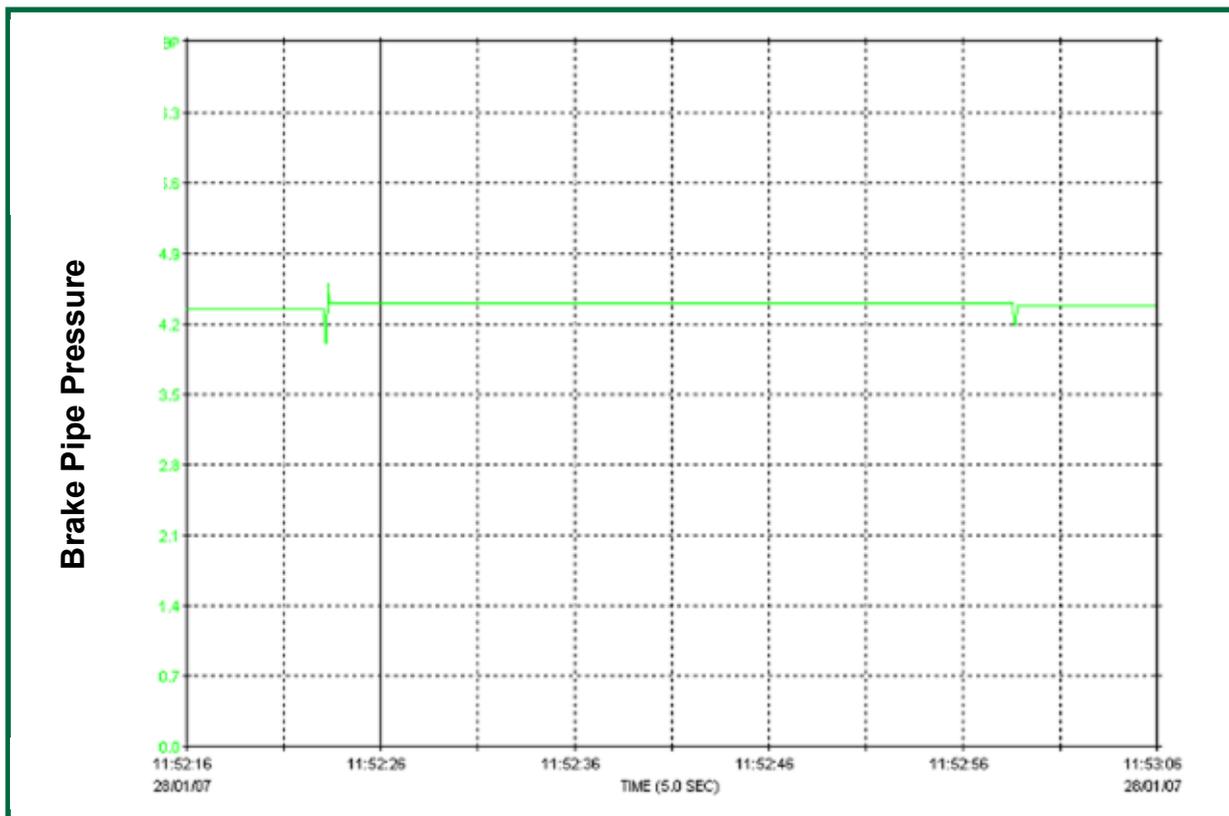
Figure 11: Extract from the download taken from the locomotive's OTMR

- 63 The OTMR output from locomotive 66095 showed two spikes on the locomotive brake pipe pressure trace at 11:52:24 hrs and at 11:52:58 hrs (see Figure 11). These are indicative of the crane's brake pipe being connected to the salmon wagon's brake pipe followed 34 seconds later by the salmon wagon's brake pipe being disconnected from the locomotive. It can be concluded from this, that at these same times, the salmon wagon was being coupled to the crane and uncoupled from the locomotive. The time between the two spikes on the brake pipe pressure trace is consistent with the time it takes to walk from one end of a salmon wagon to the other.

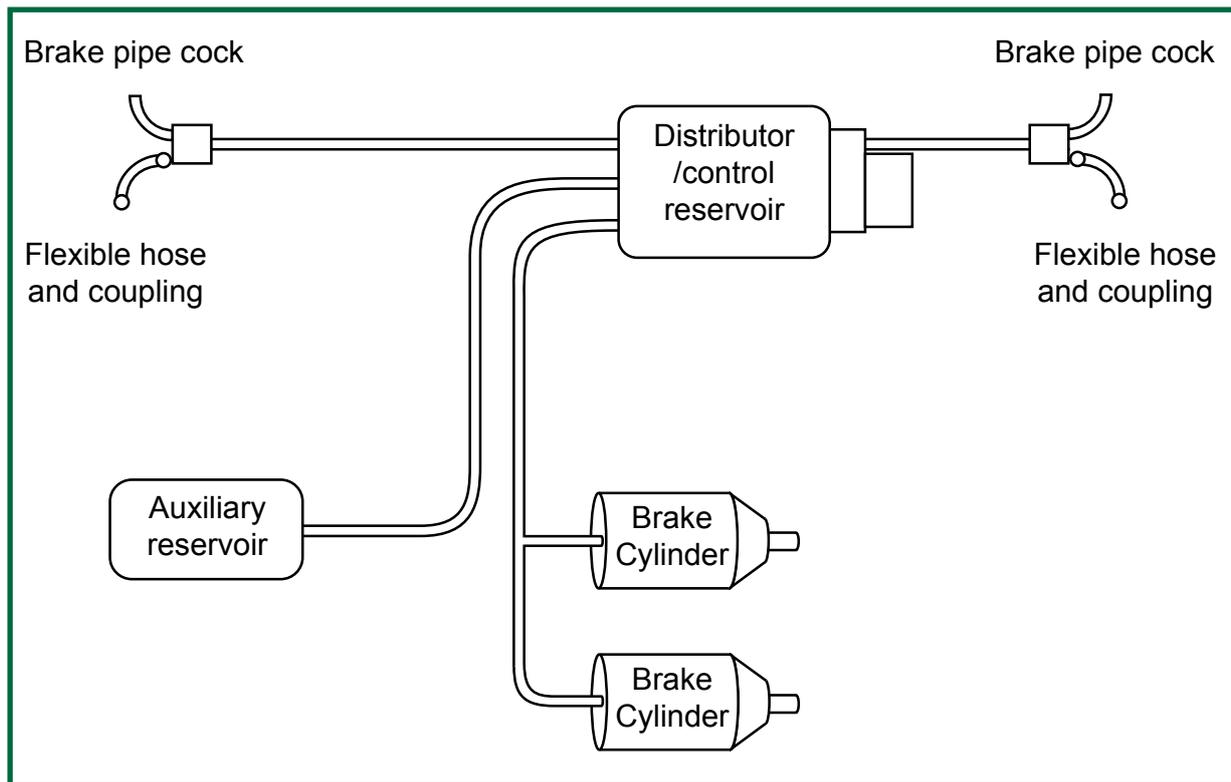
Figure 12: Salmon wagon braking system

- 64 A diagram of the brake system fitted to the salmon wagon is shown in Figure 12. The wagon is *single piped* and the air brake pipe runs the length of the vehicle. When the pressure in the brake pipe is reduced, for example through the action of the train driver applying the train's brake, the *distributor* causes air to flow from the auxiliary reservoir to the brake cylinders to apply the brake with a force (dependent on the pressure admitted) which is proportional to the amount of reduction of pressure in the air brake pipe. This proportionality is achieved by the variation in pressure between the brake pipe pressure and the pressure in the *control reservoir* which is normally maintained constant at 5 bar by the locomotive.

- 95 Therefore after the salmon wagon was uncoupled from the locomotive, there was a residual pressure of 4.4 bar in the brake pipe that had been delivered by the locomotive. At the same time, there would have been 5 bar of pressure (the normal running brake pressure) in the wagon distributor's control reservoir. Equalisation of these pressures causes the brakes to release.

- 96 The results of the brake tests on the salmon wagon (paragraph 65) showed that reducing the brake pipe pressure to 4.56 bar (equivalent to the 'initial' position of the train brake) resulted in brake cylinder pressures of 0.85 bar. The time taken for the cylinders to leak off from this pressure sufficiently to release the brake blocks from the wheels was between two and two and a half hours. Although the brake cylinder pressure would have been slightly higher than this (because the brake pipe pressure was actually reduced to 4.4 bar), once the salmon wagon was uncoupled from the locomotive (paragraph 41), the air in the brake cylinders leaked off in the period before it ran away (about 2 hrs 20 mins). This occurred while the crane was under repair, and subsequently when the salmon wagon was standing on the gradient uncoupled from any vehicle.
