Rail Accident Investigation Branch

Rail Accident Report

**Derailment in Hooley Cutting, near Merstham,
Surrey
13 January 2007**

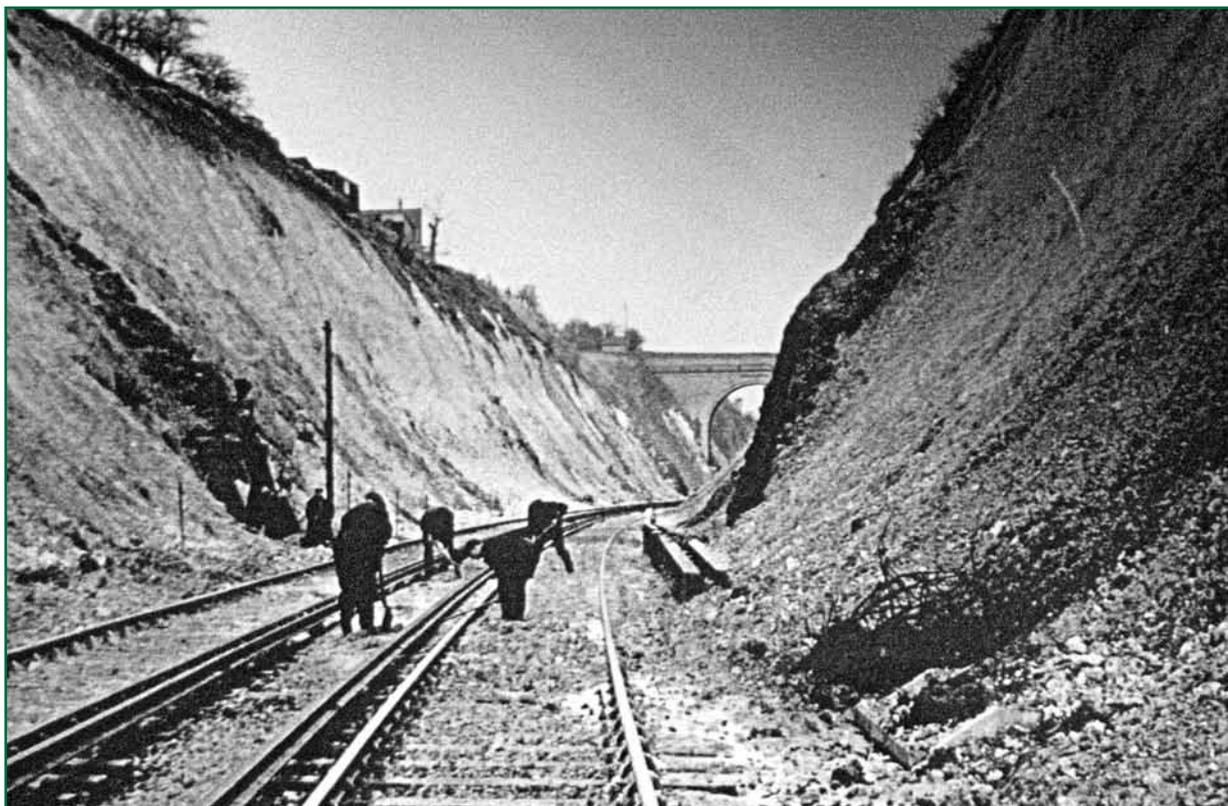
Figure 5: A rock fall on the down side of Hooley cutting during the snows of 1947. The variable depth of gravel can easily be seen on the left side of the cutting (courtesy of Network Rail)

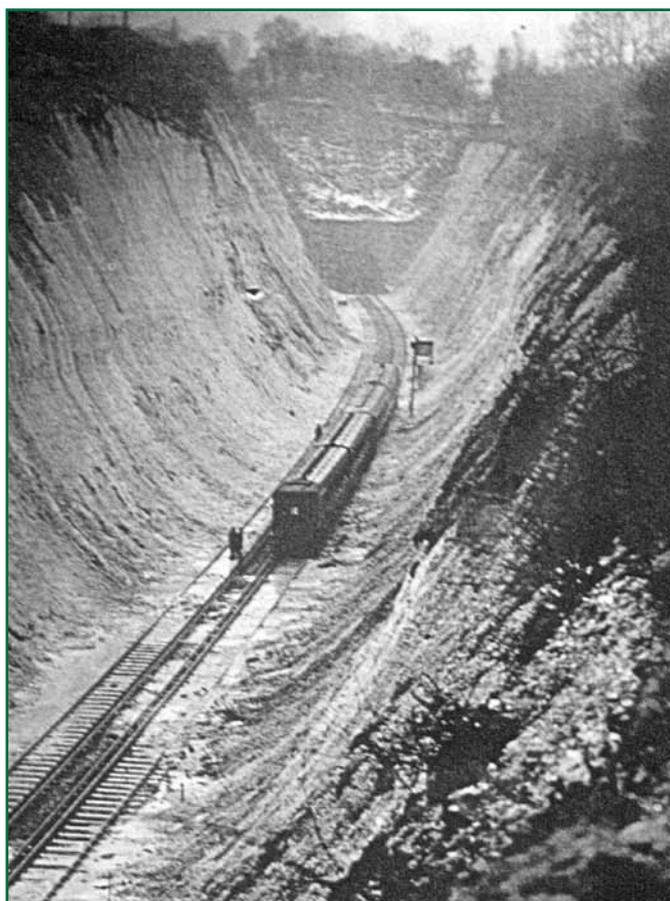
Figure 6: Photograph taken in 1947 showing a rock fall on the up side of Hooley cutting (courtesy of Network Rail)

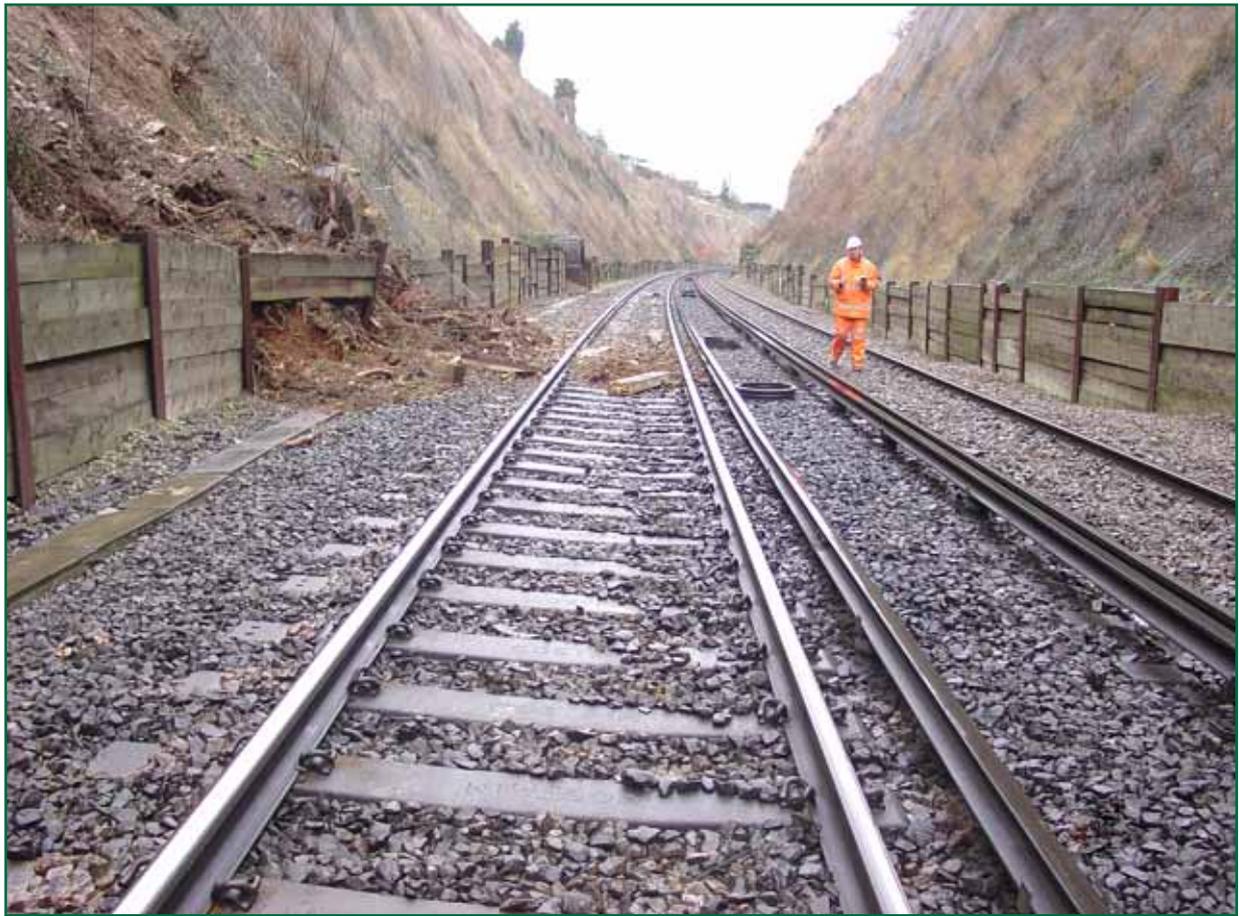
Figure 8: Hooley cutting following the derailment showing the king post wall viewed looking towards London.

38 Prior to train 1C23 emerging from the tunnel, a root ball from a previously felled tree (paragraphs 70 and 104) slipped down the cutting side approximately 100 m from the tunnel mouth. The root ball and ground material hit the king post wall, breaking the horizontal timber beams that formed the wall. Two of the beams were projected forward on to the up line (Figure 2), together with debris formed of gravel, clay, soil and small pieces of rock. The root ball was stopped from reaching the track by a vertical steel wall I beams. Most of the debris came to rest between the cess and the left hand rail (Figure 8).

- 104 The root ball came from a tree which had been felled sometime between 2001 and 2003. No records exist to determine the exact date although it is probable that it was felled in 2003 when most of the larger trees received attention. By 2007 the root ball had only rotted to a small extent. There were some small suckers growing from it indicating that it had not completely died. Most of the small roots that would have provided stability within the cutting side were missing (Figure 8).

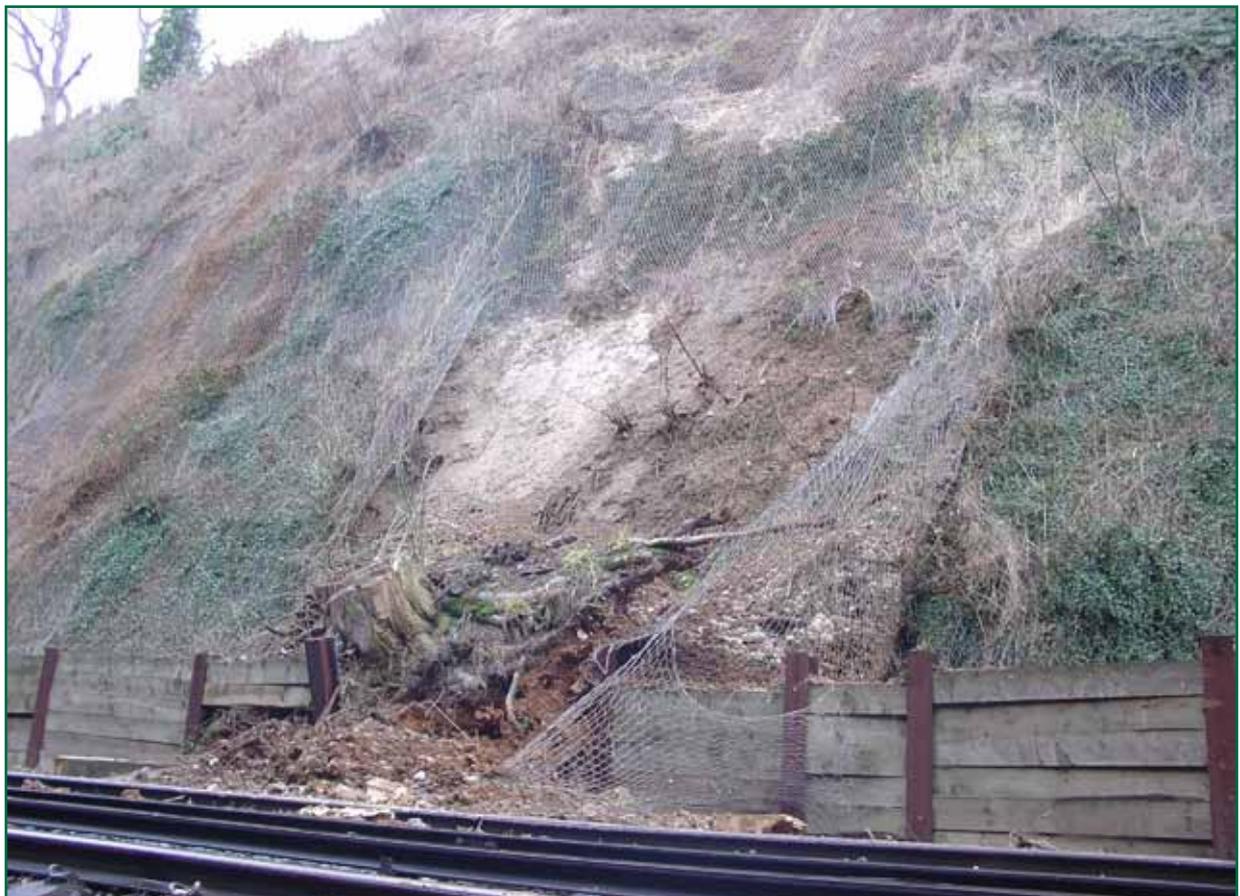
Figure 9: Hooley cutting showing the landslide

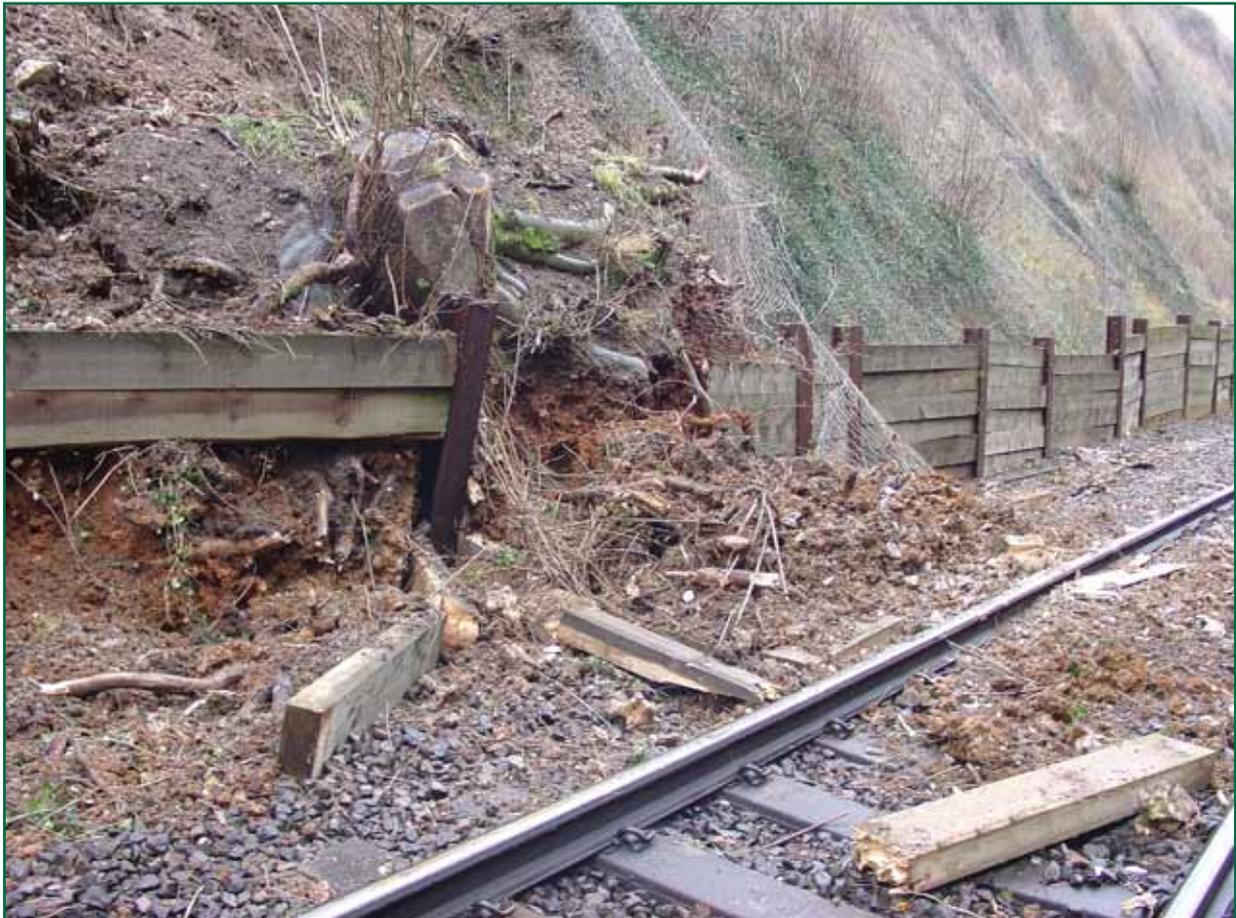
Figure 11: Debris on the track following the derailment

- 95 The debris blocking the line comprised gravel, clay, small pieces of rock, and broken parts of several timber beams from the king post wall. Most of the debris lay between the cess and the left hand rail. Only a small amount of debris lay between the rails. The 6 tonne (estimated) root ball had been contained by the wall; no part of it infringed the line, nor were any of the vertical columns displaced sufficiently to hit the train (Figures 8 and 9). Apart from the timber beams no material was present that was sufficiently large to derail a train.
- 96 The immediate cause of the derailment was an obstruction on the left hand rail formed by displaced timbers from the king post wall.

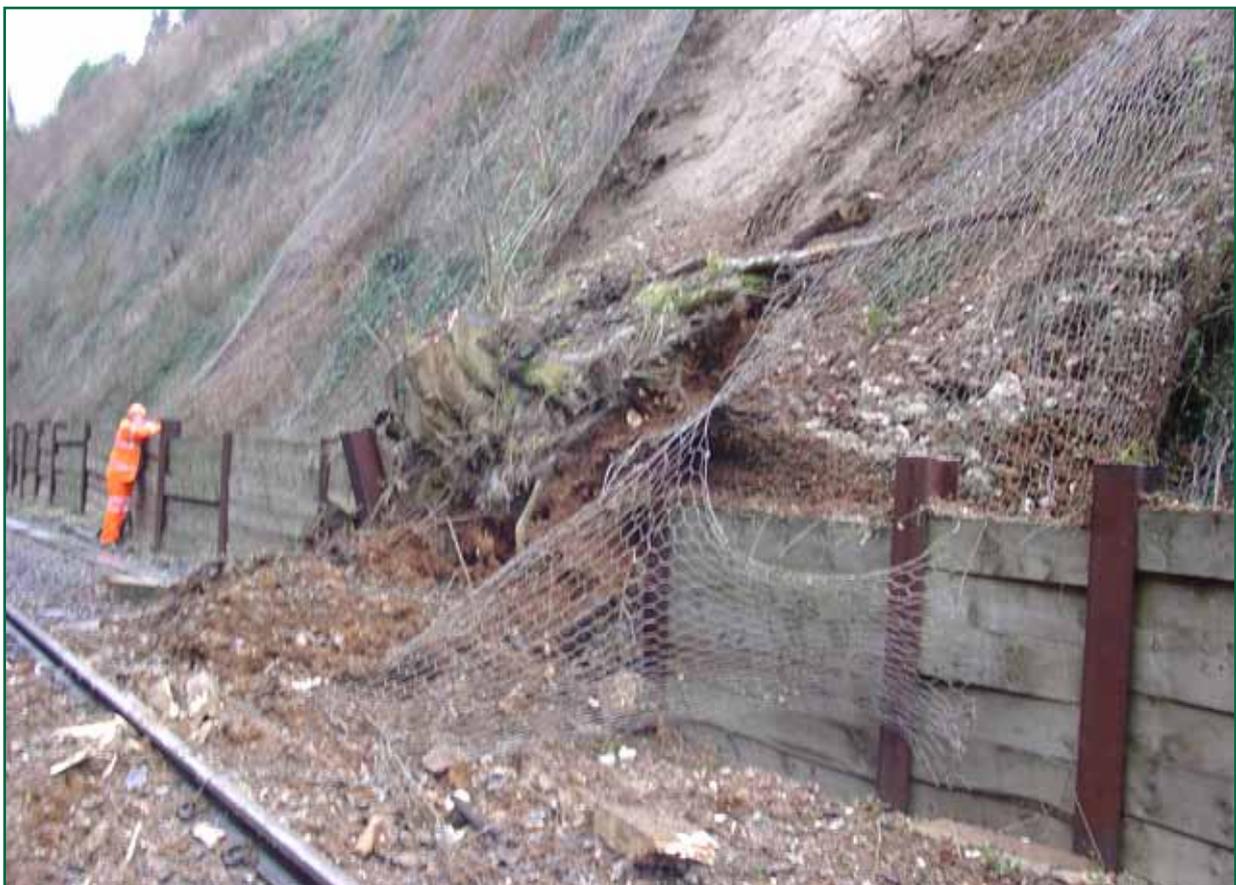
Figure 12: Debris and rootball against the king post wall

- 93 The fall of the root ball was contained by the steel verticals forming the king post wall. The impact displaced some of the timber beams, several of which were buried under small amounts of debris. Two beams were thrown forward towards the track. These were found in a broken condition. It was not possible to determine whether they had been broken by the initial impact from the tree stump or subsequently by the impact from a train wheel.
- 94 One of the vertical steel I beams was displaced towards the track by the impact from the tree stump. It did not foul the *structure gauge* of the line.

108 The mass of the root ball (paragraph 90) played a significant role in the damage that it caused to the king post wall. Had it been of lower mass then it may not have broken through the wall. The mass of the root ball was a causal factor.

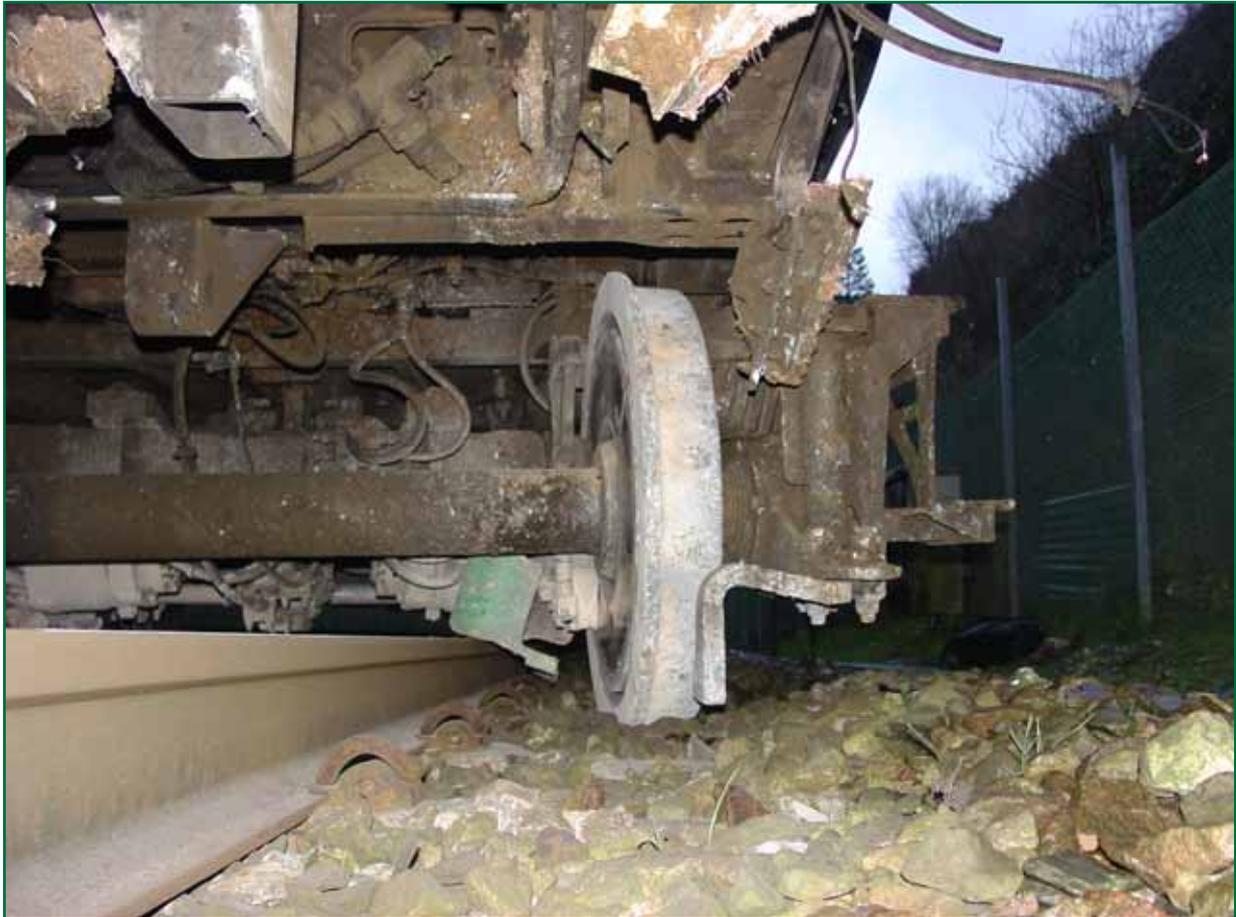
- 43 The leading wheelset derailed to the left (cess) side of the line and continued to run on the sleeper tops outside the Pandrol clips. Various items of train equipment were either detached or damaged by the debris or rails. In the derailed state the leading end of the front bogie ran approximately 200 mm lower than normal.
- 44 As they travelled over the sleepers the derailed wheels generated a large dense white cloud of concrete dust that obscured visibility through the side windows of the coaches. The train passed T466 signal before coming to a stand alongside Forge Bridge.

Figure 13: Damage to the front bogie of the train

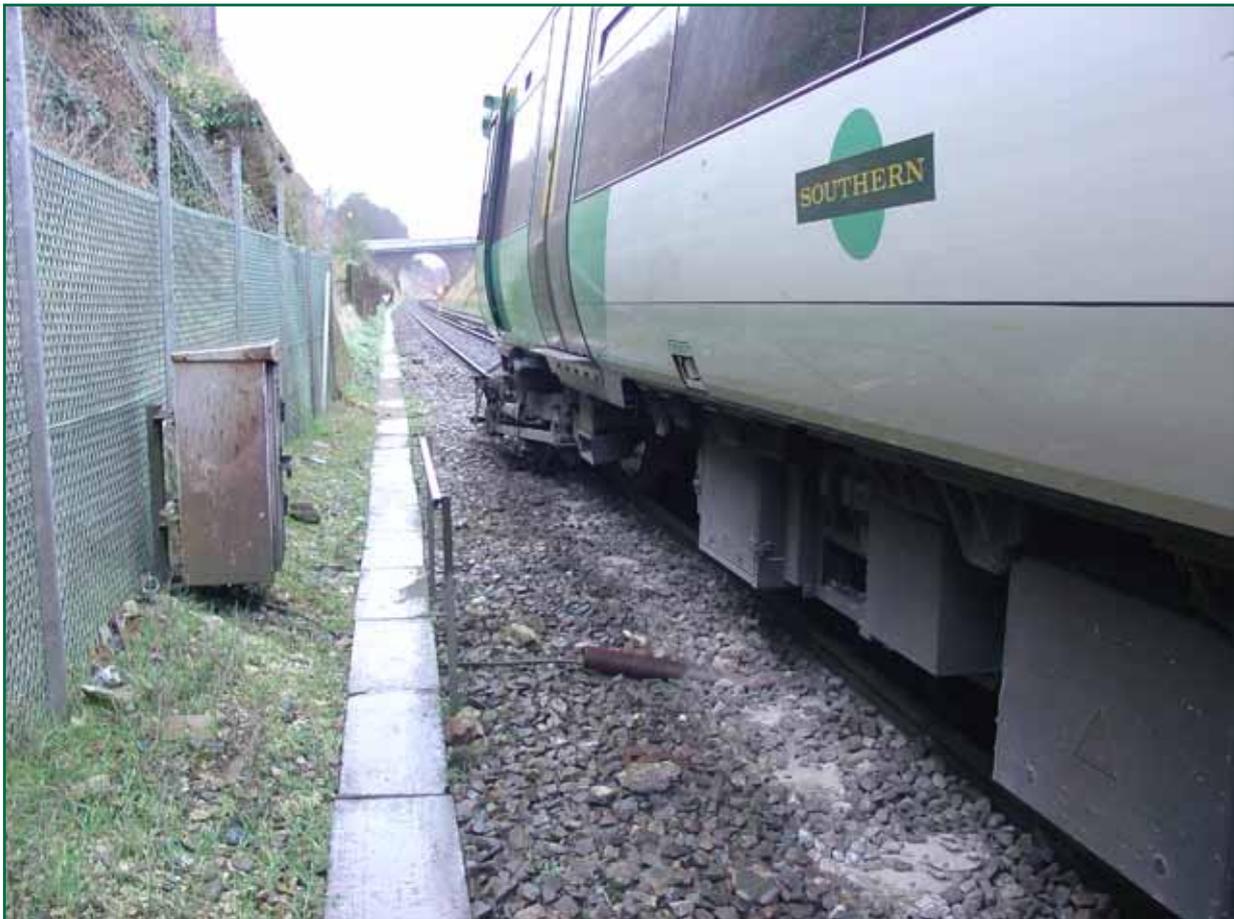
Figure 14: The derailed bogie and side of the train

- 55 Both units involved in the derailment were damaged. The flanges on the derailed wheelset were originally considered to be unsuitable for travel by Southern's Selhurst Traction Maintenance Depot Production Engineer, Southern's Lovers Walk Breakdown Supervisor and the EWS Breakdown Supervisor and arrangements were made for a *skate* to be used. When attempts were made to fit the skate to the leading bogie it was found that it would not fit. The original decision to require the train to be moved using a skate was reviewed by the above mentioned individuals. They decided to permit the train to be hauled to Selhurst depot at a very slow speed (10 mph) with inspections of the wheelset at approximately every mile. A 5 mph speed limit was imposed over switches and crossings. The movement was achieved without incident.

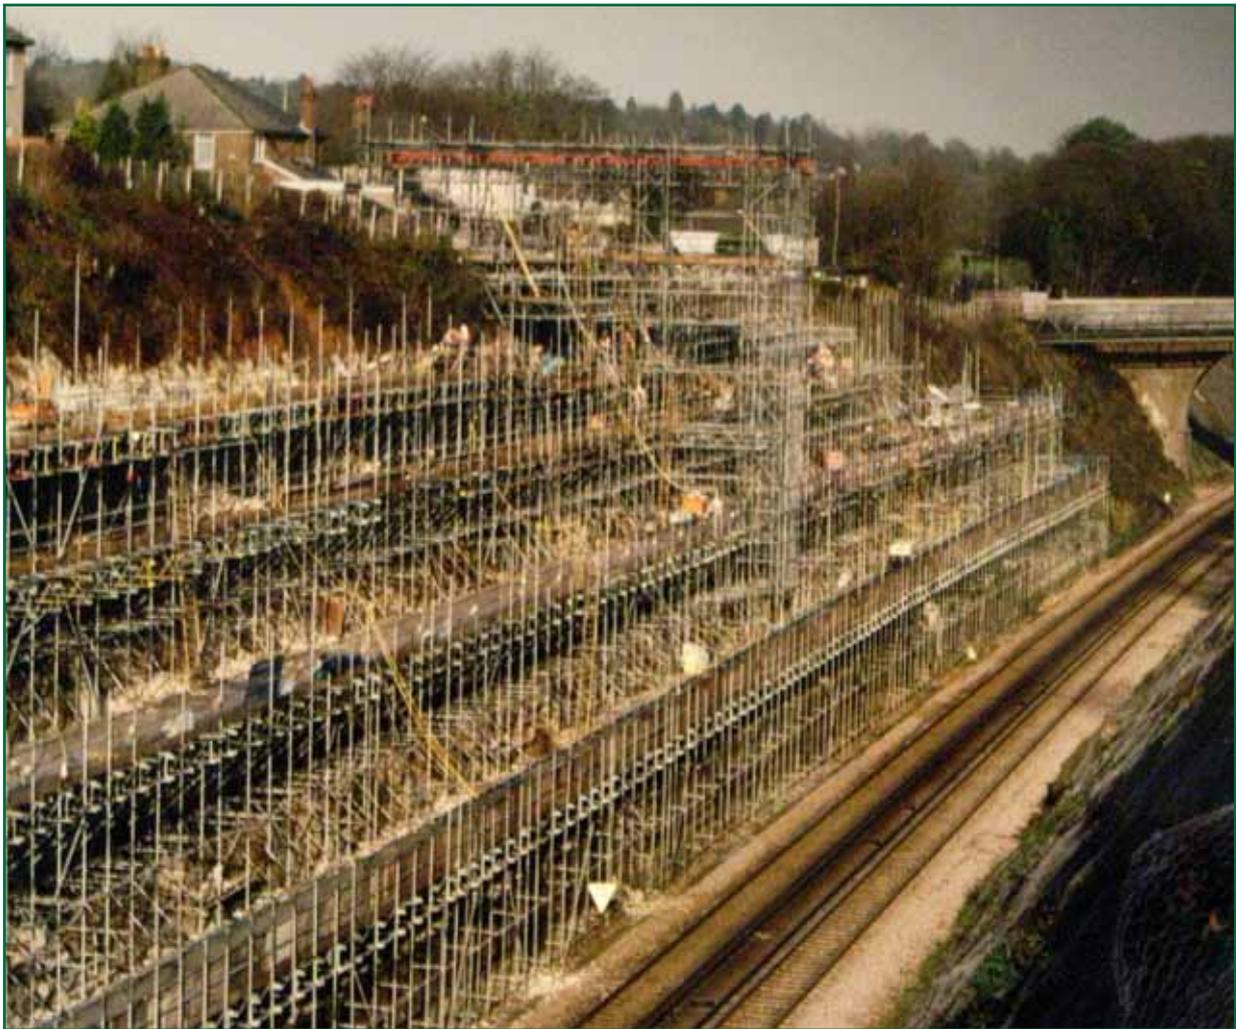
- 72 A package of stabilisation works was developed that addressed the risks of landslips to the properties at the top of the cutting and for rock falls towards the railway. The means of controlling the risk to the railway was by using steel netting secured by ground anchors at the top and bottom of the cutting. The netting had a capability of withholding rock falls of 0.5 tonnes per linear metre.

Figure 15: Photograph showing the stabilisation works of 2001 - 3 (courtesy of Network Rail)
