Rail Accident Investigation Branch

Rail Accident Investigation: Explanation of discontinuation

**Derailment of the jib runner of Crane
ADRC96702 at Greenford East Curve
20 November 2006**

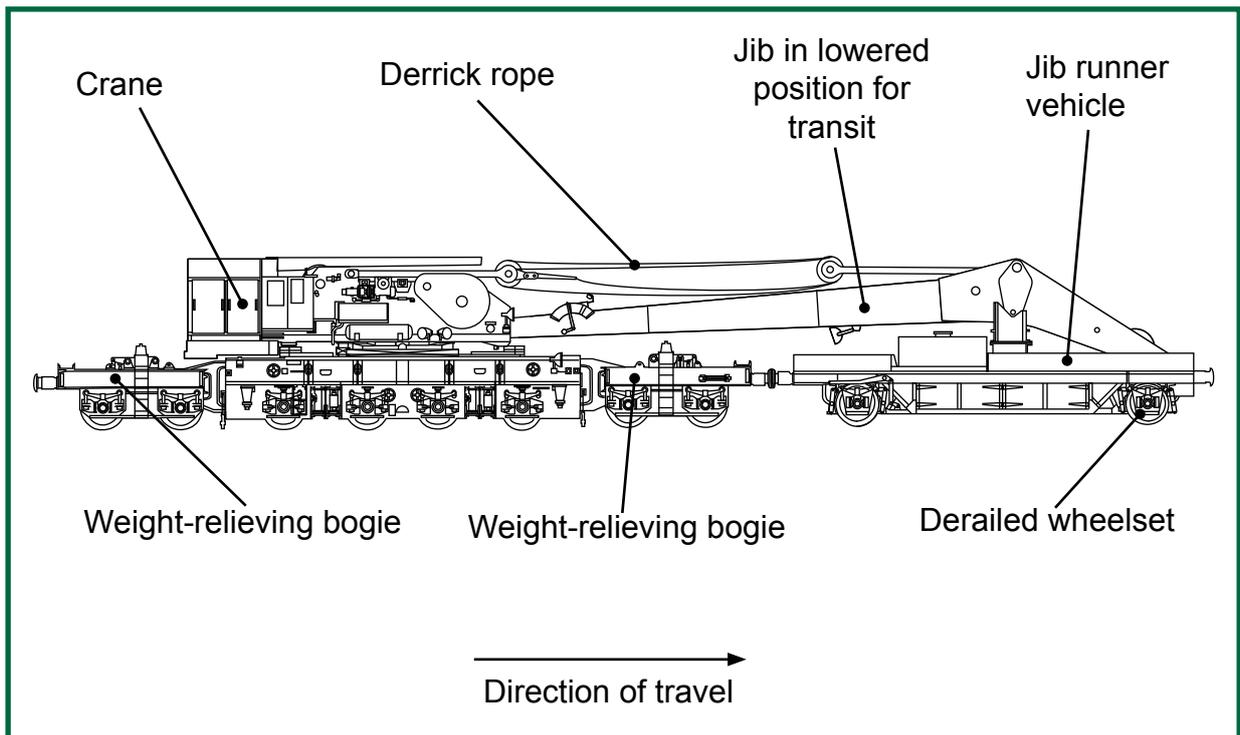
Figure 1: Crane ADRC96702 and jib runner vehicle

- 1 On 20 November 2006, breakdown train 2Z99 was travelling from Brighton to Old Oak Common depot in West London when the leading wheelset of the jib runner vehicle of crane ADRC96702 (Figure 1) derailed at 15:40 hrs on Greenford East Curve, near Greenford in West London. The derailment occurred at a speed of 13 mph (21 km/h).
- 2 The train, which was formed by the hauling Class 67 locomotive, three Mk1 coach type breakdown vans and rail crane ADRC96702, had left Brighton at 12:51 hrs, following a re-railing operation, and was on its return journey to Old Oak Common depot. Following the derailment, the train ran on for approximately 150 m before coming to rest, causing some damage to the jib runner vehicle and the track. There were no injuries.

- 10 CCTV images of train 2Z99 on its journey from Brighton were provided by Southern Railway to establish whether the derrick ropes (Figure 1), which are used to raise and lower the jib, had been correctly slackened prior to the journey.
