Rail Accident Investigation Branch

Rail Accident Report

Collision at Swanage station 16 November 2006

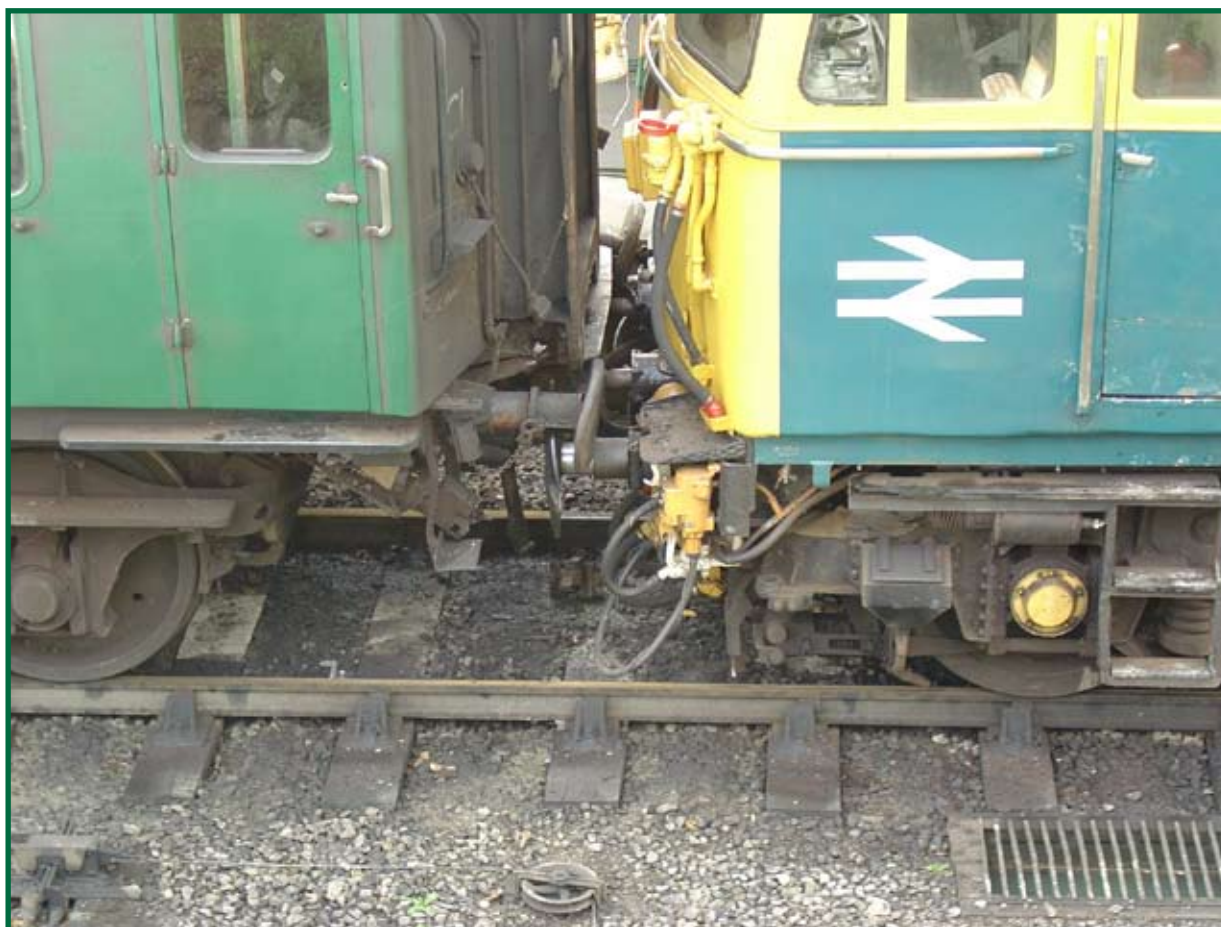
Figure 2: Damage sustained to the locomotive and carriage

- 46 The driver and one of the staff members working in the carriages were slightly injured.
- 47 The carriages were moved 0.6 m towards the buffer stops as a result of the collision. Locomotive 33 108 and the westernmost carriage became buffer-locked (Figure 2).
- 48 Locomotive 33 108 suffered damage to its buffers, buffer beam and body panels at the eastern end.
- 49 The westernmost carriage suffered damage to its buffers and a bogie centre casting.

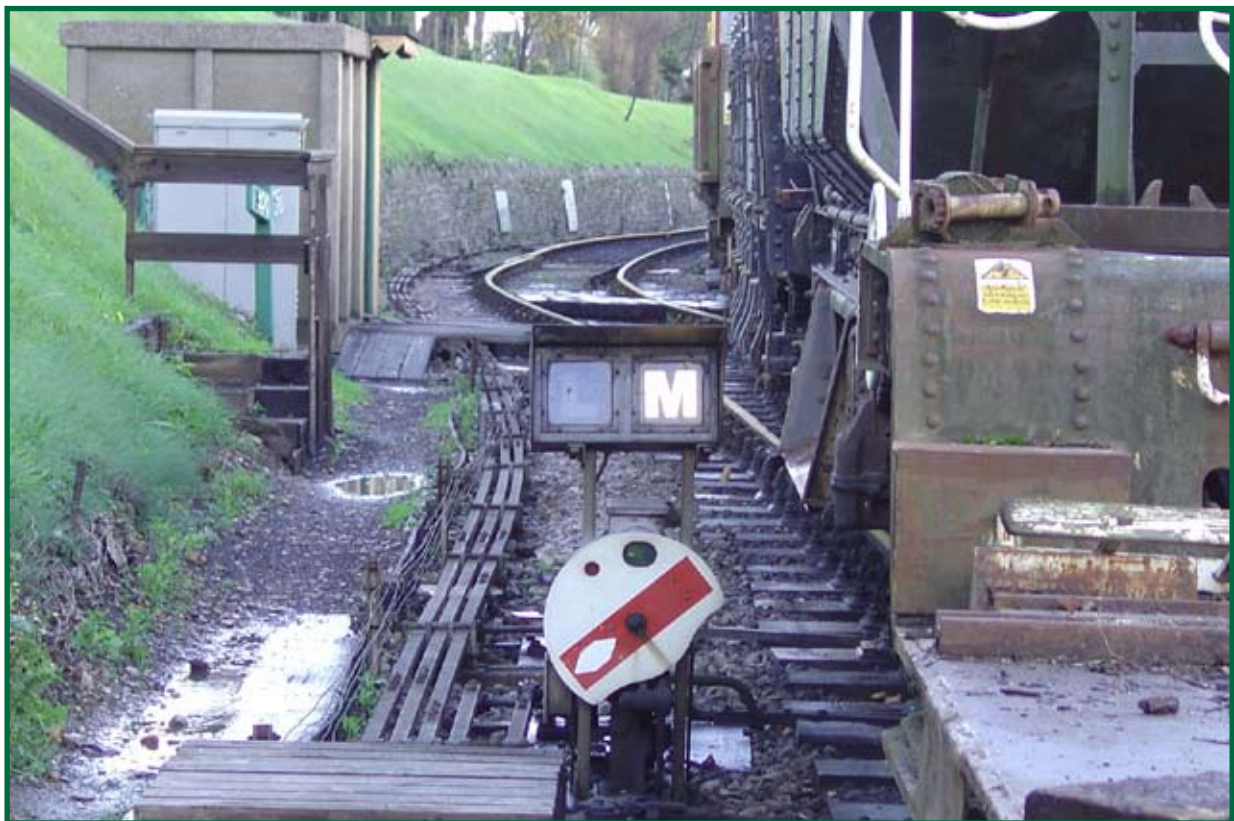
Figure 5: Signal 25 as seen looking towards Swanage station. The 'M' indication is displayed

- 55 No.25 signal had indicated that no.29 points were set for the main line, ie into platform 2. Figure 5 was taken shortly after the collision, and clearly shows the M aspect of the route indicator.

65 The signalman set and signalled the route for the train into platform 2, which was in accordance with the instructions given by the operations manager. The driver checked signal no.25 before starting the train, but did not realise that the route aspect was displaying an M rather than an L. Not recognising the route aspect is the immediate cause of the collision.

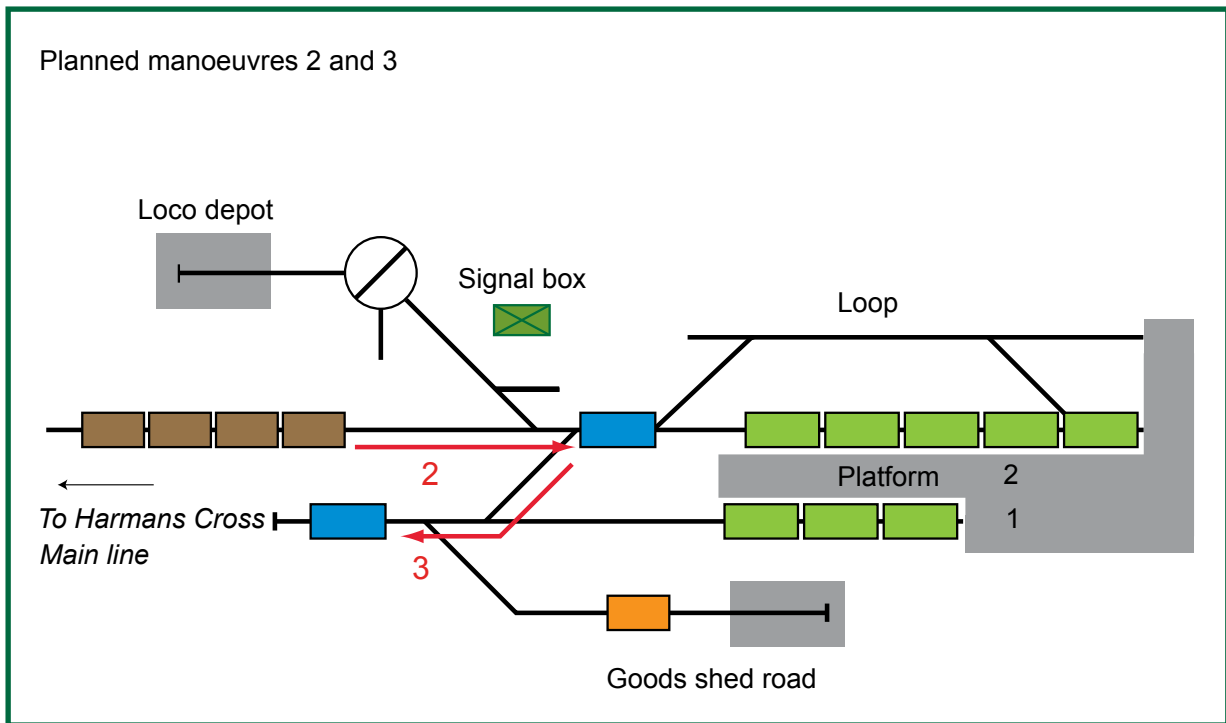
Figure 7: Sketch showing the intentions of steps 2 and 3 of the manoeuvre described in paragraph 34

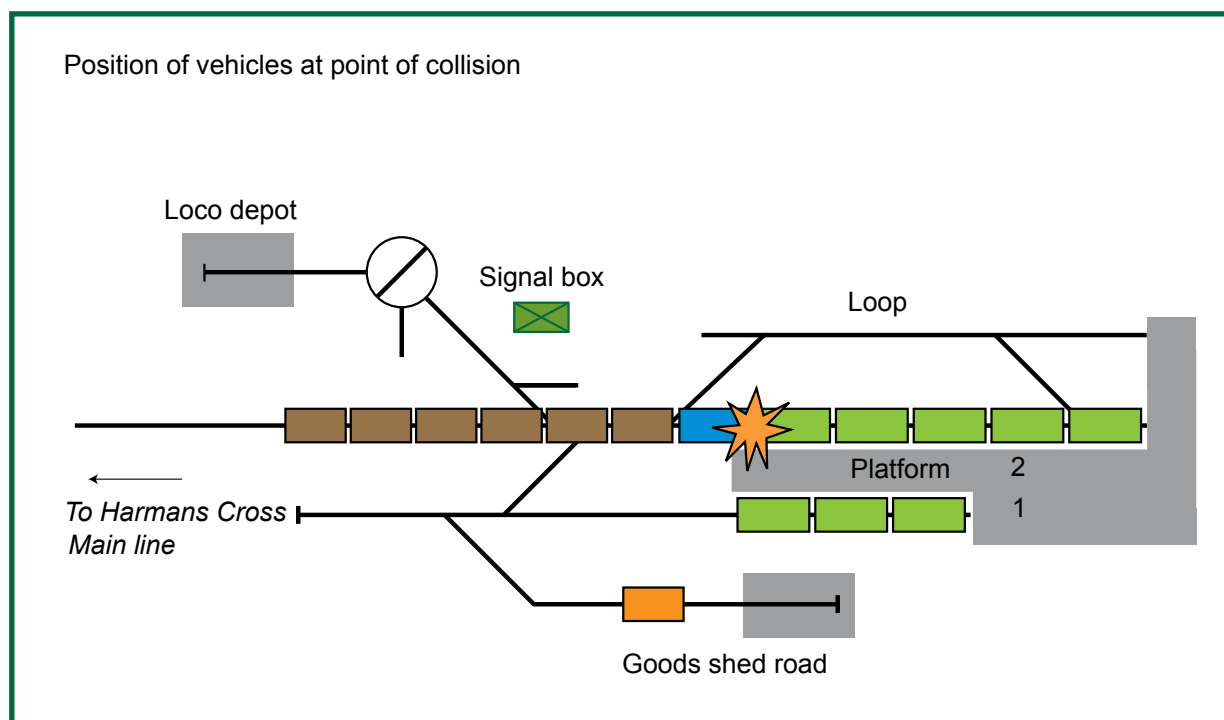
- 40 At 12:15 hrs the signaller opened the signal box and *cleared* no.19 and no.25 ground signals so that the locomotive could proceed towards the station area. No.29 points were in the *normal* position, routing traffic towards platform 2, and no.25 signal was displaying an M aspect for that line (paragraph 24).
- 41 At 12:21 hrs the driver, having started up 33 108 and controlling it from the western end, checked that signals no.19 and no.25 were showing proceed, released the brakes and took power.
- 42 The whole train moved forward towards Swanage station.
- 43 The driver, who was on the north side of the cab to observe the signals, crossed to the south side as the train moved off. This was so that he would have better visibility as the train rounded the right hand curve in the loop, towards which he thought the route was set.

Figure 8: Sketch showing the actual move of the train up to the point of collision

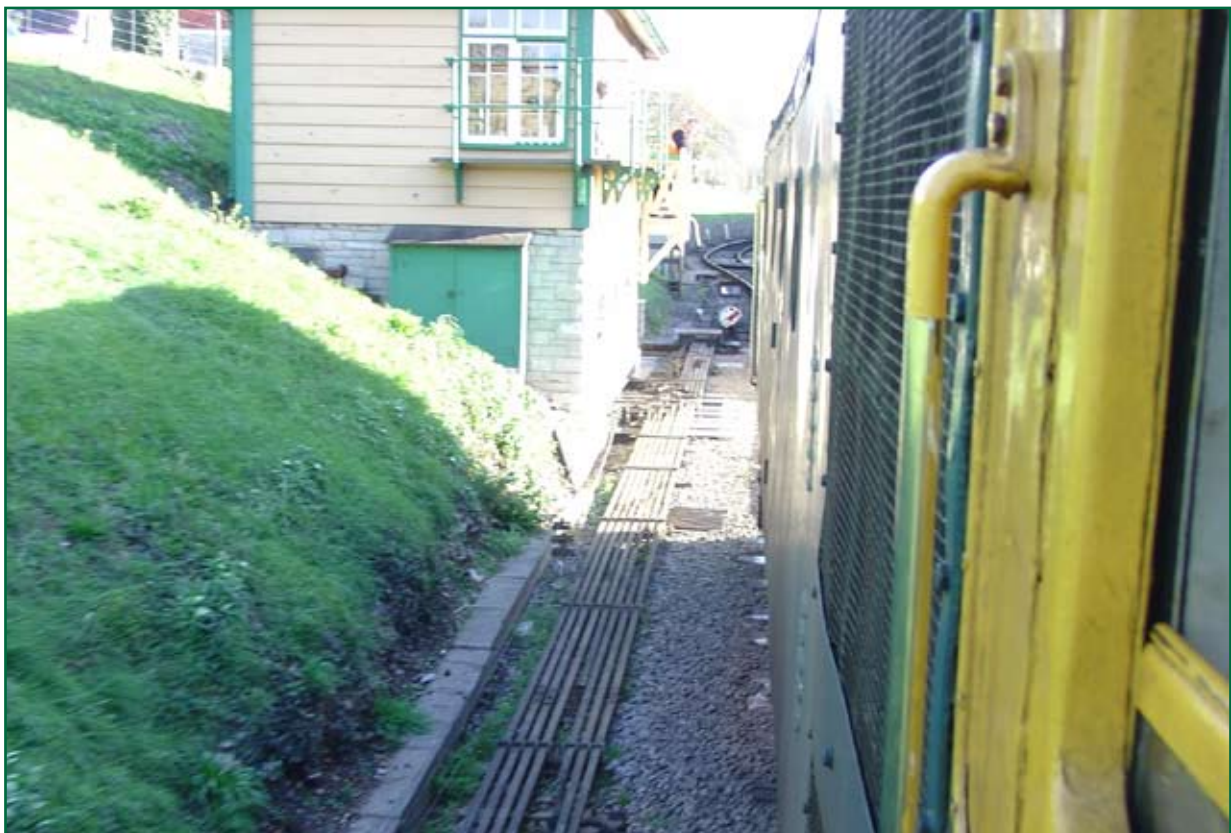
67 The driver of locomotive 33 108 chose to drive it from the rear, western, cab. Had he been in the leading, eastern, cab he would have had much better visibility of signal no.25 (Figure 9), been able to see the lie of the points, and would have realised earlier that the train was heading into platform 2. It is likely that had anyone been in the leading cab the collision would have been avoided.

Figure 9: View of signal no 25 from rear cab of locomotive 33 108, showing 'L' aspect

- 1 The Swanage Railway should amend their Rule Book to:
 - ensure that shunting movements are made by the safest possible route; and
 - ensure that whenever possible shunting moves are driven from the leading cab of the locomotive.(paragraphs 79 & 80(a), 84)
- 2 The Swanage Railway should review its implementation and monitoring of the rule book requirements for safety critical communication to ensure that the requirements are being complied with, and implement such changes as are found necessary (paragraph 80(b)).
