Rail Accident Investigation Branch

Rail Accident Report

Fatal accident to Shunter, Dagenham Dock 17 July 2006

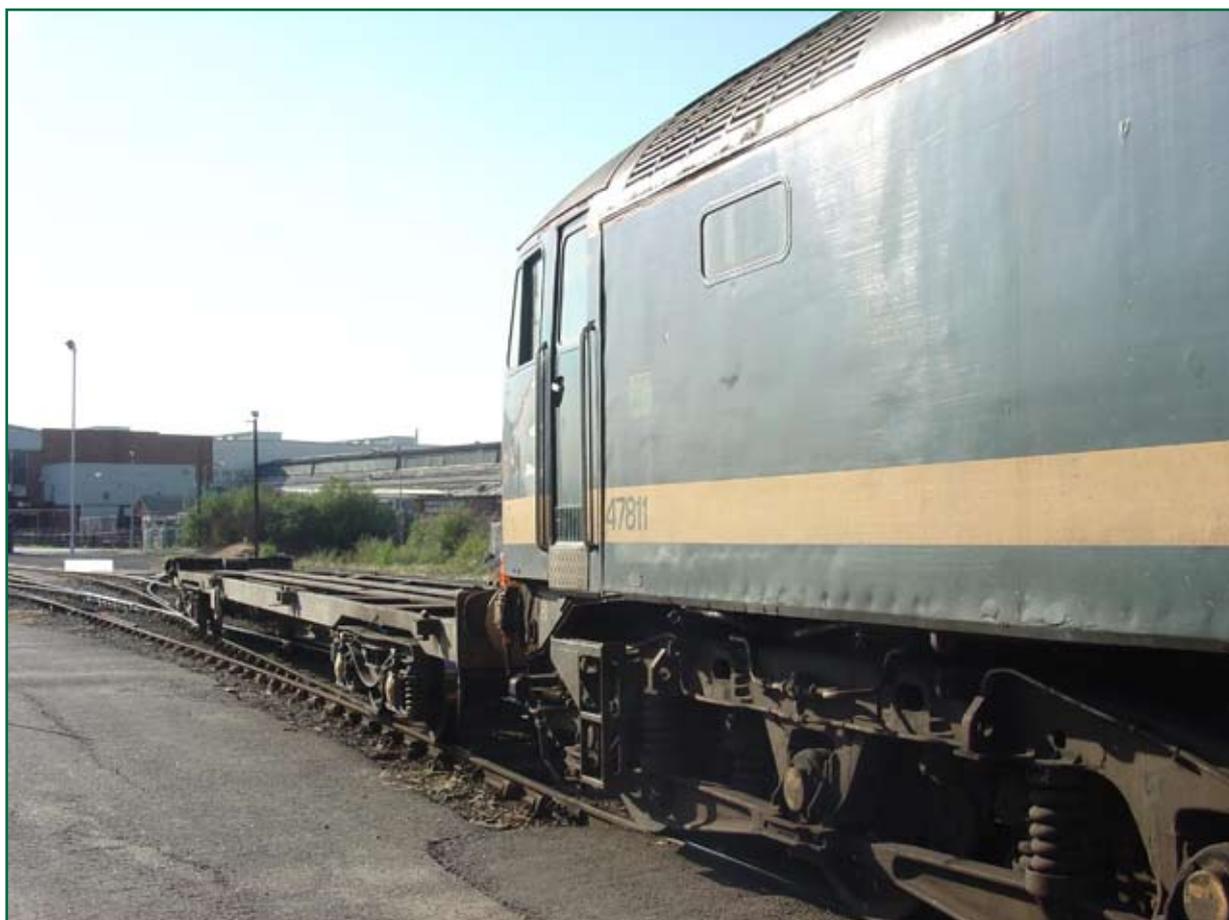
- 14 The shunter was found beside the track, between the position where the locomotive and the wagon had been coupled together and a set of *hand-points* controlling access between the sidings. The shunter had sustained injuries consistent with his having been trapped between the buffers of the locomotive and the wagon.

Figure 2: Locomotive 47 811 and wagon FRA 613035 following the accident. The shunter was found adjacent to the lamp-post in the left hand edge

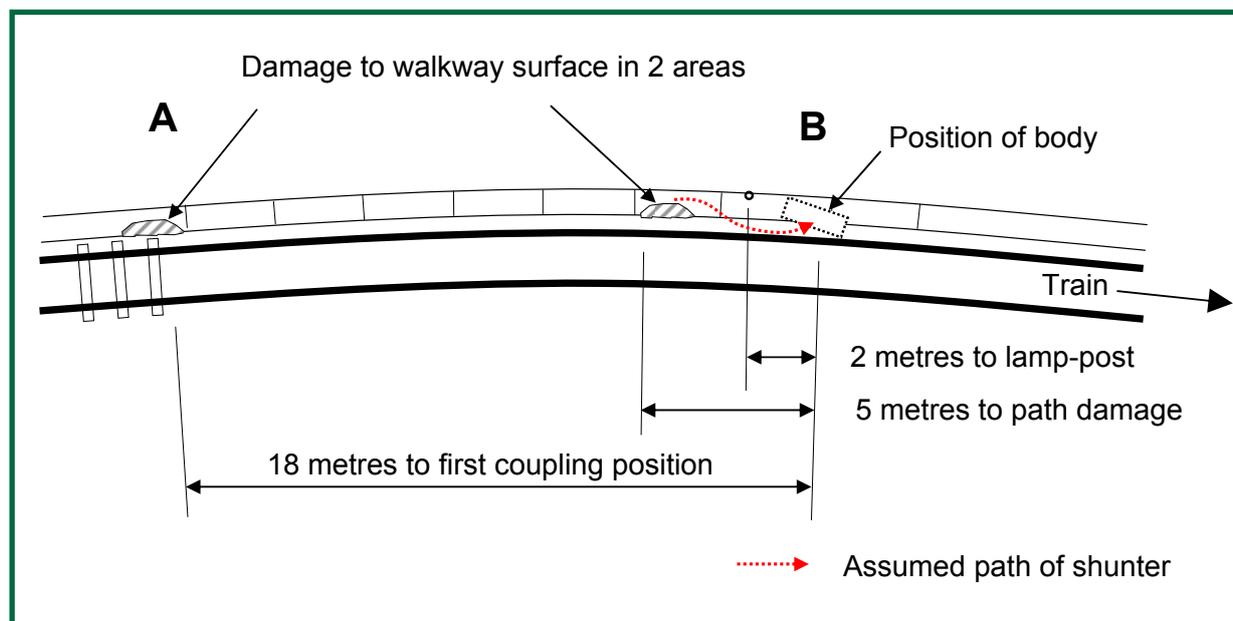
- 38 Finally, locomotive 47 811 returned to siding 4 to collect wagon FRA 613035 to move it to siding 5, ready for loading when the next delivery of loaded waste containers arrived by road. As the westward movement was made, the shunter walked beside the track, ahead of the locomotive and in contact with the driver by radio, counting down the distance to go which allowed the locomotive to reverse up to the wagon as a continuous movement. The driver made this move from the eastern cab nearer the headshunt end of the yard, which was the trailing cab for this movement. The shunter exchanged a few words with the visiting manager, who was once again passing the sidings, but their exchange did not interrupt the shunting movement. The visiting manager then saw the shunter standing beside the stationary locomotive and wagon, preparing to stoop between the buffers to couple the two vehicles together (position *A* in Figures 3 and 4).

Figure 4: Dagenham Dock down yard siding 4. Position A (coupling position) and B are as indicated in Figure 3

- 42 When the driver did not receive a further instruction, he attempted to contact the shunter by radio to determine the cause of the delay. He looked out of both sides of the cab but was unable to see anything, owing to the curve of the track and the height of the wagon. He left the cab to seek the shunter, and saw an orange high-visibility vest on the ground beside siding 4 (denoted position *B* in Figures 3 and 4) and realised that the shunter had collapsed.

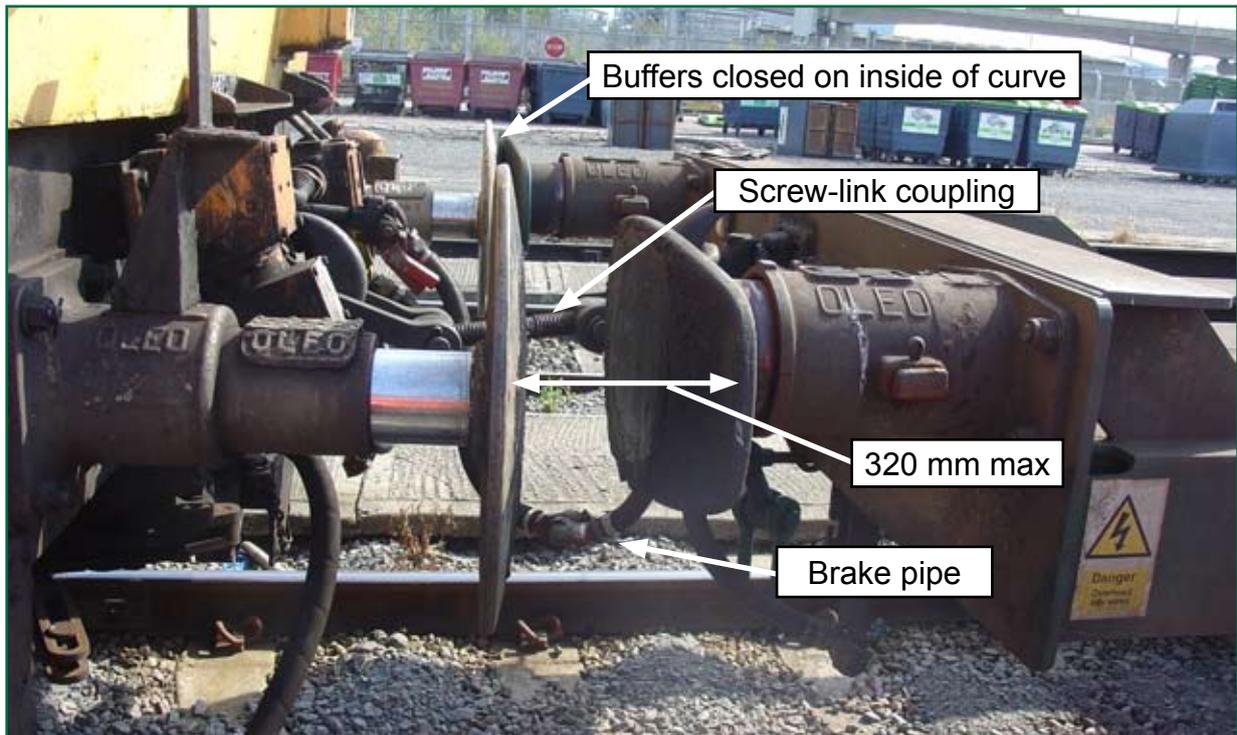
| Underlying causes | 27 |

Figure 5: Class 47 locomotive and FRA wagon coupled on curve close to position B, viewed from north side

- 111 The curved alignment of the track at the eastern end of siding 4 is a contributory factor. It leads to a widening of the gap between the buffers on the north side (Figure 5), which makes coupling and uncoupling vehicles difficult and presents an additional hazard to staff close to a train, in that the buffers are far enough apart at this point for a person to become trapped between the buffer faces. The gap between the buffers of the vehicles involved, at the time and place of the accident, was 320 mm, but was liable to change as the train moved.

- d. The relatively wide gap between the left-hand buffers of the locomotive and the wagon due to the curvature of the track at the eastern end of siding 4 (paragraph 111, **Recommendation 2**);

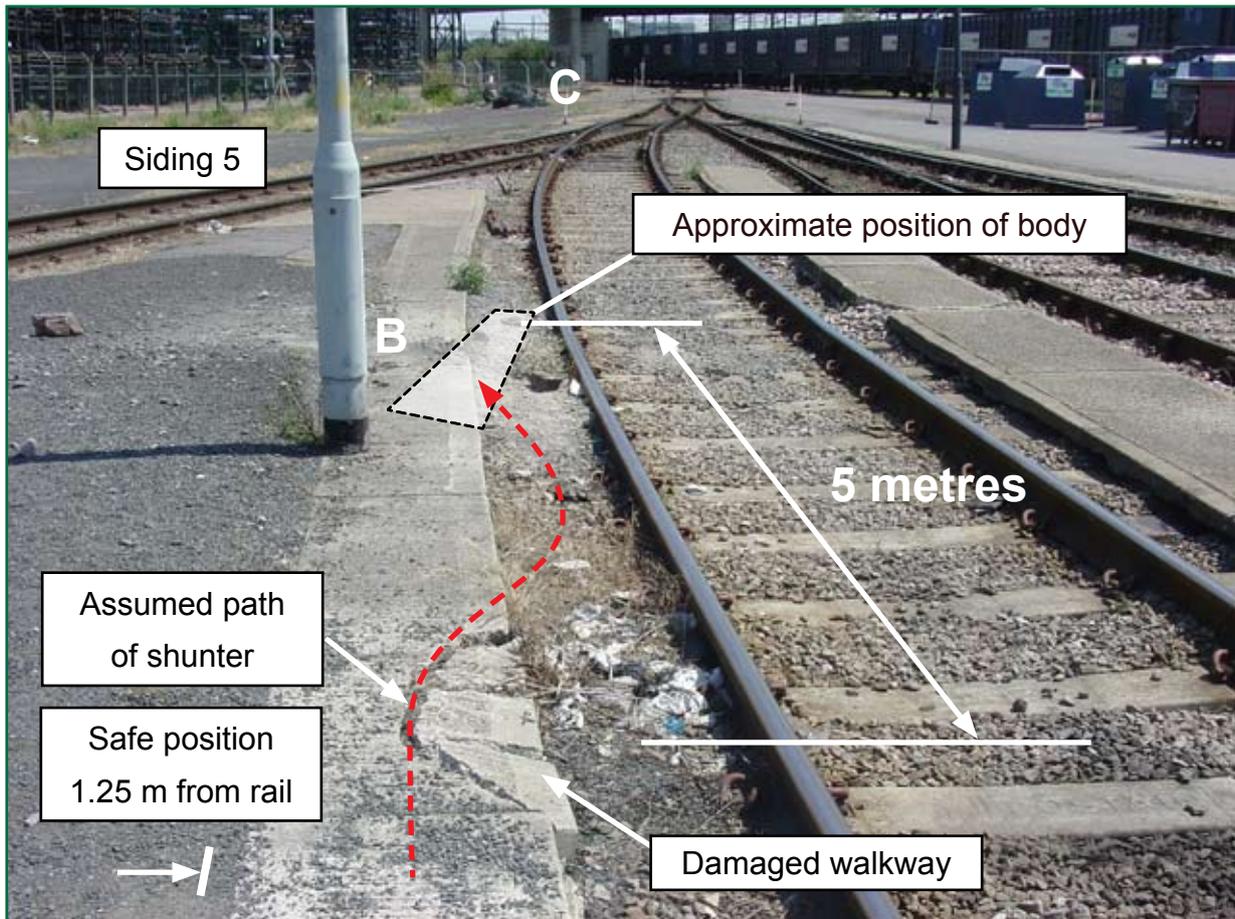
- 51 The concrete walkway 5 metres west of position B was found to be damaged and sloping towards the track.
- 52 The surface of the lamp-post was examined from pathway level to a height of 2.2 metres. It bore no signs to suggest that the shunter had collided with the lamp-post.

Figure 6: Accident scene showing damaged trackside walkway and lamp-post towards east end of siding 4

- 100 A damaged section of path, 3 metres west of the lamp-post, presents a tripping hazard (Figure 6).
- 101 There was no evidence of physical disturbance of the ballast, litter or dry grass in the ballast between the trackside walkway and the rails before a point 4 metres west of the lamp-post.

- 110 The position of the lamp-post at the eastern end of siding 4 may have been a contributory factor. This lamp-post is within one metre of the track, giving very limited clearance (Figure 6). Other lamp-posts in the yard are positioned behind the walkway rather than set into it. The risks associated with the position of this post are not mentioned in the local working instructions. The shunter had not been made aware of the risk, and although he would have been able to walk on the far side of this post, keeping it between himself and the train, the position of his body when found suggests that he did not do so.

- b. The shunter's lack of information about or experience of the specific hazards presented by siding 4 (paragraph 109, **Recommendation 5**);
- c. The proximity of a lamp-post to the track at the eastern end of siding 4. This post is in the walkway and had not been marked as having limited clearance (paragraph 110, **Recommendation 3**);

- g. Improvements in the process of obtaining previous employment records; and
- h. Repair or removal of trackside walkways in response to an Improvement Notice served by the Office of Rail Regulation on 20 July 2006. This was to address the foreseeable risk of persons tripping or stumbling and being injured.

- 3 Freightliner should designate safe walking routes between frequently used parts of its yards. This includes marking or signing any hazards, and should include an instruction not to use walkways with substandard clearances where moving trains are present (paragraph 120a).

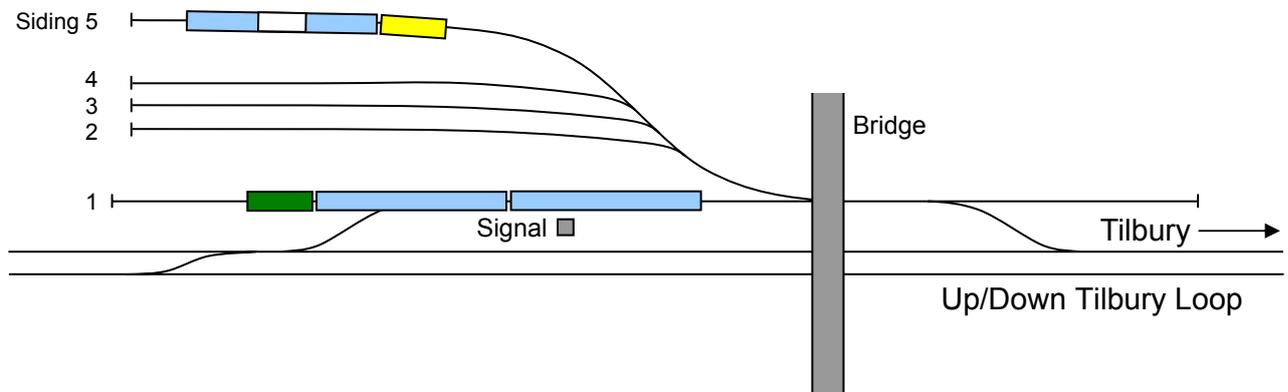
1. Waste container train loaded in sections in siding 5.
Rear section of train contains empty wagon due to late arrival of lorry.

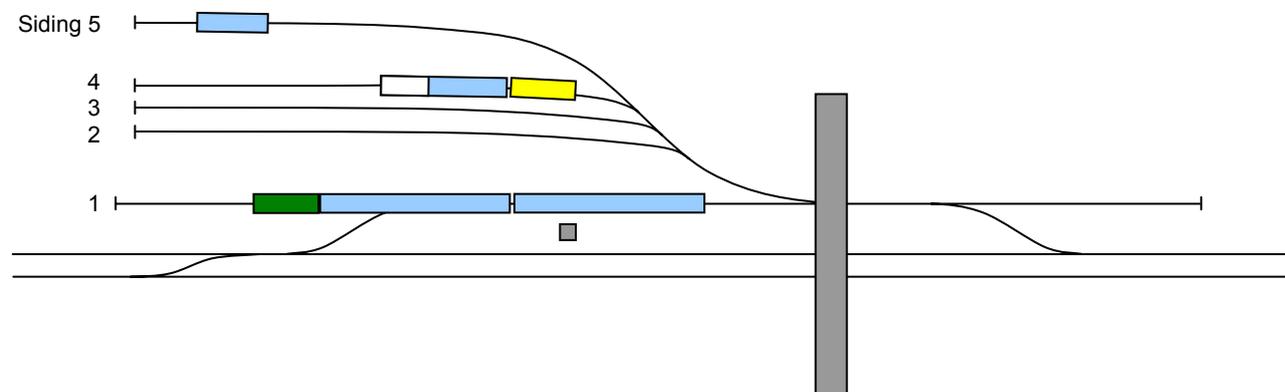
2. Unloaded wagon dropped off in siding 4.

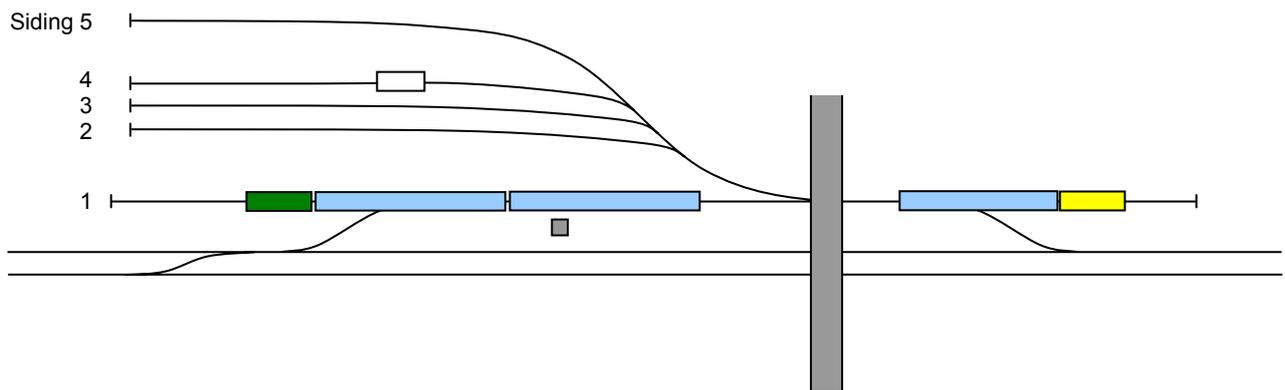
3. Rear section of train moved to siding 1 to complete outgoing train

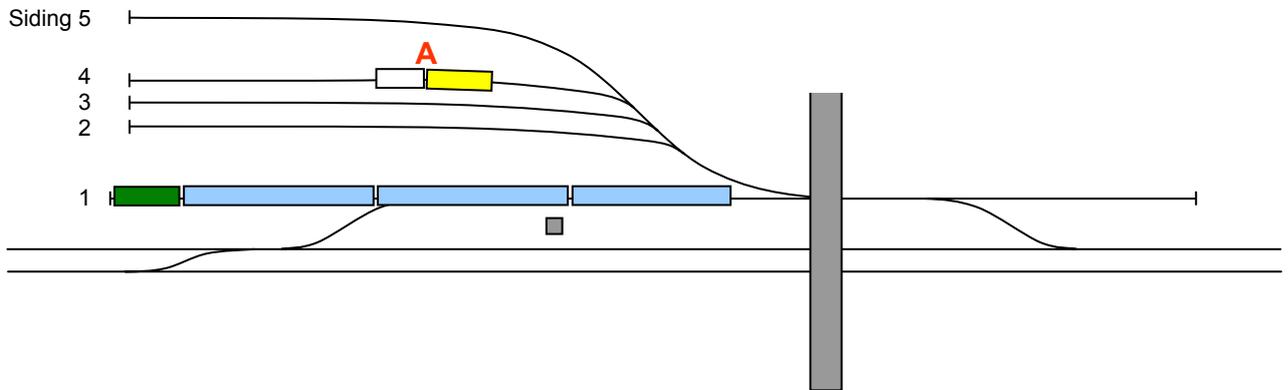
4. Class 47 locomotive returns to empty wagon on siding 4 to position it in number 5 siding in preparation for loading. Shunter observed next to stationary train at position **A**.

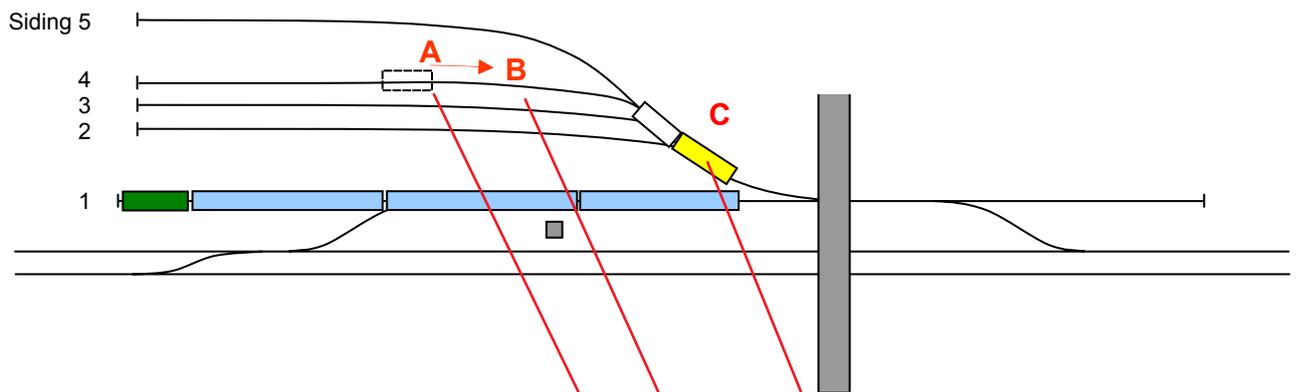
5. Class 47 locomotive moves eastwards to position **C** to clear points. Shunter is found at position **B**.
