Rail Accident Investigation Branch

# Rail Accident Report

## Derailment of a freight train at Maltby North 28 June 2006

## 28 June 2006

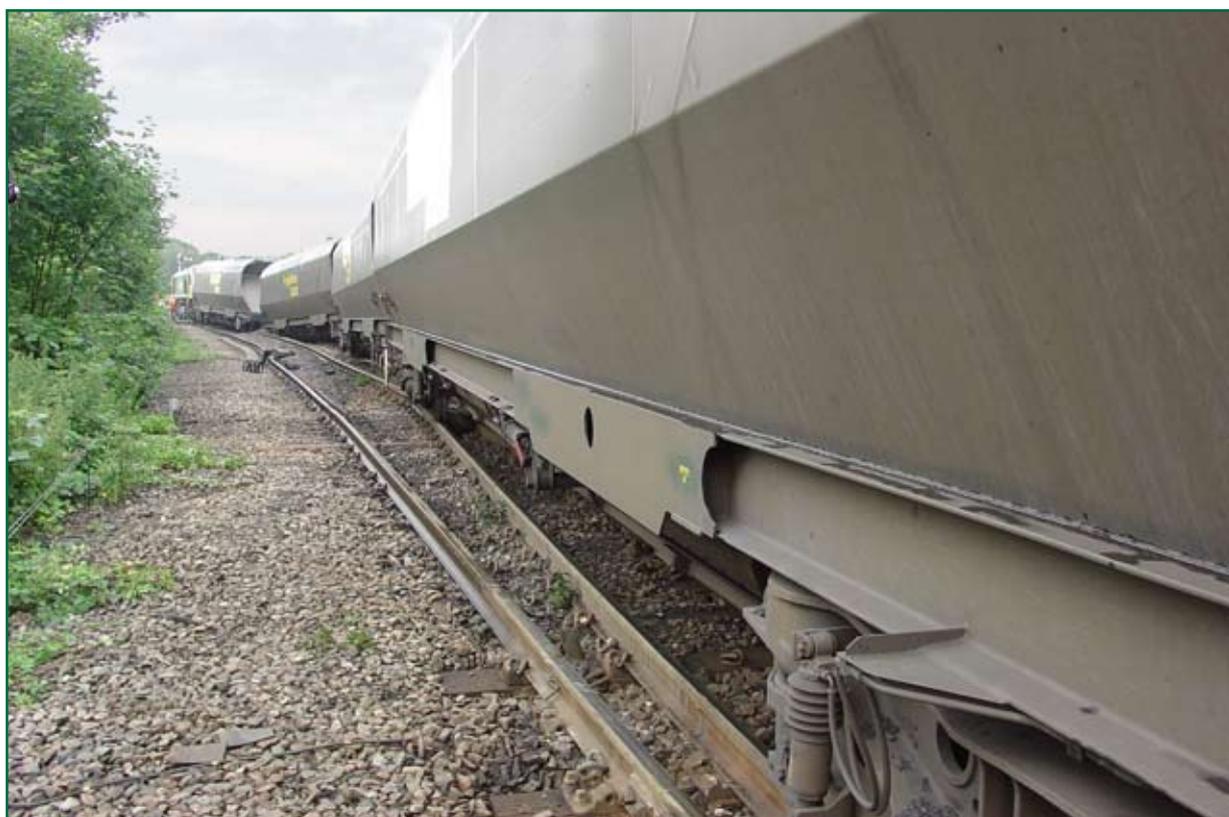
- 15 On 28 June 2006 train 6C51, a freight train operated by Freightliner Heavy Haul, was conveying coal from Redcar, near Middlesbrough, to West Burton power station, near Gainsborough. The train was travelling along the South Yorkshire Joint line between Doncaster and Worksop when it approached Maltby from the north at 03:00 hrs. The line is single track but there are two loops at Maltby which allow trains to pass. The train was being routed from the main line into one of these loops when it became derailed. Figure 2 shows the scene following the derailment.

Figure 2: Front part of train looking from 31B points towards locomotive

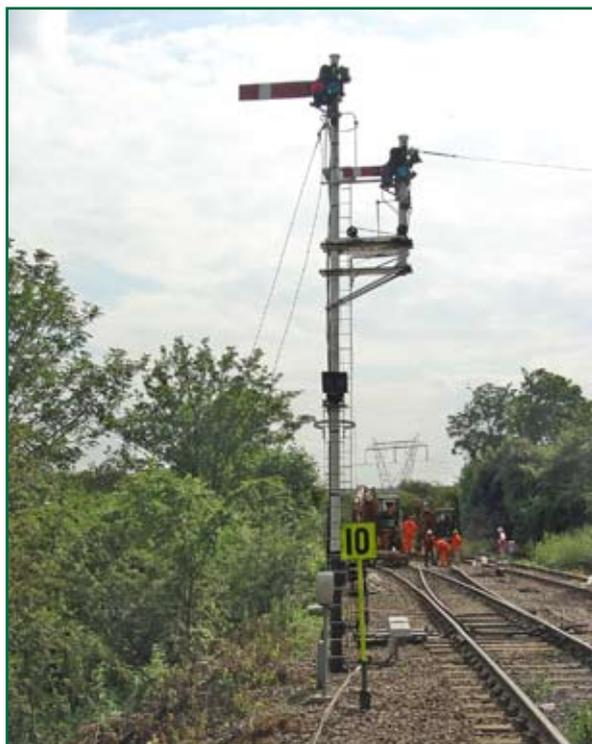
- 11 Signal M36 is poorly sited with only 3 m between it and 31B points. It does, however, have a sighting time, at the linespeed of 25 mph (40 km/h) of over 13 seconds, which adequately meets the requirements of Group Standard GE/RT8037.
- 12 Though it cannot be proven positively, on the balance of probabilities given the evidence, it is likely that the signaller pulled the lever for 31 points just as the locomotive reached signal M36. This action would not have caused an incident had the train not passed signal M36 at danger at the same time.
- 13 The length of the shifts being worked by the signallers at Maltby made them prone to fatigue during the night shift.

Figure 4: Signals M32 (right) and M36 (left)

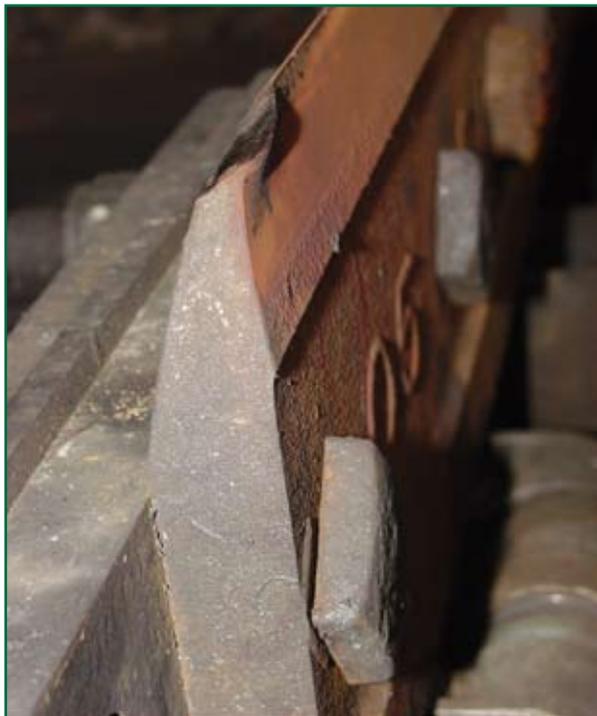
- 41 The locomotive and first bogie of the first wagon passed over the points normally and ran onto the up/down single line. The second bogie of the first wagon ran between the stock and switch rails on both sides of 31B points. This is consistent with the points motoring across to the reverse position as the inter-bogie gap of the first wagon was passing. The right hand side switch tip was struck by a wheel flange (Figure 5).
- 42 The wheelsets of the second bogie of the first wagon ran along the stock rails of 31B points forcing the switch rails together which caused one of the stretcher bars to bend (Figure 6).

Figure 5: Damage to right hand switch tip of 31B points    Figure 6: Bent stretcher bar

- 67 The marks on the rails around 31B points and the turnout itself consisted of a dent on the right hand side switch tip (Figure 5), drop in marks at the point where the distance between the diverging stock rails became greater than the distance over the wheel treads and wheel flange marks on the spacer blocks within the turnout (Figure 7). There was no evidence of flange climb on the switches which would have occurred if the switch profile had been worn. The switch rails were quite new and unworn, having been manufactured in 2005.

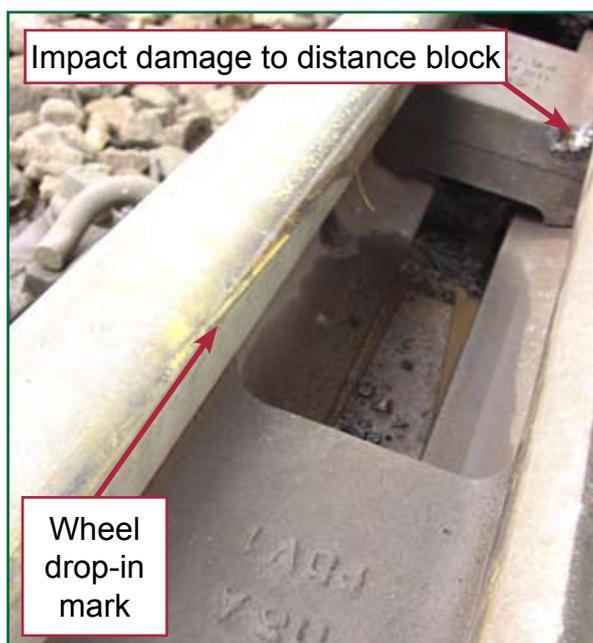
- 43 As the stock rails diverged the gap between them became large enough for the wheelsets to drop into and they then struck the distance blocks and sleepers (Figure 7).

Figure 7: Point where wheelsets derailed

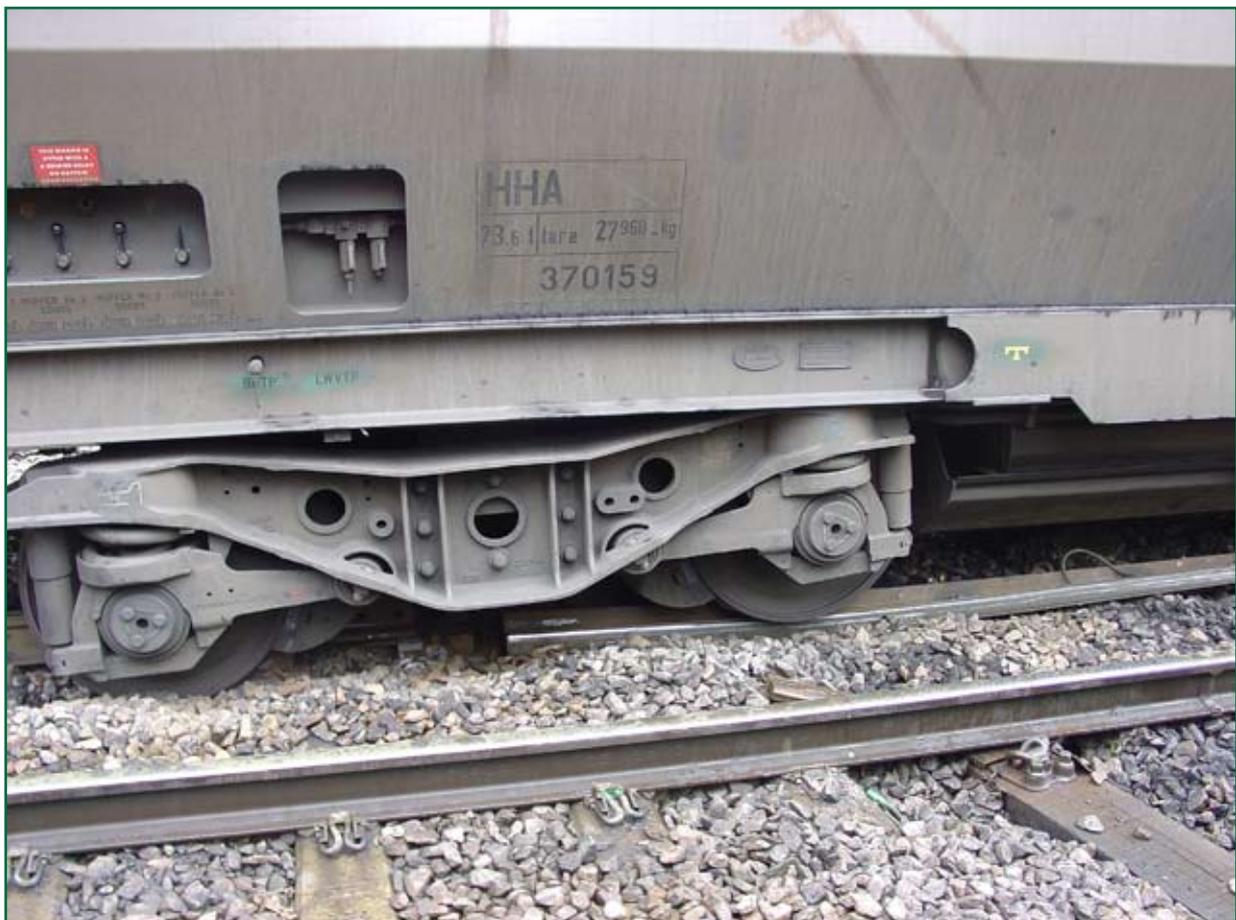
- 46 This rail, having broken free of its fastenings and its neighbour, was able to rotate and this allowed the leading bogie of the second wagon to derail to the sixfoot. The rail then sprung back sufficiently to allow the second bogie of the second wagon to pass without derailling, as evidenced by the fact that this bogie did not derail. The leading bogie of the third wagon had started to derail on passing the rail joint but the train came to rest before the second axle of this bogie had left contact with the rail (Figure 8).

Figure 8: Partially derailed bogie at front of 3rd wagon

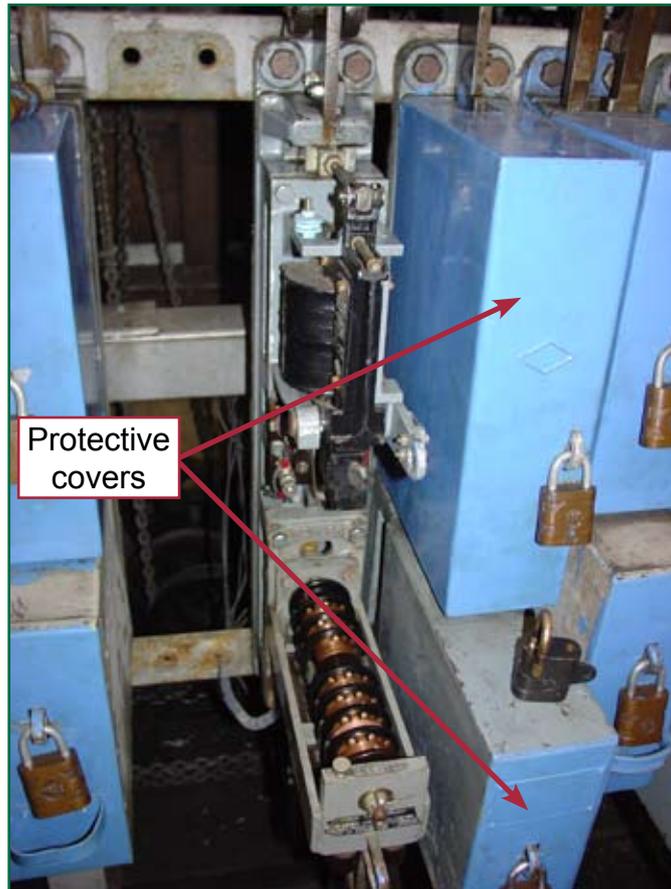
81 Where a lever works an electrical unit, such as a point machine, the electric circuit is made or broken via contacts which are driven by the lever. Levers which only operate electrical units do not require as much effort to move them as levers that work mechanical signals and points and these levers have had the handle section cut down to remind the signaller of this fact. Figure 9 shows the electrical lock and the lever contact bands that make up the electrical switch on number 31 lever. Figure 10 shows the operating floor of the box and lever frame with lever 31 in reverse and lever 36 normal.

*Figure 9: Lever lock (top) and lever bands (beneath) on lever 31 in Maltby Colliery signal box (protective covers removed from lever 31 units)*

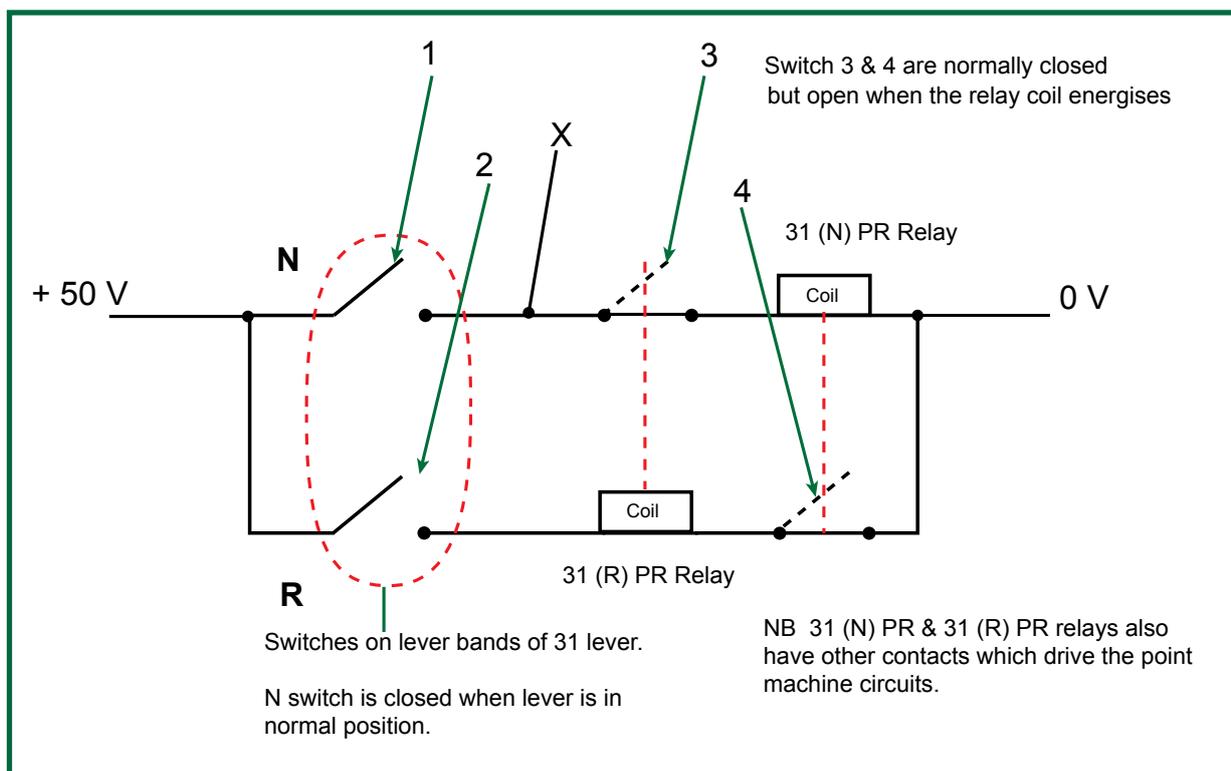
- 84 Figure 11 shows the circuit which is operated by the switch on 31 lever. In normal operation, moving the lever from normal to reverse will cause switch 1 to open and switch 2 to close. The arrangement of the switches in this circuit ensures that only one of the relay coils can be energised at any one time. Other contacts on these relays (not shown in Figure 11) are used to operate the circuits which actually drive the point machines and cause the points to move.

Figure 11: Lever band circuit on lever 36

- 85 The contacts which form switches 1 and 2 in Figure 11 are the only contacts connected to lever 31. This means that any part of the electrical interlocking which needs to know the position of lever 31 is reliant on contacts on relays 31 (N) PR and 31 (R) PR to do this. If there is a defect in one of these relays causing it to stick in the energised position, or there is a spurious electrical feed to wire 'X' in Figure 11, relay 31 (N) PR will remain in the energised position and prevent relay 31 (R) PR from operating, even though the lever has been moved and switches 1 and 2 have operated. In this state, the relay interlocking which displays the point position will continue to believe that lever 31 is in the normal position and will show normal detection for the points.

123 The design of the interlocking on 31 points is not in accordance with present-day design principles. The position of lever 31 is not proven directly from the lever bands, but from relays driven by these bands (paragraph 85). This makes it possible, under certain fault conditions, for the lever to be in reverse but the indicator to show the points set normal (paragraph 88, **Recommendation 4**).

1. Network Rail should implement a system to prevent 31 points at Maltby from operating as a train is approaching or passing over them (paragraphs 117 and 119). Time of operation locking of 31 points was implemented in May 2007 (paragraph 125).
2. Network Rail should find out whether there are other similar installations where time of operation locking is specified but not implemented. Based on this, Network Rail should implement appropriate control measures to control the risk of a similar incident occurring at these locations (paragraph 117).
3. Network Rail should design roster patterns for signal boxes that are manned by a single person such that the signaller is not subjected to undue fatigue (paragraph 121).

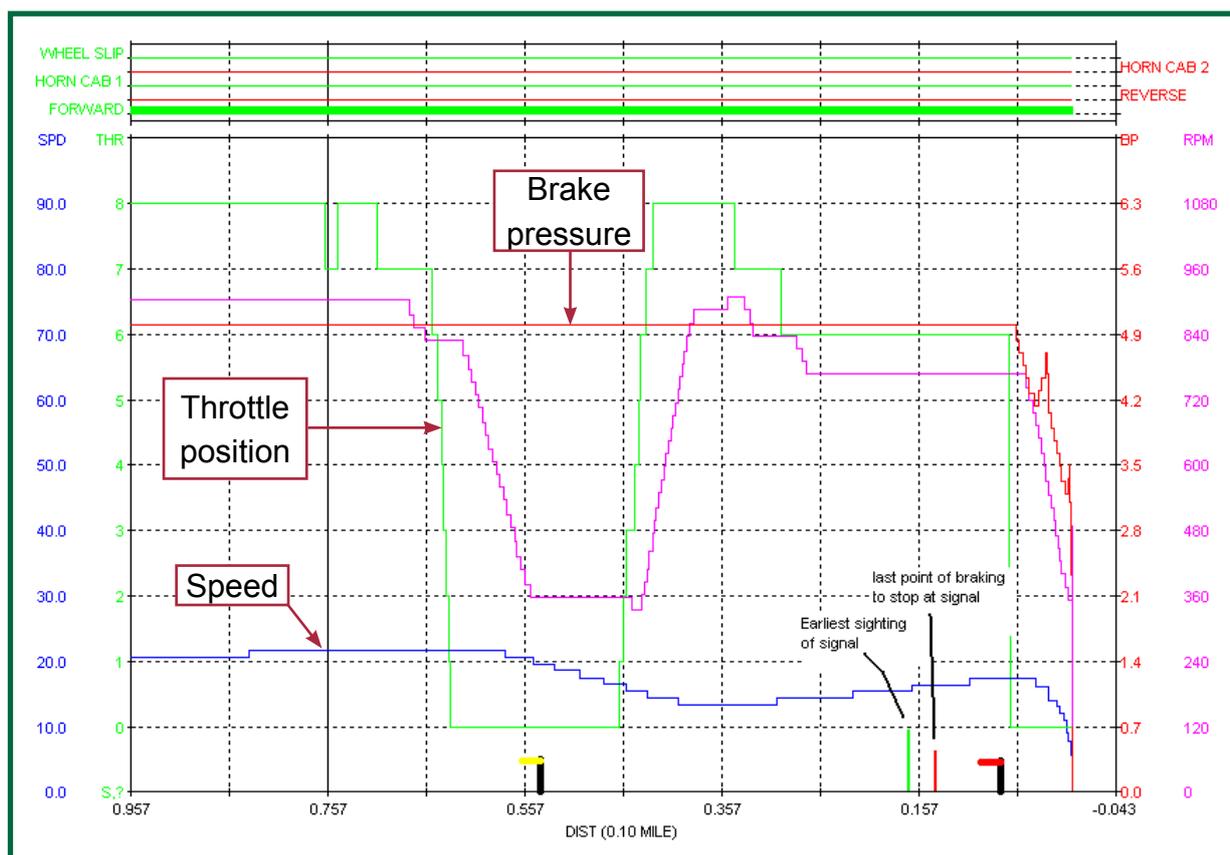
- 100 The OTMR data showing the final approach to the stop at the derailment is shown in Figure 12. The data channels shown in Figure 12 are the train speed, brake pressure and throttle setting (shown as analogue traces) and the driver's brake handle (shown as digital indication at the bottom of the figure). The data has been plotted with distance as the horizontal axis. The distance from the locomotive to points 31B and signal M36 was measured on site and the signal and point location is indicated in Figure 12.

- 101 Figure 12 shows the train approaching signal M36 with the throttle in step 6 and the speed gradually rising. Driver 2 does not alter any control positions until a point 3.3m past the signal when he closes the throttle completely and applies the brakes. This throttle movement is very rapid, taking less than 0.5 seconds to accomplish. Previous instances in the shift when driver 2 had closed the throttle involved a gradual closure, typically 6 steps in 3 seconds. The fastest throttle closure on the OTMR prior to reaching Maltby was shortly into the journey over the South Yorkshire Joint Line when the throttle was moved from step 8 to step 4 in 1.0 second in response to the train reaching linespeed.

Figure 12: Annotated display from the OTMR

102 There was no positive evidence as to why driver 2 had shut the throttle so quickly. He stated that he had seen signal M36 at clear when he approached and passed it but he could not recall seeing the route indicator stencil. Analysis of the OTMR data suggests that either driver 2 did not notice signal M36 until after he had passed it or that he suddenly noticed that the speed of the train had risen too high for the turnout route and shut off to reduce it.

104 When interviewed, driver 2 could not recall the reasons for his actions after passing the signal. It is likely that driver 2 passed signal M36 without observing its aspect. The testing of the signalling equipment (paragraphs 71 to 74) found no fault that would allow signal M36 to be cleared while 31 points were moving and so it is concluded that signal M36 must have been at danger when the train passed it.
