Rail Accident Investigation Branch

# Rail Accident Report

**Passenger door open on a moving train  
near Desborough  
10 June 2006**

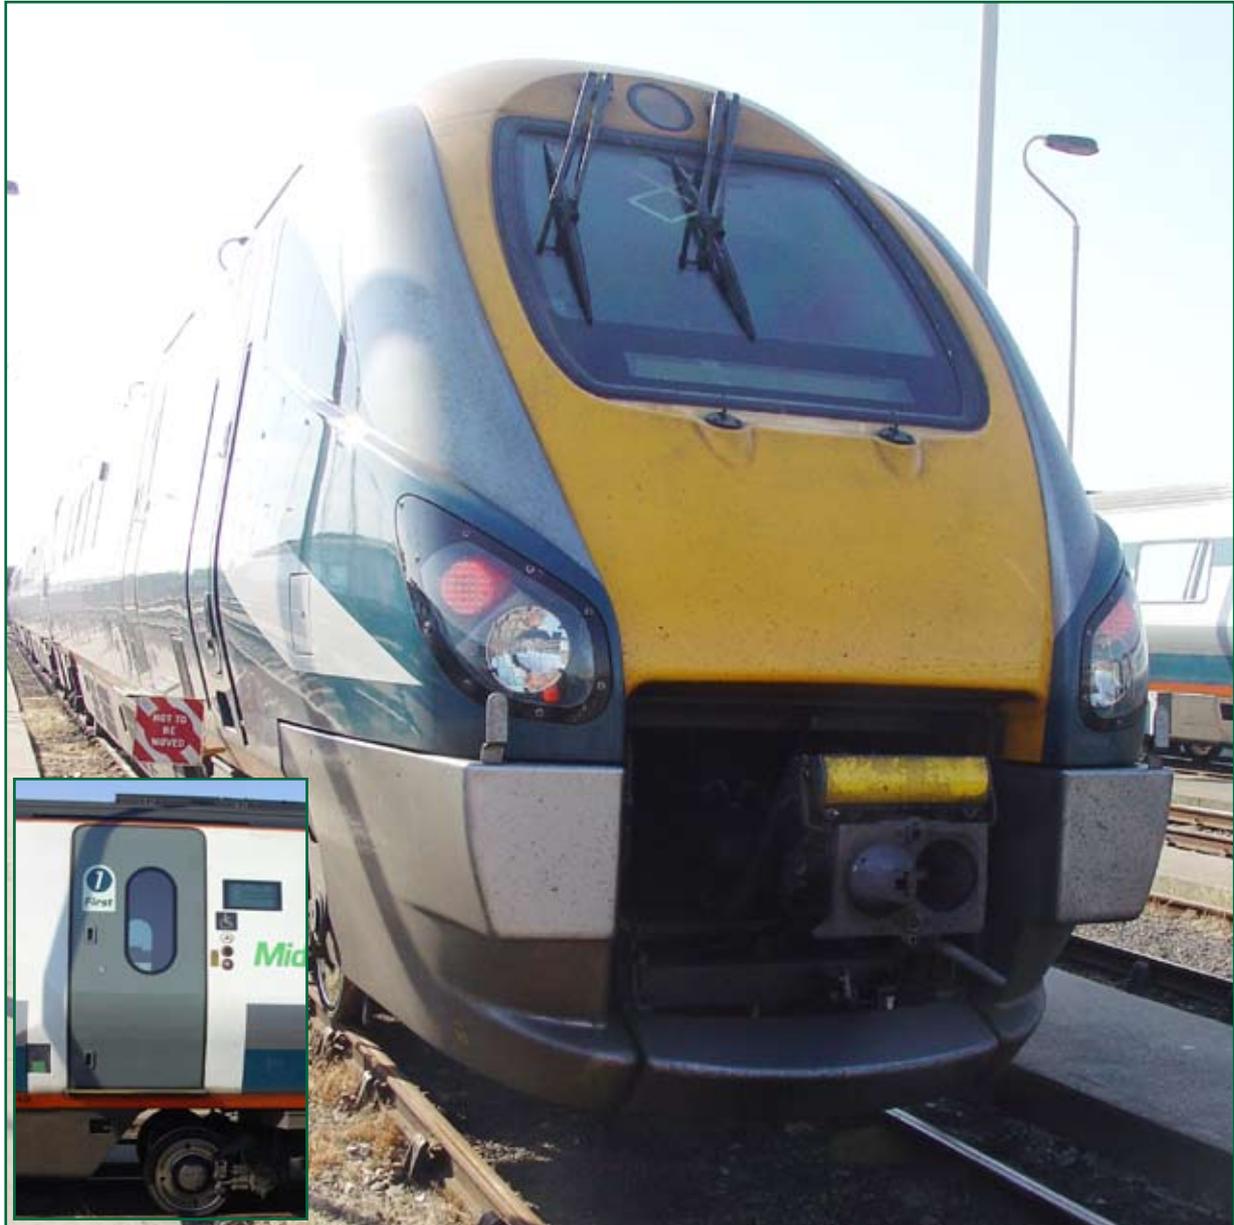
Figure 2: The train and (inset) door involved in the incident

- 16 At 11:34 hrs on Saturday 10 June 2006, a passenger on train 1D17, the 10:30 hrs London St Pancras to Sheffield service, reported to on-board staff that an exterior door was open in the first class coach (vehicle 60249) while the train was moving. The train was formed of a class 222 Meridian unit, number 222 009 (see Figure 2).

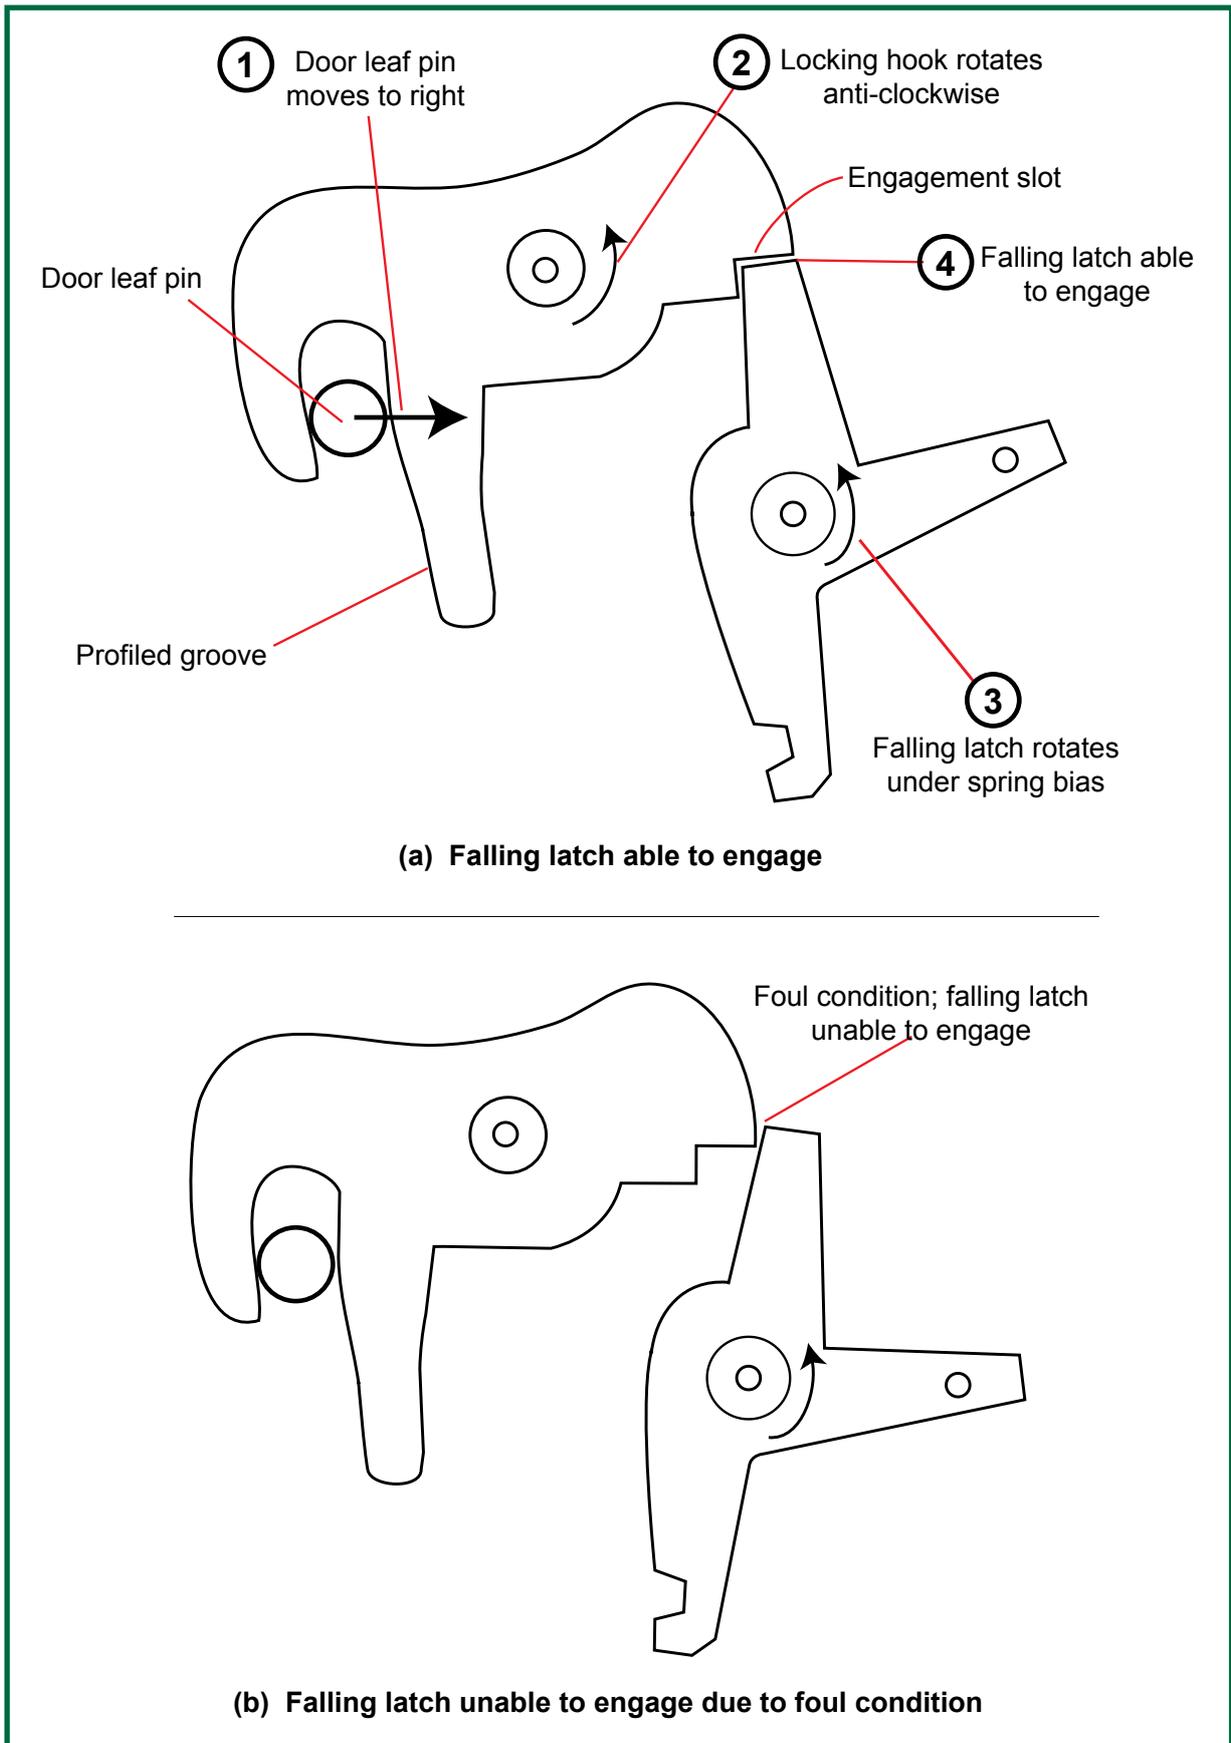
Figure 12: Relationship between the locking hook and the falling latch - annotation in diagram refers to description given in paragraph 163

- 163 Figure 12 shows the relationship between the falling latch and the locking hook. With reference to Figure 12(a), to ensure engagement of the falling latch in the locking hook, the door leaf pin must move in towards the carbody – to the right (1). This rotates the hook anti-clockwise (2), in order that the engagement slot is aligned so that the falling latch, rotating under spring bias (3), can enter (4). If the pin does not move sufficiently far enough, a foul condition results and the falling latch cannot engage, Figure 12(b).

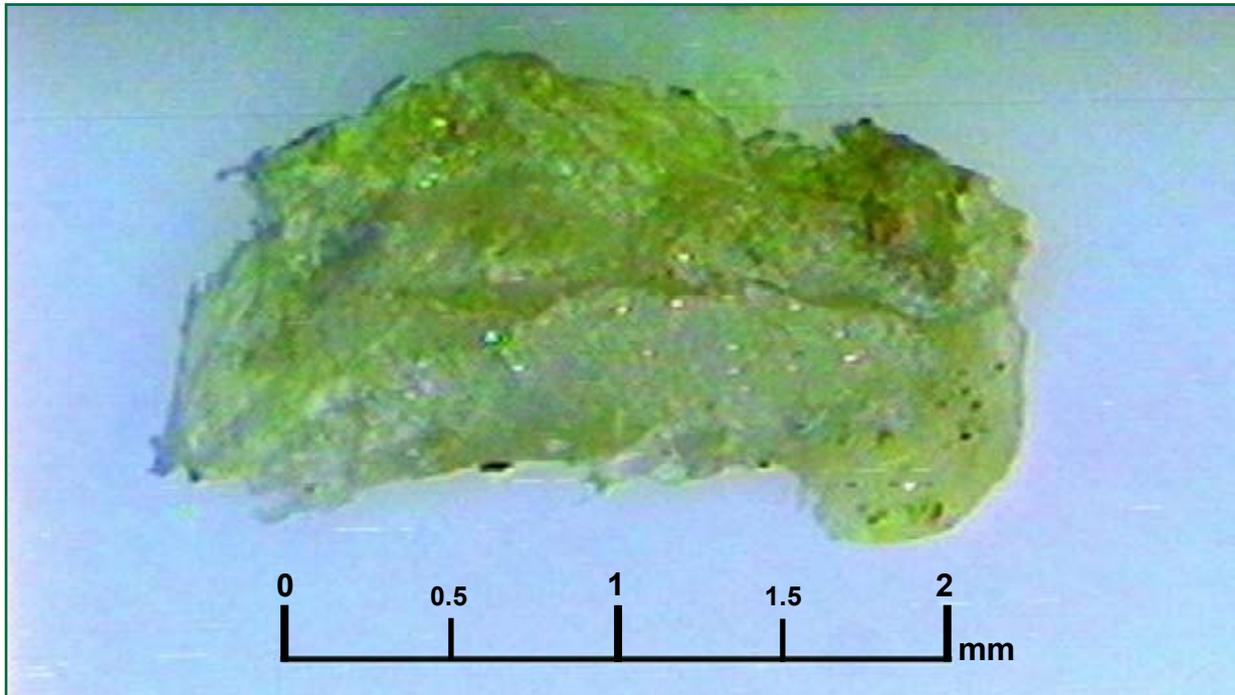
Figure 13: Particle found in the DLS

- 117 The DLS was then removed from the DLA and a small foreign body (particle) was observed to be inside the switch. The DLS was dismantled and the particle removed. Chemical analysis showed the particle and the switch to be of different materials.

- 118 Inspection showed that the particle was too large to have got into the DLS after assembly. Locations were identified within the DLS where the particle, if located, could cause the microswitch to jam.

179 Upon close examination, a small and mobile particle was found in the DLS. After dismantling the switch, the particle was examined chemically and physically. On microscopic examination the particle appeared to be of a plastic material, approximately 2.5 mm long and 1.2 mm wide, Figure 13. Its thickness, at its narrowest dimension, was 0.4 mm.

180 Chemical analysis showed the particle core to be of a different material to that of any of the switch components. However, surface analysis indicated chemical agents which are present elsewhere in the switch, notably the switch plunger.
