Rail Accident Investigation Branch

Rail Accident Report

**Derailment at Phipps Bridge on Croydon
Tramlink
25 May 2006**

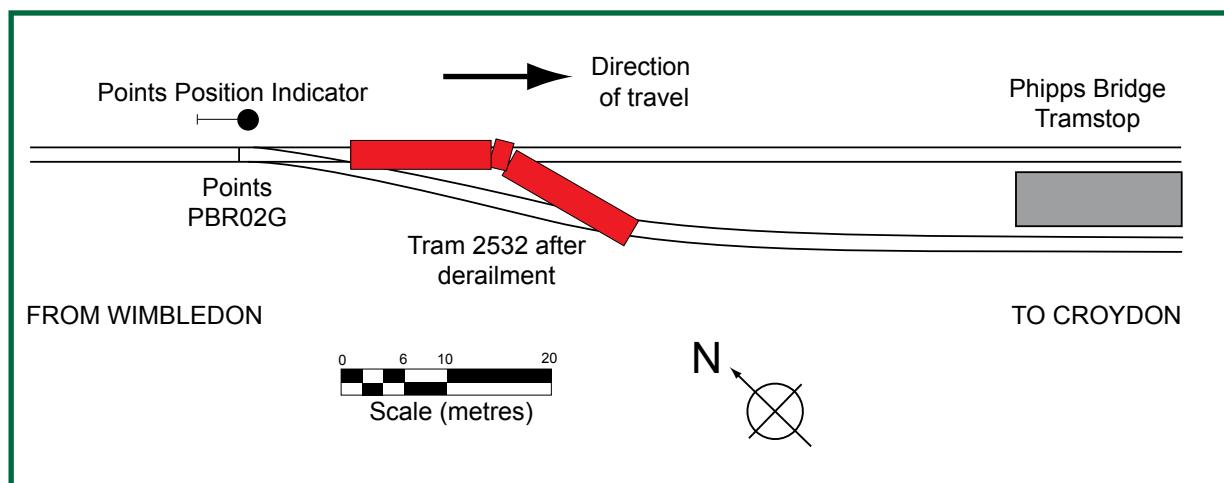
Figure 2: Site plan

- 17 The Wimbledon to Croydon line of the Tramlink system runs in a generally north west – south east direction throughout its 10 km length. It is double track from a short distance outside Wimbledon station for 2.13 km as far as Morden Road, where the line becomes single for 0.72 km. Double line resumes at points PBR02G, which are located some 90 m before reaching Phipps Bridge tram stop (Figure 2).

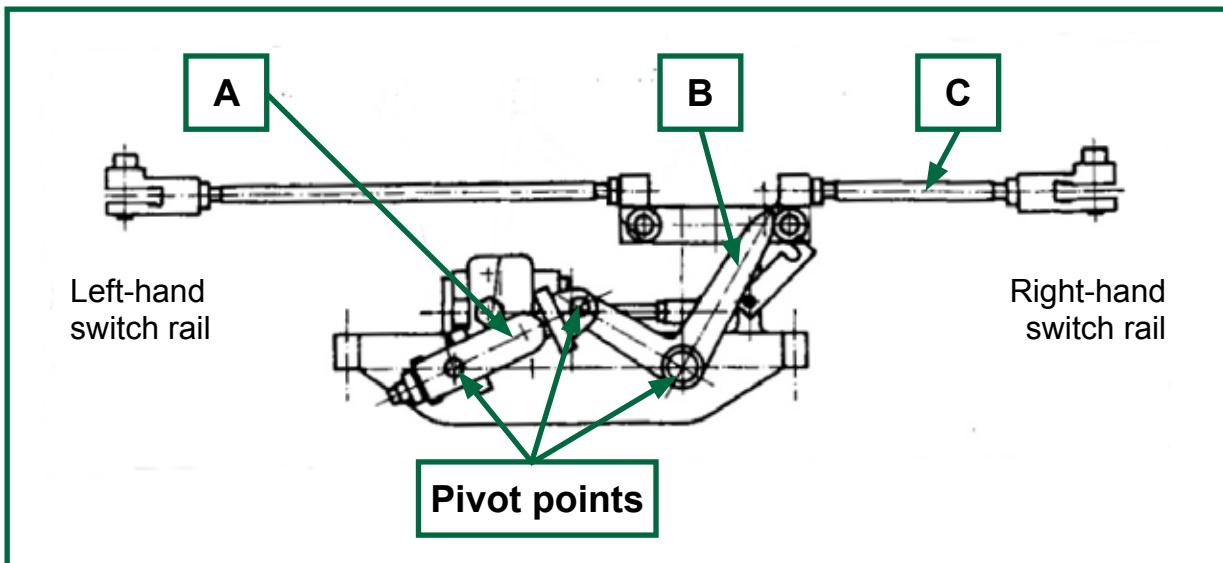
Figure 3: Hanning & Kahl spring point mechanism

- 20 The basis of the HW 160 mechanism is explained in Figure 3. It drives the switches via a lever running between rollers in the centre part of the *stretcher bar*. The compression spring, contained in the spring packet (A) acts through the linkage and the switch lever (B) to push the stretcher bar (C), and thus the switches, over to the right hand stock rail (as shown), setting the switches for the normal route.

- 23 A characteristic of this type of mechanism is that if the spring carrier is rotated sufficiently to line up all three pivot points in the linkage, it will reach a *dead-centre* position in which there is no turning moment to restore the mechanism to normal, and it will remain in that position until disturbed. In this position, although the spring is compressed to its greatest extent, the force required to disturb the mechanism is very low, and only a small impulse is required to cause the mechanism to spring back to the set position. As with all such mechanisms, whilst the theoretical dead-centre state only exists when all the pivots are exactly aligned, in practice the effect of friction in the pivot pins is such as to widen the range in which the mechanism can become stuck.

- 24 In normal operation, the movement of the stretcher bar (which is limited by the throw of the switches) should never push the operating lever into the dead-centre position. The dead-centre band is approximately 15° either side of the centre line (when the three pivot points line up as described in paragraph 23). To avoid this, the normal movement of the lever should be in the range 30° to 75° from the centre line, with the area from 15° to 30° allowing for wear or errors in setting. The manufacturer's instructions specify a maximum switch movement of 80 mm to achieve this. However, the length of the stretcher bar is adjustable using the threads at both ends of both portions, so it is possible for a wider range of movement to exist if the stretcher bar is not set up correctly. It is also possible to set the stretcher bar so that the throw is correct, but the range of movement of the operating lever (B) is asymmetrical.

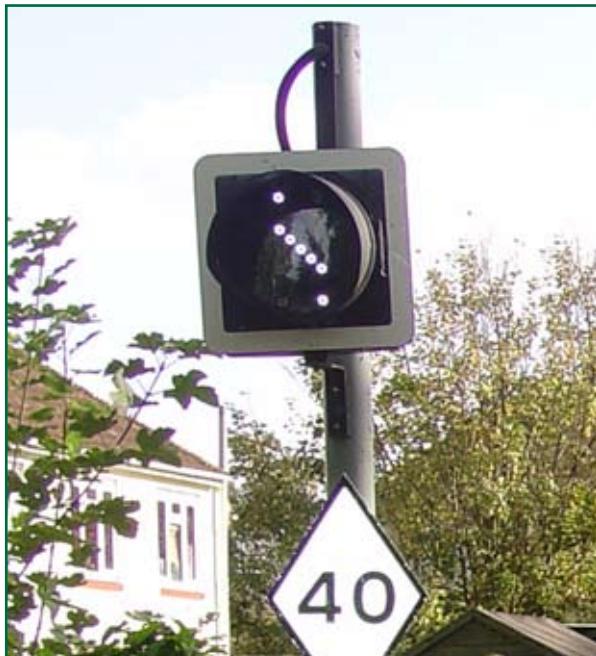
Figure 4: Points position indicator - Points correctly set

- 26 When the points are set and detected normal, the PPI indicates the left-hand route (see Figure 4). If the points are not correctly set, only the central white light of the PPI is lit (see Figure 5).

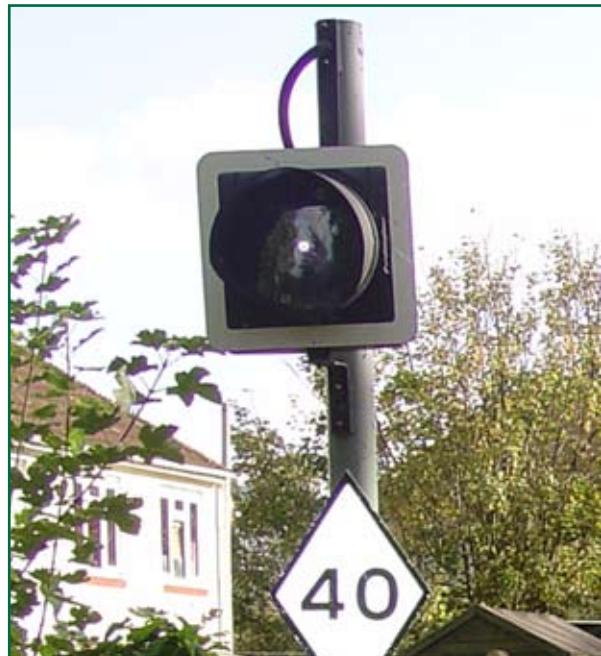
Figure 5: Points position indicator - Points not correctly set

- 46 The driver was presented with the ‘no detection’ indication of the PPI, a single white dot, the conspicuity of which was degraded (both because of its general appearance, and the sun shining on it), at the time that he was concentrating on bringing the speed of the tram down to 40 km/h to pass over the points (which he did, 26 m before reaching the points). The driver gained the impression that the indicator was showing that the points were correctly set, and continued to concentrate on controlling the speed of the tram. The sun was shining over the driver’s right shoulder onto the face of the PPI. This reduced the conspicuousness of the single dot indication, and may also have created a false impression that the route lights were lit. In the past the driver had encountered ‘two-way’ points indicators with the sun shining on them and giving the impression that both sets of route lights were lit (see picture below, Figure 6, in which only the centre dot is actually lit). Drivers’ representatives have also expressed concern about the visibility in sunlight of another signal on the system, and this signal has since been re-angled as a mitigation measure. It is TOL’s intention to carry out a system-wide review to try to identify any other signals or PPIs where similar problems may be experienced.

- 60 Recommendation 1 of the report into the above derailment was that 'the conspicuity of the PPI 'abnormal' indication should be assessed and improved by an appropriate means, such as display of a horizontal white bar when the points are not correctly set.'

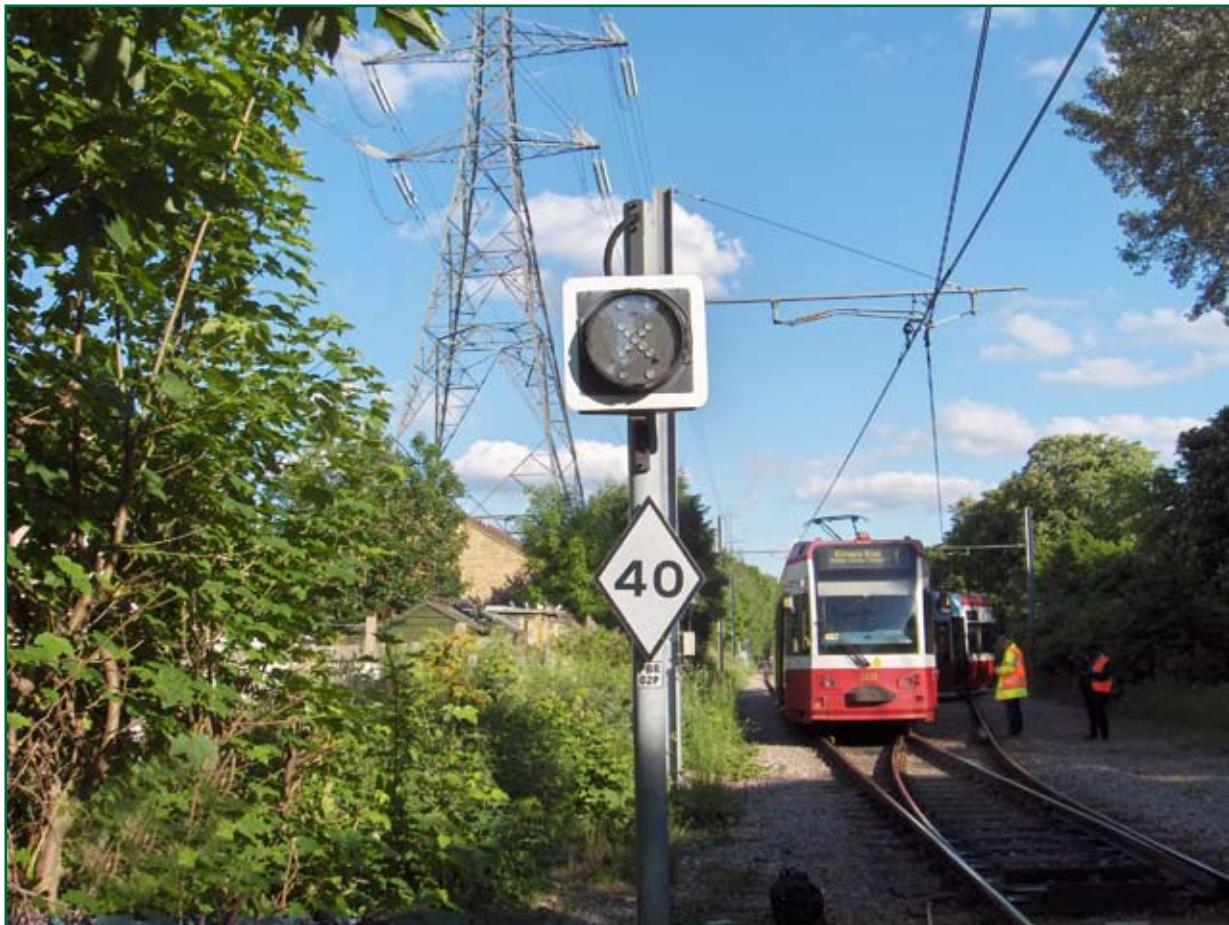
Figure 6: Phipps Bridge soon after the derailment. This picture is not taken from the viewpoint of the driver, and may not represent what he saw on this occasion. The points have been manually changed since the derailment, and are set for the right hand route

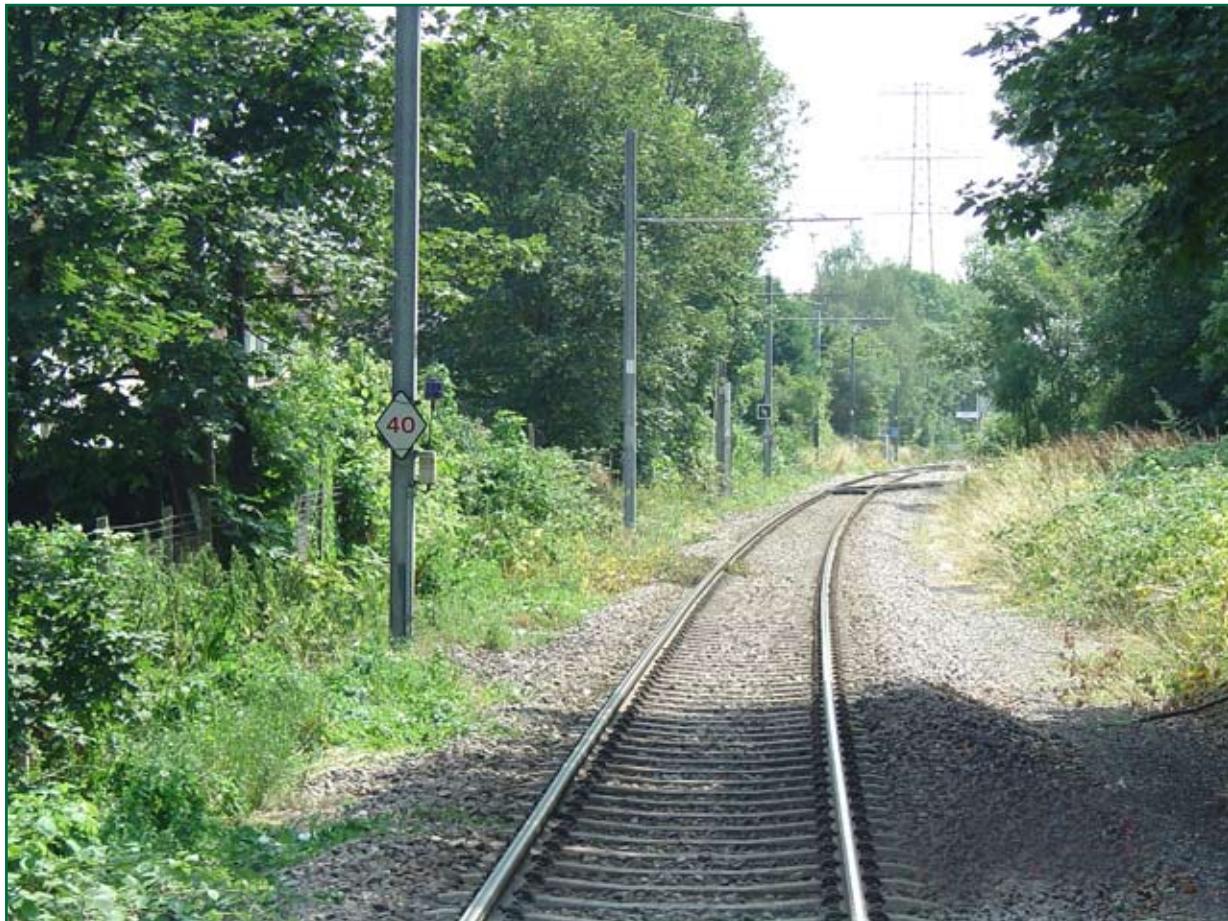
Figure 7: The approach to Phipps Bridge, showing the re-sited speed restriction and the PPI

- 76 Following the derailment, TOL and TCL modified the 40 km/h speed restriction through the points at Phipps Bridge to commence two OLE stanchions (approximately 80 m) before the points, rather than at the PPI. This will make it easier for the driver to bring the speed of the tram down to 40 km/h and then transfer attention from the speedometer to the PPI as the tram approaches the points (Figure 7).
