# Rail Accident Report

**Traction control failure causing a signal to be passed at danger, Camden Road  
7 April 2006**

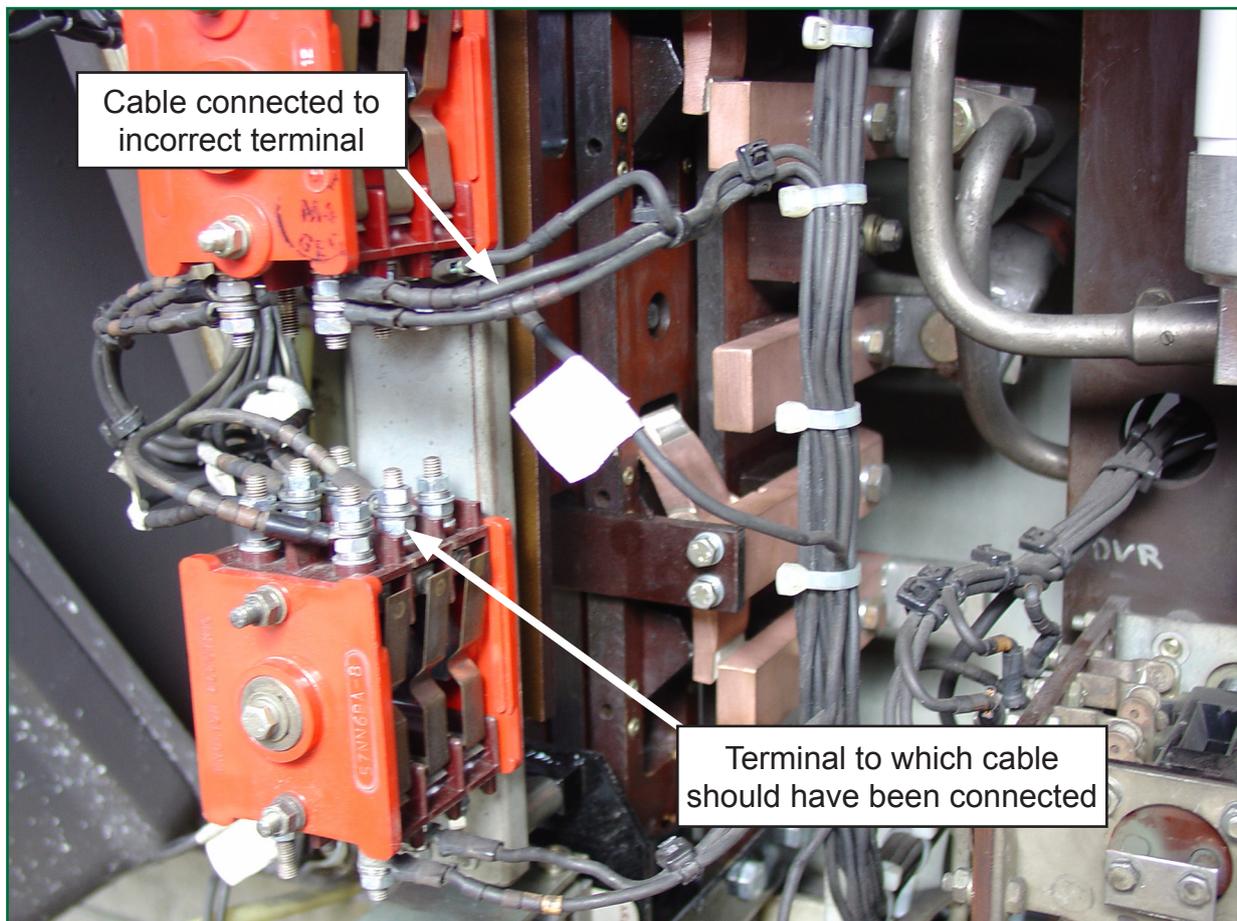
- 36 That examination established that the immediate cause was an incorrectly connected wire attached to an interlock terminal on the Supply Changeover Switch of 'B' coach, number 62596. This resulted in the Traction Motors being permanently powered when the unit was operated from a direct current (dc) power supply and when the control sequence reached '*Full Series*' for the first time.

*Figure 2: The Supply Changeover Switch and connections as found during fault investigation*

- 62 The cable concerned had a masking tape identification lettered 'TRM' on it and the number 5305. The original cable identification numbers were no longer visible.
- 63 The identity of the cable was established, indicating that it should have been connected to the top of the lower interlock block as shown in Figure 2. It was re-connected accordingly and this eliminated the fault.
- 64 After testing, including movement on both ac overhead and dc third rail systems to ensure that the unit operated correctly, it was returned to traffic.

- 65 The wrongly connected wire explained the behaviour of the unit.
- 66 The incorrect connection by-passed various relays used to control the power *contactors*. This caused the power contactors to remain closed, when the control sequence reached 'Full Series' for the first time after the dc supply was selected.

#### The test process

2. HSBC and Silverlink (as appropriate) should examine the condition of cable and terminal identification on class 313 rolling stock to establish its condition and the nature of any corrective action necessary (paragraph 112).

3. While cable and terminal identification remains illegible, Railcare (Wolverton) should develop and implement a documented method of recording the terminals from which cables have been removed during the component replacement process (paragraph 112).
