Rail Accident Investigation Branch

Rail Accident Report

Derailment of a Ballast Plough Brake Van at Carlisle 6 February 2006

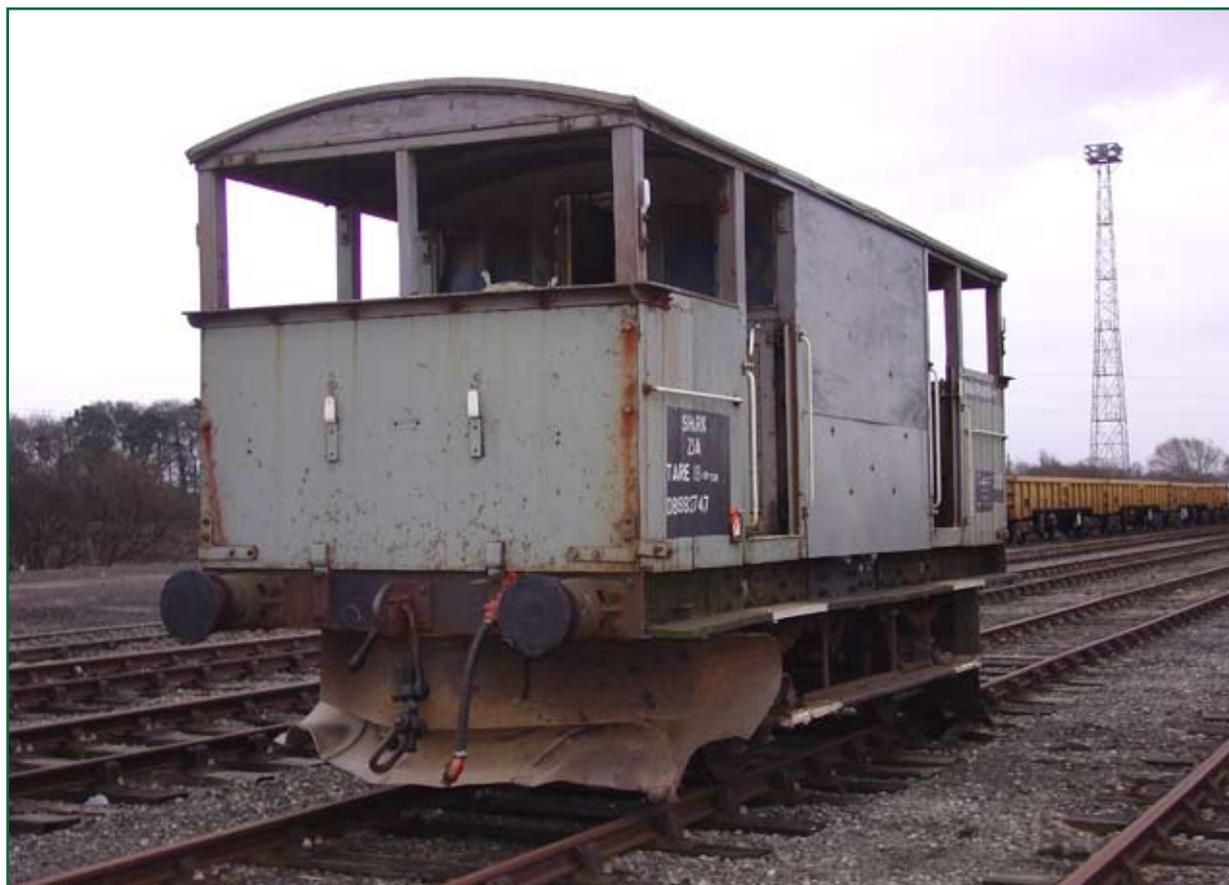
Figure 2: Shark Plough van DB993747

- 58 The left hand side of the ballast plough at the leading end of the Shark plough brake van had contacted a converging rail on the approach to 756A points and derailed the vehicle all wheels. This had caused the brake pipe between the brake van and the wagon immediately in front to part and initiate the brake application.

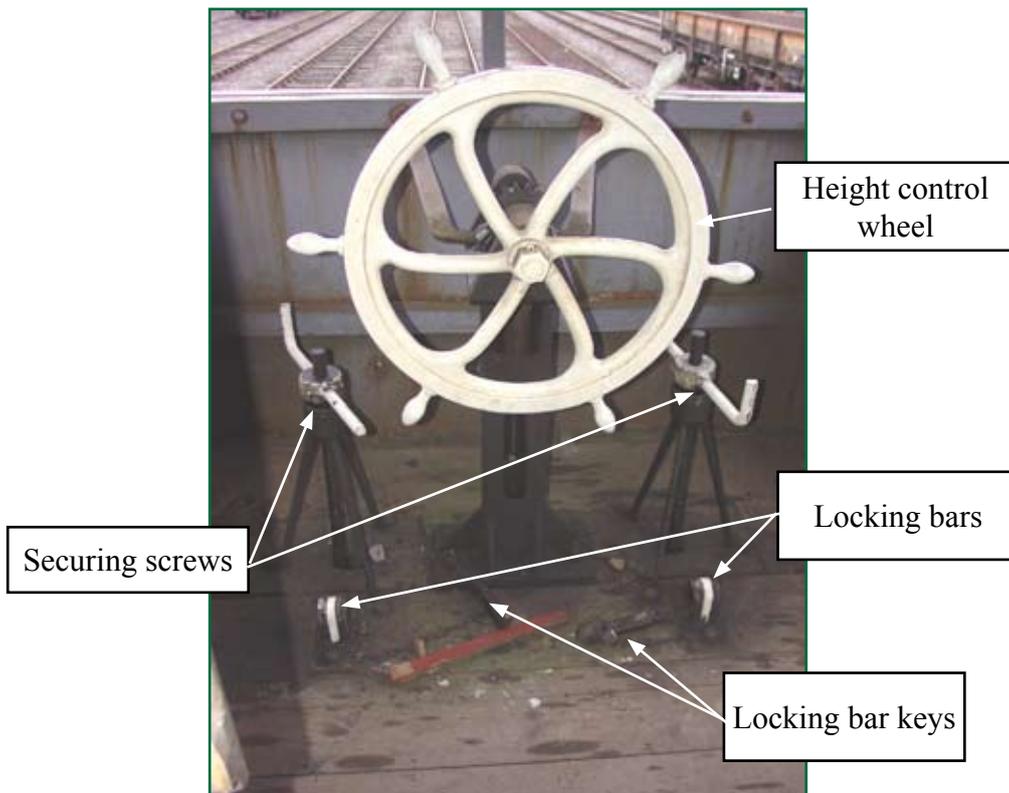
Figure 4: Inside view of a Shark plough brake van showing height control wheel, securing screws and locking bars with plough in working position

- 15 Plough brake vans are unpowered and are towed or propelled. When in use the height of the plough is adjusted using the control wheel, shown in Figure 4 and Figure 5, to achieve the desired degree of ballast distribution and level. The plough must be raised above railhead height where obstructions exist in the four foot or on the sleeper ends, eg at points or at *AWS magnets*.

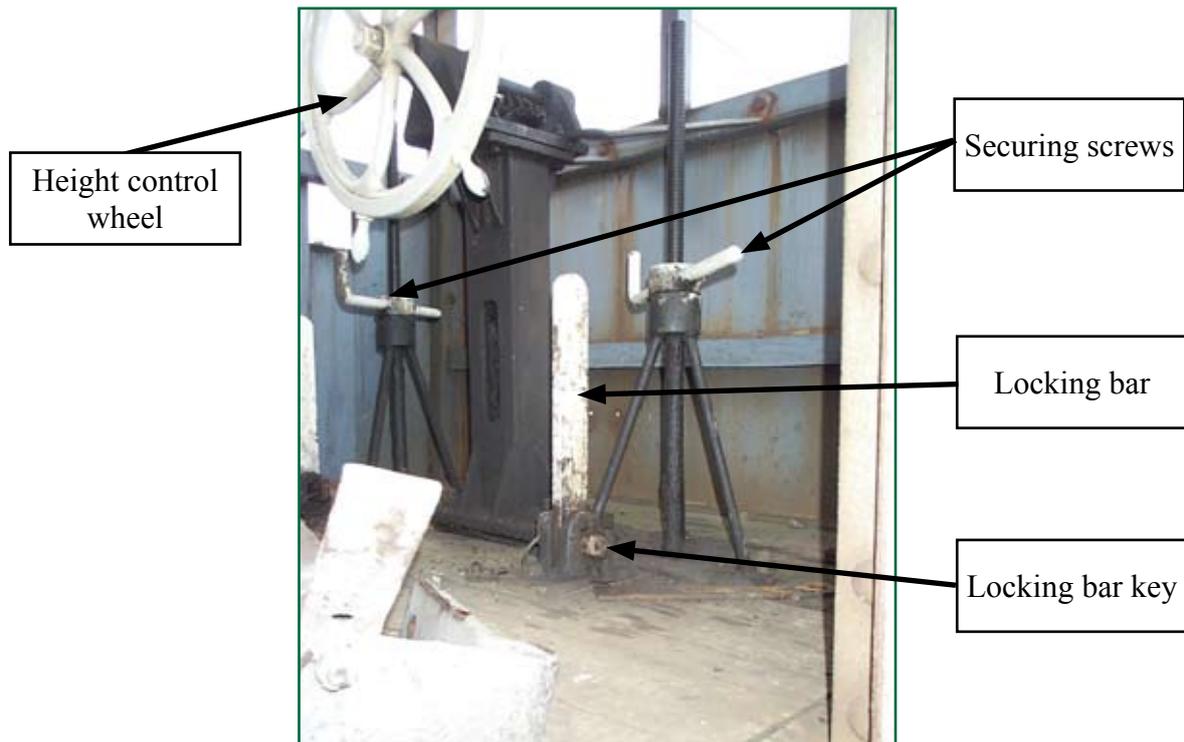
Figure 5: Inside view of a Shark plough brake van, with ballast plough in travelling position, showing securing screws and locking bars with keys inserted.

- 60 The procedure to be applied in raising the ballast plough is:
- turn the plough height control wheel to lift the plough;
 - tighten both securing screws clockwise to hold the plough;

- put both keys into the locking bars – these will only fit with the plough fully raised.
- 61 The design of the locking bars and keys is robust and proven. There was no damage to the locking or securing system and therefore a failure of these is discounted. The keys, which are inserted into the locking bars, have a ‘drop end’ latch to prevent keys vibrating or falling out or being displaced unintentionally. They are also retained to the vehicle by short chains, to prevent loss. These are shown fitted in Figure 4. Both keys being properly inserted and subsequently coming adrift is discounted.
