Rail Accident Investigation Branch

Rail Accident Report

**Derailment of a freight train at Cricklewood Curve
31 January 2006**

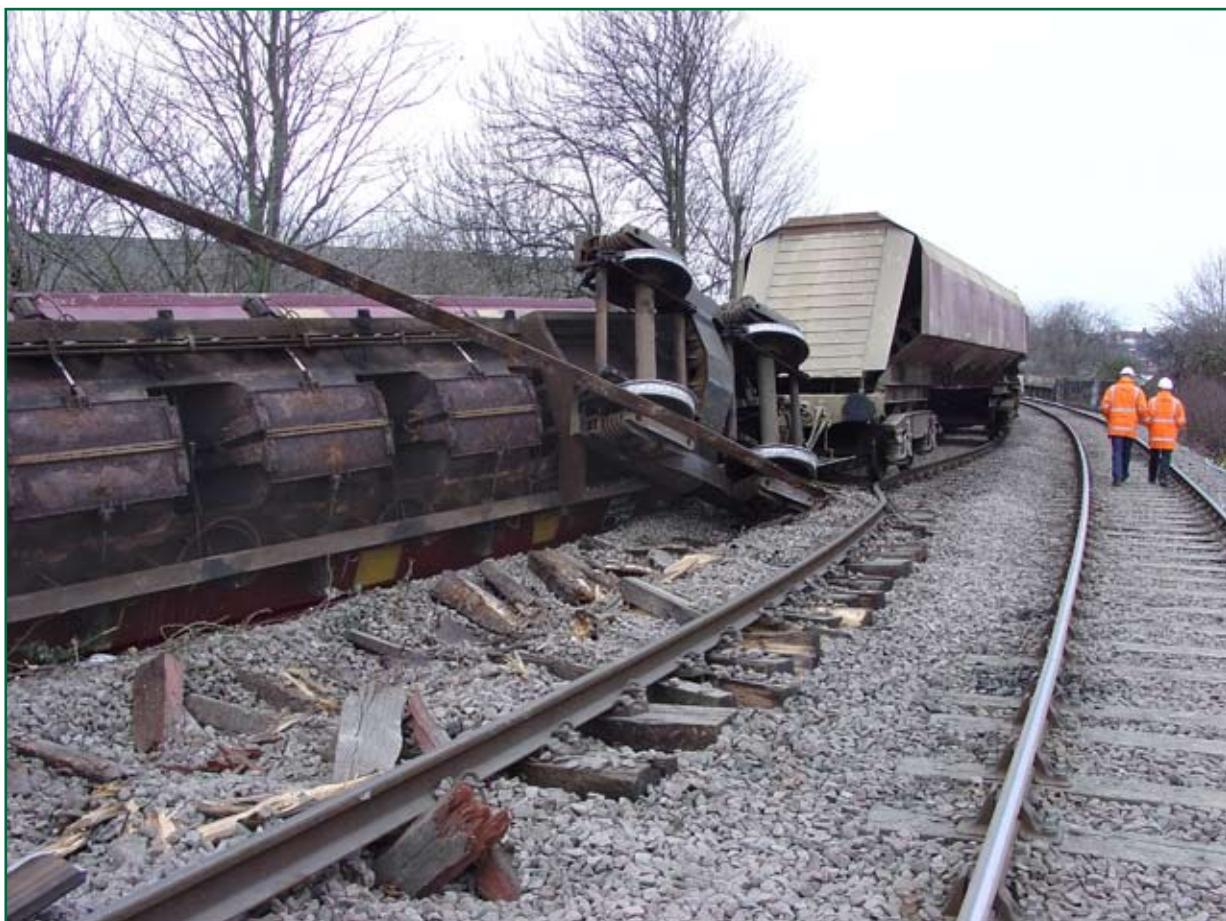
- 39 The two derailed wagons overturned and started to slide down the embankment. Figure 5 shows the leading derailed wagon and some of the damage to the track.

Figure 5: Leading derailed vehicle and track damage.

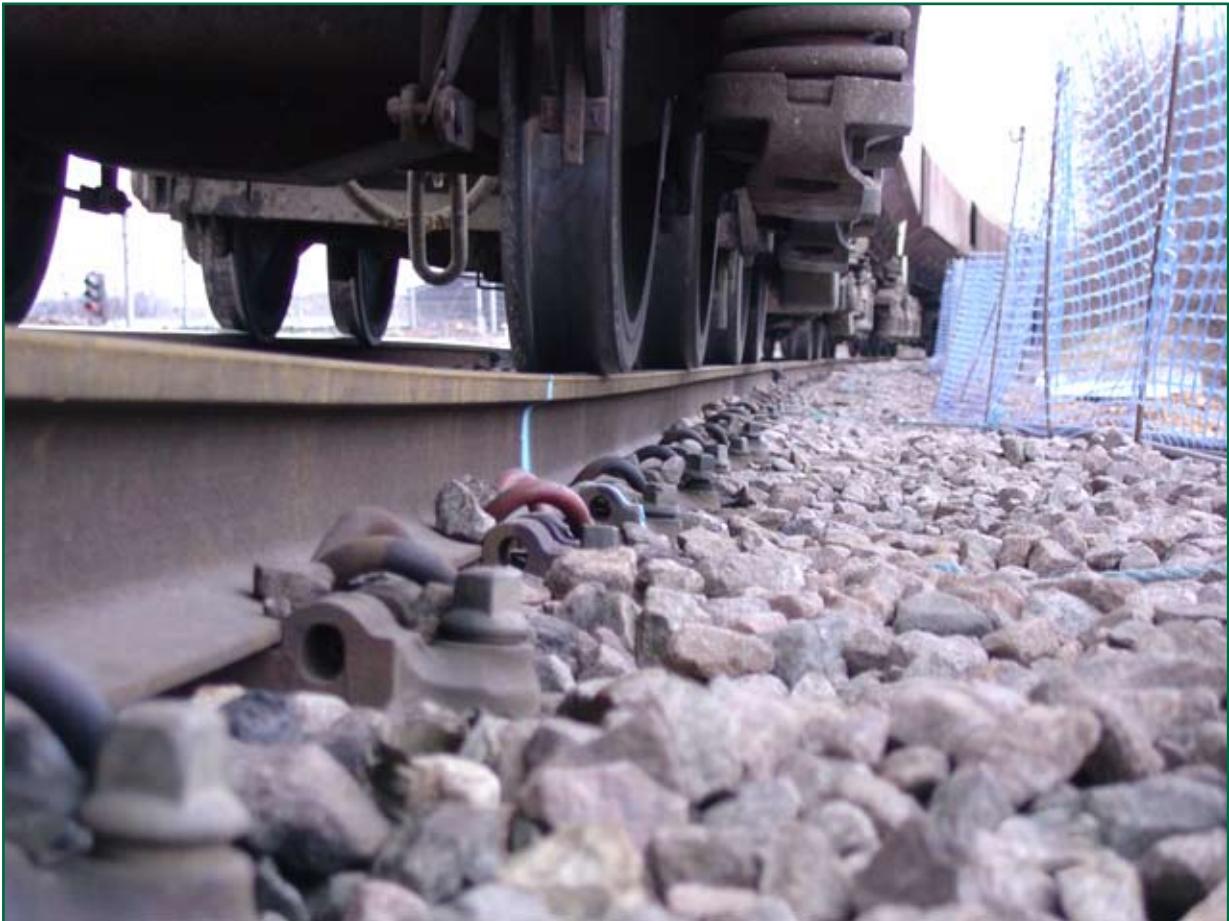
45 The immediate cause of the derailment was severe track twist near to the end of the bank repair site. This twist came about as a result of the loss of vertical support to the cess rail over the area of the bank slip leading to a long dip in the cess rail. This loss of support ended abruptly close to the end of the site where a large tree root system had stabilised the bank. The passage of the loaded wagons over the site caused the cess rail to dip further, increasing the cant up to 160 mm, except where the bank was supported by the tree root system. Here the cant remained close to the design value of 55 mm leading to a track twist of 29 mm (1 in 68) over the 2 m wheelbase of the freight train's bogies. The limit value of twist (over a 3m base) in the Network Rail track maintenance business process document NR/SP/TRK/001 is 1 in 200 (ie 15 mm over a 3 m base, 10 mm over a 2 m base) for a curve of under 400 m radius (as here). If the twist is more severe, time limits are given for the correction of the fault; a twist between 1 in 200 and 1 in 126 must be rectified within 7 days, between 1 in 125 and 1 in 91 it must be rectified within 36 hours and a twist of 1 in 90 or worse requires immediate closure of the line. The severity of the twist following the derailment can be seen in Figure 6.

Figure 6: track twist beneath rear part of train.

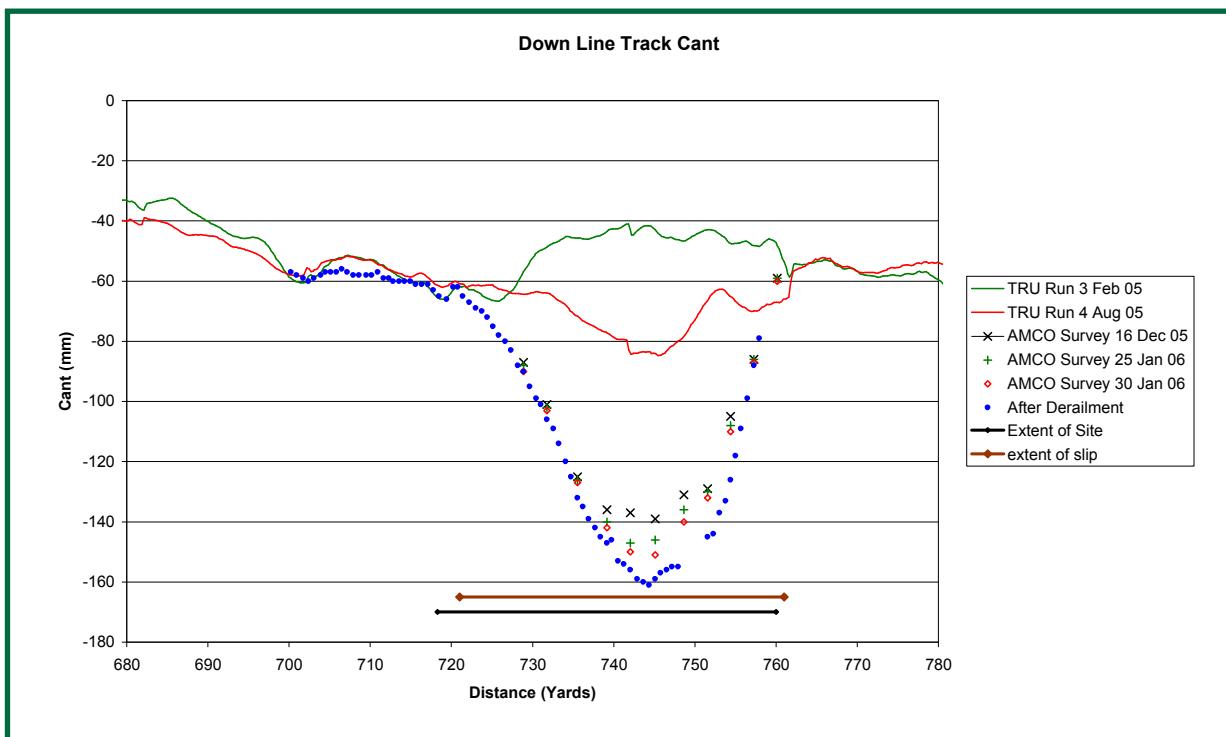
- 48 The Network Rail *Track Recording Unit* (TRU) recorded the track geometry of this line on 3 February 2005 and again on 4 August 2005. The first of these runs revealed some vertical alignment defects at the site that required attention within 10 days. These were attended to by manual maintenance and by tamping. The run on 4 August 2005 showed no alignment defects at the site. However, if the actual numerical alignment data is examined in detail, the effect of the bank slip can be seen as an increase in cant. Figure 7 shows the cant measurements from the two track recording unit runs along with the cant measurements taken after the incident. The traces show how the cant has increased at the site from 45 mm in February, to 80 mm in August and over 160 mm at the time of the derailment. The design cant for the curve was 55 mm. These traces show that the movement of the bank was continuous throughout 2005.

Figure 7: Track cant plotted against distance over time.

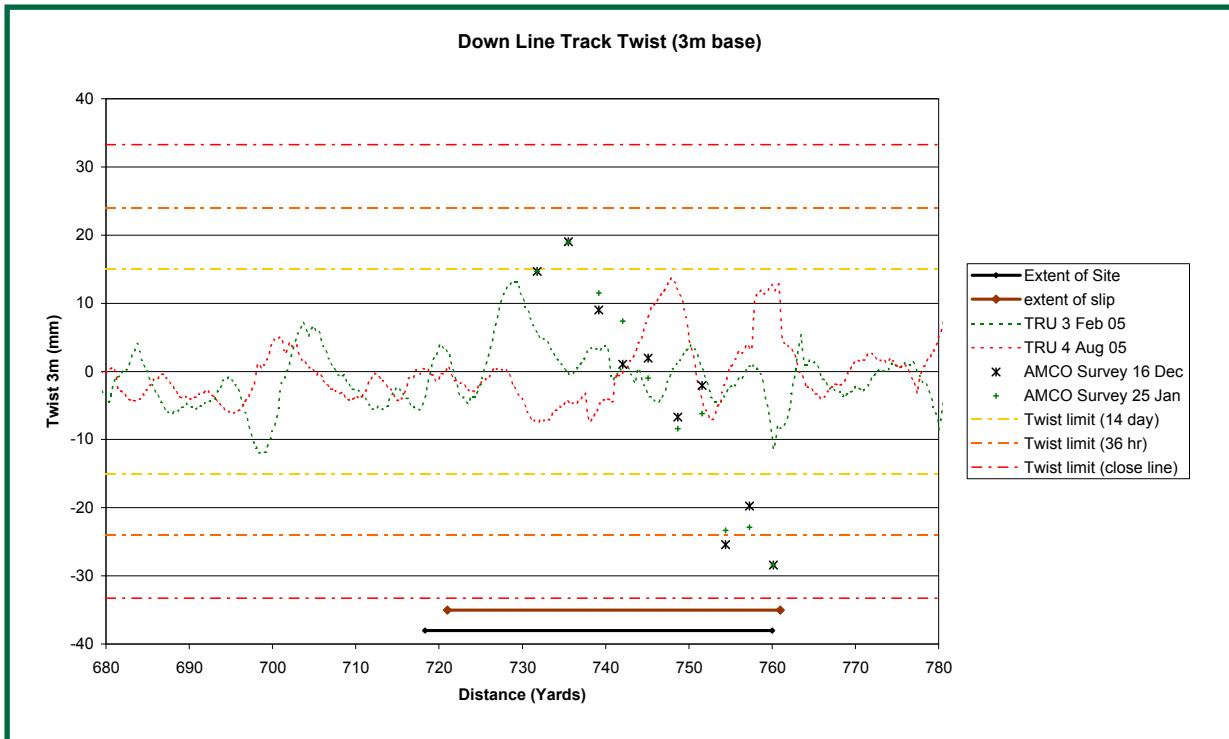
- 49 The track twist was output by the TRU and the twist over a 3 m base is plotted in Figure 8. Discrete values of twist over a 3 m base were also calculated from the AMCO cant readings, using the measured distance between the AMCO monitoring points rather than the 'nominal' 3 m spacing. These twist values have also been plotted in Figure 8. The limits on twist given in NR/SP/TRK/001 (and in paragraph 45) are shown in Figure 8 as broken horizontal lines. It is evident from Figure 8 that the track twist at the time that AMCO started monitoring was at a level where a twist fault existed that should have been attended to within 36 hours. As AMCO were not calculating track twist, this fault went unnoticed.

Figure 8: Track twist plotted against distance.

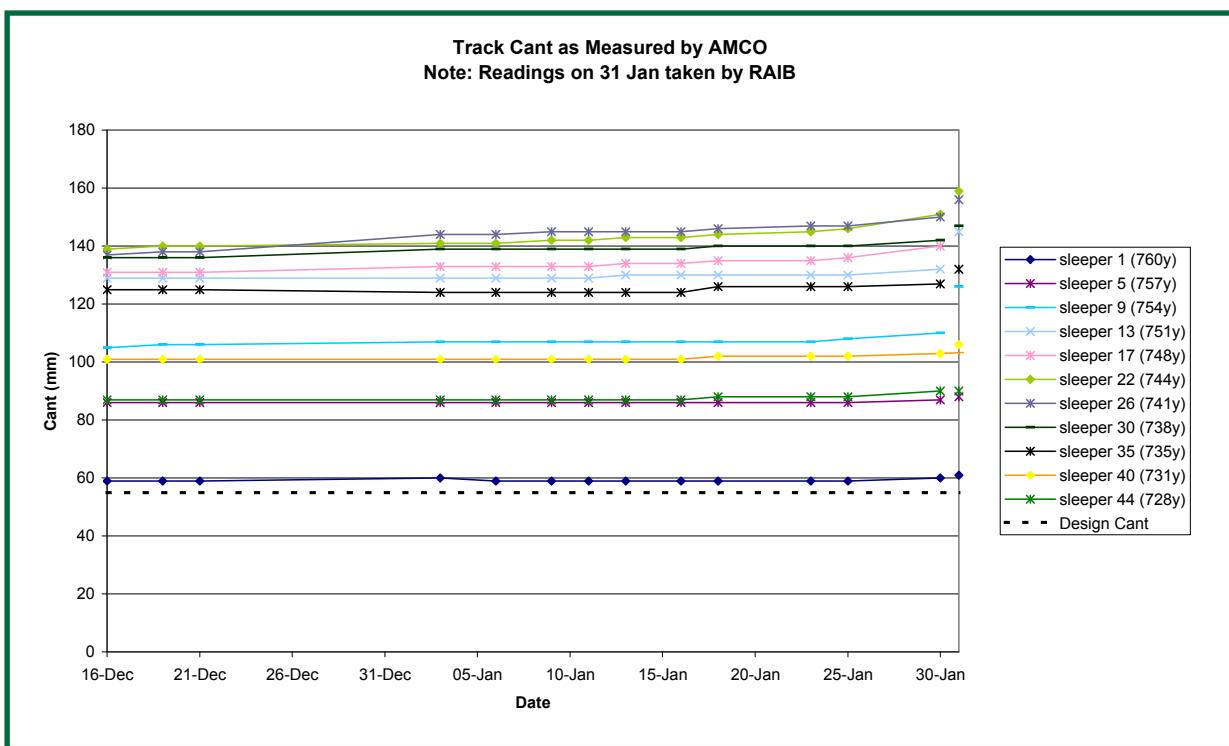
Figure 9: Cant readings taken by AMCO plotted against time.

- 50 The AMCO cant monitoring results have been plotted in Figure 9. These show a slow movement at most of the monitoring points up to 25 January when the apparent rate of movement increases slightly, which might indicate that the bank has become more unstable. The AMCO figures have been plotted with the figures derived from the TRU results in Figure 10 to show the relative rate of movement after the work started on site in December 2005. The apparent rate of movement is greatest at points where the cant is high, points 22, 26 and 30. However, the readings taken from 25 January onwards were taken with the new cant gauge and no correlation was done between the new cant gauge and the old, defective, cant gauge. Therefore the change in cant could be due, at least partly, to the change of instrument. However, in the area away from the derailment, the readings taken by AMCO were within 3 percent of those taken by the RAIB, so the AMCO cant gauge was in reasonable calibration. The only clear conclusion that can be drawn from this is that the bank was unstable and was moving throughout 2005.

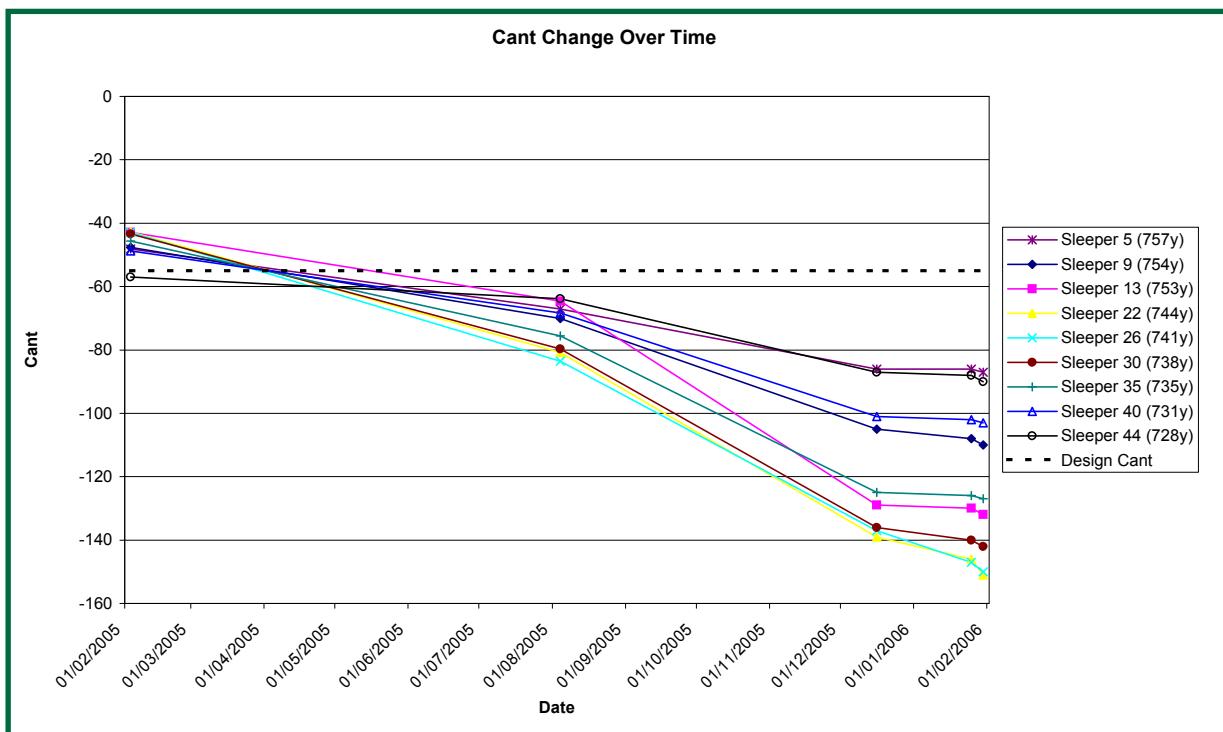
Figure 10: Cant readings from both sources plotted against time.

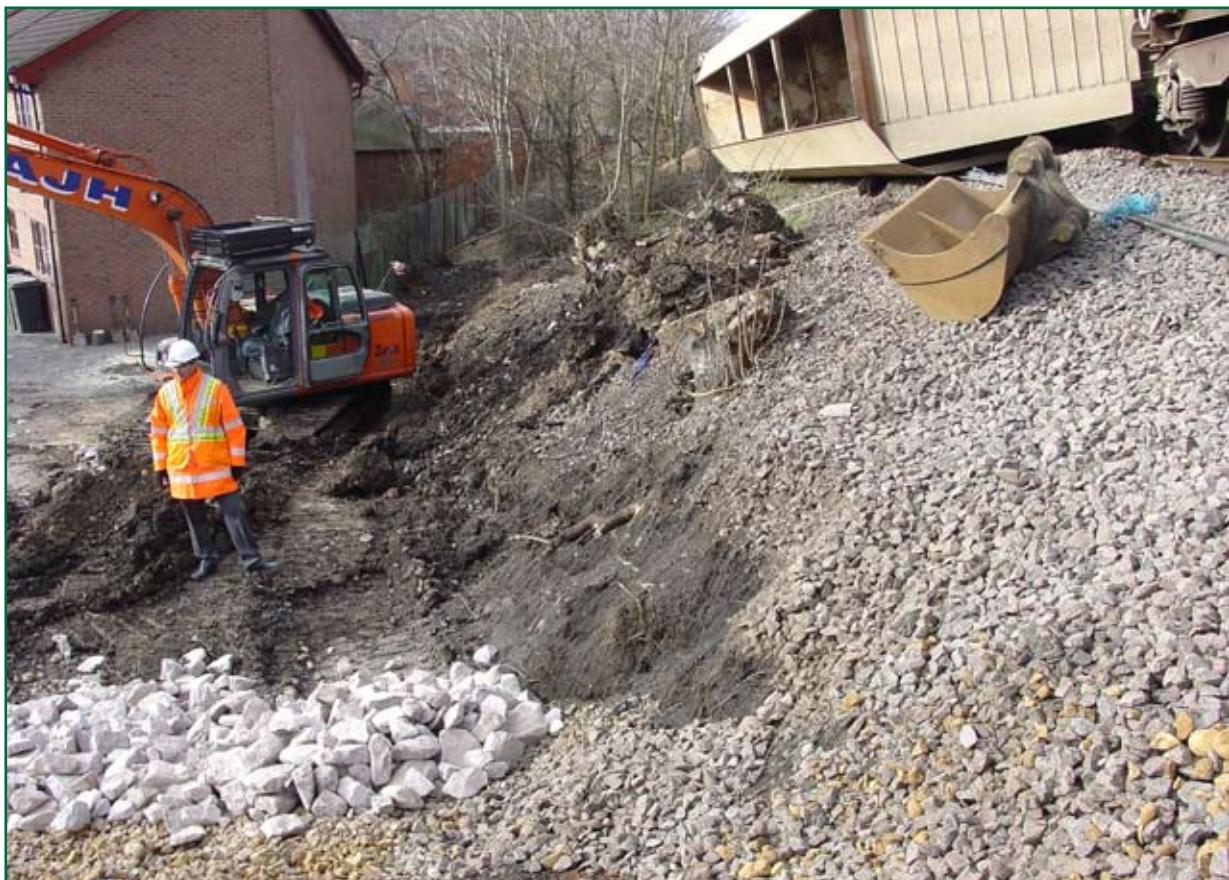
- 69 The excavation works for the embankment repair included the excavation of an access road along the length of the repaired section. This roadway was to provide access for an excavator and a dumper. The width of this roadway was about 2.5 m and a level surface was created, partly by placing fill material on the lower part of the bank and partly by cutting into the bank. This cutting-in left a near-vertical face in the embankment fill. At the site of the derailment, adjacent to the tree stump, this face was 1 m high. On completion of each stage of the repair work, this cut face, and the access road, was buried under the stone fill that forms the repaired embankment. At the time of the derailment, this cut face was exposed over a distance of 5 m. The cut face was approximately 3 m from the cess rail (Figure 11).

Figure 11: Cut face beside access road at site of derailment.

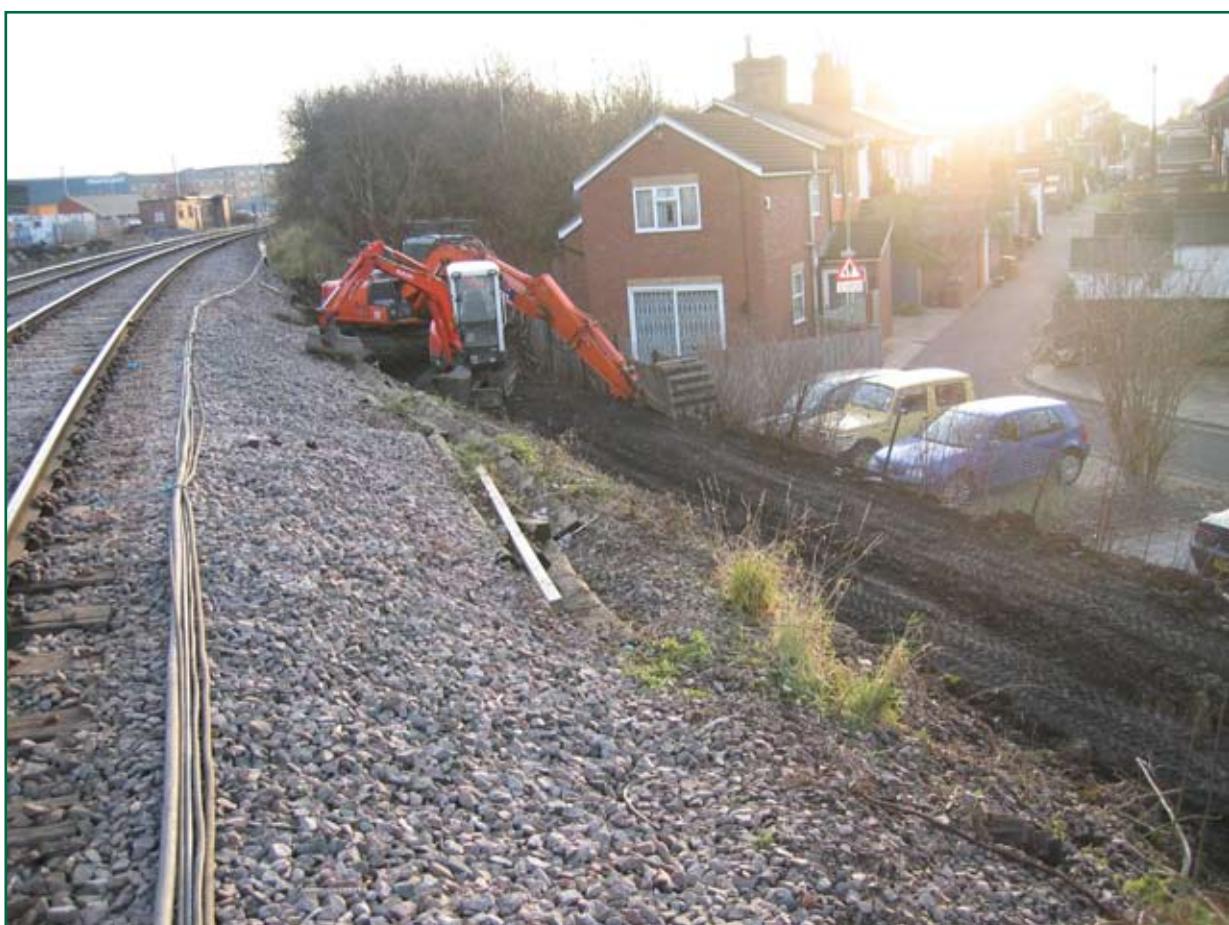
Figure 12: Access road through site, looking towards Cricklewood Junction, in early stage of works.

- 70 The construction of the access road was mentioned in the method statement but its position was not defined. An AMCO progress photograph (Figure 12) shows the roadway to have been situated part way up the bank. The steep face cut into the bank on the track side of this access road would have reduced the stability of this part of the bank. It is not possible to determine whether the bank movement under the train was due to its inherent weakness or whether presence of the access road cut made it unstable.
