Rail Accident Investigation Branch

# Rail Accident Report

## Station over-run at Haywards Heath 12 January 2006

Report 10/2006  
July 2006

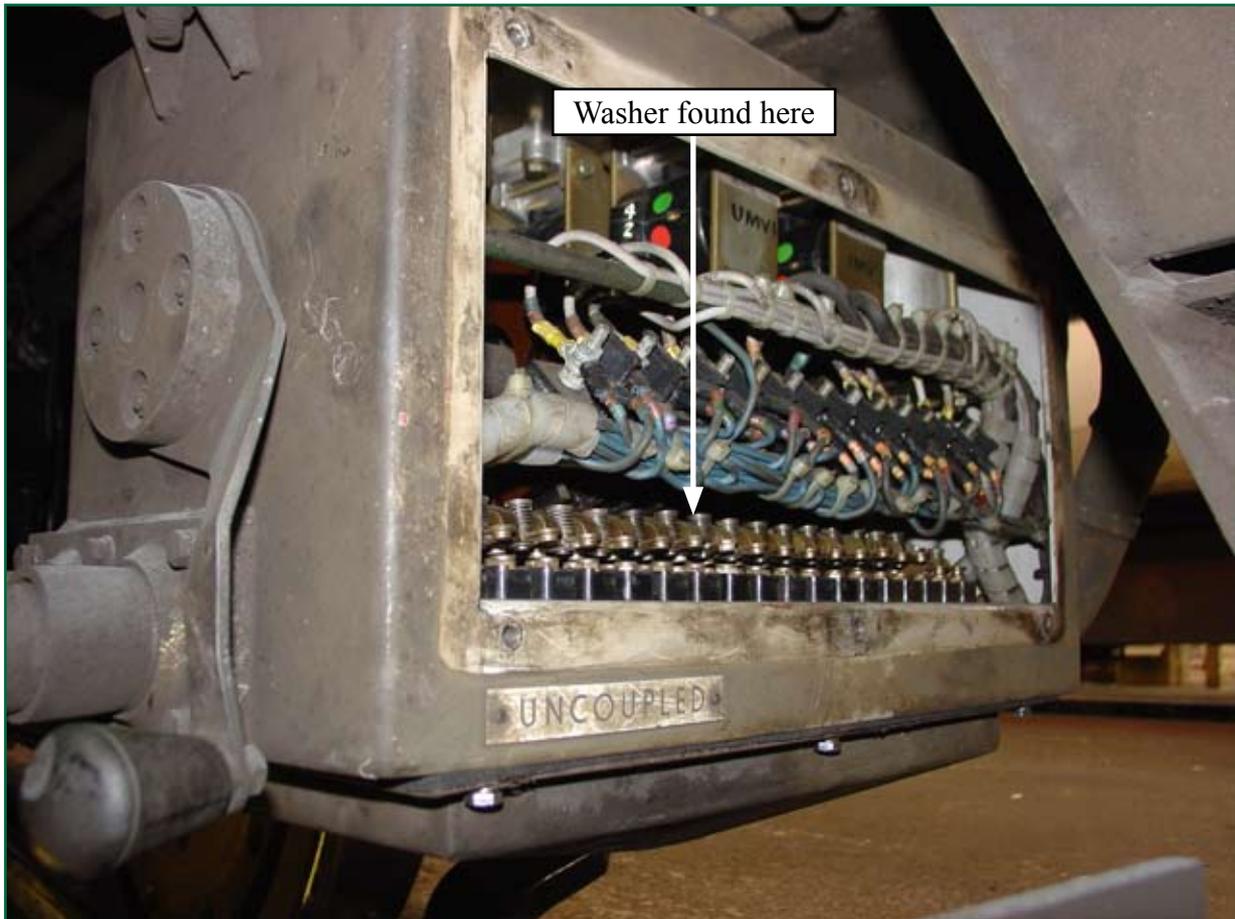
- 14 The fault was traced to the presence of an extraneous 6 mm washer in the *drumswitch* adjacent to the coupler on vehicle 77297 of unit 319004 in the centre of the train. The washer was causing a short circuit, and therefore a false feed, between two wires operating the brakes.

- 15 Figure 2 shows the drumswitch with a cover removed to reveal the terminals where the washer was found.
- 16 Class 319 units have a brake with 4 positions, Steps 1 – 3 and Emergency, Step 1 providing the lowest braking rate.

- 17 The false feed caused by the washer was such that when the brake controller was placed in either Step 2 or 3 positions no brake application occurred. Step 1 and Emergency brake positions worked satisfactorily. The brakes worked correctly immediately the washer was removed. Their operation was confirmed by a functional brake test.

Figure 2: Class 319 drumswitch with cover removed showing terminals where the washer was found

- 20 The origin of the washer is not known. It is likely that it had been loose in the drumswitch and became dislodged from its resting place by the movement of the train, falling onto the terminals of the wires concerned. It is possible that it may have been originally part of the securing assembly for a pair of valves in the upper part of the drumswitch.

- 22 The rear and bottom sections of the drumswitch are reasonably accessible. Examination of the front section, where the washer was found, is severely hindered by the presence of the obstacle deflector and, unless a mirror is used, only an oblique view can be obtained. The view shown in Figure 2 was obtained by placing the camera in a position adjacent to the coupler which cannot be reached by the naked eye.

- 23 The maintenance instructions have been altered to require the use of a mirror where a direct line of sight cannot be obtained (Recommendation 1).
- 24 The maintenance records do not show any 'out of course' attention to the drumswitch on vehicle 77297 in the 12 months before the incident. However, the unit underwent classified attention at Alstom's Wolverton Works in August 2005. During that attention the drumswitches were opened to change the magnet valves.

1. First Capital Connect (formerly Thameslink) and Southern should arrange for an inspection mirror to be used when examining the interior of the drumswitch. This recommendation has already been implemented (paragraphs 31, 32, 34 and 35).
2. Alstom to review procedures, processes and equipment in order to identify an effective means of preventing loose material from interfering with the operation of the drumswitch (paragraphs 24, 25 and 31).
