Rail Accident Investigation Branch

Rail Accident Report

**Cutting of rail from a line that was still open to traffic, near Thirsk station, East Coast Main Line.
11 January 2006**

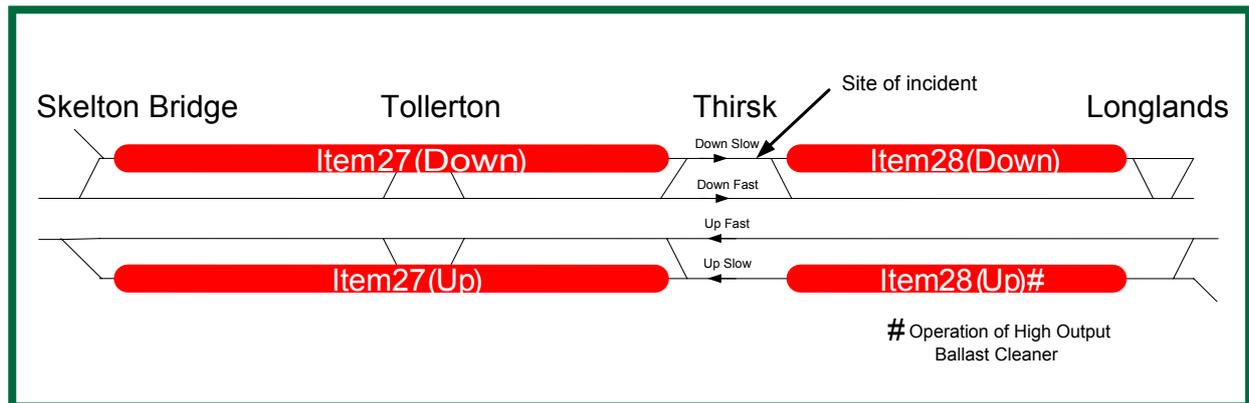
Figure 4: Overview of possessions in the area of Thirsk on the night of 11/12 January 2006

- 35 On 11 January 2006 two engineer's possessions were taken on the slow lines of the ECML in accordance with the arrangements published in the WON. The first of these (shown as item 27 in the WON) was taken between Skelton Bridge and 872 points. The second (shown as item 28 in the WON) was taken between 875 points and Longlands Junction. Each of these possessions had a separate PICOP. The PICOP for the item 28 possession was located at Longlands Junction.
- 36 An overview of the possessions taken on the night of 11/12 January 2006 is to be found at Figure 4.

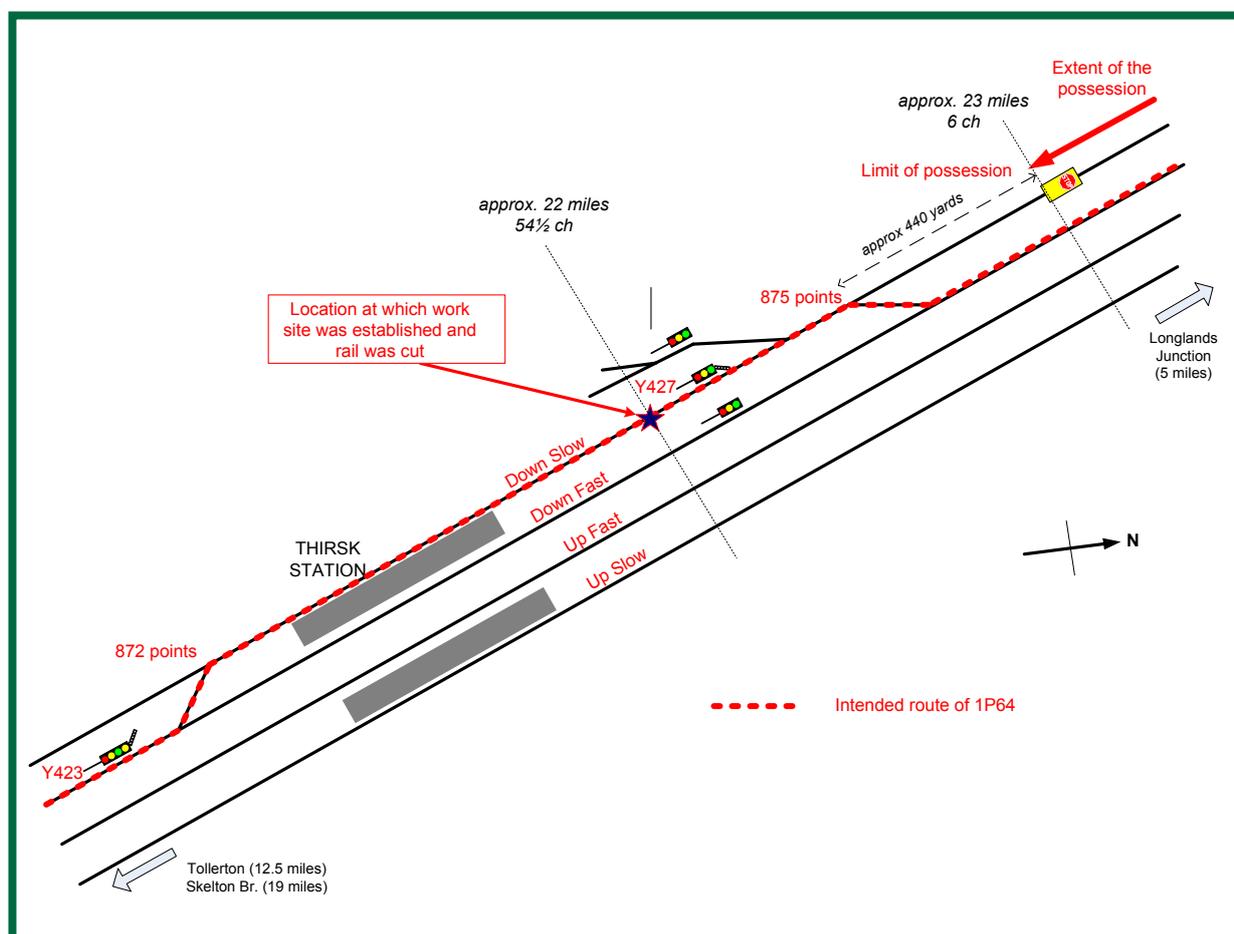
Figure 5: Overview of the incident

41 The possession arrangements described in paragraph 35 necessitated a short term alteration in the *working timetable* in order that the last train scheduled to call at Thirsk, 1P64 the 21:22 hrs Manchester Airport to Newcastle could be routed from the down fast to the down slow via 872 points. It would therefore be able to call at the down slow platform at Thirsk before being routed back onto the down fast via 875 points. The intended route of the train is illustrated at Figure 5.

- 42 At about 23:35 hrs the track circuit on the approach to signal Y427, 'TT', showed occupied. As a consequence the signaller was unable to set the route between signals Y423 and Y427 for train 1P64. This train was by now on the final approach to the Y423 and within two minutes was at a stand awaiting the route to be set across 872 points. (See Figure 5 for a general overview diagram of the incident).
