Rail Accident Investigation Branch

Rail Accident Report

**Near miss of two track persons by a tram on
the Manchester Metrolink, Radcliffe
8 November 2005**

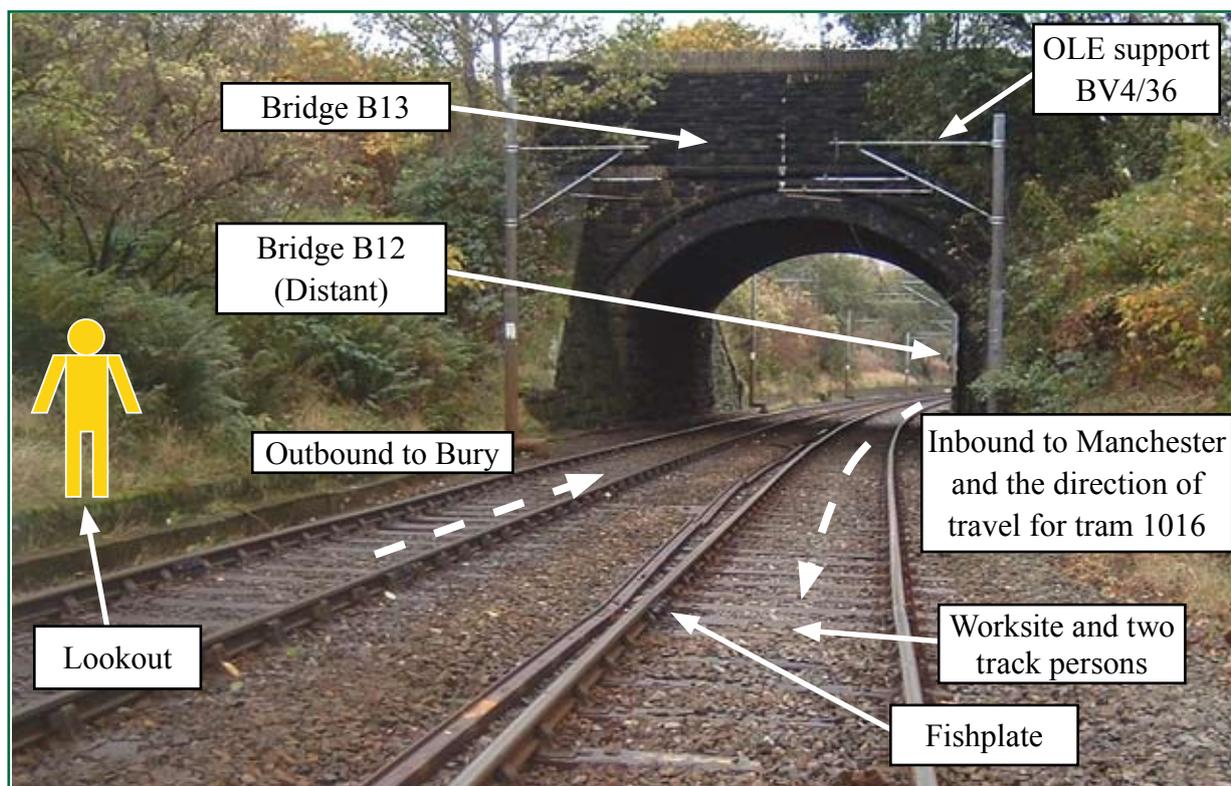
Figure 2: Photograph of the location

20 The incident occurred in the segregated section south of Bury, between Radcliffe and Whitefield tram stops. The location was the inbound running line beyond OLE support BV4/36. It is shown in the photograph (Figure 2) and the site plan (Figure 1). Events following the incident extended the incident site to the operational area bounded by Radcliffe and Whitefield stations.

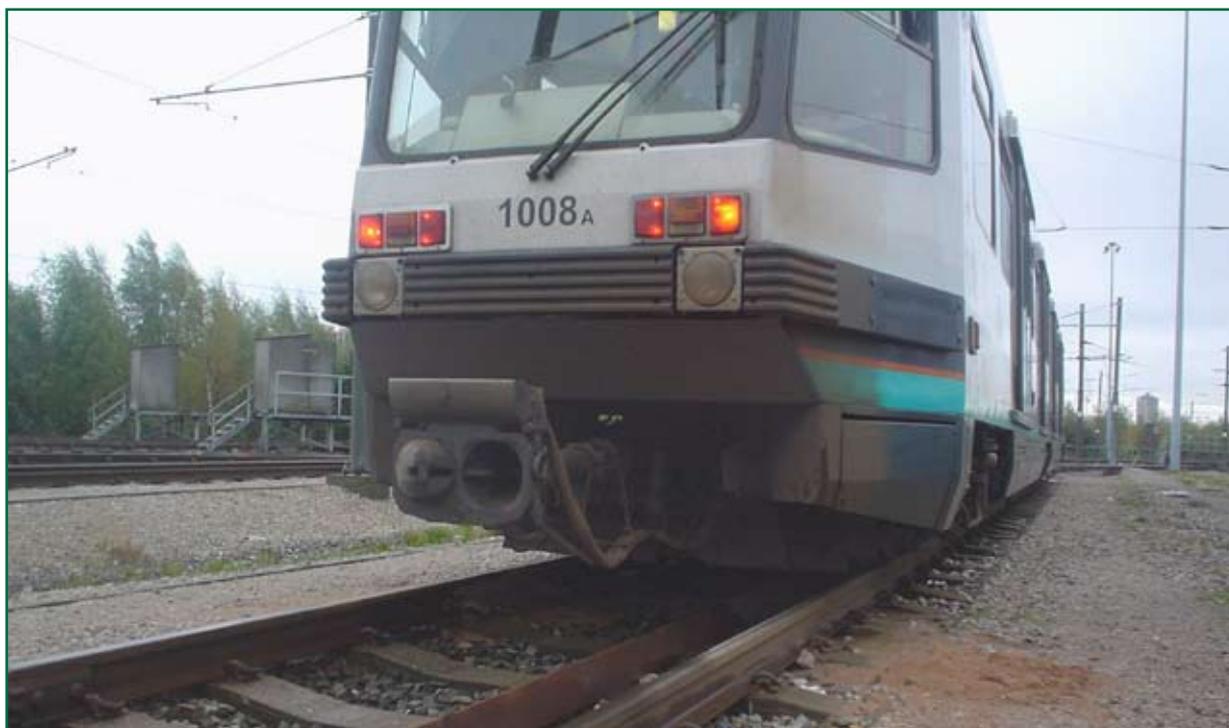
Figure 4: Photograph of the lower aspect of a phase 1 tram

35 There were neither fatalities nor injuries among the tram driver, passengers or track persons. The tram sustained minor damage to brake rigging adjacent to the leading axle, the Vehicle Recognition System (VRS) coils and an Automatic Tram Stop (ATS) beacon. Inspection, repairs and functional testing were carried out during the day of the incident and the tram was back in service by early evening. Photographs of the lower aspect of a phase 1 tram and the irreparably damaged Bance are shown in Figures 4 and 5.

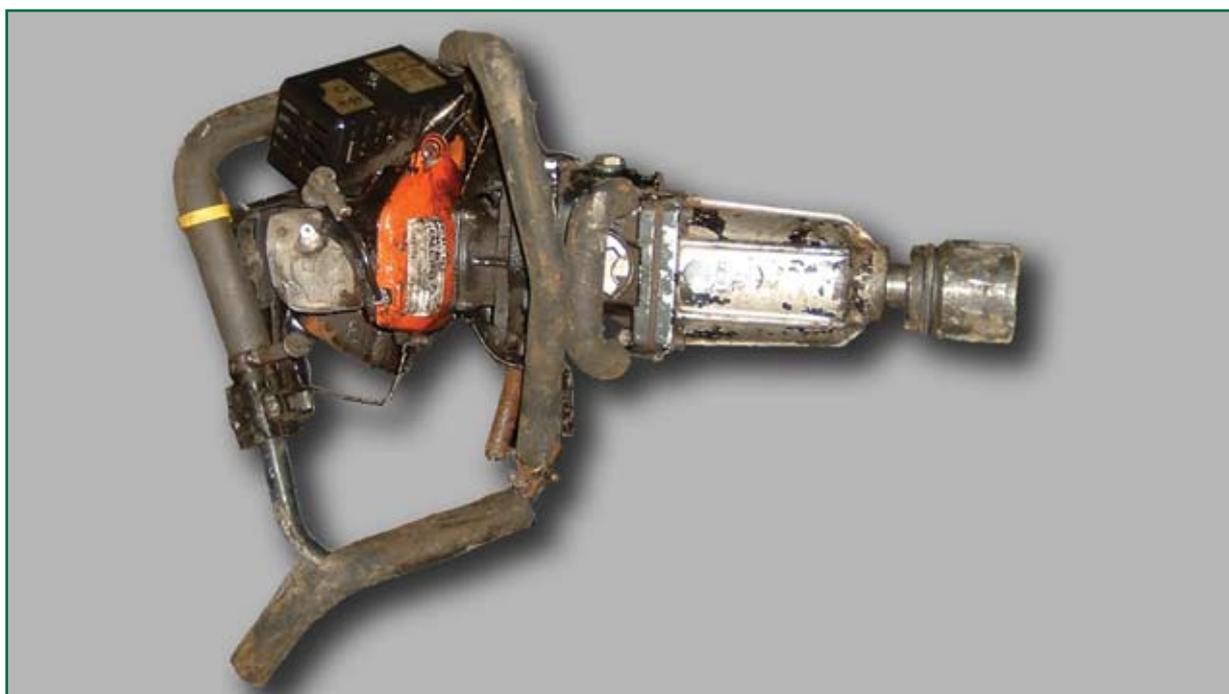
Figure 5: Photograph of the irreparably damaged Bance

- 34 The tram struck the Bance that neither PIC 1 nor contractor A had the opportunity to take to a position of safety. The tram stopped with its rear car 40 metres from the worksite. The actions of the driver and the response of the tram can be seen in the context of time, distance and location in the diagram in Appendix C.

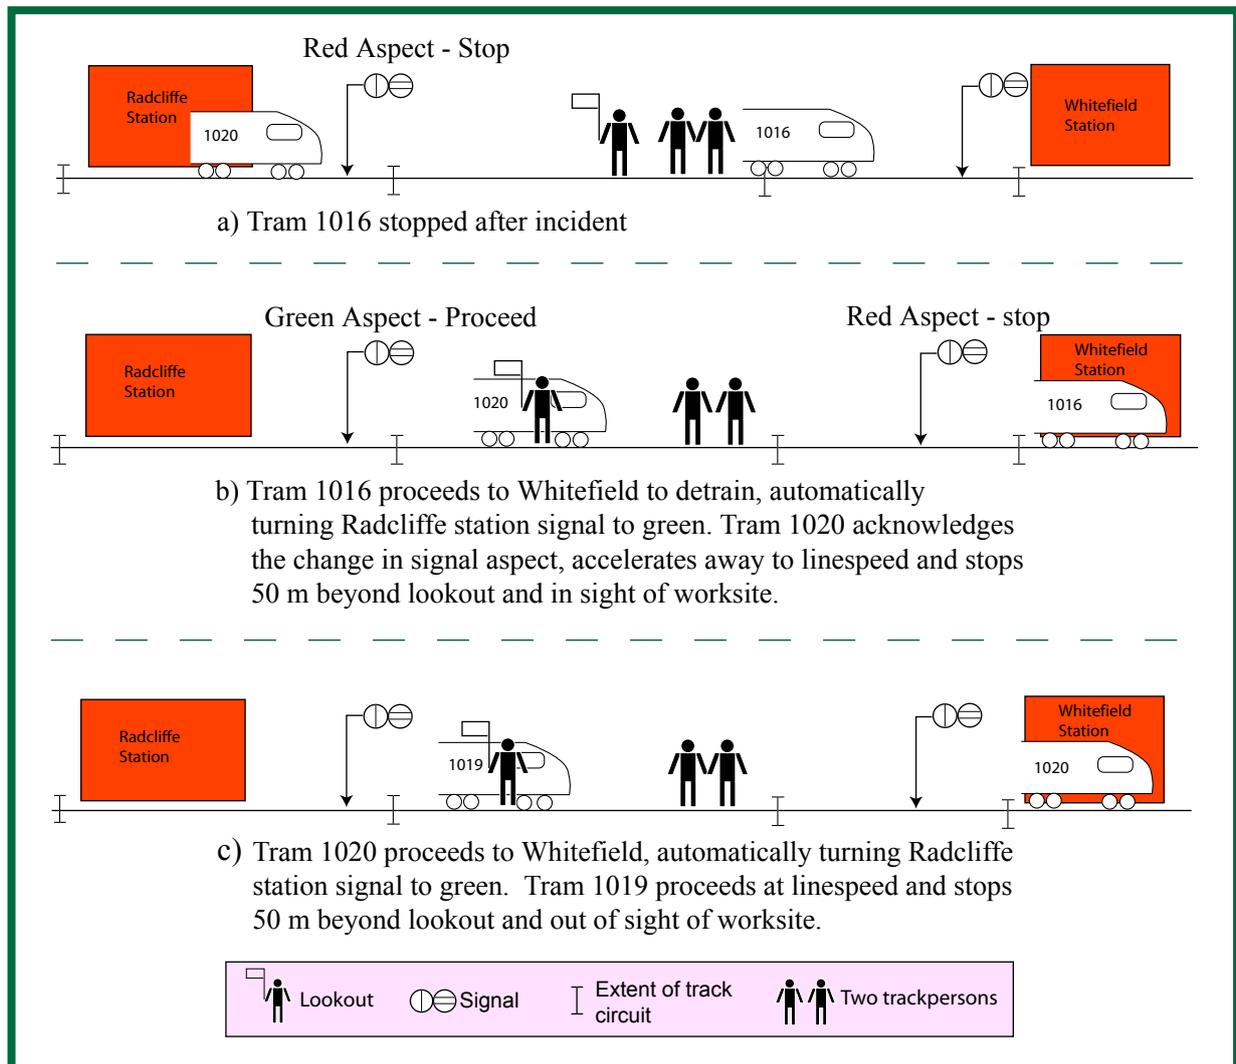
Figure 6: Sequence of events following the incident

36 The sequence of events following the incident are illustrated in Figure 6.

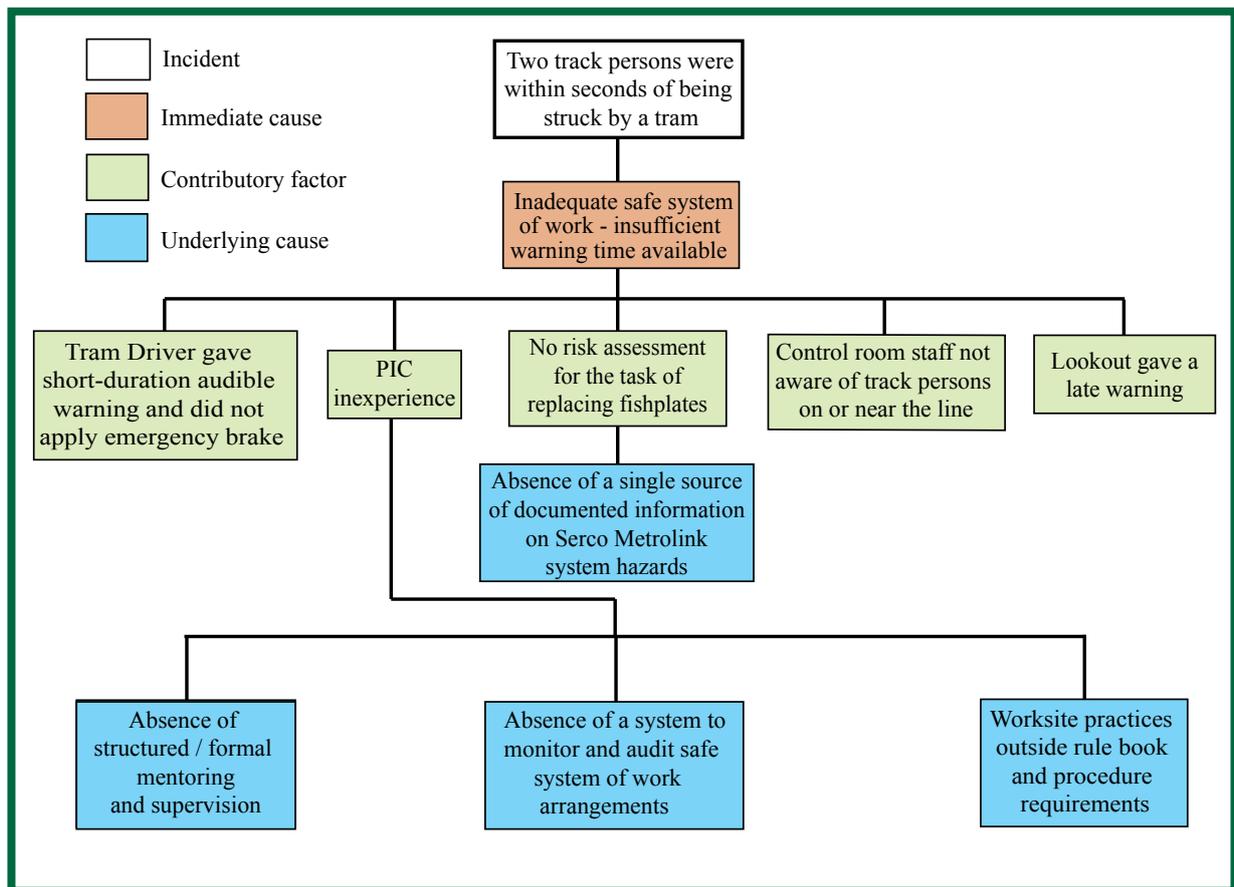
Figure 7: Summary of causal analysis

73 The causal analysis is presented below.
