Rail Accident Investigation Branch

Rail Accident Report

Tram, Pedestrian Collision at Staniforth Road, Sheffield, 27 October 2005

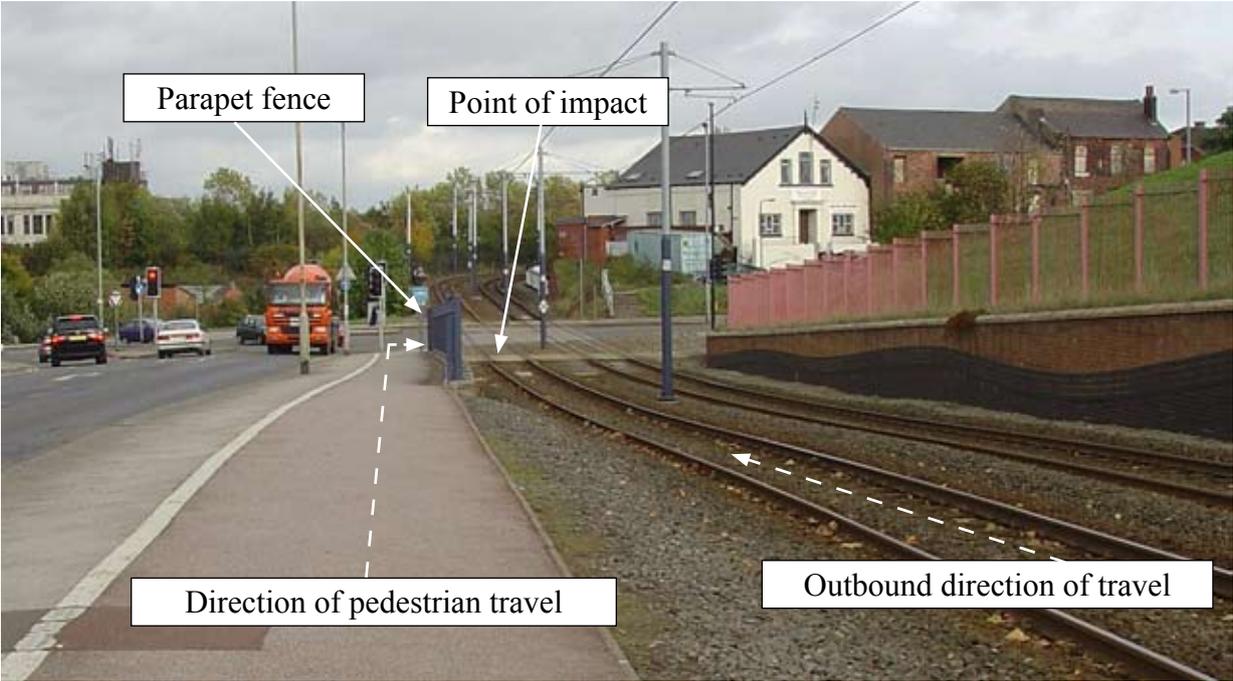
Figure 1: Site layout

- 12 The line to Meadowhall is made up of two tracks running south-west/north-east. They are designated as “outbound” running towards Meadowhall and “inbound” towards the City Centre. Trams travelling “outbound” leave the Woodbourn Road tramstop and run parallel to Woodbourn Road on the left. This is shown in Appendix B Figure 1. Between the carriageway and the tramway is a wide pavement forming both a footway and a cycleway.

- 13 Staniforth Road crosses Woodbourn Road and the tramway on the level. There are separate pedestrian crossings of the tramway immediately to the north-east and south-west of Staniforth Road. The incident took place on the south-west crossing.

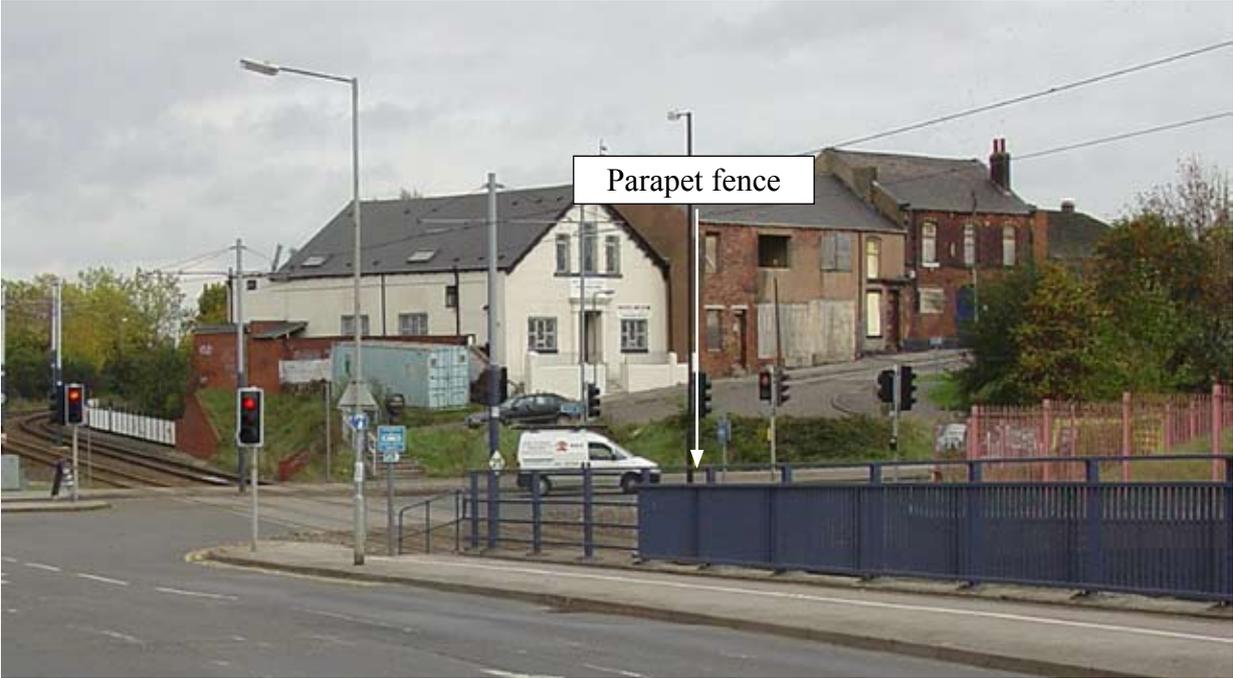
Figure 2: Parapet fence

- 17 The fencing has three distinct sections as shown in Appendix B Figure 2 and described below:
 - The 4.5 metres of fence adjacent to the crossing is of a type normally associated with a pedestrian crossing. It provides little impediment to visibility.

- The next three fence panels are of a parapet design, 1.4 metres high, designed to restrain pedestrians, cyclists and motor vehicles. The design comprises substantial vertical posts with horizontal bars and mesh to aid through visibility.

- The remainder of the fence is of a parapet design comprising substantial vertical posts and closely spaced vertical bars that when viewed from the angle of a tram approaching the crossing, block the tram driver’s view of the pavement.

- 18 The parapet fence partly obstructs the tram driver's view of pedestrians, particularly when they are in the last few metres before reaching the crossing when the pavement slopes downwards to meet the level of the tramway at the crossing.

34 The design and positioning of the fence separating the tramway from the pavement affected the driver's view of the pedestrians. It is a Supertram requirement to sound an audible warning if the driver believes it is necessary to draw the attention of pedestrians and road users to the presence of a tram. Rule book section D paragraph 9.1 refers. Driver training and assessment records that were examined suggest that the tram driver is generally cautious and uses audible warnings in an appropriate manner. It is therefore quite possible that had he had better sight of the pedestrians as they approached the crossing, he would have used the bell or horn earlier than he in fact did, and given the pedestrian more warning of the danger. Assuming that the pedestrian would have then reacted differently and not walked in front of the tram, the accident would have been avoided. Such a scenario is not a certainty but is reasonably likely. As such, the effect of the fence on the driver's view of the pedestrians may have been a contributory factor in this incident. The recommendations in this report relate to restricted visibility of pedestrians at or near to tram crossings.

- 35 The immediate cause of the accident was the pedestrian stepping directly in front of the oncoming tram.
- 36 The design and positioning of the parapet fence separating the foot and cycleways from the tramway on the approach to the crossing may have been a contributory factor.

- 37 Stagecoach Supertram, South Yorkshire Police and Sheffield City Council have started discussions on the replacement of the fence adjacent to the crossing.
- 38 Stagecoach Supertram have introduced a compulsory audible warning by all trams at this location as an interim measure.
- 39 Stagecoach Supertram have carried out an assessment of the entire route and have identified a number of locations where similar conditions exist. They have begun to fully assess all the identified locations and, where necessary, will introduce measures to reduce the chance of a similar event occurring.

- 1 Stagecoach Supertram should either replace the fence with a design that provides the tram driver with better visibility of pedestrians as they approach the crossing, introduce compulsory audible warnings and/or take other appropriate measures so as to reduce the likelihood of such an event reoccurring (paragraph 34).

Until this has been done, the interim use of compulsory audible warnings (see paragraph 38) should be maintained.

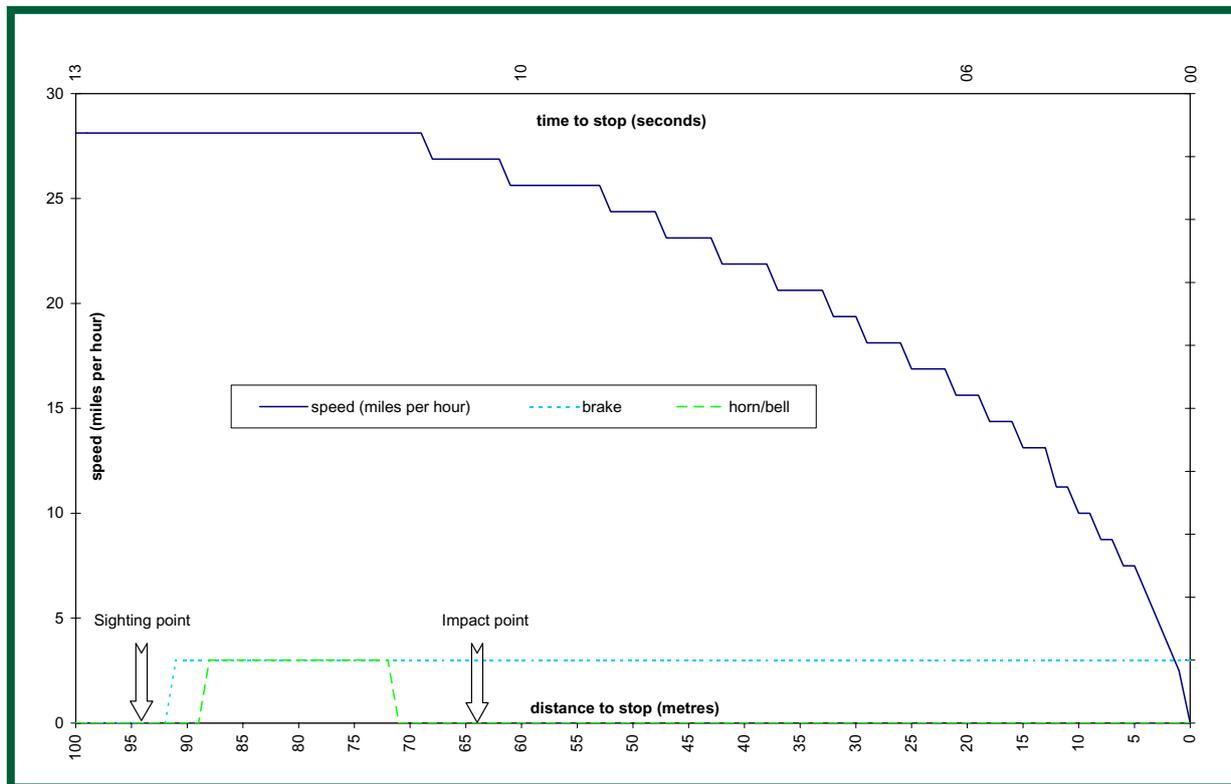
Figure 3: Graph of tram braking and use of horn / bell (NOTE: The distance scale is linear, the time scale is not)

- 26 As the tram approached the foot/cycle crossing, the pedestrian turned right towards the crossing and was first noticed by the tram driver beyond the end of the fencing. At around that time, the driver started braking. He then sounded the horn and increased the brake rate to full service brake within around a second. The tram slowed and collided with the pedestrian around 2.5 seconds after he had become visible to the tram driver beyond the end of the fence. See Appendix C for information on speed, braking, audible warnings and distance travelled through the stop.

- 29 The application of the brake by the tram driver at around the same time as the pedestrians came into view was most likely a response to his rising speed rather than to the presence of the pedestrians. As such, the initial brake rate was low. On perceiving the risk, the driver sounded the horn and increased the brake rate to full service brake. The tram began to slow and struck the pedestrian a short time later at a speed of around 26 mph. This is shown on the diagram in Appendix C.
