Rail Accident Investigation Branch

# Rail Accident Report

**Freight train derailment at Hatherley, near  
Cheltenham Spa  
18 October 2005**

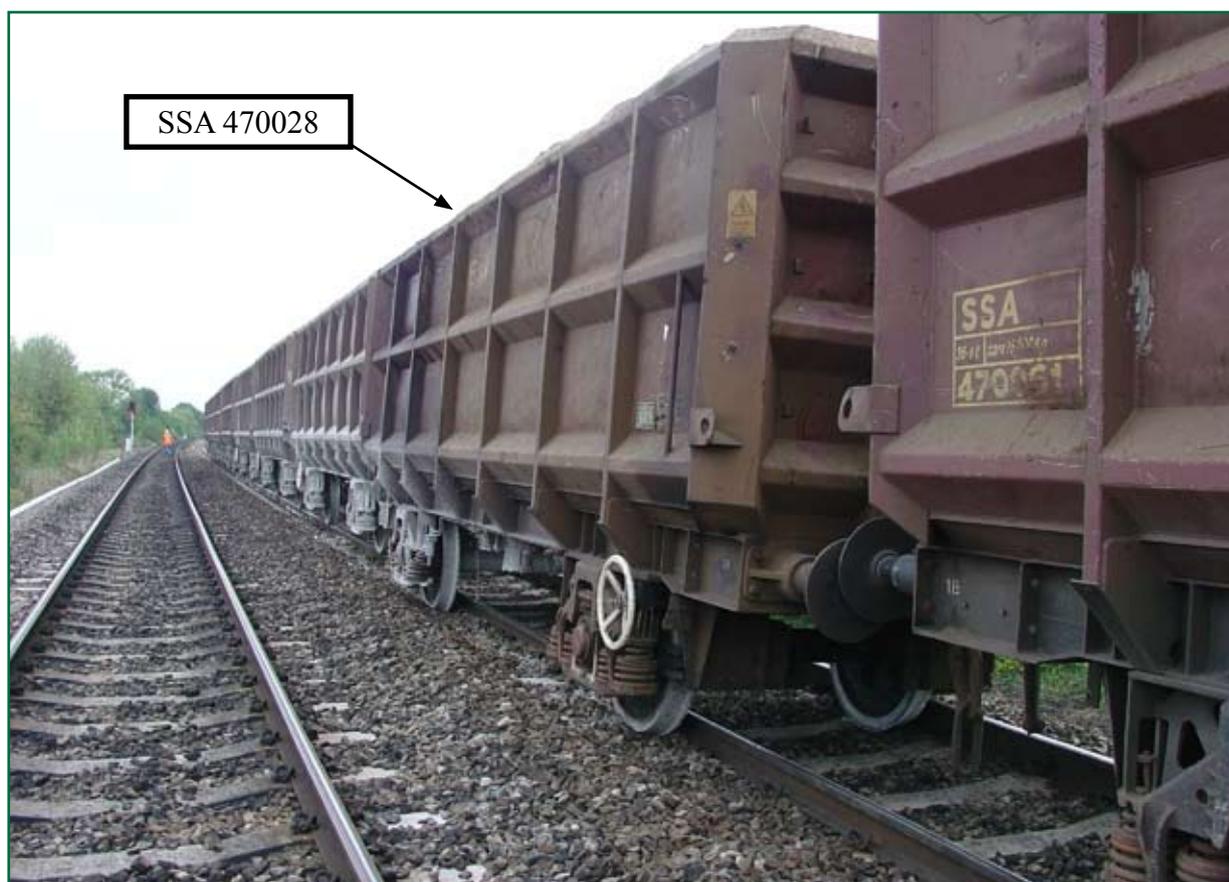
Figure 2: SSA 470028 after derailment

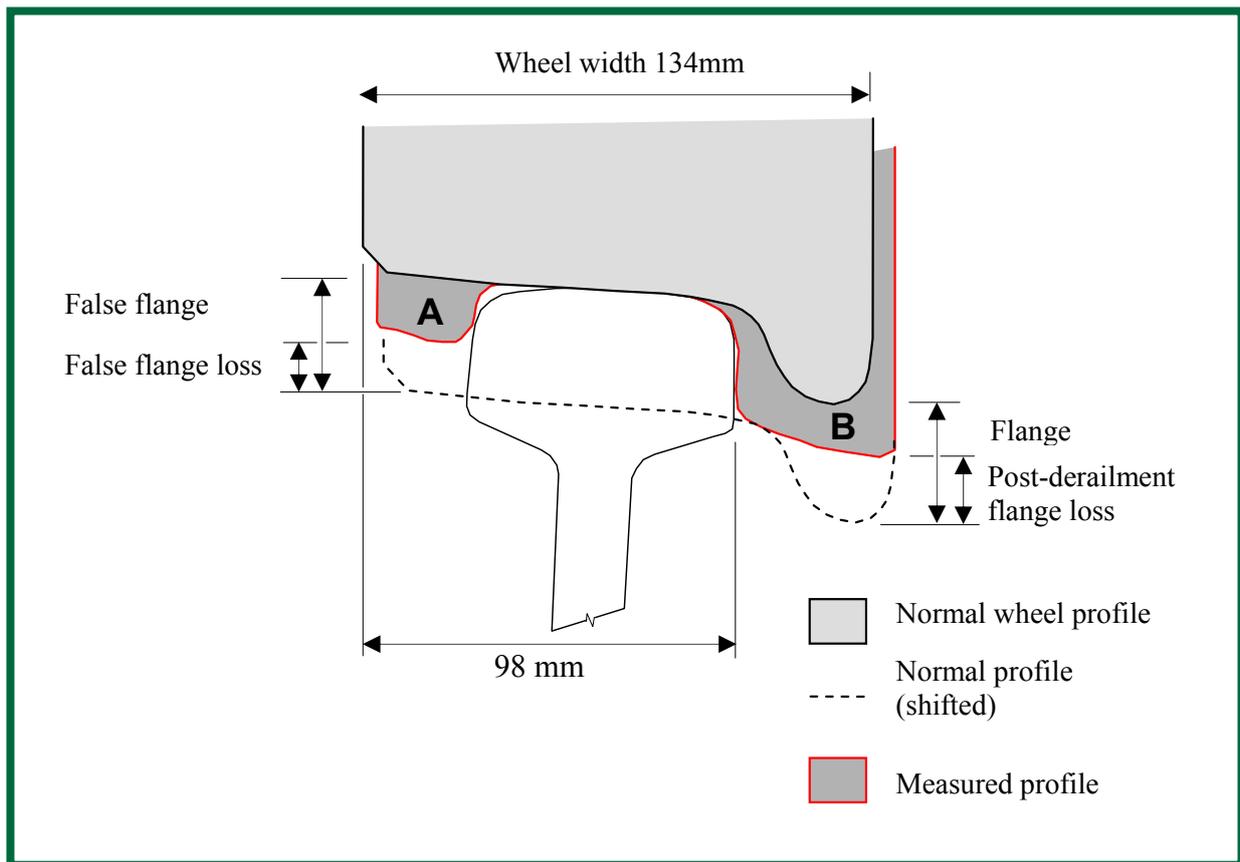
56 Having departed from Bescot Yard with the handbrake on, Wagon SSA 470028 ran with the leading wheelset dragging (ie not properly rotating). This had the effect of gradually wearing down the profile of the wheels, leading to an increased flange depth and allowing a false flange to develop as the centre part of the tread wore away (Figure 4). The normal profile of a rail wheel is such that it allows limited movement across the rail head. With the second (false) flange, the effect was for the wheel to 'clutch' the railhead, impacting with obstacles in its path. The majority of the flange loss indicated in Figure 4 occurred as the wheels ran on their flanges over ballast and sleepers for 4 miles post-derailment.

Figure 4: Profile of SSA 470028 Wheel 2A (leading left wheel) and illustration of flattened wheel profile wrapping around the rail head. The false flange is indicated at **A**, and the increased flange depth is shown on the opposite side at **B**.

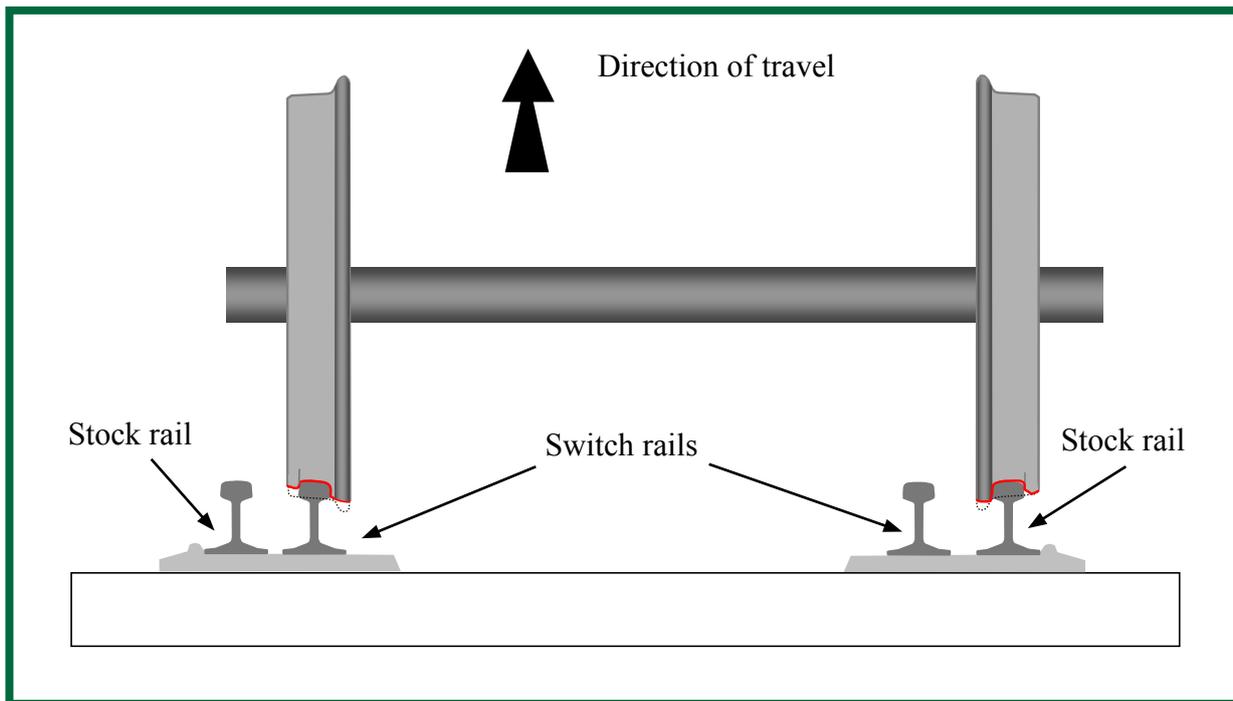
- 60 The derailment commenced as the leading wheelset passed through 673B points (trailing) which form the exit to the Down Goods Loop near Hatherley. The left wheel followed a similar path to that taken at 669A points, in that the false flange dropped between the left hand *stock rail* and *switch rail*, experiencing an increasing lateral force to the right as the rails converged (Figures 5 and 6).
- 61 The derailment sequence has been deduced from the damage and markings on site and is illustrated below. Sleeper 0 is located at the point of derailment (POD), which was identified as being at the toes of 673B points.

Figure 5: False flange on left wheel drops into gap between converging stock and switch rail at 673B points, 12 sleepers before point of derailment.

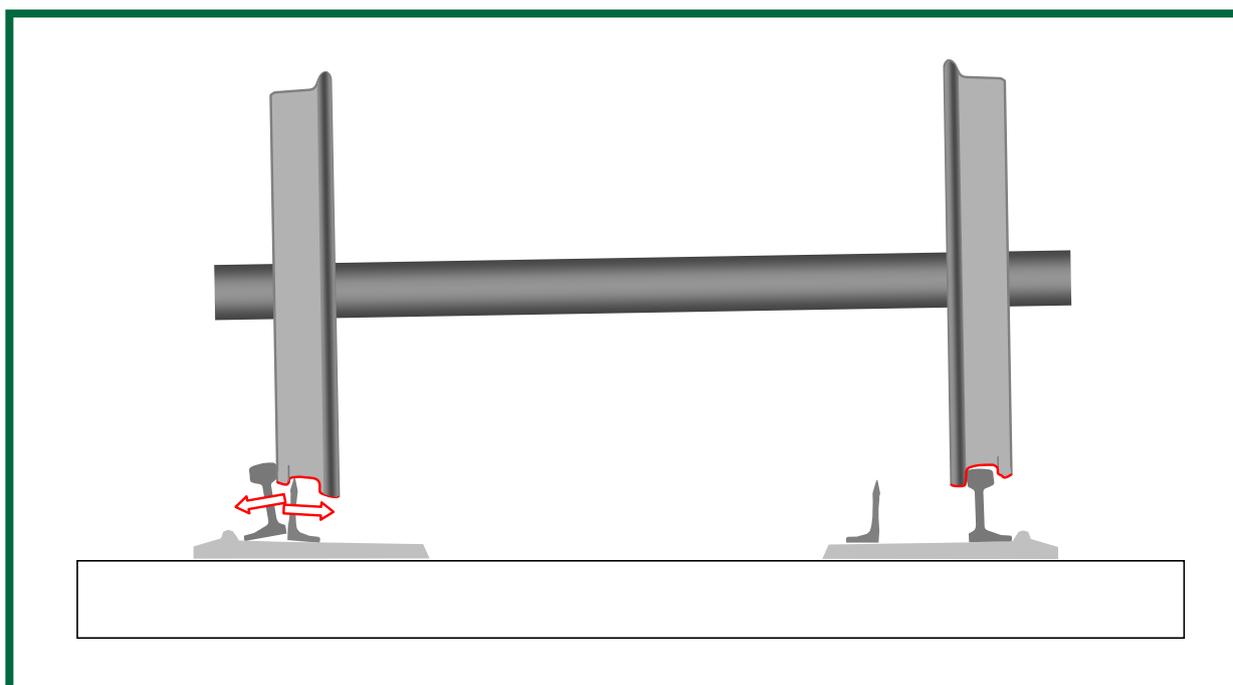
Figure 6: Six sleepers before point of derailment. As left-hand stock and switch rails converge, the stock rail is displaced to accommodate the false flange on this wheel. The left wheel is now running below the rail head.

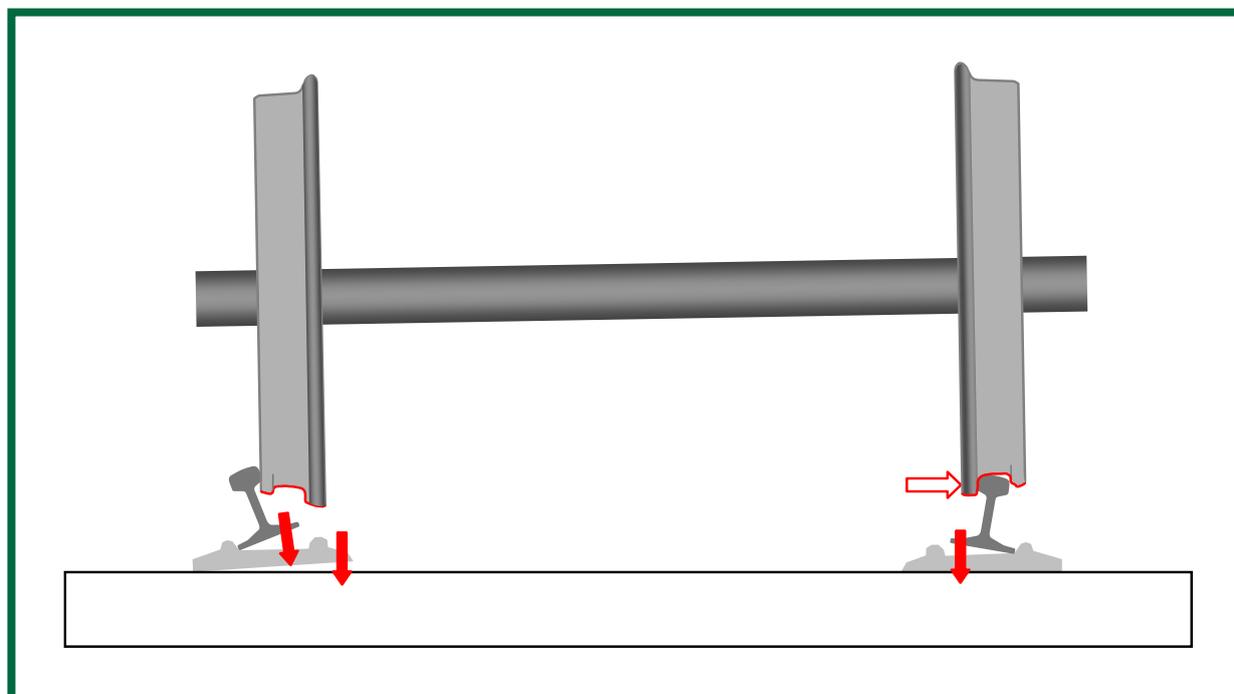
- 63 The leading wheelset continued to skid in this partly derailed configuration (Figure 7), with the tread (outer) face contacting the *gauge face* of the left rail. Gauge widening was accommodated by the partial overturning of the left rail, evidenced by lifted and fractured baseplates and displaced rail clips from the *gauge side* of the left rail (Figure 8). The resistance to gauge spreading forces on the next length of track was sufficient to prevent the left wheel descending onto the ballast, but not high enough to force the wheel back into the normal running position, as was the case beyond 669A points.

Figure 7: One sleeper after point of derailment. High lateral forces are developed by track's resistance to gauge spreading following partial derailment of left wheel. A 98 mm effective gauge increase was accommodated by lifting of baseplates and failure or displacement of 'Pandrol clips' (see Appendix B), resulting in outwards rotation of left rail.

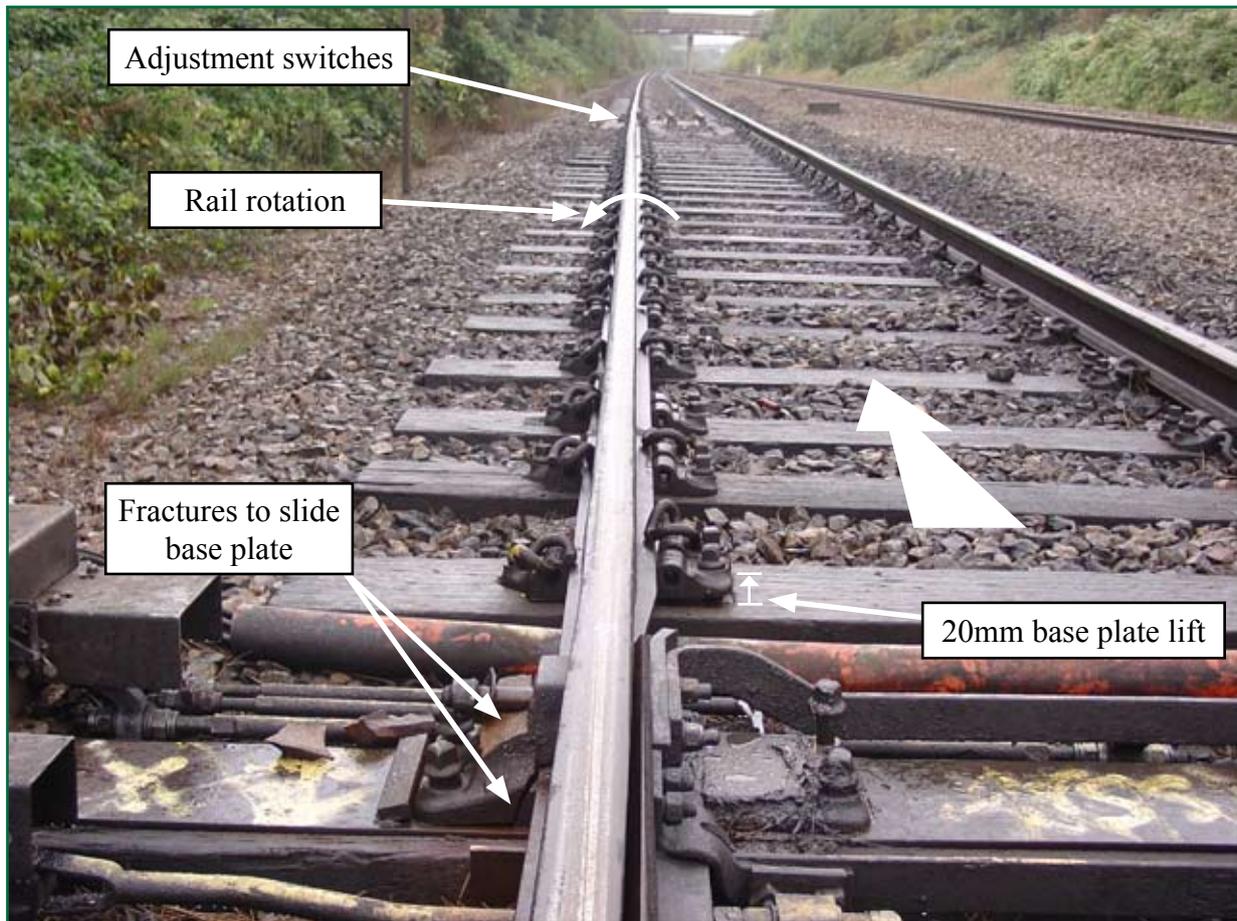
Figure 8: View along left hand rail in direction of travel from toes of 673B points showing rotated rail, lifted baseplates and displaced rail clips. The partially split points are visible in the foreground as a result of the action of the false flange at the point of derailment of the first wheel (sleeper 0). The adjustment switches, where full derailment occurred, are visible in the background.

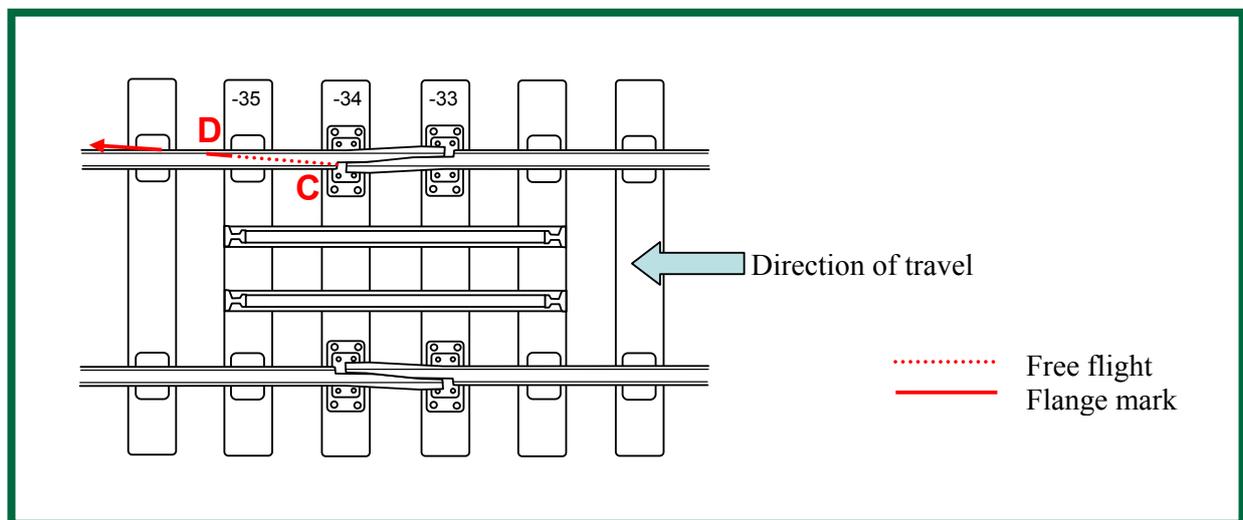
- 66 Rail markings showed that the right wheel flange made contact with the machined notch on the right hand rail (point C, Figure 9) as a result of the high lateral forces imposed on it. The wheel struck the notch and was catapulted into free flight for a distance of 700 mm, releasing the gauge spreading force which resulted in a lateral movement to the right (Figure 10). The flange landed on the rail head and lacking lateral restraint, descended onto the ballast (Figure 11) derailing to the *field side*.

Figure 9: Full derailment triggered by impact of right wheel with machined notch in adjustment switch layout (C). Flange landed on rail head after free flight of approx 700 mm at (D). Sleeper numbers are indicated. Figure 11 uses the same notation.

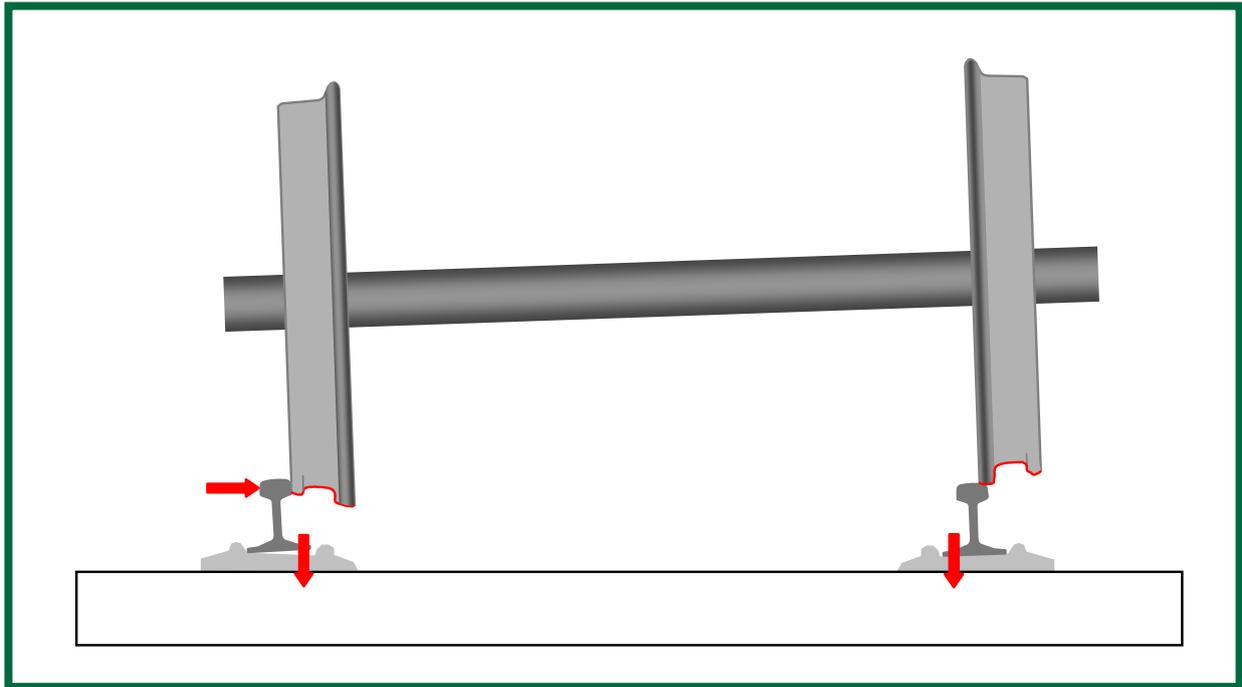
Figure 10: 35 sleepers after the point of derailment. As right wheel passes adjustment switches, it is catapulted into free flight. Resistance to gauge spreading forces exerted by the left rail caused the wheelset to be displaced sideways leading to full derailment to the right.

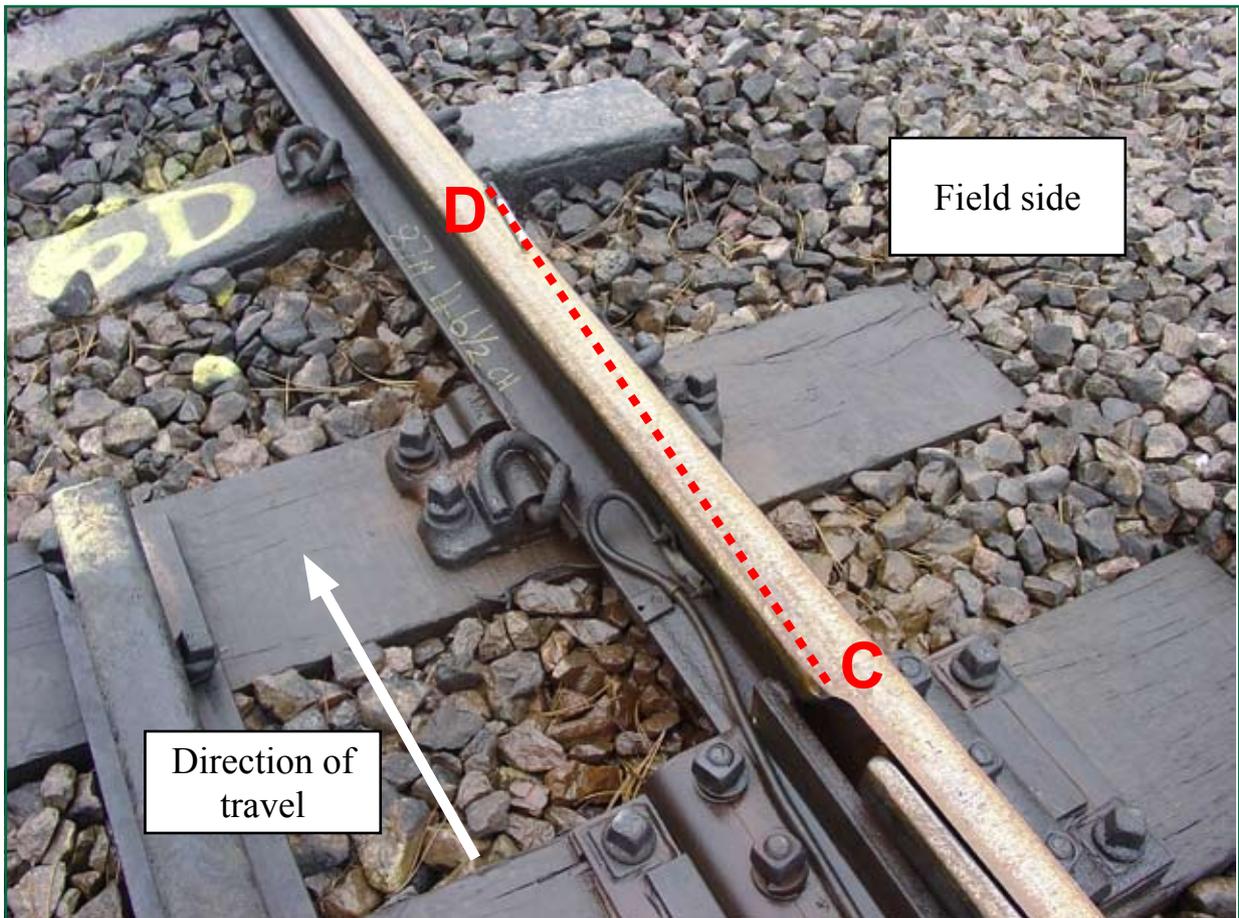
Figure 11: Photograph of adjustment switches showing point of impact with the machined notch (C) and derailment mark indicated by the position of the pen on rail head (D) where right hand wheel landed after being in free flight for 700 mm (grinding marks are visible on the rail head, showing light corrosion following overnight rain).

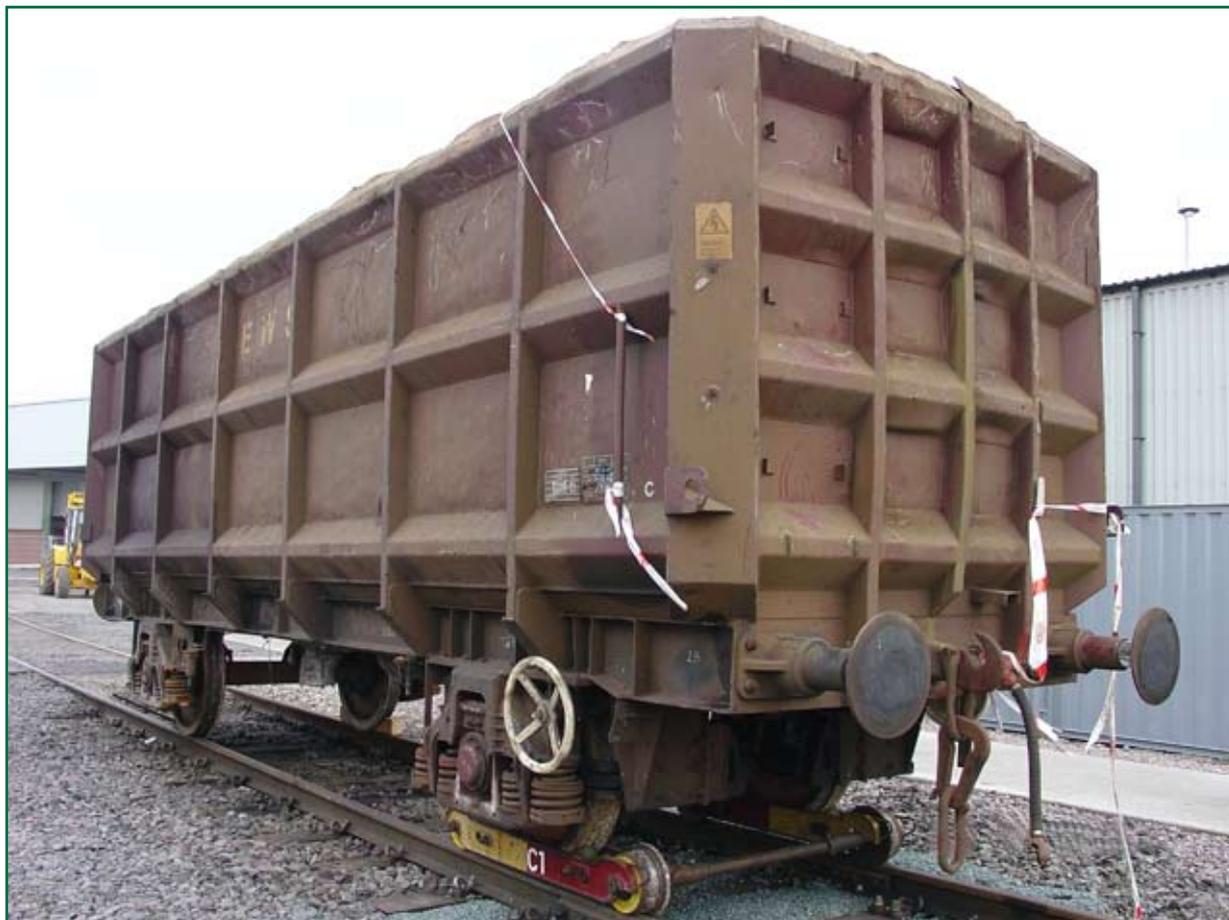
*Figure 12: SSA 470028 after recovery to Toton Depot with wheel skate (marked C1) used to move the wagon with its damaged wheelset after the derailment*

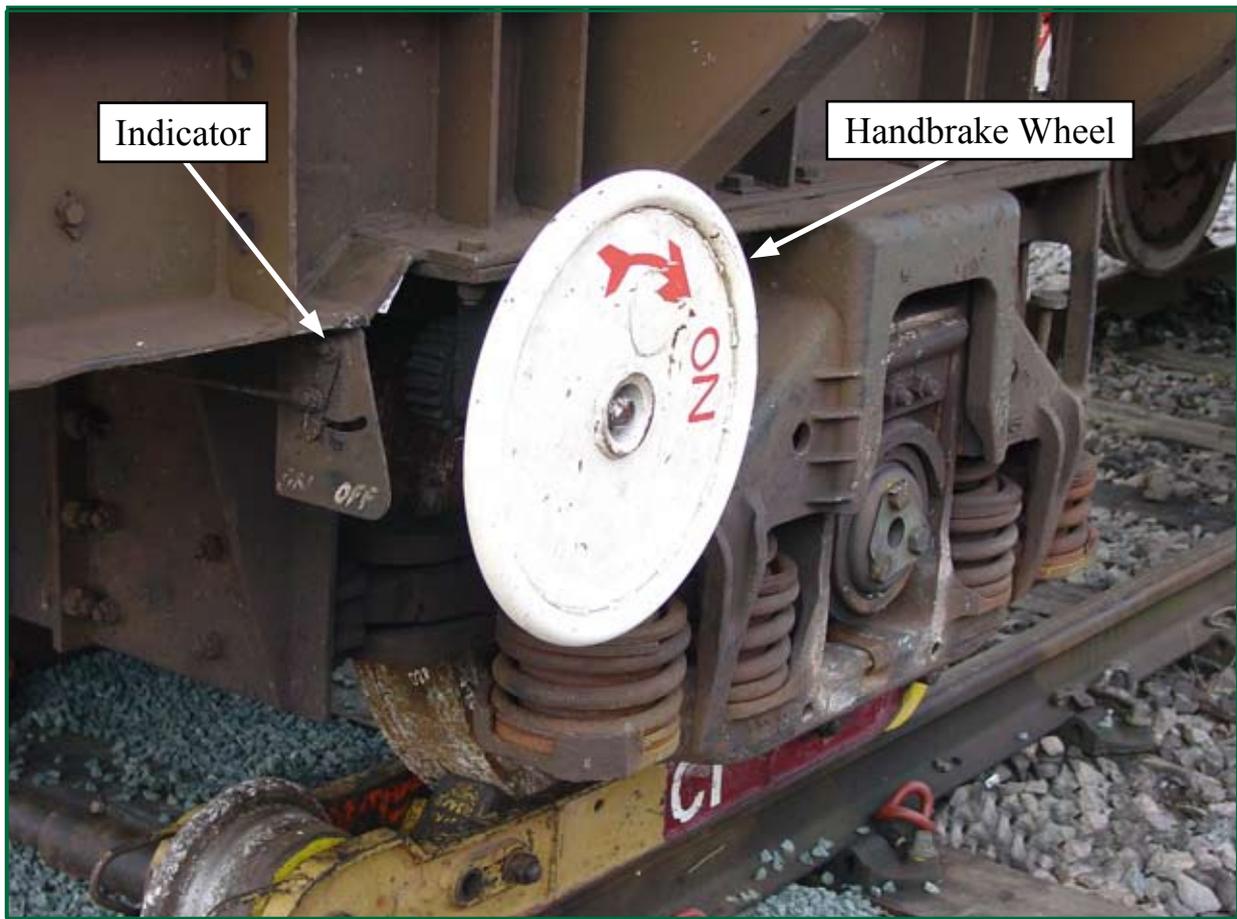
Figure 13: Handbrake wheel and indicator on SSA 470028

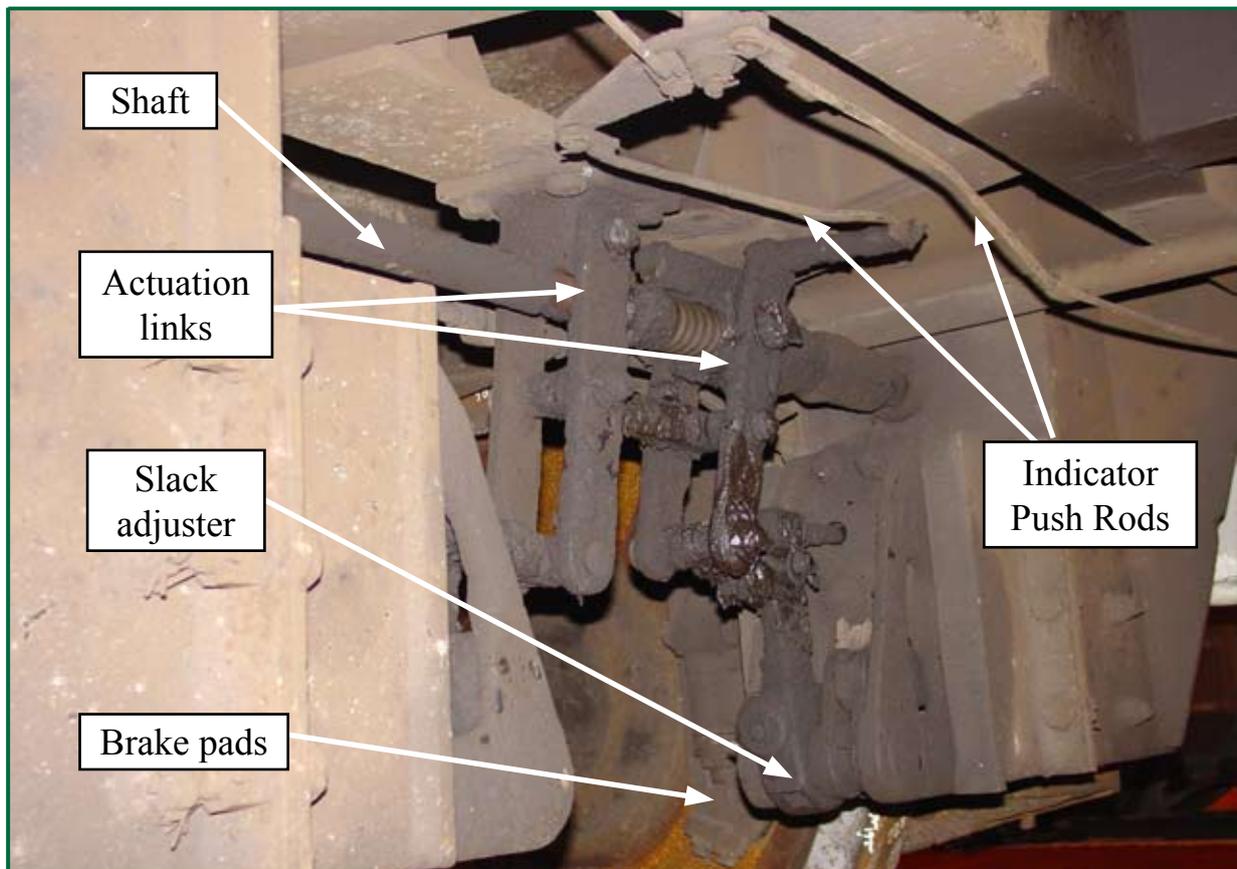
Figure 14: SSA 470028 handbrake components below the underframe.

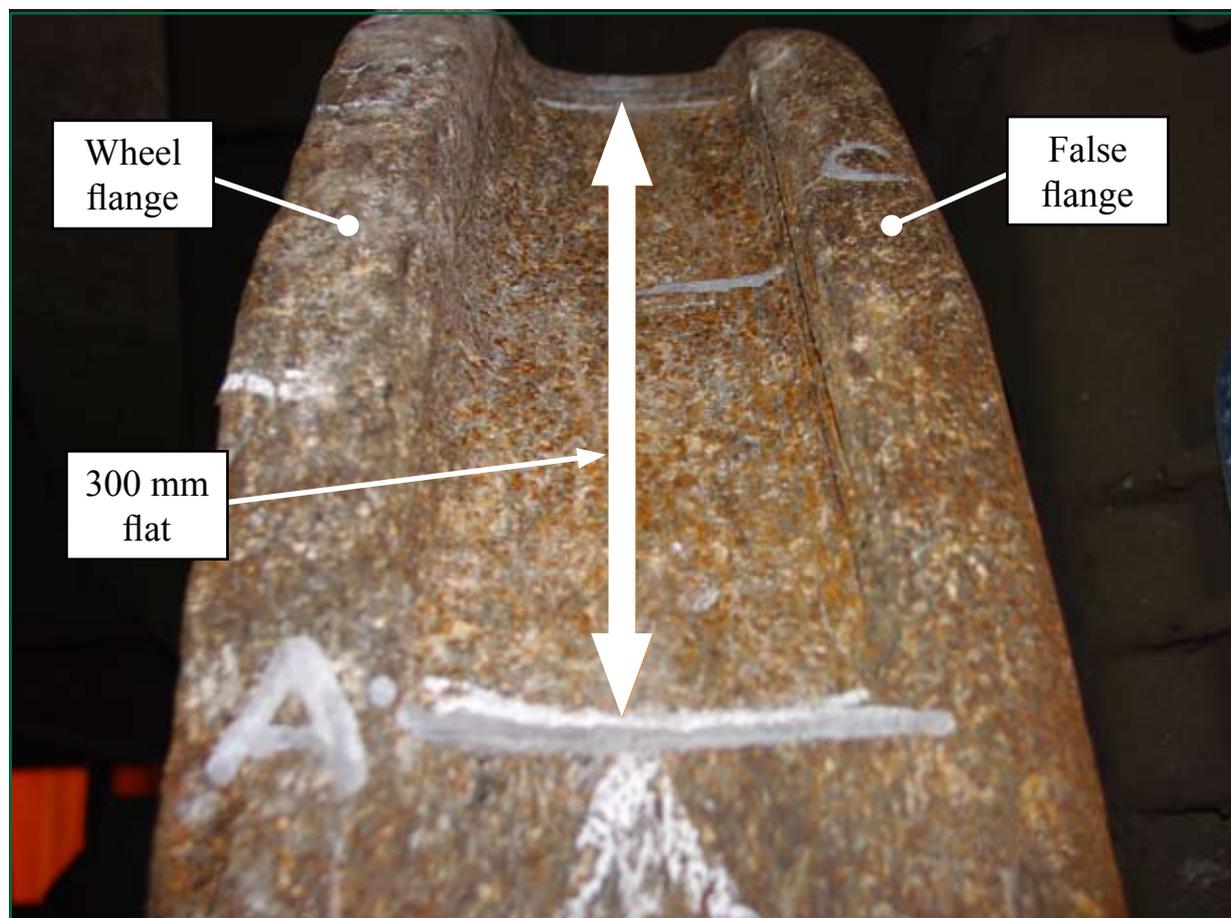
- 48 SSA 470028 suffered extensive damage to the leading (handbraked) wheelset, each wheel of which had developed large flats and deep false flanges (Figure 15). Additionally, there was also some suspension damage.

- 99 The principal features of the leading wheelset were the large flats, approximately 300 mm in length and deep false flanges which had developed on the wheels, as shown in Figure 15.
- 100 The distance required to create such large flats is dependant on many factors and there is no rigorous method for evaluating the distance dragged. However, it has been estimated by Serco Assurance, based on evidence from previous incidents in which wheelsets have run in a seized condition for long distances, that this wheelset had been dragged a distance consistent with an origin at Bescot. It is therefore unlikely that the handbrake had been left on prior to arrival at Bescot Yard. The previous occasion when the handbrake could have been applied was at Washwood Heath on 17 October.

*Figure 15: Large wheel flat and false flange on right leading wheel of SSA 470028*

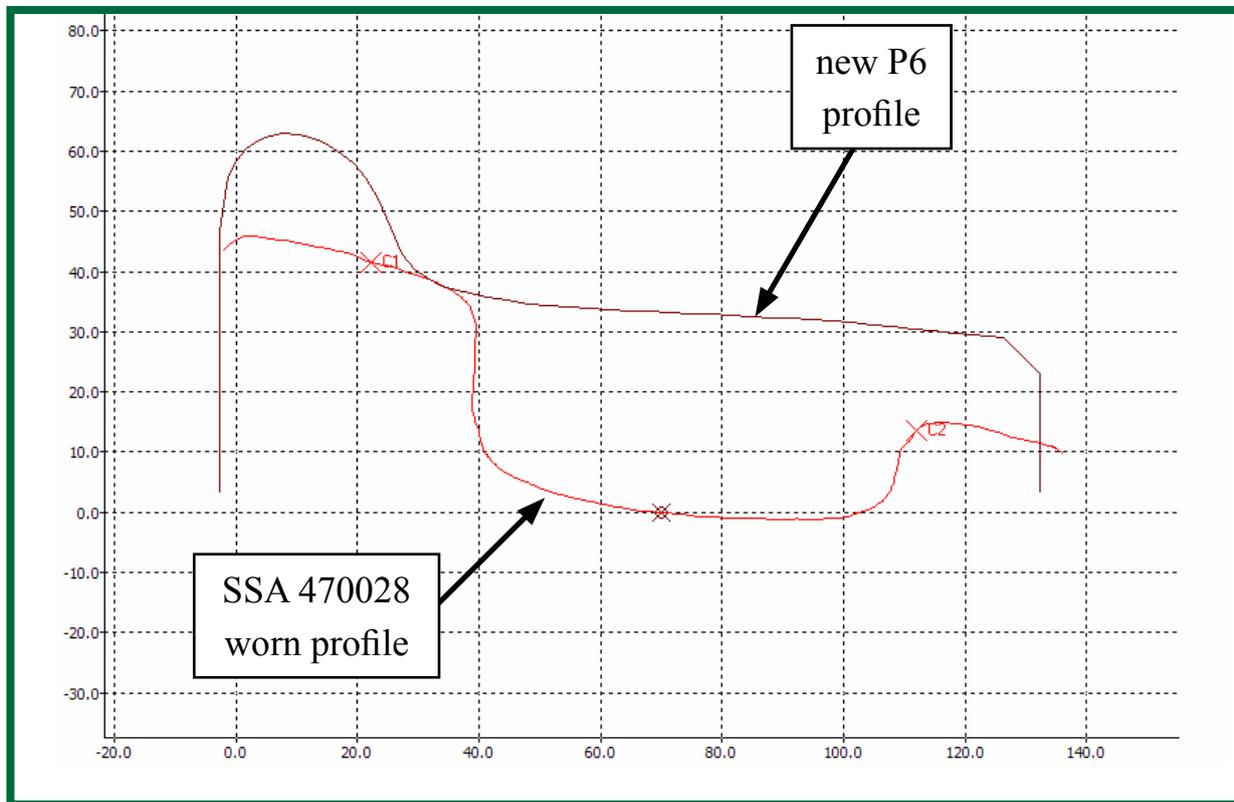
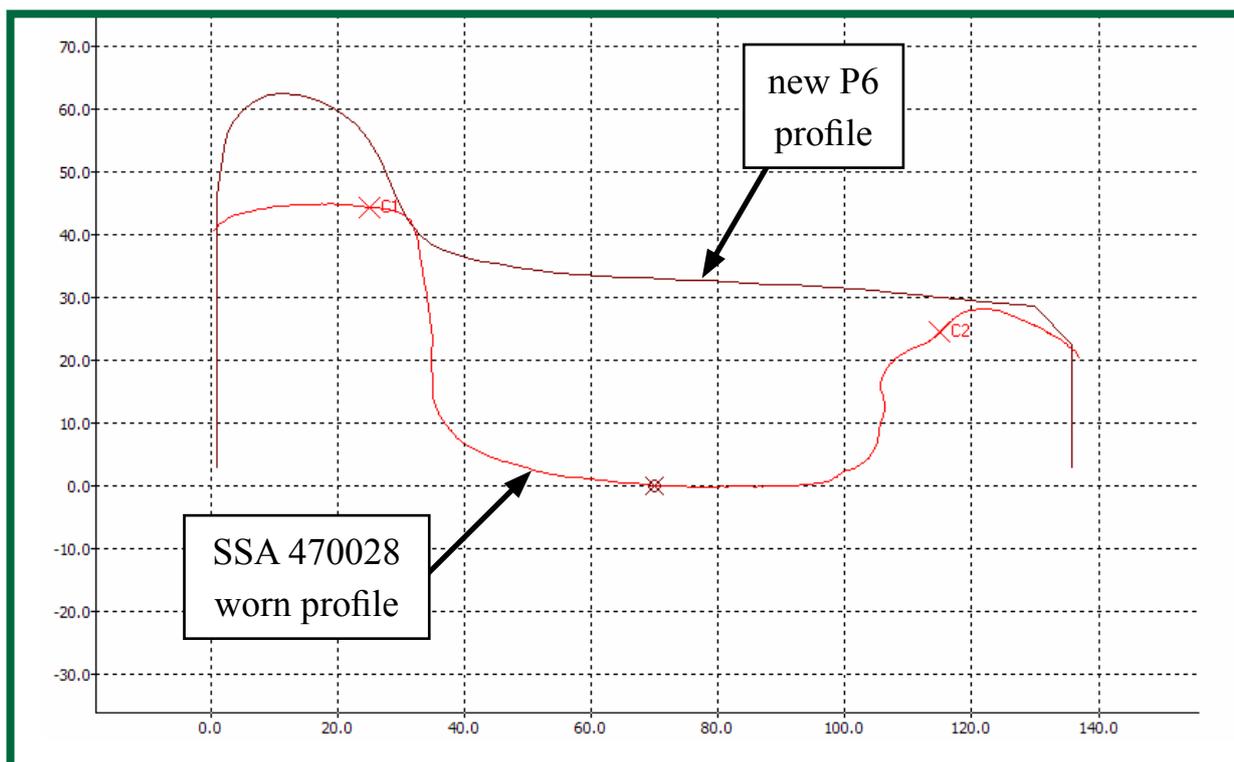
101 The profiles of the two wheels are shown in Figures 16 and 17. The different depths of the two false flanges, measured at the centre of the flats, is attributed to post derailment impact damage; the left wheel suffering more damage than the right. Some of this damage may have resulted from impacts with track components before derailing as explained in paragraph 57.

Figure 16: Profile of left leading wheel near centre of large flat

Figure 17: Profile of right leading wheel near centre of large flat

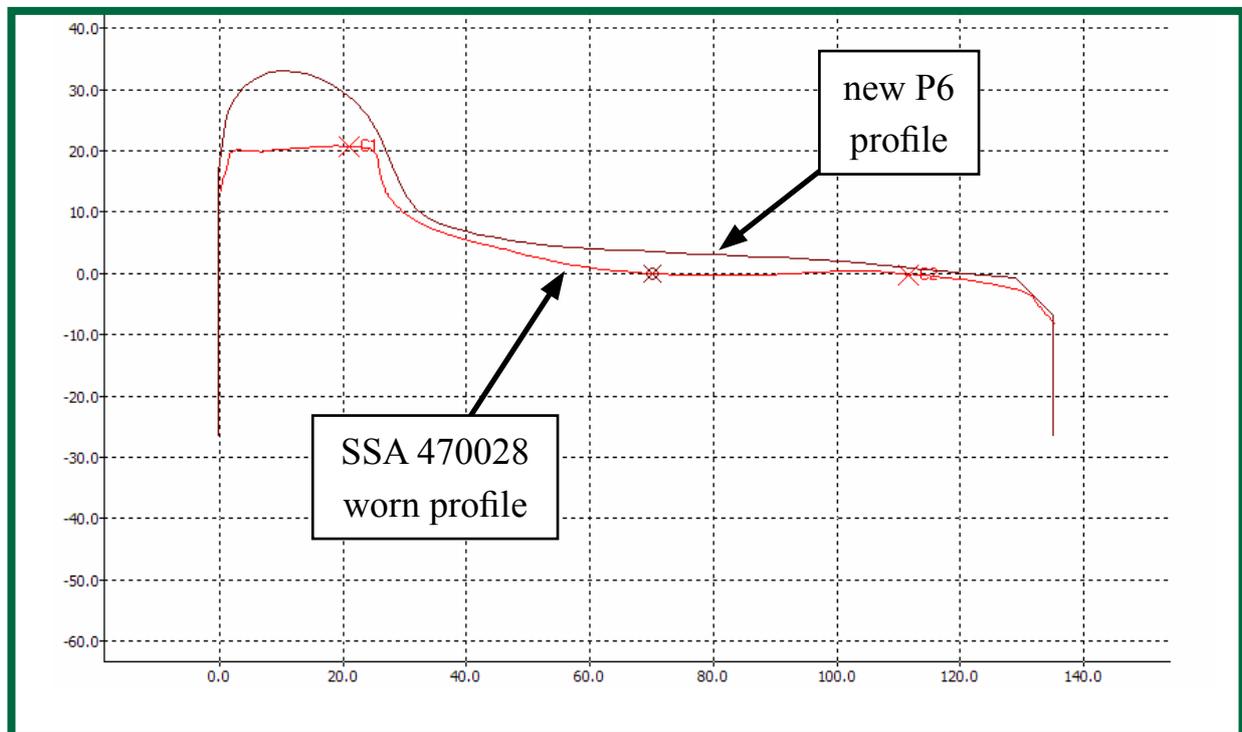
102 Each wheel of the leading wheelset also exhibited a uniform 'groove' similar in appearance to hollow wear, approximately 2-3 mm deep, around three quarters of the circumference (Figure 18). Over the remaining quarter, the depth of this groove increased in depth up to the trailing edge of the large flat.

Figure 18: Profile of right leading wheel showing uniform groove pattern due to slow rotation and wear during early part of journey.

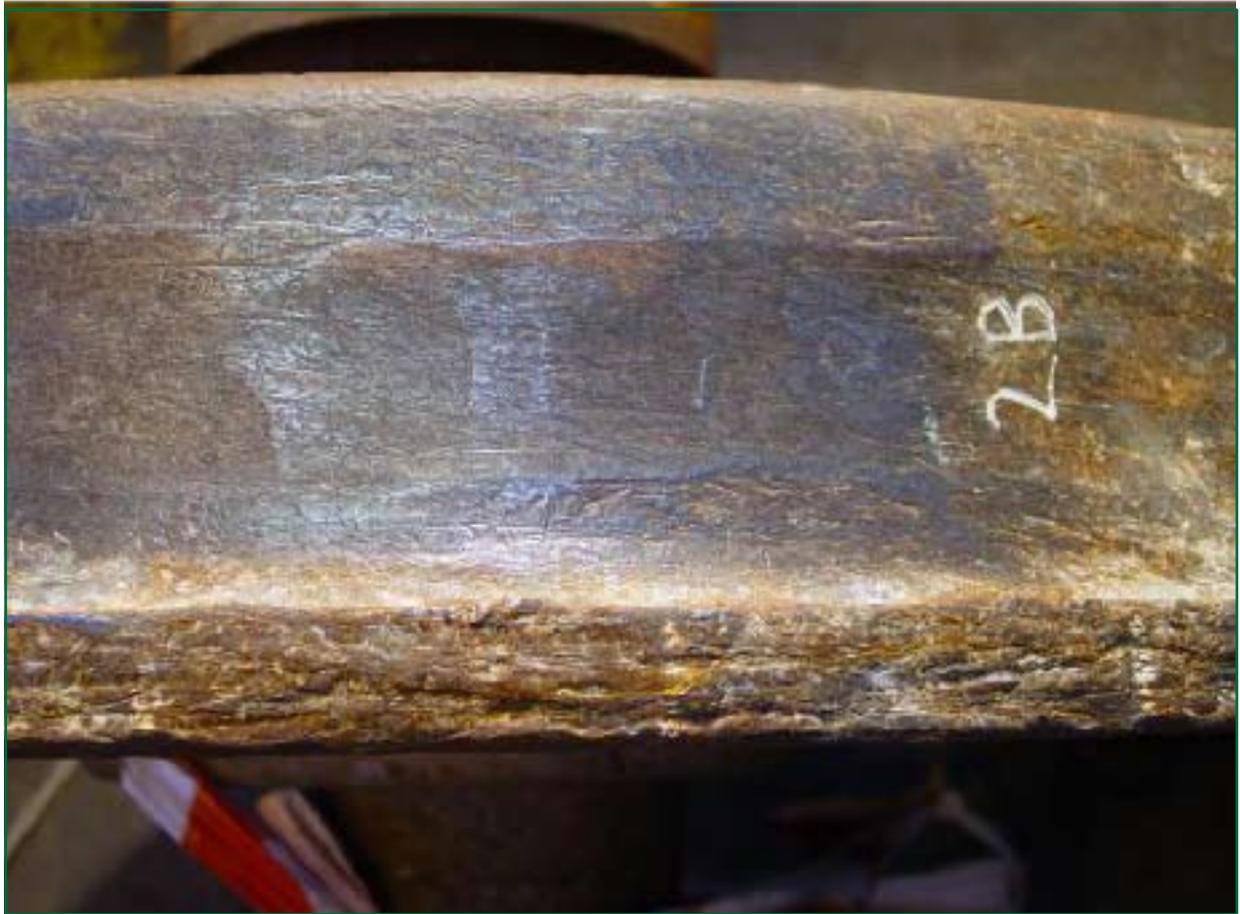
105 It is considered that the leading wheelset was initially locked (due to the handbrake being left on) when it began its journey from Bescot Yard, based on evidence from skid tests as explained later in paragraph 117. However, as the journey progressed the wheels appear to have crept round against the brake pads. This resulted in gross slip and wear at the wheel/rail interface around the whole circumference of the wheels and the formation of the uniform groove. Detailed examination of the surface of the groove (Figure 19) revealed evidence of metal flow consistent with this.

*Figure 19: Surface the uniform groove, visible after gentle burnishing.*

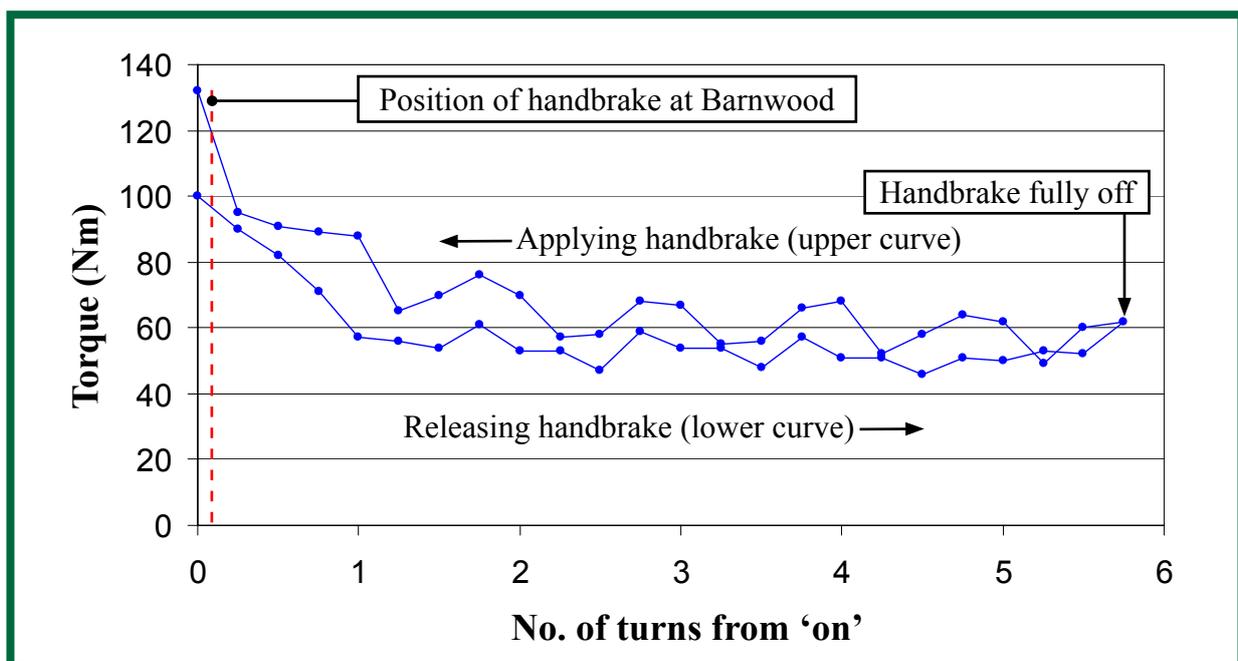
- 110 The handbrake on SSA 470028 was tested three times from each side (six in total), turning the wheel through its full range. On each test, the wheel was found to be stiff to operate, requiring torques of between approximately 50 and 70 Nm to turn it from 'off' to within two turns from 'on'. Thereafter it rose sharply, over the final two revolutions. There is no specification for the allowable maximum torque in the maintenance procedure. Figure 20 shows the variation of torque with number of turns. The position the handbrake was found at Barnwood is also shown.

Figure 20: Observed variation of applied torque with turns of the handbrake wheel on SSA wagon 470028

- 111 The torque was also found to vary cyclically within a revolution of the handbrake wheel, particularly when applying the handbrake (upper curve in Figure 20). The possibility was considered that this cyclic variation could have led ground staff, reliant on the sense of feel alone, to believe that a handbrake was 'off' when it was actually 'on'. However, at the position found post-derailment, the handbrake wheel did not exhibit cyclic variation and the wavelength of the variation elsewhere was too short to cause confusion if the correct handbrake release routine was used. Nevertheless, it is conceivable that if the handbrake wheel was briefly checked by turning to the 'off' position only (ie contrary to standard practice), the stiffness of the handbrake wheel could lead a train preparer to incorrectly believe the handbrake was 'off'. The handbrake indicators were rechecked and found to be the same as noted on site (see paragraph 91)
