ACCIDENT

Aircraft Type and Registration:	Ikarus C42 FB80, G-DCDO	
No & Type of Engines:	1 Rotax 912-UL piston engine	
Year of Manufacture:	2010 (Serial no: 1008-7115)	
Date & Time (UTC):	2 July 2014 at 1520 hrs	
Location:	Dunkeswell Airfield, Devon	
Type of Flight:	Private	
Persons on Board:	Crew - 1	Passengers - 1
Injuries:	Crew - None	Passengers - None
Nature of Damage:	Burst front tyre and damage to nosewheel fork and nose gear mountings	
Commander's Licence:	Private Pilot's Licence	
Commander's Age:	59 years	
Commander's Flying Experience:	154 hours (of which 38 were on type) Last 90 days - 20 hours Last 28 days - 20 hours	
Information Source:	Aircraft Accident Report Form submitted by the pilot

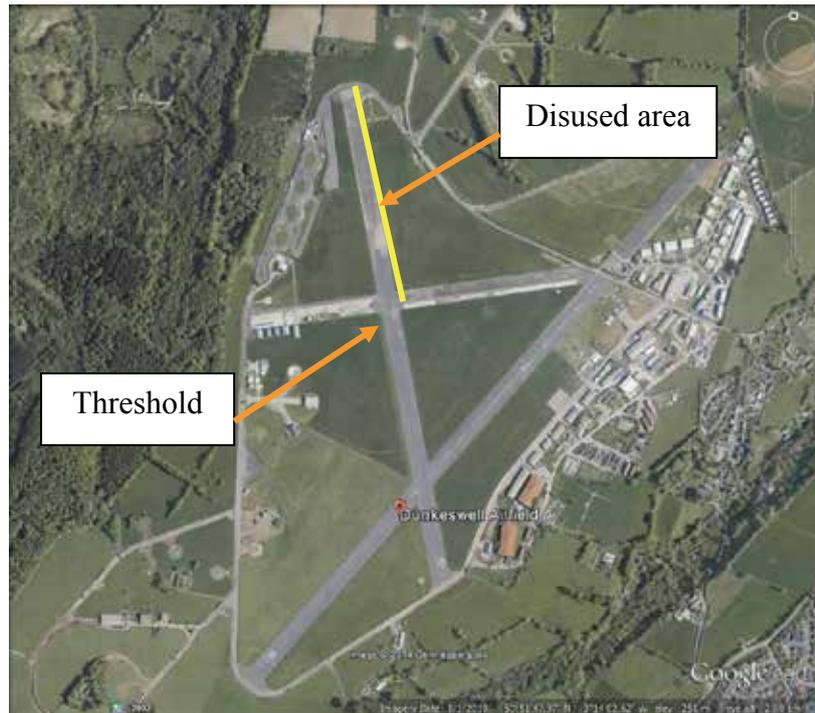
Figure 1

Dunkeswell Airfield showing displaced threshold of Runway 17
