ACCIDENT

Aircraft Type and Registration:	Enstrom 280C Shark, G-IDUP	
No & Type of Engines:	1 Lycoming HIO-360-E1AD piston engine	
Year of Manufacture:	1979 (Serial no: 1163)	
Date & Time (UTC):	3 June 2014 at 1657 hrs	
Location:	Northampton/Sywell Aerodrome, Northamptonshire	
Type of Flight:	Private	
Persons on Board:	Crew - 1	Passengers - None
Injuries:	Crew - None	Passengers - N/A
Nature of Damage:	Damage to the rotor blades and fuselage, and gearbox shock-loaded	
Commander's Licence:	Private Pilot's Licence	
Commander's Age:	70 years	
Commander's Flying Experience:	1,572 hours (of which 1,210 were on type) Last 90 days - 18 hours Last 28 days - 5 hours	
Information Source:	Aircraft Accident Report Form submitted by the pilot

Synopsis

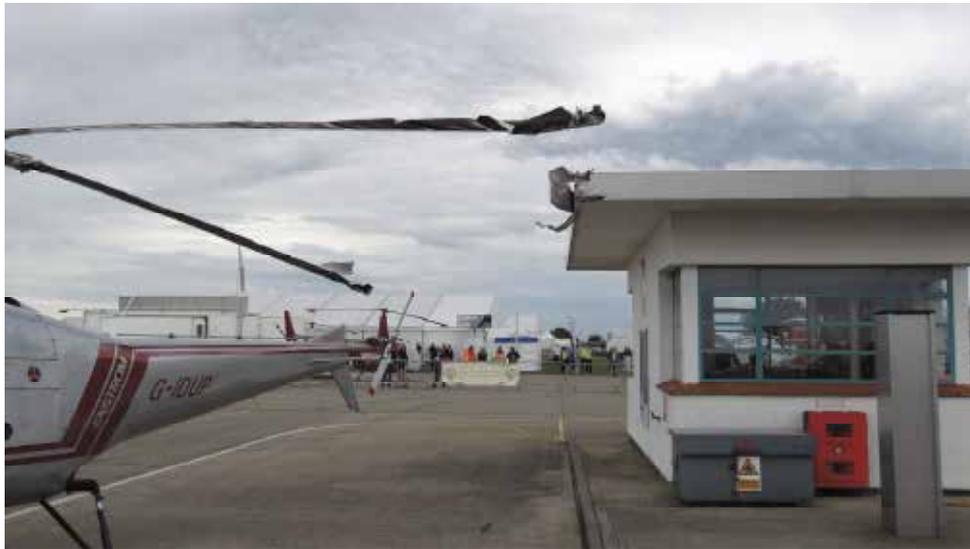
Figure 1

The position of the point of impact on the building meant that it was outside the pilot's field of view when he was looking ahead, to land (see Figure 1).

The pilot considered that, as he approached the fuel pumps, his eye line was level with the roof overhang and he had not appreciated the potential hazard. On turning parallel with the pumps, the building was then located over his left shoulder, behind him and out of his field of view. When he descended to land, he could not see the obstacle and the main rotor blade tips struck the roof overhang.

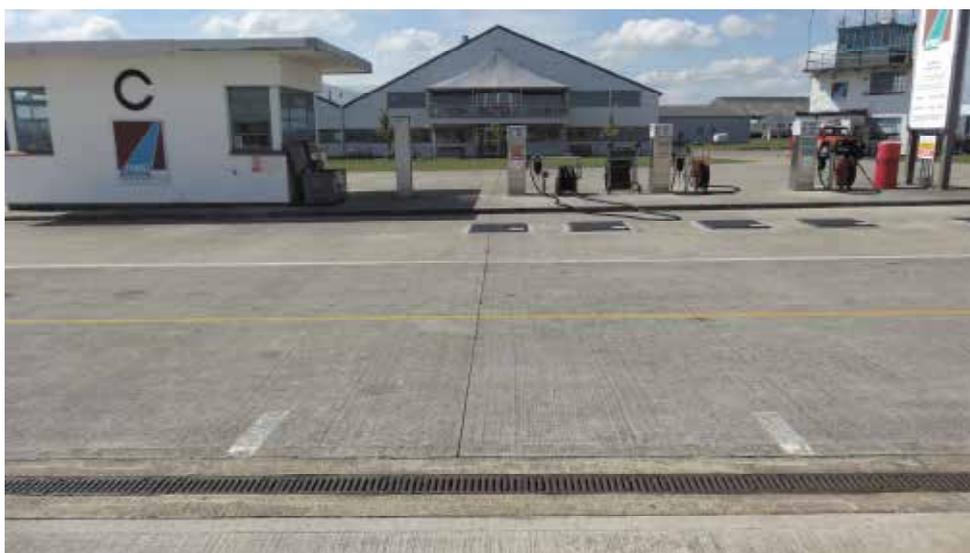
Figure 2

The aerodrome operator informed the investigation that a white line surrounds the refuelling area. Also, there are two short parallel white lines, adjacent to a drainage channel (see Figure 2) and opposite the fuel pump nearest the single-storey building, which has a longer hose, that provide position guidance for helicopters being refuelled.

This information does not appear in the United Kingdom Aeronautical Information Publication (UKAIP) or commercially available flight guides.

The pilot had consulted a commercially available flight guide but was not aware of the unpublished information regarding the white markings at the refuelling area.
