## ACCIDENT

<b>Aircraft Type and Registration:</b>	Czech Sport Aircraft SportCruiser, G-EMSA	
<b>No &amp; Type of Engines:</b>	1 Rotax 912ULS piston engine	
<b>Year of Manufacture:</b>	2010 (Serial no: 09SC323)	
<b>Date &amp; Time (UTC):</b>	30 August 2014 at 1245 hrs	
<b>Location:</b>	Near Saffron Walden, Essex	
<b>Type of Flight:</b>	Private	
<b>Persons on Board:</b>	Crew - 1	Passengers - None
<b>Injuries:</b>	Crew - None	Passengers - N/A
<b>Nature of Damage:</b>	Damage to propeller, engine cowling and exhaust, noseleg and landing light	
<b>Commander's Licence:</b>	Commercial Pilot's Licence	
<b>Commander's Age:</b>	60 years	
<b>Commander's Flying Experience:</b>	2,065 hours (of which 2,057 were on type) Last 90 days - 180 hours Last 28 days - 60 hours	
<b>Information Source:</b>	Aircraft Accident Report Form submitted by the pilot and technical information published by the aircraft manufacturer

## Synopsis

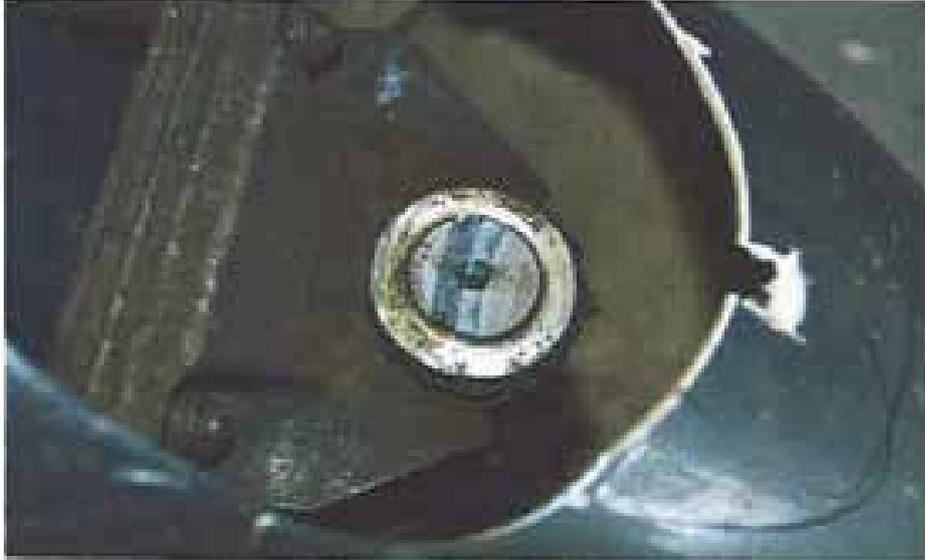
**Figure 1**

The pilot explained that the nosewheel assembly had detached following a failure in the nose leg. The failure occurred in a vertical spindle at the forward, lower end of the leg, which entered an upper bushing on the nosewheel bracket. The pilot attributed the failure of the vertical spindle to fatigue, and noted that no corrosion was visible on the leg. A photograph of the failed component is shown at Figure 1.

Photograph of the failed vertical spindle, taken from above

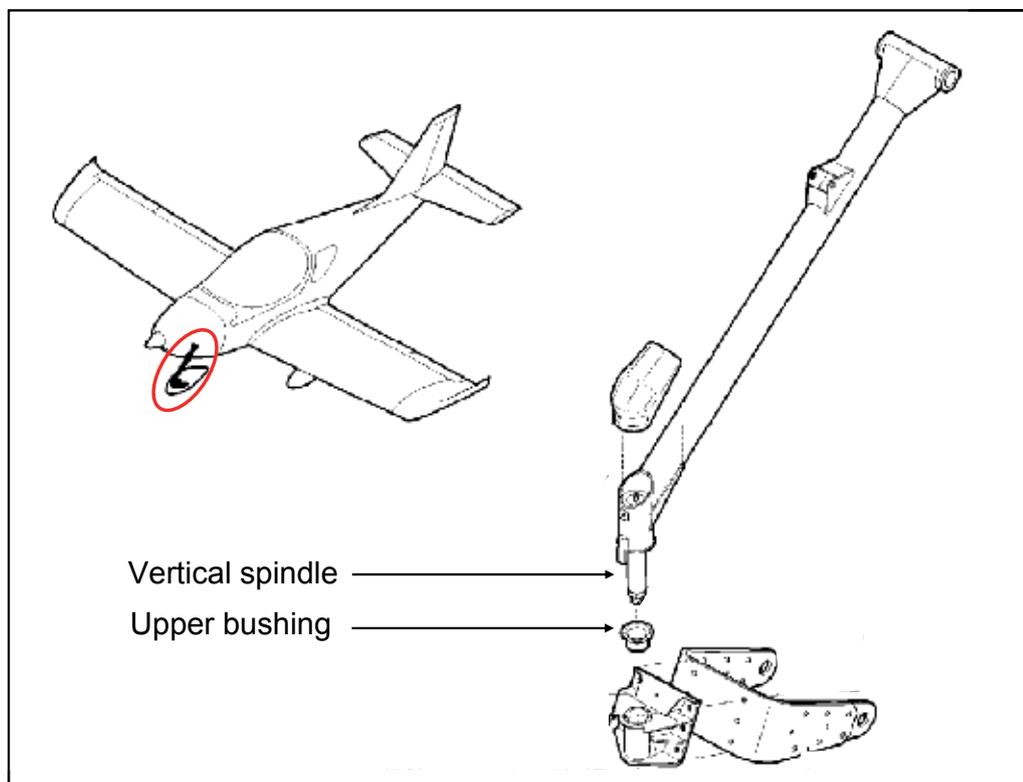
**Figure 2**

Figure 2 shows the general arrangement of the nose landing gear (NLG), being a simplified version of a diagram included in the manufacturer's illustrated parts catalogue. The vertical spindle and upper bushing, referred to by the pilot, are identified.

Nose landing gear assembly (simplified, nosewheel omitted)
